**Flood Control Project Maintenance
Levee Inspections**

Fall 2011 Levee Maintenance Deficiency Summary Report

Sacramento River Basin

Reclamation District No. 0341 Sherman Island

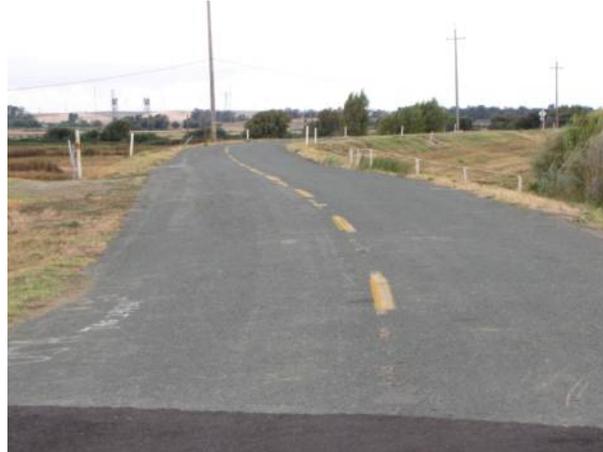
LMIR No.	Levee Mile		Category	Item	Location *	Rating **	Action/Comment	GPS Latitude/Longitude		Issue No. Photo
	Start	End						Start	End	
1	0.00	0.00	Earthen Levee	Vegetation	LS	A	Remove the wild growth other than native grasses from the levee slopes. Inspector Comments: The District does a great job on maintenance.	38.085580 ° -121.686494 °	38.085580 ° -121.686494 °	9 Y
2	1.25	1.75	Earthen Levee	Encroachments	LS	PO	Fences	38.099663 ° -121.706390 °	38.098232 ° -121.706273 °	4

Levee Mile Report Line	1
Start Levee Mile	0.00
End Levee Mile	0.00
Location	
Category	Earthen Levee
Item	Vegetation
Unit 1 RD 341 Looking downstream from L/M 0.00 Photo taken 10-04,-2011	
phillips_f_20111004_223.jpg

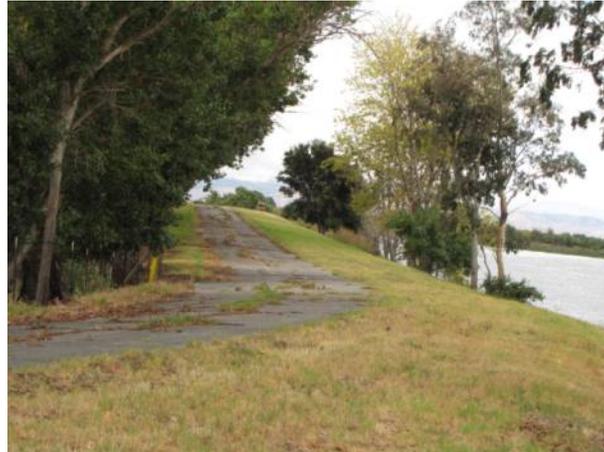
LMIR No.	Levee Mile		Category	Item	Location *	Rating **	Action/Comment	GPS Latitude/Longitude		Issue No. Photo
	Start	End						Start	End	
1	0.00	0.00	Earthen Levee	Vegetation	WS	A	Remove the wild growth other than native grasses from the levee slopes. Inspector Comments: This District has done a great job on keeping the levees mowed and maintained.	38.105230 ° -121.702571 °	38.105230 ° -121.702571 °	10 Y
2	1.25	1.25	Earthen Levee	Trim / Thin Trees	LS	N	Tree stumps.	38.104642 ° -121.704082 °	38.104642 ° -121.704082 °	4 Y
3	4.14	4.17	Supplemental	USACE Erosion Survey	WS	M	Inspector Comments: 2011: Large new erosion pocket probably hidden by vegetation in the past. [2011 Site ID: SAC_8-2_L]	38.095148 ° -121.706367 °	38.094590 ° -121.706393 °	5 Y
4	4.32	4.50	Supplemental	USACE Erosion Survey	WS	M	Inspector Comments: 1999 - New small slump in eroded bank. 2005 - Reach extended because of vertical bank along the roadway upstream. 2011: More slumping since last year. [2011 Site ID: SAC_8-0_L]	38.090620 ° -121.706684 °	38.088572 ° -121.707127 °	7 Y

Levee Mile Report Line	1
Start Levee Mile	0.00
End Levee Mile	0.00
Location	Water Side
Category	Earthen Levee
Item	Vegetation
Unit 2 RD 341 Looking downstream. Photo taken 10-04-2011.	
phillips_f_20111010_008.jpg

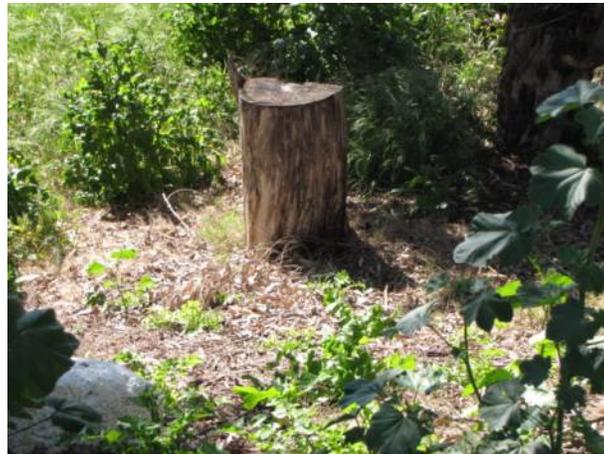
Levee Mile Report Line	2
Start Levee Mile	1.25
End Levee Mile	1.25
Location	Land Side
Category	Earthen Levee
Item	Trim / Thin Trees
Stump off toe of levee L/M 1.25 landward .	
phillips_f_20110929_082.jpg

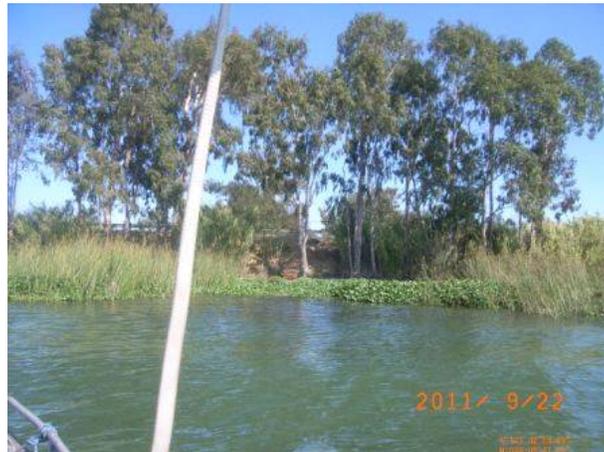
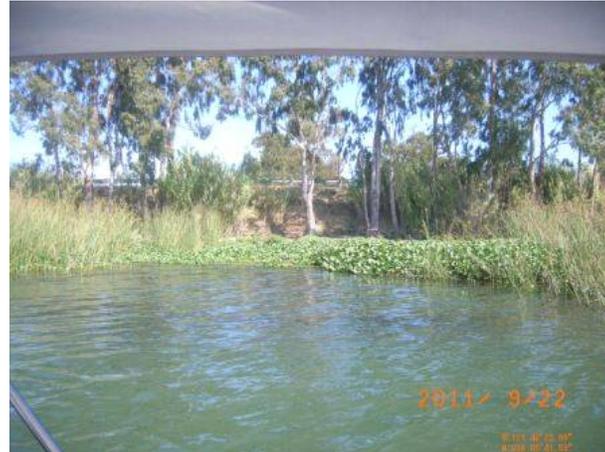
Levee Mile Report Line	3
Start Levee Mile	4.14
End Levee Mile	4.17
Location	Water Side
Category	Supplemental
Item	USACE Erosion Survey
USACE 2011 Photo #1	
USACE2011_SAC_8-2_L_1.jpg

Levee Mile Report Line	3
Start Levee Mile	4.14
End Levee Mile	4.17
Location	Water Side
Category	Supplemental
Item	USACE Erosion Survey
USACE 2011 Photo #2	
USACE2011_SAC_8-2_L_2.jpg

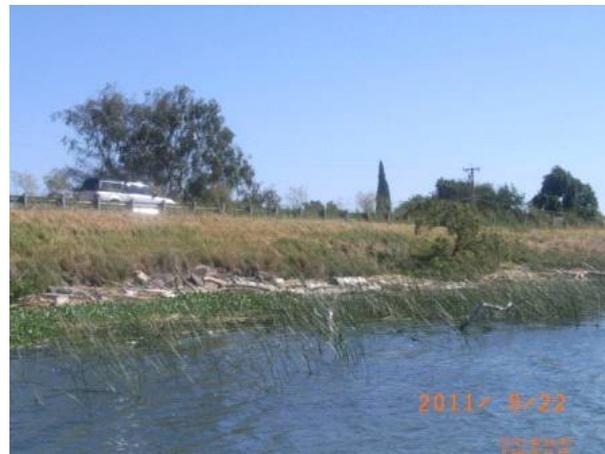
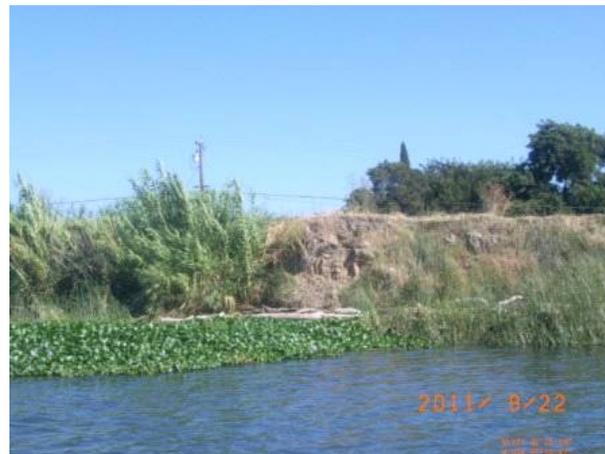
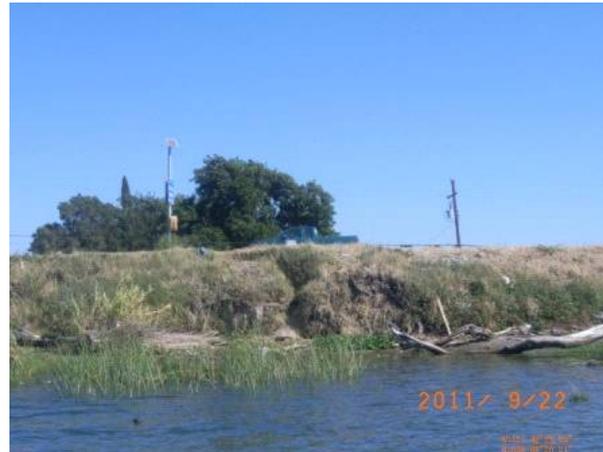
Levee Mile Report Line	4
Start Levee Mile	4.32
End Levee Mile	4.50
Location	Water Side
Category	Supplemental
Item	USACE Erosion Survey
USACE 2011 Photo #1	
USACE2011_SAC_8-0_L_1.jpg

Levee Mile Report Line	4
Start Levee Mile	4.32
End Levee Mile	4.50
Location	Water Side
Category	Supplemental
Item	USACE Erosion Survey
USACE 2011 Photo #2	
USACE2011_SAC_8-0_L_2.jpg

Levee Mile Report Line	4
Start Levee Mile	4.32
End Levee Mile	4.50
Location	Water Side
Category	Supplemental
Item	USACE Erosion Survey
USACE 2011 Photo #3	
USACE2011_SAC_8-0_L_3.jpg

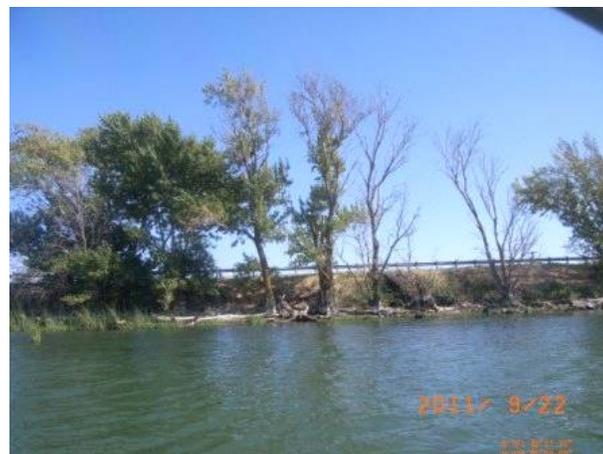
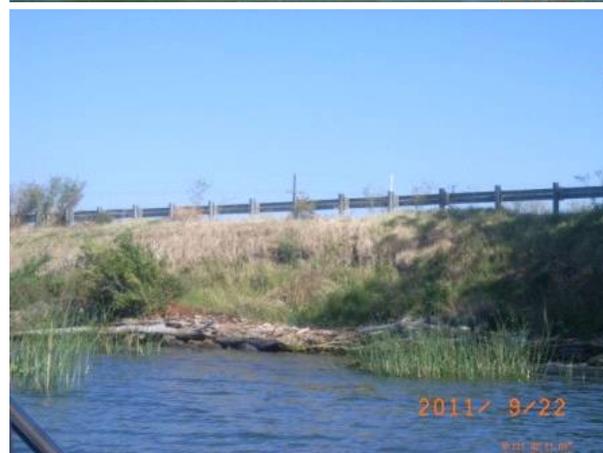
5	4.58	4.65	Supplemental	USACE Erosion Survey	WS	M	Inspector Comments: 2011: Large slump section [2011 Site ID: SAC_7-9_L]	38.086603 ° -121.707786 °	38.086110 ° -121.708114 °	8 Y
6	5.98	6.03	Supplemental	USACE Erosion Survey	WS	U	Inspector Comments: 2011: Large slump at downstream end. Gully formed from surface runoff from the road. Shallow slumping throughout site. [2011 Site ID: SAC_7-3_L]	38.080526 ° -121.730483 °	38.080370 ° -121.728341 °	9 Y
7	6.32	6.35	Earthen Levee	Trim / Thin Trees	LS	M	Trim trees to at least five feet above ground level.	° °	° °	2
8	7.92	8.10	Earthen Levee	Encroachments	LS	PO	Fences	38.073268 ° -121.759500 °	38.072275 ° -121.762510 °	6

Levee Mile Report Line	5
Start Levee Mile	4.58
End Levee Mile	4.65
Location	Water Side
Category	Supplemental
Item	USACE Erosion Survey
USACE 2011 Photo #1	
USACE2011_SAC_7-9_L_1.jpg

Levee Mile Report Line	5
Start Levee Mile	4.58
End Levee Mile	4.65
Location	Water Side
Category	Supplemental
Item	USACE Erosion Survey
USACE 2011 Photo #2	
USACE2011_SAC_7-9_L_2.jpg

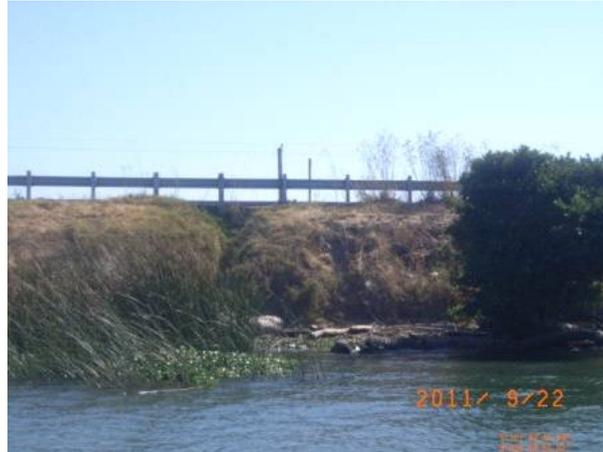
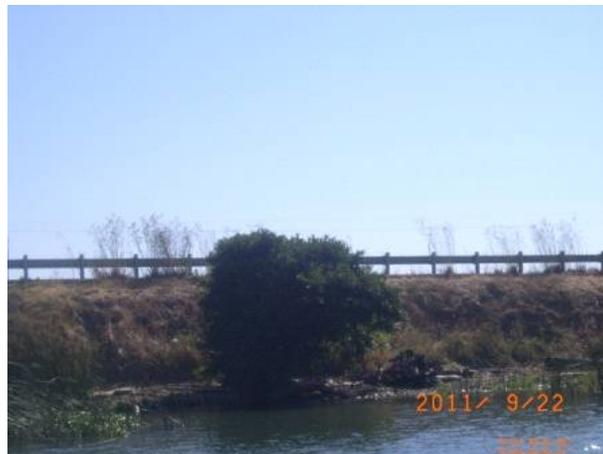
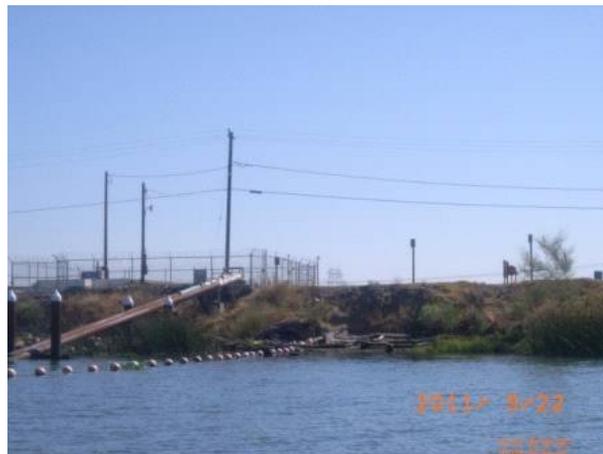
Levee Mile Report Line	6
Start Levee Mile	5.98
End Levee Mile	6.03
Location	Water Side
Category	Supplemental
Item	USACE Erosion Survey
USACE 2011 Photo #1	
USACE2011_SAC_7-3_L_1.jpg

Levee Mile Report Line	6
Start Levee Mile	5.98
End Levee Mile	6.03
Location	Water Side
Category	Supplemental
Item	USACE Erosion Survey
USACE 2011 Photo #2	
USACE2011_SAC_7-3_L_2.jpg

Levee Mile Report Line	6
Start Levee Mile	5.98
End Levee Mile	6.03
Location	Water Side
Category	Supplemental
Item	USACE Erosion Survey
USACE 2011 Photo #3	
USACE2011_SAC_7-3_L_3.jpg
