**Flood Control Project Maintenance
Levee Inspections
LMA District Cover Sheet
Spring 2011 Levee Inspection Results**

Reclamation District No. 0341 Sherman Island

Levee Inspection Report By Mile - Spring 2011

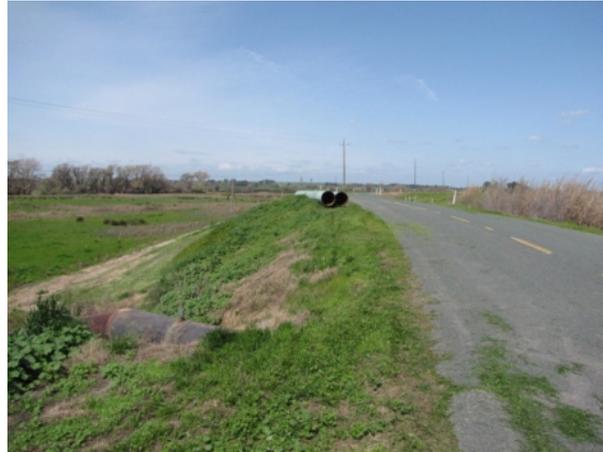
Levee Mile Report Line	1
Start Levee Mile	0.00
End Levee Mile	0.00
Location	Land Side
Category	Earthen Levee
Item	Vegetation

This photo taken from levee mile 0.00 of RD 341 standing on landside looking downstream. Photo taken 3-16-2011.

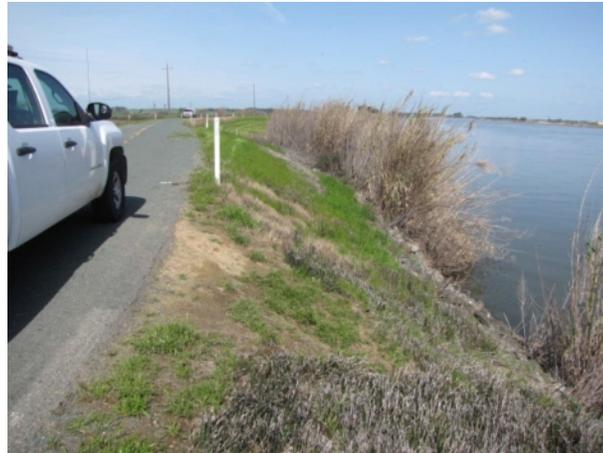
Levee Mile Report Line	2
Start Levee Mile	0.00
End Levee Mile	0.00
Location	Water Side
Category	Earthen Levee
Item	Vegetation

Photo taken of the waterside of levee slope Unit 1 RD 341. Looking downstream from levee mile 0.00. Photo taken 3-16-2011 The weeds have been sprayed in the rip rap but removed from levee section.

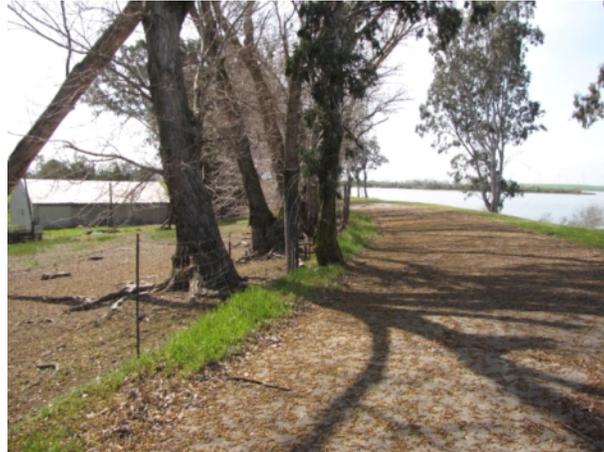
Levee Mile Report Line	1
Start Levee Mile	0.00
End Levee Mile	0.00
Location	Land Side
Category	Earthen Levee
Item	Vegetation
<p>This photo taken at levee mile 0.00 at gate looking downstream landside unit 2 RD 341. Photo taken 03-06-2011</p>	
<p>phillips_s_20110321_210.jpg</p>

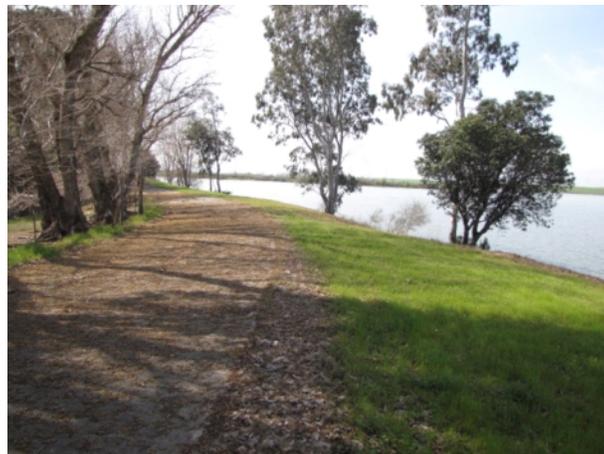
Levee Mile Report Line	2
Start Levee Mile	0.00
End Levee Mile	0.00
Location	Water Side
Category	Earthen Levee
Item	Vegetation
<p>This photo shows the waterside of unit 2 standing at the gate looking downstream from levee mile 0.00. Photo taken 03-16-2011</p>	
<p>phillips_s_20110321_211.jpg</p>

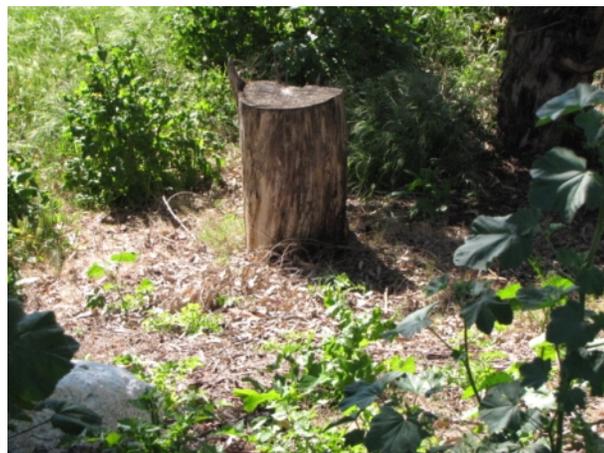
Levee Mile Report Line	3
Start Levee Mile	1.25
End Levee Mile	1.25
Location	Land Side
Category	Earthen Levee
Item	Trim / Thin Trees
<p>Stump off toe of levee L/M 1.25 landward .</p>	
<p>phillips_s_20110228_157.jpg</p>

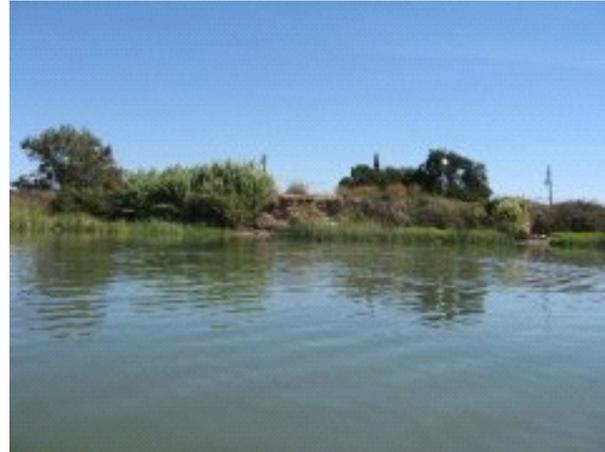
Levee Mile Report Line	4
Start Levee Mile	4.45
End Levee Mile	4.60
Location	Water Side
Category	Supplemental
Item	USACE Erosion Survey
2009: no berm, vertical slope, no stability issues, clays and silts, 5.13 ft/s [2009 SiteID:SAC_8-0_L]	
phillips_s_20110228_158.JPG
