**Flood Control Project Maintenance
Levee Inspections**
LMA District Cover Sheet
Spring 2014 Levee Inspection Results

Reclamation District No. 0341 Sherman Island

Spring 2014 Levee Inspection Results

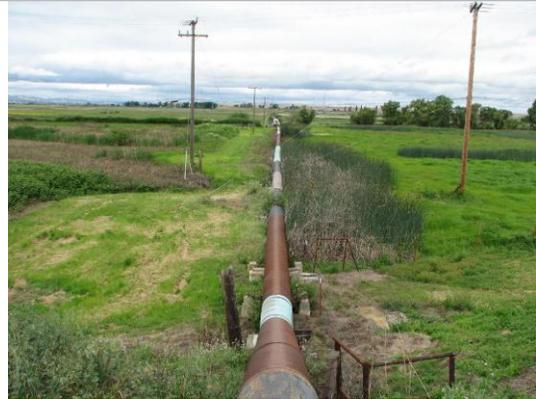
Photo 1 of 1 : UCIP_2802.jpg

LM Start	0.00	Rating **	M	Issue No.	43
LM End	0.00	Issue Type +	En	Location *	LS
Category	Supplemental			GPS Latitude/Longitude	
				Start	End
Item	DWR UCIP Field Study			38.085507 °	38.085507 °
				-121.686528 °	-121.686528 °
DWR ID	DWR_RD0341_01_s_2014_43				
Action/Comments					
Inspector Comments: FS_ID:22063 EP_NO: N/A Repair Type: Crossing Status: UCIP Comments: Dense vegetation limits the inspector's visibility to identify signs of pipe failure (leaks) along the slopes. Recommend removing vegetation along pipe alignment to conduct proper inspection of structure and appurtenances. FIELD_STRUCT_DESC: 30-inch steel drainage pipe through the levee, 11.1 feet below the crown. CM cutoff wall around pipe at center of levee. Siphon breaker on both sides. Pump on landward side approximately 300 feet from landward toe. Pipe exposed on both levee slopes. Rock revetment on waterward slope. (USACE-1962). This entry matches the Drainage or Irrigation Structure referenced in O&M manual (HLM 0.0). Marine Station number 1 located on waterward side with attached small solar panel on top. FS Date: 5/5/2009

Overview of landward slope above ground once it exits levee. Pump is located approximately 300 feet from levee toe.

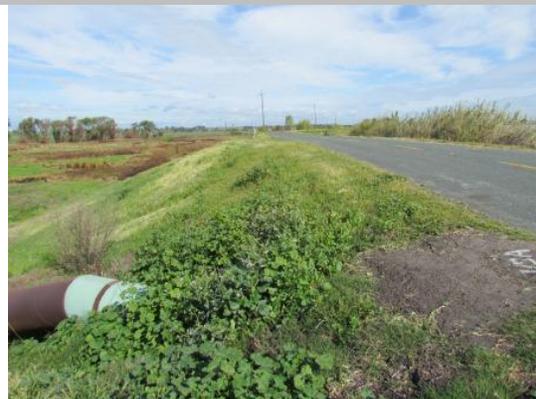
Photo 1 of 1 : phillips_s_20140522_05936.jpg

LM Start	0.00	Rating **	A/W	Issue No.	2
LM End	3.34	Issue Type +	Ma	Location *	LS
Category	Earthen Levee			GPS Latitude/Longitude	
				Start	End
Item	Vegetation			38.085533 °	38.105209 °
				-121.686480 °	-121.702210 °
DWR ID	DWR_RD0341_01_s_2013_2				
Action/Comments					
Control annual grass and weeds on the levee slopes and easements.

RD 341 Unit 1 levee mile 0.00 landside levee section. Photo taken 03-04-2014.

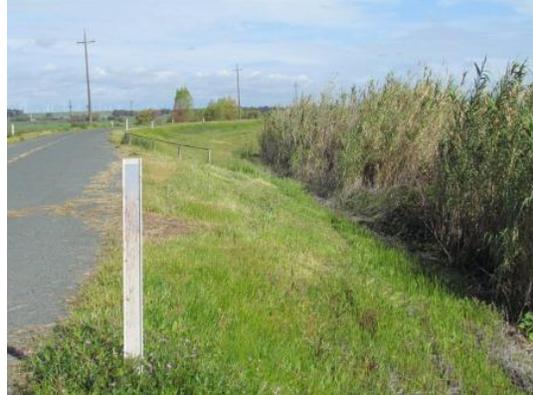
Photo 1 of 1 : phillips_s_20140522_05937.jpg

RD 341 Unit 1 levee mile 0.00 waterside slope arundo present at toe of levee section. Photo taken 03-04-2014.

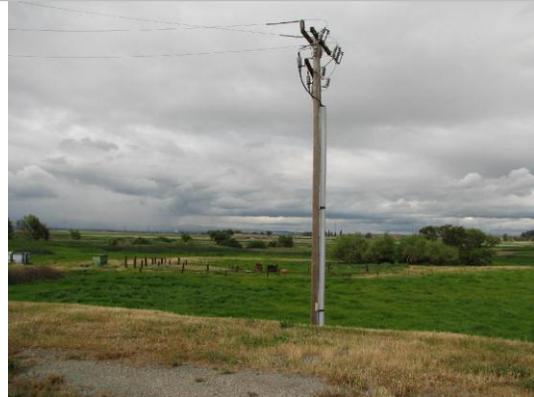
Photo 1 of 1 : UCIP_2804.jpg

LM Start	0.48	Rating **	M	Issue No.	48
LM End	0.48	Issue Type +	En	Location *	WS
Category	Supplemental			GPS Latitude/Longitude	
				Start	End
Item	DWR UCIP Field Study			38.092464 °	38.092464 °
				-121.686962 °	-121.686962 °
DWR ID	DWR_RD0341_01_s_2014_48				
Action/Comments					
Inspector Comments: FS_ID:22064 EP_NO: 6297 Repair Type: Crossing Status: UCIP Comments: Markers Missing. No markers found to confirm crossing is still in use--need to contact owner to determine status of crossing. FIELD_STRUCT_DESC: 3-inch electrical conduit through the levee, 3.5 feet below the crown. Location marker on waterward shoulder--no marker found. Pole on landward side. Rock revetment on waterward slope. (Permit No. 6297-1969) FS Date: 5/5/2009

Power pole located on landward side aligns with crossing.

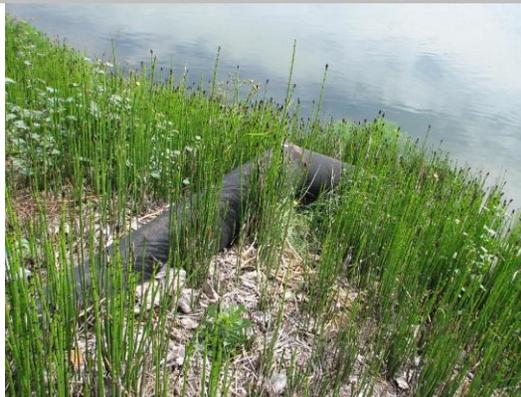
Photo 1 of 1 : UCIP_2809.jpg

LM Start	0.50	Rating **	M	Issue No.	49
LM End	0.50	Issue Type +	En	Location *	WS
Category	Supplemental		GPS Latitude/Longitude		
			Start	End	
Item	DWR UCIP Field Study		38.092754 °	38.092754 °	
			-121.686878 °	-121.686878 °	
DWR ID	DWR_RD0341_01_s_2014_49				
Action/Comments					
Inspector Comments: FS_ID:22068 EP_NO: 1477 Repair Type: Crossing Status: UCIP Comments: Dense vegetation limits the inspector's visibility to identify signs of pipe failure (leaks) along the slopes. Recommend removing vegetation along pipe alignment to conduct proper inspection of structure and appurtenances. FIELD_STRUCT_DESC: 10-inch steel pipe through the levee, 1.8 feet below the crown. Pipe is encased in 12-inch CM condutor pipe under crown. Pump on landward side. Air vent and metal distribution box with gate on the landward side. Rock revetment on the waterward slope. (USACE-1962). This entry matches the Drainage or Irrigation Structure referenced in O&M manual (HLM 0.50). 30-feet of pipe under crown was replaced and encased in CM pipe under Permit No. 1477 (1950). FS Date: 5/5/2009

View of pipe on waterward side.

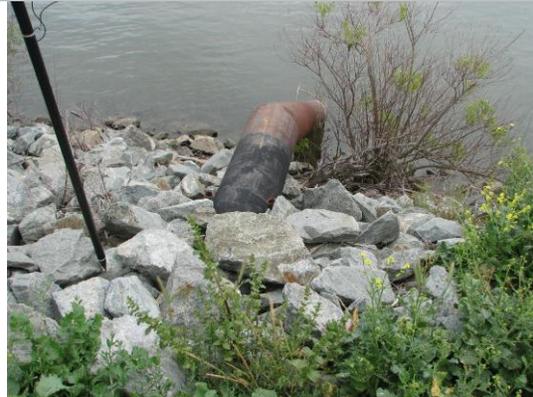
Photo 1 of 1 : UCIP_2818.jpg

LM Start	1.07	Rating **	M	Issue No.	50
LM End	1.07	Issue Type +	En	Location *	WS
Category	Supplemental			GPS Latitude/Longitude	
				Start	End
Item	DWR UCIP Field Study			38.100972 °	38.100972 °
				-121.686813 °	-121.686813 °
DWR ID	DWR_RD0341_01_s_2014_50				
Action/Comments					
Inspector Comments: FS_ID:22070 EP_NO: 11095 Repair Type: Crossing Status: UCIP Comments: Dense vegetation limits the inspector's visibility to identify signs of pipe failure (leaks) along the slope. Recommend removing vegetation along pipe alignment to conduct proper inspection of structure and appurtenances. FIELD_STRUCT_DESC: 18-inch pipe sleeved through 24-inch pipe through the levee, 4.0 feet below the crown. Air vent and monitoring well on landward side. Pipe exposed on the waterward slope. This pipe was retained under ABO No. 11095 (1975). FS Date: 5/5/2009

View of pipe located on waterward side.

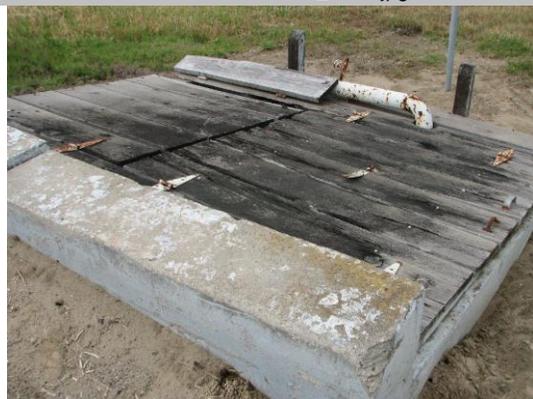
Photo 1 of 1 : UCIP_2825.jpg

LM Start	1.43	Rating **	M	Issue No.	51
LM End	1.43	Issue Type +	En	Location *	WS
Category	Supplemental			GPS Latitude/Longitude	
				Start	End
Item	DWR UCIP Field Study			38.106183 °	38.106183 °
				-121.685541 °	-121.685541 °
DWR ID	DWR_RD0341_01_s_2014_51				
Action/Comments					
Inspector Comments: FS_ID:22074 EP_NO: N/A Repair Type: Crossing Status: UCIP Comments: Need to contact owner to determine if crossing is still active and to determine last inspection date. Will need copy of letter showing crossings passed inspection. NEED photo of emergency contact information from marker. FIELD_STRUCT_DESC: 10-inch steel gas line through the levee. Valve in concrete box on the landward side. (USACE-1962). This entry matches the Drainage or Irrigation Structure referenced in O&M manual (HLM 1.42). FS Date: 5/5/2009

Concrete box located on landward side.

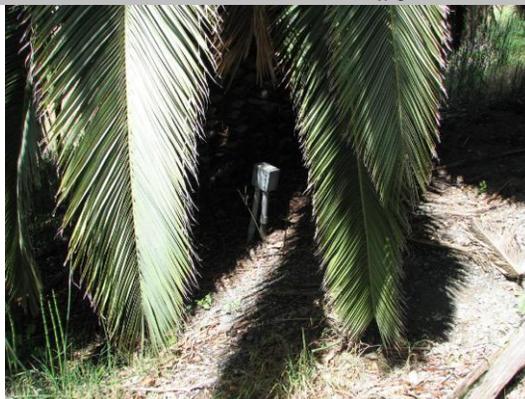
Photo 1 of 1 : UCIP_2833.jpg

LM Start	1.95	Rating **	M	Issue No.	53
LM End	1.95	Issue Type +	En	Location *	WS
Category	Supplemental			GPS Latitude/Longitude	
				Start	End
Item	DWR UCIP Field Study			38.113641 °	38.113641 °
				-121.684112 °	-121.684112 °
DWR ID	DWR_RD0341_01_s_2014_53				
Action/Comments					
Inspector Comments: FS_ID:22086 EP_NO: 11103 Repair Type: Crossing Status: UCIP Comments: Unable to determine if crossing is the same as permitted under permit no. 11103. Need to contact owner and determine status of crossing under permit no. 11103. Believe steel conduit is exposed on landward side. FIELD_STRUCT_DESC: 1.5-inch iron water pipe and 3.5-inch electrical steel conduit through the levee, both 3.0 feet below the crown. Pressure system and service pole on landward slope. Fishing resort on waterward side. This pipe was retained under ABO No. 11103 (1975). FS Date: 5/5/2009

Power connection on waterward side no other appurtenances found.

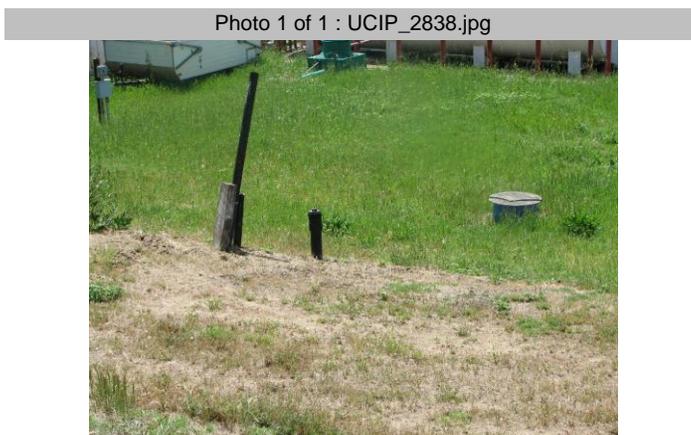
LM Start	1.99	Rating **	M	Issue No.	55
LM End	1.99	Issue Type +	En	Location *	WS
Category	Supplemental			GPS Latitude/Longitude	
				Start	End
Item	DWR UCIP Field Study			38.114092 °	38.114092 °
				-121.684524 °	-121.684524 °
DWR ID	DWR_RD0341_01_s_2014_55				
Action/Comments					
Inspector Comments: FS_ID:22091 EP_NO: 5427 Repair Type: Crossing Status: UCIP Comments: Unable to find pipe or sump pump. Indicators found on landward side include potential septic tank and observation well. Need to contact owner of crossing to determine status of crossing. FIELD_STRUCT_DESC: 1 of 2: 4-inch diameter pipe sleeved through 6-inch pipe through the levee, 3.7 feet below the crown. Sump pump on waterward slope. Septic tank and observation well on the landward side. (Permit No. 5427-1966) FS Date: 5/5/2009

View of potential observation well on landward side.

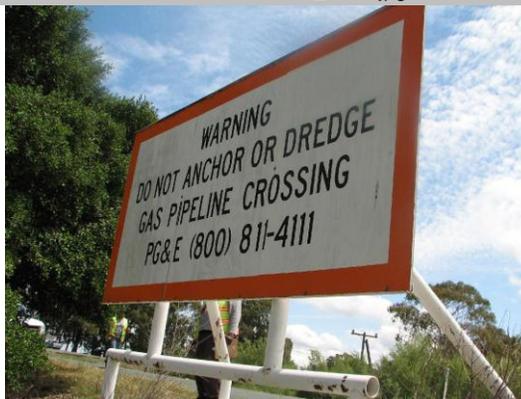
Photo 1 of 1 : UCIP_2850.jpg

LM Start	2.04	Rating **	M	Issue No.	56
LM End	2.04	Issue Type +	En	Location *	WS
Category	Supplemental			GPS Latitude/Longitude	
				Start	End
Item	DWR UCIP Field Study			38.114043 °	38.114043 °
				-121.685421 °	-121.685421 °
DWR ID	DWR_RD0341_01_s_2014_56				
Action/Comments					
Inspector Comments: FS_ID:22098 EP_NO: 960 Repair Type: Crossing Status: UCIP Comments: Need to contact owner to determine last inspection and status of crossing. FIELD_STRUCT_DESC: 2 of 2: 10-inch gas line through the levee, 2.0 feet below the crown. Cutoff wall around pipes at center of levee. Valve pit on landward shoulder, with 2-inch drain pipe along landward slope. Location marker on waterward slope. (Permit No. 960-1944) This entry matches the Drainage or Irrigation Structure referenced in O&M manual (HLM 2.04). Pipe video inspected by PG&E under Permit No. 15319 (1990). FS Date: 5/5/2009

Warning marker visible on waterward shoulder.

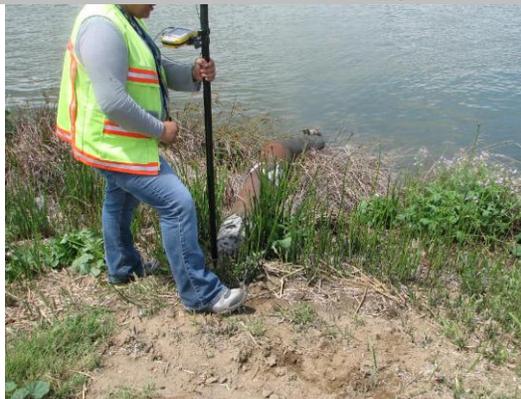
Photo 1 of 1 : UCIP_2853.jpg

LM Start	2.34	Rating **	M	Issue No.	58
LM End	2.34	Issue Type +	En	Location *	WS
Category	Supplemental			GPS Latitude/Longitude	
				Start	End
Item	DWR UCIP Field Study			38.111444 °	38.111444 °
				-121.689785 °	-121.689785 °
DWR ID	DWR_RD0341_01_s_2014_58				
Action/Comments					
Inspector Comments: FS_ID:22106 EP_NO: 11102 Repair Type: Crossing Status: UCIP Comments: Dense vegetation limits the inspector's visibility to identify signs of pipe failure (leaks) along the slope. Recommend removing vegetation along pipe alignment to conduct proper inspection of structure and appurtenances. FIELD_STRUCT_DESC: 10-inch pipe sleeved through 12-inch pipe through the levee, 4.6 feet below the crown. Annular gap grouted. Siphon breaker at landward shoulder. Pump on landward side. Irrigation canal with distribution box at landward toe. Rock revetment on waterward slope. This entry matches the Drainage or Irrigation Structure referenced in O&M manual (HLM 2.33). This pipe was retained under ABO No. 11102 (1975). FS Date: 5/5/2009

View of pipe on waterward side.

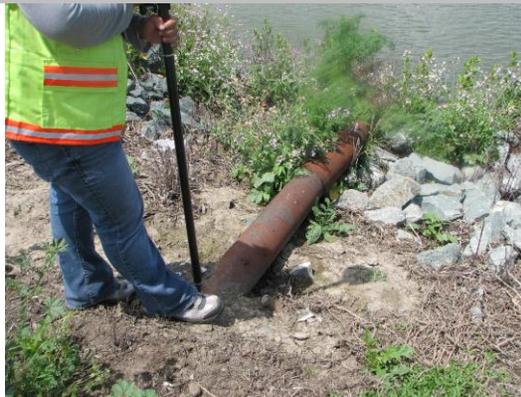
Photo 1 of 1 : UCIP_2869.jpg

Action/Comments
 Inspector Comments: FS_ID:22116
 EP_NO: N/A
 Repair Type:
 Crossing Status:
 UCIP Comments: Pipe side does not match--found 10 inch instead of 8 inch. Pipe (2 of 2) was supposed to be removed and replaced with 12-inch steel irrigation pipes under Permit No. 5629 (1966). Historical Levee Logs from 1992 do not reflect that the replacement was completed, verify diameter of pipes and status with applicant. Dense vegetation limits the inspector's visibility to identify signs of pipe failure (leaks) along the slope. Recommend removing vegetation along pipe alignment to conduct proper inspection of structure and appurtenances.
 FIELD_STRUCT_DESC: 2 of 2: 10-inch (not 8-inch as originally mentioned in desk study) steel irrigation pipe through the levee, 1.6 feet below the crown. Siphon breaker on landward side. Irrigation ditch with distribution box at landward toe. Pipe exposed on both slopes. Rock revetment on waterward slope. (USACE-1962). This entry matches the Drainage or Irrigation Structure referenced in O&M manual (HLM 2.93).

View of pipe and rip rap located on waterward side.

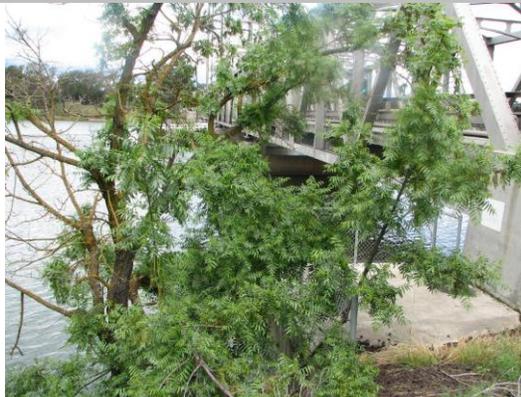
Photo 1 of 1 : UCIP_2870.jpg

LM Start	3.31	Rating **	M	Issue No.	61
LM End	3.31	Issue Type +	En	Location *	WS
Category	Supplemental		GPS Latitude/Longitude		
			Start	End	
Item	DWR UCIP Field Study		38.105183 °	38.105183 °	
			-121.702026 °	-121.702026 °	
DWR ID	DWR_RD0341_01_s_2014_61				
Action/Comments					
Inspector Comments: FS_ID:22183 EP_NO: N/A Repair Type: Crossing Status: UCIP Comments: New crossing found in field--need to find owner and determine permit authorizing work. FIELD_STRUCT_DESC: 10-inch corrugated metal pipe extruding from the waterward slope. FS Date: 5/5/2009

View of waterward side.

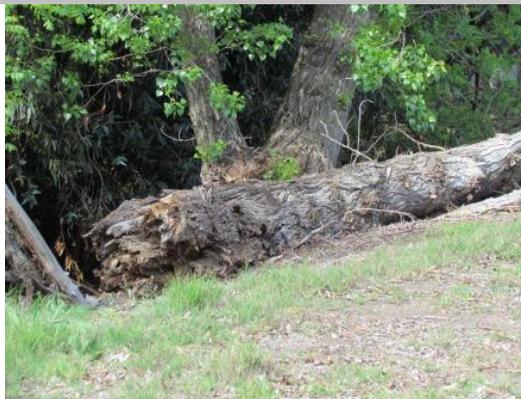
Photo 1 of 1 : phillips_s_20140522_05938.jpg

Fallen tree on the landward slope and toe of the levee section. Photo taken 03-04-2014.

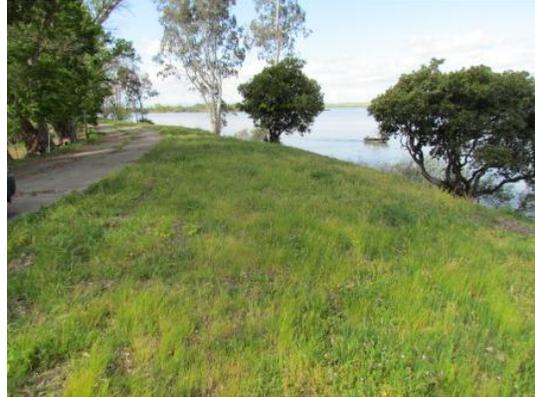
Photo 1 of 1 : phillips_s_20140522_05939.jpg

Water side levee mile 3.34 looking from shoulder. Photo taken 03-04-2014.

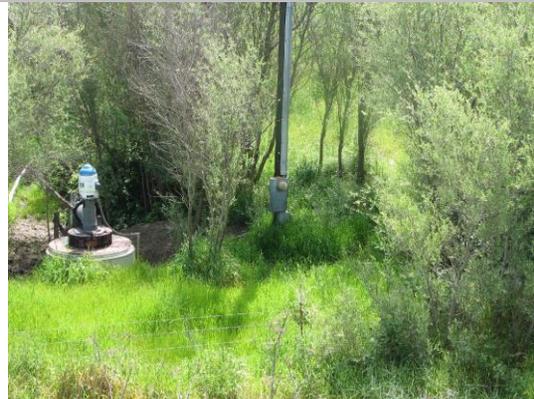
Photo 1 of 1 : UCIP_2879.jpg

LM Start	4.03	Rating **	M	Issue No.	72
LM End	4.03	Issue Type +	En	Location *	WS
Category	Supplemental		GPS Latitude/Longitude		
			Start	End	
Item	DWR UCIP Field Study		38.096783 °	38.096783 °	
			-121.706173 °	-121.706173 °	
DWR ID	DWR_RD0341_02_s_2014_72				
Action/Comments					
Inspector Comments: FS_ID:22203 EP_NO: 11110 Repair Type: Crossing Status: UCIP Comments: Need to determine status of crossing--need to contact owner. Dense vegetation limits the inspector's visibility to identify signs of pipe failure (leaks) along the slope. Recommend removing vegetation along pipe alignment to conduct proper inspection of structure and appurtenances. FIELD_STRUCT_DESC: 10-inch pipe sleeved through 12-inch pipe through the levee, 3.8 feet below the crown. Pump on concrete well on landward slope. (USACE-1962). This entry matches the Drainage or Irrigation Structure referenced in O&M manual (HLM 4.03). 10-inch pipe was retained under ABO No. 11110 (1975). FS Date: 5/6/2009

View of well and pump located on landward side.

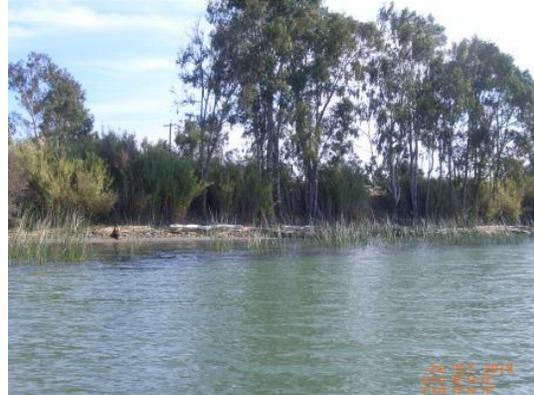
Photo 1 of 1 : USACE2013A_SAC_8-2_L_2.jpg

LM Start	4.20	Rating **	M	Issue No.	8
LM End	4.20	Issue Type +	Ma	Location *	WS
Category	Supplemental			GPS Latitude/Longitude	
				Start	End
Item	USACE Erosion Survey			38.094590 °	38.095148 °
				-121.706393 °	-121.706367 °
DWR ID					
Action/Comments					
Inspector Comments: 2011 - Large new erosion pocket probably hidden by vegetation in the past. 2013: No observed changes. [2013 Site ID: SAC_8-2_L]

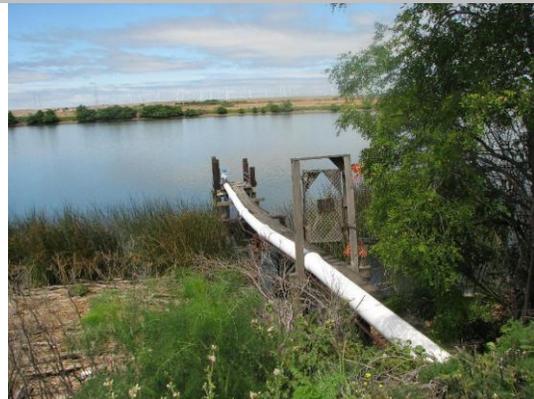
Photo 1 of 1 : UCIP_2880.jpg

LM Start	4.29	Rating **	M	Issue No.	74
LM End	4.29	Issue Type +	En	Location *	WS
Category	Supplemental			GPS Latitude/Longitude	
				Start	End
Item	DWR UCIP Field Study			38.092900 °	38.092900 °
				-121.706070 °	-121.706070 °
DWR ID	DWR_RD0341_02_s_2014_74				
Action/Comments					
Inspector Comments: FS_ID:22223 EP_NO: 11106 Repair Type: Crossing Status: UCIP Comments: Need to contact owner to determine status of crossing. Dense vegetation limits the inspector's visibility to identify signs of pipe failure (leaks) along the slope. Recommend removing vegetation along pipe alignment to conduct proper inspection of structure and appurtenances. FIELD_STRUCT_DESC: 12-inch pipe through the levee, 4.0 feet below the crown. Pump on pile structure in stream. (USACE-1962). This entry matches the Drainage or Irrigation Structure referenced in O&M manual (HLM 4.29). 12-inch pipe was retained under ABO No. 11106 (1975). FS Date: 5/6/2009

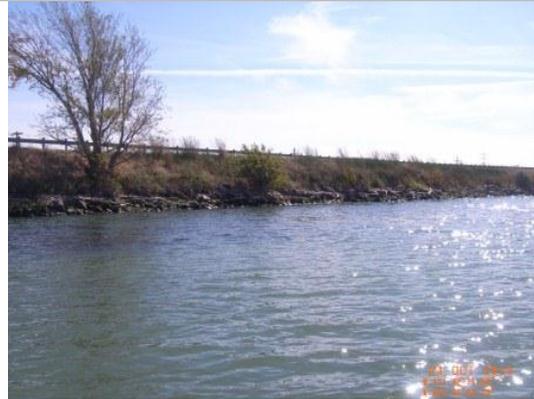
Photo 1 of 1 : USACE2013A_SAC_7-9_L_1.jpg

LM Start	4.73	Rating **	U	Issue No.	5
LM End	4.81	Issue Type +	Ma	Location *	WS
Category	Supplemental			GPS Latitude/Longitude	
				Start	End
Item	USACE Erosion Survey			38.086603 °	38.085459 °
				-121.707786 °	-121.708607 °
DWR ID					
Action/Comments					
Inspector Comments: 2011 - Large slump section. 2012 - Site extended downstream, upgraded to critical, severe windwave. Slope is very steep and may be effecting the highway on top of the levee. 2013: No observed changes. [2013 Site ID: SAC_7-9_L]

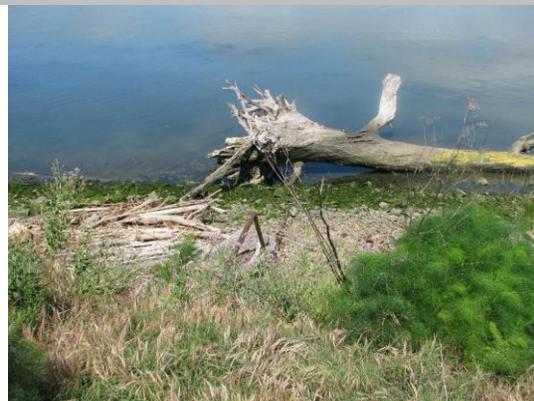
Photo 1 of 1 : UCIP_2875.jpg

LM Start	4.76	Rating **	M	Issue No.	75
LM End	4.76	Issue Type +	En	Location *	WS
Category	Supplemental			GPS Latitude/Longitude	
				Start	End
Item	DWR UCIP Field Study			38.086119 °	38.086119 °
				-121.707912 °	-121.707912 °
DWR ID	DWR_RD0341_02_s_2014_75				
Action/Comments					
Inspector Comments: FS_ID:22186 EP_NO: 4855 Repair Type: Crossing Status: UCIP Comments: Dense vegetation limits the inspector's visibility to identify signs of pipe failure (leaks) along the slope. Recommend removing vegetation along pipe alignment to conduct proper inspection of structure and appurtenances. FIELD_STRUCT_DESC: 2-inch steel irrigation pipe through the levee, 3.0 feet below the crown. Valve and pump on landward side. Rock revetment on waterward slope. (Permit No. 4855-1965) FS Date: 5/6/2009

View of crossing on waterward side--dense vegetation on slopes.

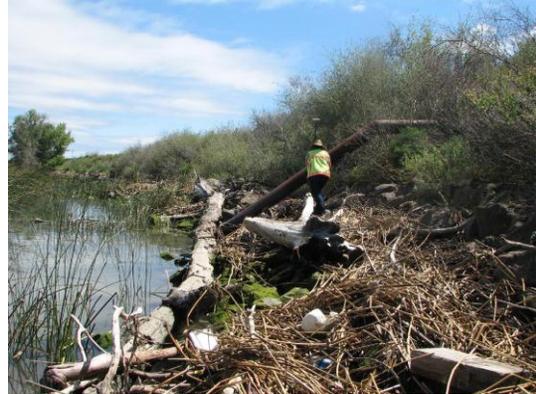
Photo 1 of 1 : UCIP_2882.jpg

LM Start	4.95	Rating **	M	Issue No.	76
LM End	4.95	Issue Type +	En	Location *	WS
Category	Supplemental			GPS Latitude/Longitude	
				Start	End
Item	DWR UCIP Field Study			38.083881 °	38.083881 °
				-121.710060 °	-121.710060 °
DWR ID	DWR_RD0341_02_s_2014_76				
Action/Comments					
Inspector Comments: FS_ID:22224 EP_NO: 1806 Repair Type: Crossing Status: UCIP Comments: Crossing has failed. Large holes present on waterward side. Need to contact owner. Crossing needs to be addressed. Dense vegetation limits the inspector's visibility to identify signs of pipe failure (leaks) along the slope. Recommend removing vegetation along pipe alignment to conduct proper inspection of structure and appurtenances. FIELD_STRUCT_DESC: 12-inch pipe sleeved through 14-inch pipe through the levee, 6.8 feet below the crown. Hand primer pump in pumphouse on landward slope. Pipe exposed on both slopes. (Permit No. 1806-1959) This entry matches the Drainage or Irrigation Structure referenced in O&M manual (HLM 5.02). FS Date: 5/6/2009

View of crossing on waterward side. Dense vegetation limits inspection of crossing.

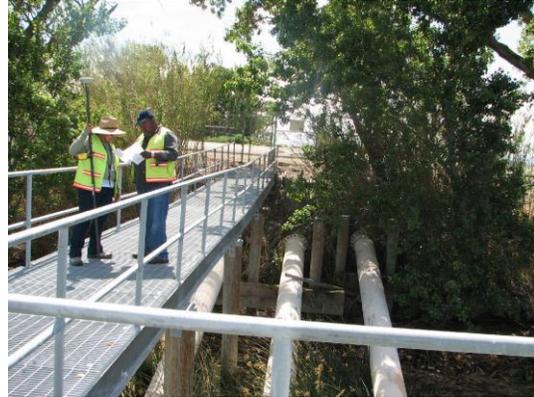
Photo 1 of 1 : UCIP_2891.jpg

LM Start	5.01	Rating **	M	Issue No.	78
LM End	5.01	Issue Type +	En	Location *	WS
Category	Supplemental			GPS Latitude/Longitude	
				Start	End
Item	DWR UCIP Field Study			38.083137 °	38.083137 °
				-121.710916 °	-121.710916 °
DWR ID	DWR_RD0341_02_s_2014_78				
Action/Comments					
Inspector Comments: FS_ID:22254					
EP_NO: 15175					
Repair Type:					
Crossing Status:					
UCIP Comments: Dense vegetation limits the inspector's visibility to identify signs of pipe failure (leaks) along the slope. Recommend removing vegetation along pipe alignment to conduct proper inspection of structure and appurtenances.					
FIELD_STRUCT_DESC: 2 of 4: 24-inch steel irrigaiton pipe in 30-inch steel casings through the levee, 6.6 feet below the crown. Annular gap grouted. Siphon breakers at waterward shoulder, with concrete risers on both ends. Screened inlet manifold (36-inch) with backwash system on pile structure in stream. Surrounded by fence with entry gate. Irrigation pond at landward toe. (Permit No. 15175-1993). Structure in stream installed under Permit No. 16737 (2000). FS Date: 5/6/2009

Pipes, walkway, fence, and support piles located on waterward side.

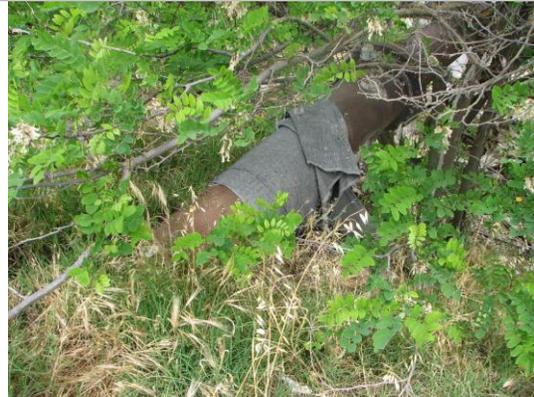
Photo 1 of 1 : UCIP_2904.jpg

LM Start	5.34	Rating **	M	Issue No.	80
LM End	5.34	Issue Type +	En	Location *	WS
Category	Supplemental			GPS Latitude/Longitude	
				Start	End
Item	DWR UCIP Field Study			38.081790 °	38.081790 °
				-121.716868 °	-121.716868 °
DWR ID	DWR_RD0341_02_s_2014_80				
Action/Comments					
Inspector Comments: FS_ID:22256 EP_NO: 11116 Repair Type: Crossing Status: UCIP Comments: Need to coordinate with owner to determine status of crossing. If crossing is no longer in use owner will need to contact the CVFPB to comply with Title 23. Dense vegetation limits the inspector's visibility to identify signs of pipe failure (leaks) along the slope. Recommend removing vegetation along pipe alignment to conduct proper inspection of structure and appurtenances. FIELD_STRUCT_DESC: 16-inch pipe sleeved through 18-inch pipe through the levee, 2.5 feet below the crown. Annular gap grouted. Air vent on waterward side. (USACE-1962). This entry matches the Drainage or Irrigation Structure referenced in O&M manual (HLM 5.40). This pipe was retained under ABO No. 11116 (1975). Annular gap grouted and pipe lengthened under Permit No. 15372 (1993). FS Date: 5/6/2009

Pipe on waterward side at daylight.

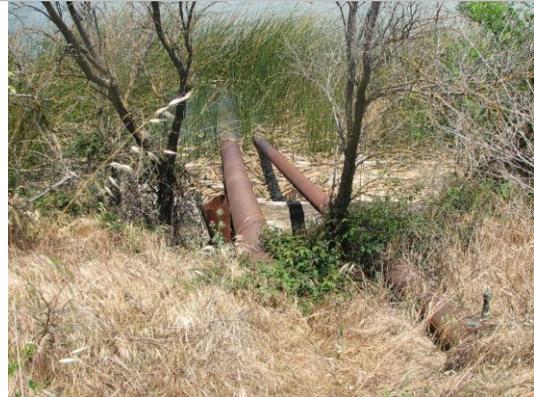
Photo 1 of 1 : UCIP_2908.jpg

LM Start	5.81	Rating **	M	Issue No.	81
LM End	5.81	Issue Type +	En	Location *	WS
Category	Supplemental			GPS Latitude/Longitude	
				Start	End
Item	DWR UCIP Field Study			38.080381 °	38.080381 °
				-121.725534 °	-121.725534 °
DWR ID	DWR_RD0341_02_s_2014_81				
Action/Comments					
Inspector Comments: FS_ID:22258 EP_NO: 11116 Repair Type: Crossing Status: UCIP Comments: Dense vegetation limits the inspector's visibility to identify signs of pipe failure (leaks) along the slope. Recommend removing vegetation along pipe alignment to conduct proper inspection of structure and appurtenances. FIELD_STRUCT_DESC: 1 of 2: 8-inch pipe sleeved through 10-inch pipe through levee, 2.5 feet below the crown. Annular gap grouted. Concrete distribution box with slide gate at landward toe. Air vent on waterward side. (USACE-1962). This entry matches the Drainage or Irrigation Structure referenced in O&M manual (HLM 5.81). This pipe was retained under ABO No. 11116 (1975). Distributon box installed and pipe along landward slope removed and replaced with longer 10-inch steel pipe under Permit No. 15372 (1993). FS Date: 5/6/2009

8-inch pipe and 14-inch pipe on waterward side.

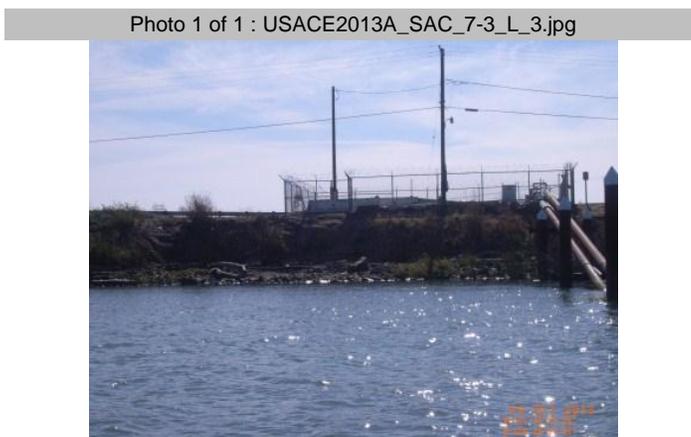
LM Start	5.96	Rating **	U	Issue No.	4
LM End	6.09	Issue Type +	Ma	Location *	WS
Category	Supplemental			GPS Latitude/Longitude	
				Start	End
Item	USACE Erosion Survey			38.080370 °	38.080526 °
				-121.728341 °	-121.730483 °
DWR ID					
Action/Comments					
Inspector Comments: 2011 - Large slump at downstream end. Gully formed from surface runoff from the road. Shallow slumping throughout site. 2012 - The gully at upstream end has increased in size and site continues to worsen. 2013: No observed changes. [2013 Site ID: SAC_7-3_L]

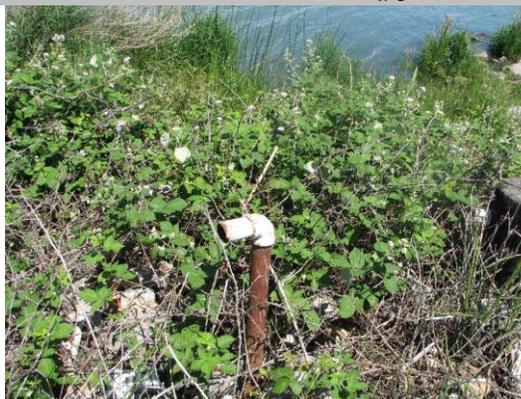
Photo 1 of 1 : UCIP_2922.jpg

View of waterward side air vent pipe could be associated with crossing.

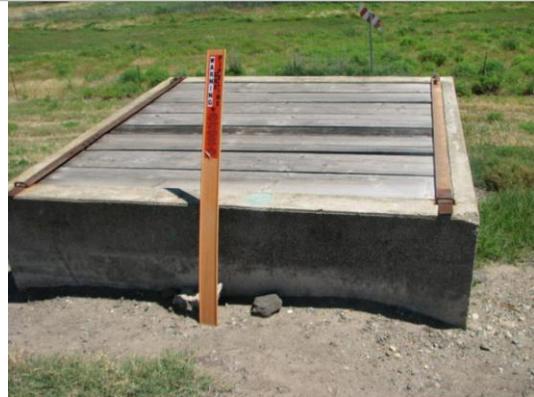
Photo 1 of 1 : UCIP_2926.jpg

View of landward side. Concrete box and markers indicating gas pipeline. Additional marker located at levee toe.

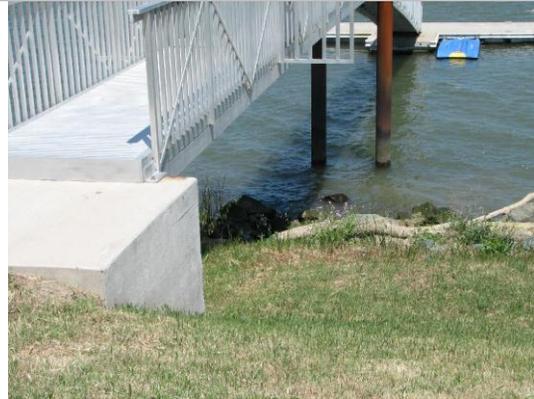
Photo 1 of 1 : UCIP_2955.jpg

View of waterward side. Conduit goes though concrete structure connecting walkway.

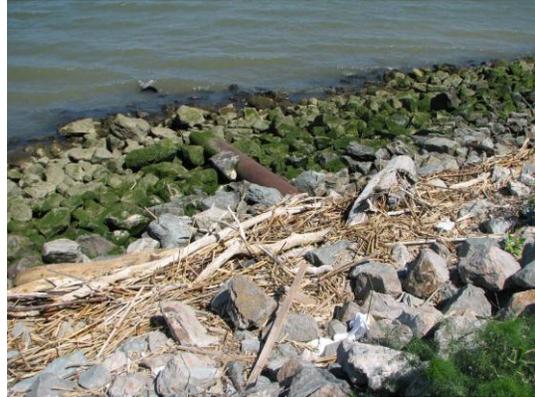
Photo 1 of 1 : UCIP_2970.jpg

Overview of waterward side. Slope protection along bank.
