**Flood Control Project Maintenance  
Levee Inspections**  
**LMA District Cover Sheet**  
**Spring 2015 Levee Inspection Results**

**Reclamation District No. 0341 Sherman Island**

**Spring 2015 Levee Inspection Results**

Waterway		Bank	Unit Miles
Unit No. 01 Threemile Slough		Right	3.36

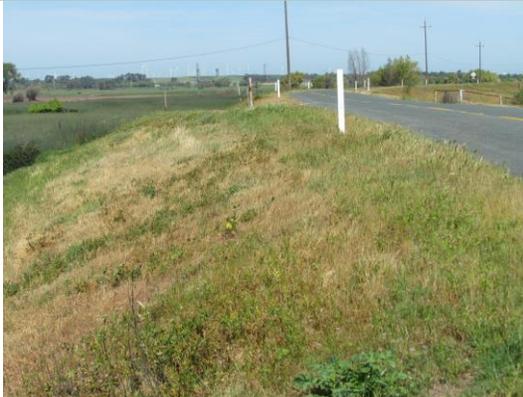
Photo 1 of 1 : SP\_2015\_RD0341\_167\_390\_20150406\_00070.jpg

Action/Comments					
Control annual grass and weeds on the levee slopes and easements. Inspector Comments: During this inspection the district was in the process of mowing levee slopes.

Looking downstream at the landside.

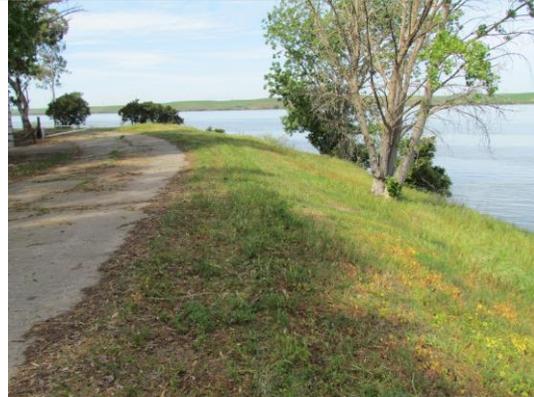
Photo 1 of 1 : SP\_2015\_RD0341\_168\_2\_20150406\_00128.jpg

LM Start	<b>3.34</b>	Rating **	A	Issue No.	<b>2</b>
LM End	<b>3.37</b>	Issue Type +	Ma	Location *	WS
Category	Earthen Levee			GPS Latitude/Longitude	
				Start	End
Item	Vegetation			38.105130 °	38.105313 °
				-121.702000 °	-121.702713 °
DWR ID	DWR_RD0341_02_s_2015_2				
Action/Comments					
Control annual grass and weeds on the levee slopes and easements. Inspector Comments: District mowed this section of levee slope prior to my inspection.

Looking downstream from the waterward slope levee mile 3.34.

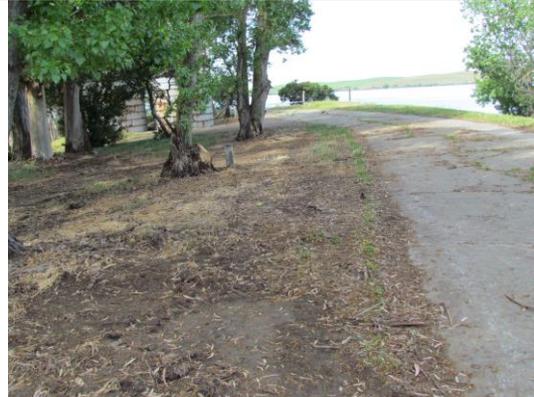
Photo 1 of 1 : SP\_2015\_RD0341\_168\_4\_20150406\_00129.jpg

LM Start	<b>3.37</b>	Rating **	A	Issue No.	<b>4</b>
LM End	<b>3.38</b>	Issue Type +	Ma	Location *	LS
Category	Earthen Levee		GPS Latitude/Longitude		
			Start	End	
Item	Vegetation		38.105313 °	38.105358 °	
			-121.702713 °	-121.703030 °	
DWR ID	DWR_RD0341_02_f_2014_4				
Action/Comments					
Control annual grass and weeds on the levee slopes and easements.

Looking downstream from landside.

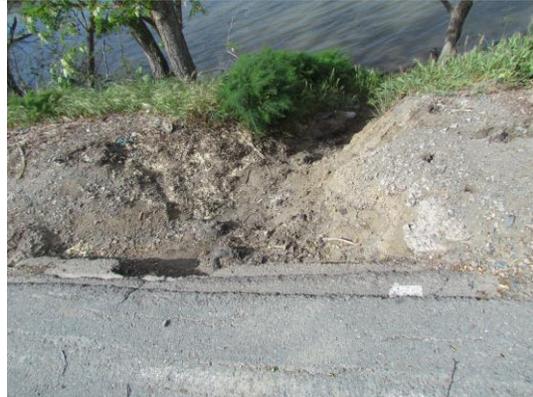
Photo 1 of 2 : SP\_2015\_RD0341\_168\_599\_20150406\_00126.jpg

LM Start	<b>5.53</b>	Rating **	U	Issue No.	<b>599</b>
LM End	<b>5.53</b>	Issue Type +	Ma	Location *	WS
Category	Earthen Levee			GPS Latitude/Longitude	
				Start	End
Item	Erosion / Bank Caving			38.081297 °	38.081297 °
				-121.719400 °	-121.719400 °
DWR ID	DWR_RD0341_02_s_2015_599				
Action/Comments					
Note and monitor erosion site. Inspector Comments: This erosion needs to be repaired.

Erosion greater than 6" on waterside shoulder.

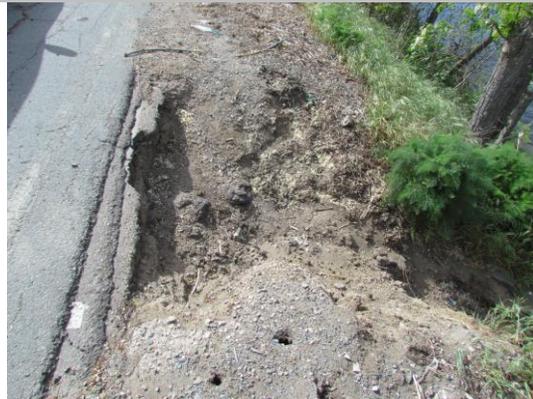
Photo 2 of 2 : SP\_2015\_RD0341\_168\_599\_20150406\_00127.jpg

LM Start	<b>5.53</b>	Rating **	U	Issue No.	<b>599 (cont)</b>
LM End	<b>5.53</b>	Issue Type +	Ma	Location *	WS

View from upstream of erosion site.

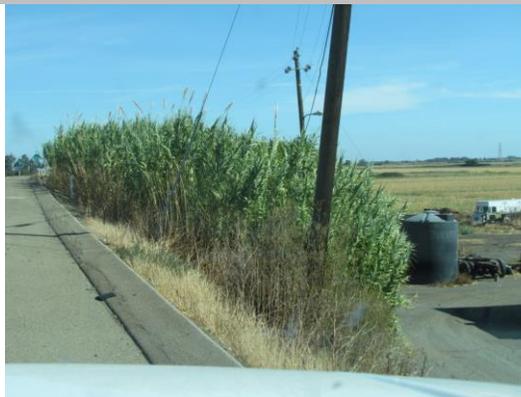
Photo 1 of 1 : SP\_2015\_RD0341\_168\_12\_20150312\_00005.jpg

LM Start	<b>6.30</b>	Rating **	U	Issue No.	<b>12</b>
LM End	<b>6.32</b>	Issue Type +	Ma	Location *	LS
Category	Earthen Levee			GPS Latitude/Longitude	
				Start	End
Item	Vegetation			38.081078 °	38.081133 °
				-121.732975 °	-121.733445 °
DWR ID	DWR_RD0341_02_f_2014_12				
Action/Comments					
Remove the wild growth other than native grasses from the levee slopes. Inspector Comments: Remove the Arundo from the landside levee slope.

Unwanted arundo present on the levee slopes landward slope looking upstream.
