**Flood Control Project Maintenance  
Levee Inspections**

**Maintenance Issue Types Only, Levee Inspection Report By Mile - Spring 2016**

**Reclamation District No. 0341 Sherman Island**

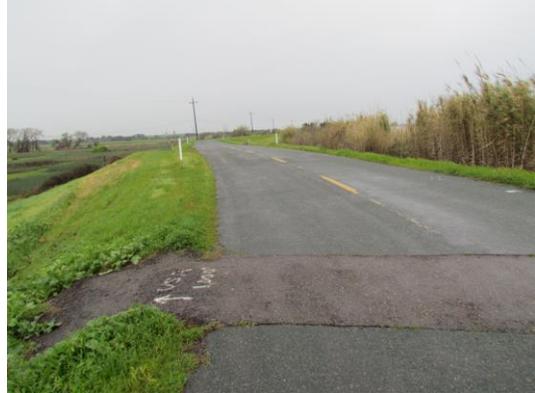
Photo 1 of 1 : SP\_2016\_RD0341\_167\_20\_20160316\_00045.jpg

LM Start	<b>0.00</b>	Rating **	A	Issue No.	<b>20</b>
LM End	<b>3.35</b>	Issue Type +	Ma	Location *	LS
Category	Earthen Levee		GPS Latitude/Longitude		
			Start	End	
Item	Vegetation		38.085535 °	38.105238 °	
			-121.686463 °	-121.702391 °	
DWR ID	DWR_RD0341_01_s_2016_20				
Comment Code					
V1 : Control annual grass and weeds on the levee slopes and easements.					
Inspector Comment					
No unwanted vegetation from 0.00 - 3.35.

Looking upstream from levee mile 0.00 landside unit 1 RD 341.

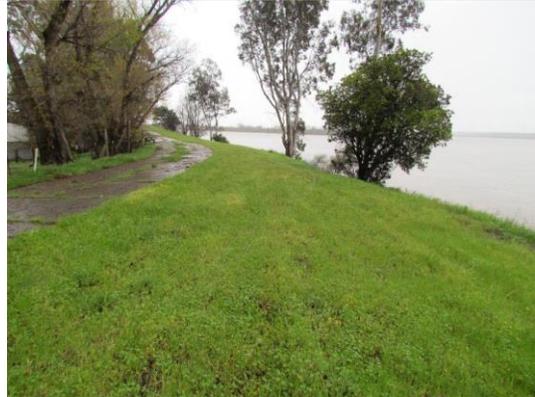
Photo 1 of 1 : SP\_2016\_RD0341\_168\_38\_20160316\_00079.jpg

LM Start	<b>3.40</b>	Rating **	A	Issue No.	<b>38</b>
LM End	<b>3.97</b>	Issue Type +	Ma	Location *	WS
Category	Earthen Levee		GPS Latitude/Longitude		
			Start	End	
Item	Vegetation		38.105310 °	38.097763 °	
			-121.703313 °	-121.706290 °	
DWR ID	DWR_RD0341_02_s_2016_38				
Comment Code					
V1 : Control annual grass and weeds on the levee slopes and easements.					
Inspector Comment					
No unwanted vegetation along this section of levee.

Looking downstream of Sacramento River Levee mile 3.40 Unit 2 RD 341.

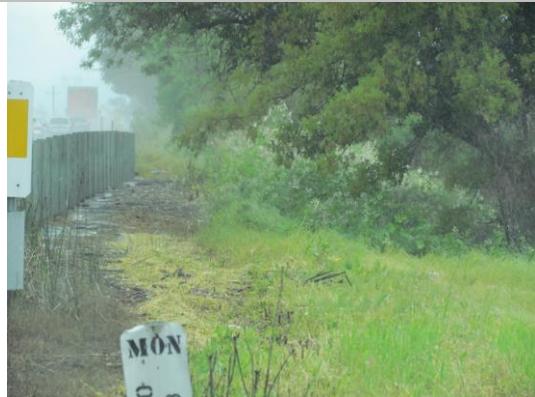
Photo 1 of 1 : SP\_2016\_RD0341\_168\_45\_20160316\_00080.jpg

LM Start	<b>3.97</b>	Rating **	U	Issue No.	<b>45</b>
LM End	<b>6.19</b>	Issue Type +	Ma	Location *	WS
Category	Earthen Levee		GPS Latitude/Longitude		
			Start	End	
Item	Vegetation		38.097763 °	38.080573 °	
			-121.706288 °	-121.731113 °	
DWR ID	DWR_RD0341_02_f_2015_45				
Comment Code					
V2 : Remove the wild growth other than native grasses from the levee slopes.					
Inspector Comment					
The unwanted vegetation on the waterside needs spraying or mowing. The arundo present blocks view of the levee section.

Looking downstream from the waterside levee mile 3.97 to levee mile 6.19 unwanted vegetation on the slope and shoulder.

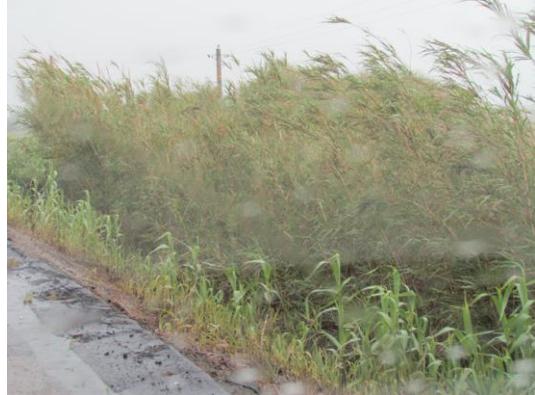
Photo 1 of 1 : SP\_2016\_RD0341\_168\_46\_20160316\_00081.jpg

LM Start	<b>3.97</b>	Rating **	U	Issue No.	<b>46</b>
LM End	<b>6.15</b>	Issue Type +	Ma	Location *	LS
Category	Earthen Levee		GPS Latitude/Longitude		
			Start	End	
Item	Vegetation		38.097763 °	38.080323 °	
			-121.706287 °	-121.730453 °	
DWR ID	DWR_RD0341_02_f_2015_46				
Comment Code					
V1 : Control annual grass and weeds on the levee slopes and easements.					
Inspector Comment					
Remove the wild vegetation from the landside slope and shoulder.

This picture was taken from downstream levee mile 6.15 looking upstream of the landside levee slope and shoulder towards levee mile 3.97.

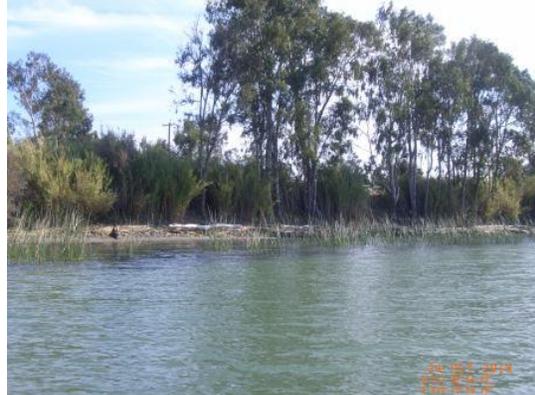
Photo 1 of 1 : SP\_2016\_RD0341\_168\_7\_20160223\_00005.jpg

LM Start	<b>4.15</b>	Rating **	M	Issue No.	<b>7</b>
LM End	<b>4.19</b>	Issue Type +	Ma	Location *	WS
Category	Supplemental		GPS Latitude/Longitude		
			Start	End	
Item	2015 USACE Erosion Survey, DRAFT		38.095148 °	38.094590 °	
			-121.706367 °	-121.706393 °	
DWR ID	DWR_RD0341_02_s_2016_7				
Comment Code					
Inspector Comment					
2011 - Large new erosion pocket probably hidden by vegetation in the past. 2015: No observed changes. [2015 Site ID: SAC_8-2_L]

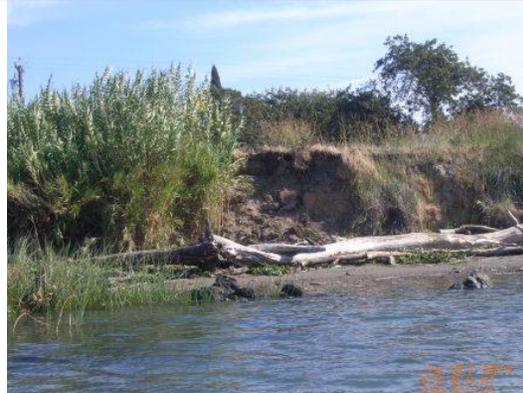
Photo 1 of 1 : SP\_2016\_RD0341\_168\_3\_20160223\_00003.jpg

LM Start	<b>4.47</b>	Rating **	U	Issue No.	<b>3</b>
LM End	<b>4.62</b>	Issue Type +	Ma	Location *	WS
Category	Supplemental			GPS Latitude/Longitude	
				Start	End
Item	2015 USACE Erosion Survey, DRAFT			38.090620 °	38.088572 °
				-121.706684 °	-121.707127 °
DWR ID	DWR_RD0341_02_s_2016_3				
Comment Code					
Inspector Comment					
1999 - New small slump in eroded bank. 2005 - Reach extended because of vertical bank along the roadway upstream. 2011 - More slumping since last year. 2012 - Site upgraded to critical. Very steep slope which may be effecting the highway on top of the levee. 2015: New erosion towards downstream end of site. [2015 Site ID: SAC_8-0_L]

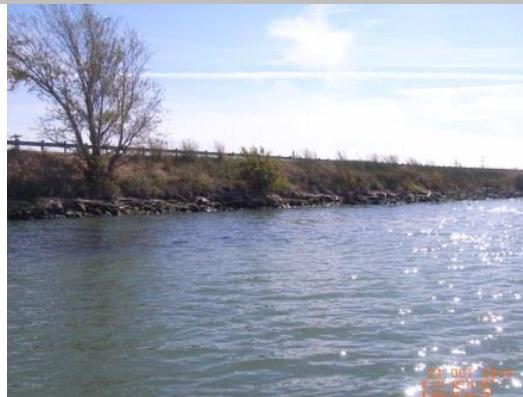
Photo 1 of 1 : SP\_2016\_RD0341\_168\_4\_20160223\_00004.jpg

LM Start	<b>4.76</b>	Rating **	U	Issue No.	<b>4</b>
LM End	<b>4.85</b>	Issue Type +	Ma	Location *	WS
Category	Supplemental			GPS Latitude/Longitude	
				Start	End
Item	2015 USACE Erosion Survey, DRAFT			38.086603 °	38.085459 °
				-121.707786 °	-121.708607 °
DWR ID	DWR_RD0341_02_s_2016_4				
Comment Code					
Inspector Comment					
2011 - Large slump section. 2012 - Site extended downstream, upgraded to critical, severe windwave. Slope is very steep and may be effecting the highway on top of the levee. 2015: No observed changes. [2015 Site ID: SAC_7-9_L]

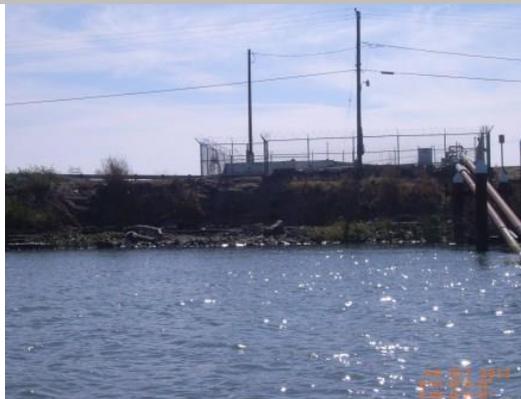
Photo 1 of 1 : SP\_2016\_RD0341\_168\_1\_20160223\_00001.jpg

LM Start	<b>6.03</b>	Rating **	U	Issue No.	<b>1</b>
LM End	<b>6.16</b>	Issue Type +	Ma	Location *	WS
Category	Supplemental			GPS Latitude/Longitude	
				Start	End
Item	2015 USACE Erosion Survey, DRAFT			38.080370 °	38.080526 °
				-121.728341 °	-121.730483 °
DWR ID	DWR_RD0341_02_s_2016_1				
Comment Code					
Inspector Comment					
2011 - Large slump at downstream end. Gully formed from surface runoff from the road. Shallow slumping throughout site. 2012 - The gully at upstream end has increased in size and site continues to worsen. 2015: No observed changes. [2015 Site ID: SAC_7-3_L]

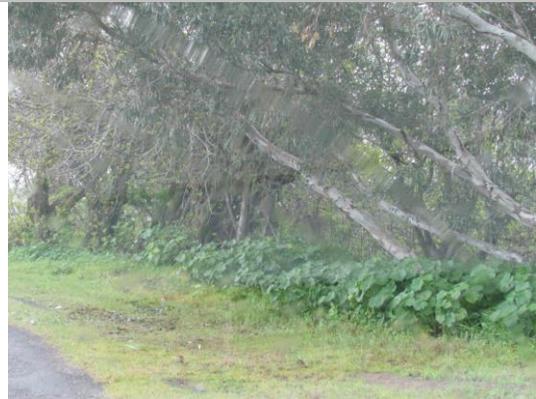
Photo 1 of 1 : SP\_2016\_RD0341\_168\_47\_20160316\_00078.jpg

LM Start	<b>6.29</b>	Rating **	U	Issue No.	<b>47</b>
LM End	<b>6.32</b>	Issue Type +	Ma	Location *	LS
Category	Earthen Levee		GPS Latitude/Longitude		
			Start	End	
Item	Trim / Thin Trees		38.081075 °	38.081142 °	
			-121.732813 °	-121.733465 °	
DWR ID	DWR_RD0341_02_f_2015_47				
Comment Code					
T2 : Thin trees to allow visibility of the ground and room to flood fight.					
Inspector Comment					
Remove the unwanted fig trees from the levee section.

Landside slope blocked by woody growth of fig trees.
