**Flood Control Project Maintenance
Levee Inspections
LMA District Cover Sheet
Spring 2010 Levee Inspection Results**

Reclamation District No. 0341 Sherman Island

Levee Inspection Report By Mile - Spring 2010

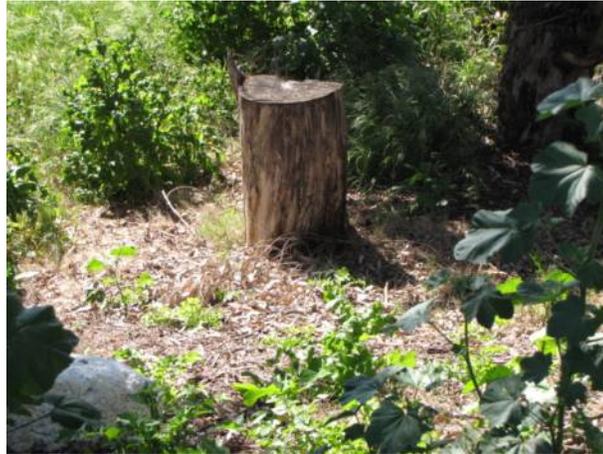
Levee Mile Report Line	1
Start Levee Mile	1.25
End Levee Mile	1.25
Location	Land Side
Category	Earthen Levee
Item	Trim / Thin Trees
Stump off toe of levee L/M 1.25 landward .	
phillips_s_20100504_034.jpg

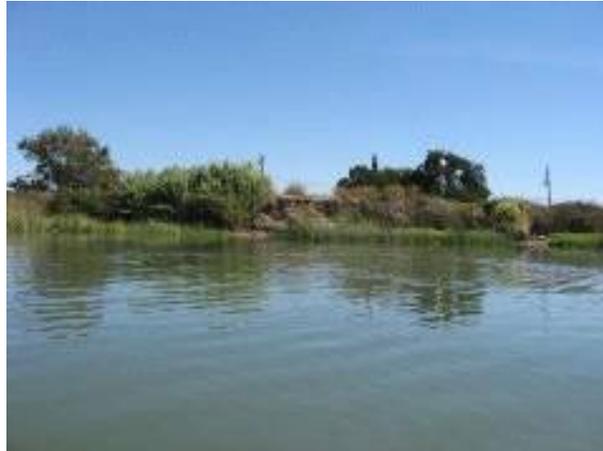
Levee Mile Report Line	2
Start Levee Mile	4.45
End Levee Mile	4.60
Location	Water Side
Category	Supplemental
Item	USACE Erosion Survey
2009: no berm, vertical slope, no stability issues, clays and silts, 5.13 ft/s [2009 SiteID:SAC_8-0_L]	
USACE2009_SAC_8-0_L_2009_09_18-D4P37_small.JPG
