**Flood Control Project Maintenance
Levee Inspections**
LMA District Cover Sheet
Spring 2013 Levee Inspection Results

Reclamation District No. 0341 Sherman Island

Levee Inspection Report By Mile - Spring 2013

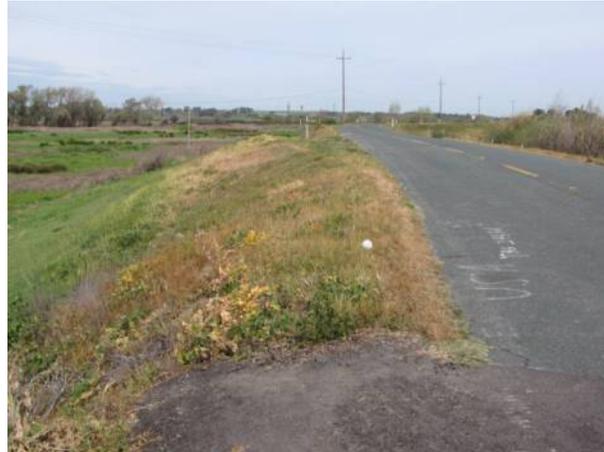
Levee Mile Report Line	4
Start Levee Mile	0.00
End Levee Mile	0.00
Location	Land Side
Category	
Item	Vegetation
RD 341 L/M 0.00 Looking downstream landside. Photo taken 3-19-2013.	
phillips_s_20130325_346.JPG

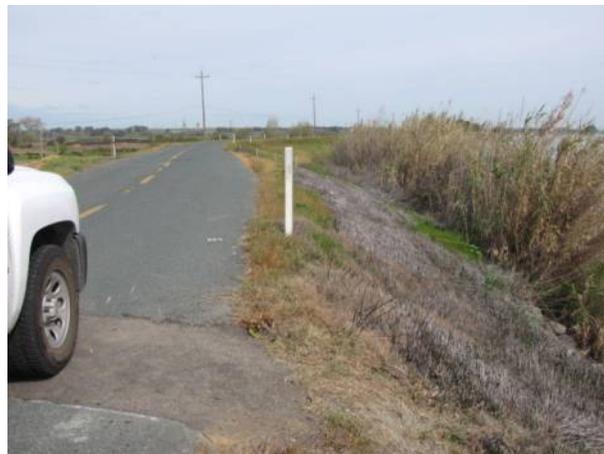
Levee Mile Report Line	5
Start Levee Mile	0.00
End Levee Mile	0.00
Location	Water Side
Category	
Item	Vegetation
RD 341 Standing at levee mile 0.00 looking downstream waterside. Photo taken 3-19-2013.	
phillips_s_20130325_347.JPG

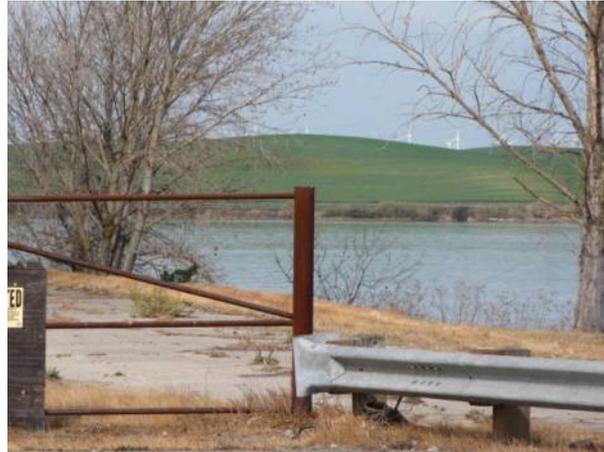
LMIR No.	Levee Mile		Category	Item	Location	Rating	Action/Comment	GPS Latitude/Longitude		Issue No. Photo
	Start	End						Start	End	
1	3.34	3.34		Vegetation	WS Ma	A	V1 : Control annual grass and weeds on the levee slopes and easements.	38.105209 ° -121.702210 °	38.105209 ° -121.702210 °	9 Y
DWR ID: DWR_RD0341_02_s_2013_9										
2	4.15	4.19	Supplemental	USACE Erosion Survey	WS Ma	M	Inspector Comments: 2011 - Large new erosion pocket probably hidden by vegetation in the past. 2012: No observed change. [2012 Site ID: SAC_8-2_L]	38.095148 ° -121.706367 °	38.094590 ° -121.706393 °	4 Y
DWR ID: DWR_RD0341_02_s_2013_4										
3	4.46	5.04		Vegetation	WS Ma	M	V2 : Remove the wild growth other than native grasses from the levee slopes.	38.090363 ° -121.706227 °	38.083138 ° -121.711478 °	1
DWR ID: DWR_RD0341_02_f_2012_1										
4	4.52	4.60	Supplemental	USACE Erosion Survey	WS Ma	U	Inspector Comments: 1999 - New small slump in eroded bank. 2005 - Reach extended because of vertical bank along the roadway upstream. 2011 - More slumping since last year. 2012: Site upgraded to critical. Very steep slope which may be effecting the highway on top of the levee. [2012 Site ID: SAC_8-0_L]	38.090620 ° -121.706684 °	38.088572 ° -121.707127 °	5 Y

Levee Mile Report Line	1
Start Levee Mile	3.34
End Levee Mile	3.34
Location	Water Side
Category	
Item	Vegetation
RD 341 Looking downstream from levee mile 3.34 waterside levee section. Photo taken 3-19-2013.	
phillips_s_20130404_366.JPG

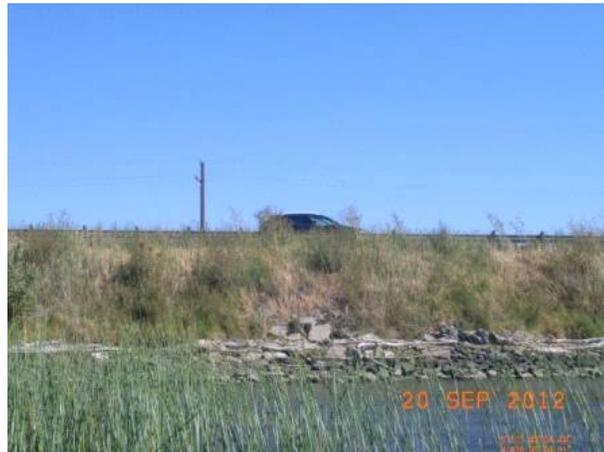
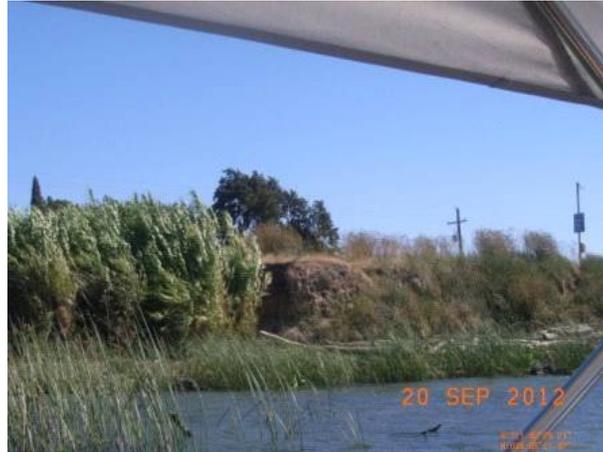
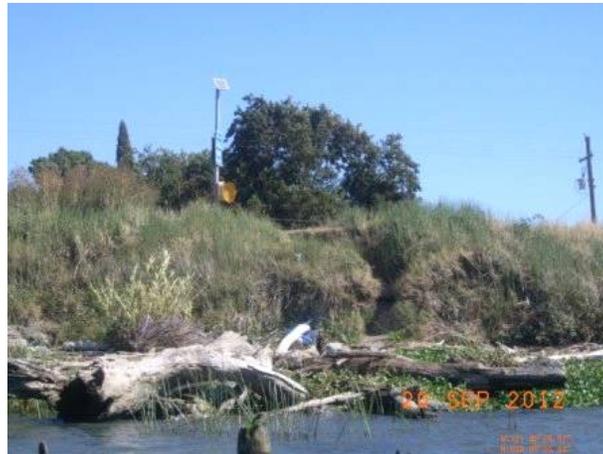
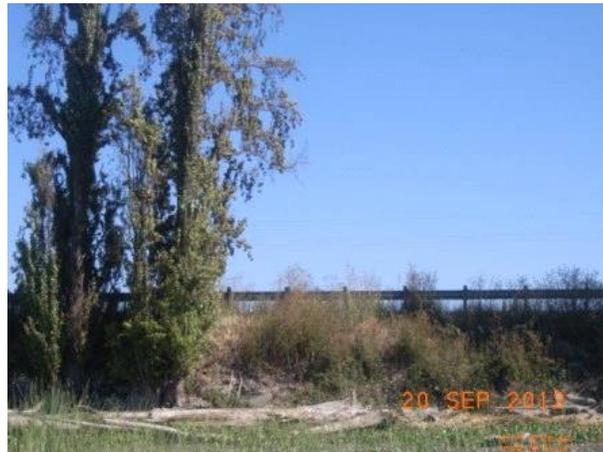
Levee Mile Report Line	4
Start Levee Mile	4.52
End Levee Mile	4.60
Location	Water Side
Category	Supplemental
Item	USACE Erosion Survey
USACE 2012 Photo #1	
phillips_s_20130228_074.jpg

Levee Mile Report Line	4
Start Levee Mile	4.52
End Levee Mile	4.60
Location	Water Side
Category	Supplemental
Item	USACE Erosion Survey
USACE 2012 Photo #2	
phillips_s_20130228_075.jpg

Levee Mile Report Line	4
Start Levee Mile	4.52
End Levee Mile	4.60
Location	Water Side
Category	Supplemental
Item	USACE Erosion Survey
USACE 2012 Photo #3	
phillips_s_20130228_076.jpg

Levee Mile Report Line	4
Start Levee Mile	4.52
End Levee Mile	4.60
Location	Water Side
Category	Supplemental
Item	USACE Erosion Survey
USACE 2012 Photo #4	
phillips_s_20130228_077.jpg

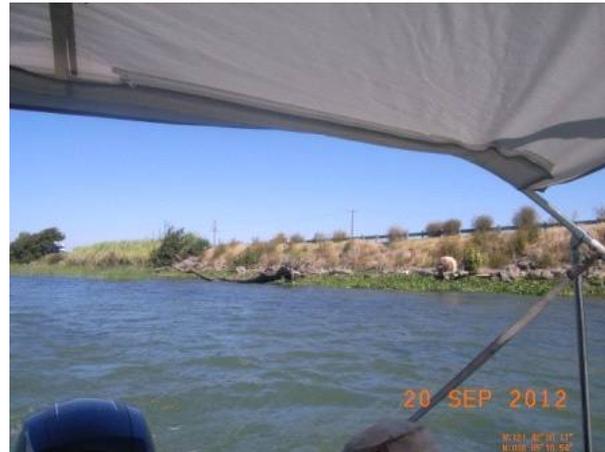
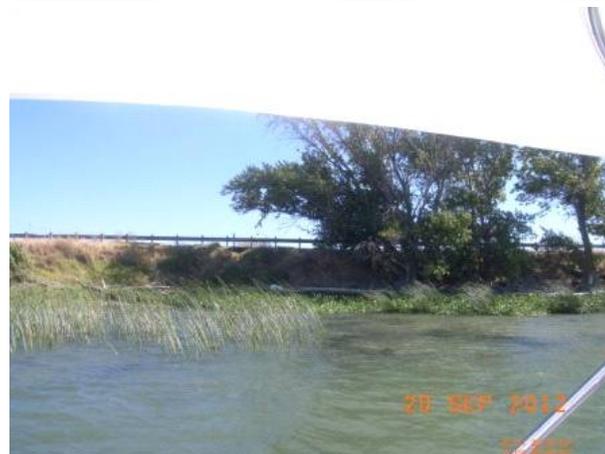
DWR ID: DWR_RD0341_02_s_2013_5										
5	4.73	4.81	Supplemental	USACE Erosion Survey	WS Ma	U	Inspector Comments: 2011 - Large slump section 2012: Site extended downstream, upgrade to critical, severe windwave. Slope is very steep and may be effecting the highway on top of the levee. [2012 Site ID: SAC_7-9_L]	38.086603 ° -121.707786 °	38.085459 ° -121.708607 °	7 Y
DWR ID: DWR_RD0341_02_s_2013_7										
6	5.25	5.86		Vegetation	WS Ma	M	V2 : Remove the wild growth other than native grasses from the levee slopes.	38.082194 ° -121.715246 °	38.080228 ° -121.726459 °	2
DWR ID: DWR_RD0341_02_f_2012_2										
7	5.96	6.09	Supplemental	USACE Erosion Survey	WS Ma	U	Inspector Comments: 2011 - Large slump at downstream end. Gully formed from surface runoff from the road. Shallow slumping throughout site. 2012: The gully at upstream end has increased in size and site continues to worsen. [2012 Site ID: SAC_7-3_L]	38.080370 ° -121.728341 °	38.080526 ° -121.730483 °	8 Y

Levee Mile Report Line	5
Start Levee Mile	4.73
End Levee Mile	4.81
Location	Water Side
Category	Supplemental
Item	USACE Erosion Survey
USACE 2012 Photo #1	
phillips_s_20130228_078.jpg

Levee Mile Report Line	5
Start Levee Mile	4.73
End Levee Mile	4.81
Location	Water Side
Category	Supplemental
Item	USACE Erosion Survey
USACE 2012 Photo #2	
phillips_s_20130228_079.jpg

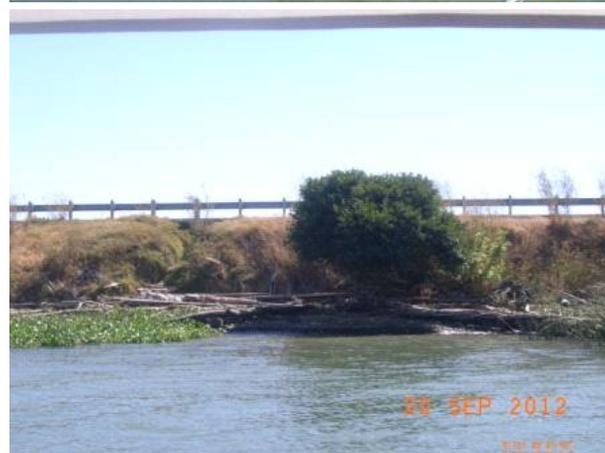
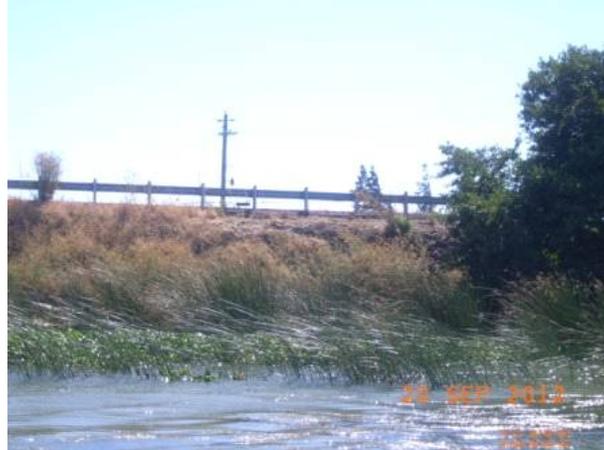
Levee Mile Report Line	7
Start Levee Mile	5.96
End Levee Mile	6.09
Location	Water Side
Category	Supplemental
Item	USACE Erosion Survey
USACE 2012 Photo #1	
phillips_s_20130228_080.jpg

Levee Mile Report Line	7
Start Levee Mile	5.96
End Levee Mile	6.09
Location	Water Side
Category	Supplemental
Item	USACE Erosion Survey
USACE 2012 Photo #2	
phillips_s_20130228_081.jpg
