**Flood Control Project Maintenance  
Levee Inspections**

**Fall 2014 Levee Maintenance Deficiency Summary Report**

**Flood Control Project Maintenance  
Levee Inspections**  
**LMA District Cover Sheet**  
**Fall 2014 Levee Inspection Results**

**Reclamation District No. 0349 Sutter Island**

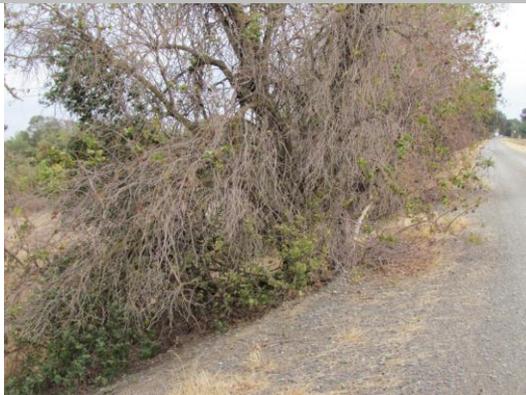
Photo 1 of 1 : FA\_2014\_RD0349\_204\_5\_20141103\_00003.jpg

Looking downstream from levee mile 0.00 waterside wild growth present on slope.

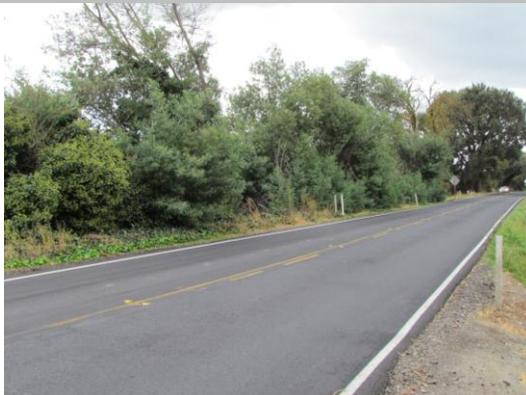
Photo 1 of 1 : FA\_2014\_RD0349\_204\_2\_20141016\_00002.jpg

LM Start	<b>0.00</b>	Rating **	U	Issue No.	<b>2</b>
LM End	<b>0.12</b>	Issue Type +	Ma	Location *	WS
Category	Earthen Levee		GPS Latitude/Longitude		
			Start	End	
Item	Vegetation		38.327037 °	38.325390 °	
			-121.576978 °	-121.577402 °	
DWR ID	DWR_RD0349_01_f_2014_2				
Action/Comments					
Remove the wild growth other than native grasses from the levee slopes. Inspector Comments: This wild growth needs to be removed from the waterward levee shoulder and slope.

Unwanted woody tree growth on waterside levee section, completely blocking view of the slope.

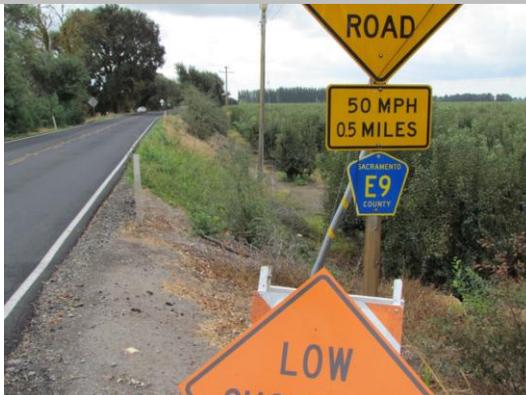
Photo 1 of 1 : FA\_2014\_RD0349\_204\_1\_20141016\_00001.jpg

LM Start	<b>0.00</b>	Rating **	U	Issue No.	<b>1</b>
LM End	<b>0.97</b>	Issue Type +	Ma	Location *	LS
Category	Earthen Levee		GPS Latitude/Longitude		
			Start	End	
Item	Vegetation		38.327037 °	38.313367 °	
			-121.576978 °	-121.578807 °	
DWR ID	DWR_RD0349_01_f_2014_1				
Action/Comments					
Remove the wild growth other than native grasses from the levee slopes. Inspector Comments: Tall weeds need to be removed from levee section.

Unit 1 levee mile 0.00 landside unwanted tall weeds on levee slope.

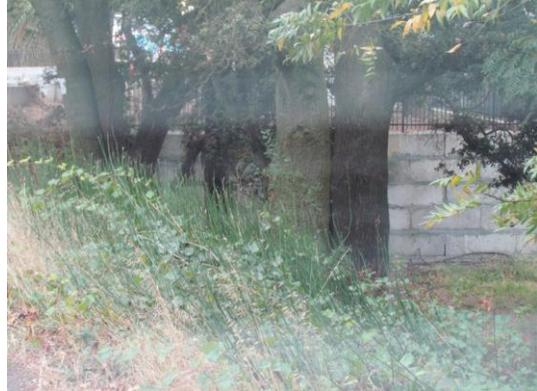
Photo 1 of 1 : FA\_2014\_RD0349\_204\_12\_20141103\_00004.jpg

Looking downstream at levee mile 1.55 unauthorized block wall placed on landward levee section, no CVFPB Permit.

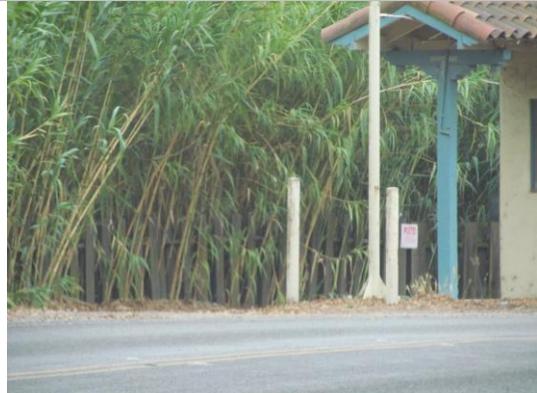
Photo 1 of 1 : FA\_2014\_RD0349\_204\_13\_20141103\_00005.jpg

LM Start	<b>1.57</b>	Rating **	<b>U</b>	Issue No.	<b>13</b>
LM End	<b>1.59</b>	Issue Type +	<b>Ma</b>	Location *	<b>WS</b>
Category	Earthen Levee		GPS Latitude/Longitude		
			Start	End	
Item	Vegetation		38.305450 °	38.305162 °	
			-121.574687 °	-121.574750 °	
DWR ID	DWR_RD0349_01_f_2014_13				
Action/Comments					
Remove the wild growth other than native grasses from the levee slopes. Inspector Comments: This Arundo present on the waterward section is blocking the view of the levee section.

Unwanted Arundo has complete blocked view of waterward levee slope and shoulder.

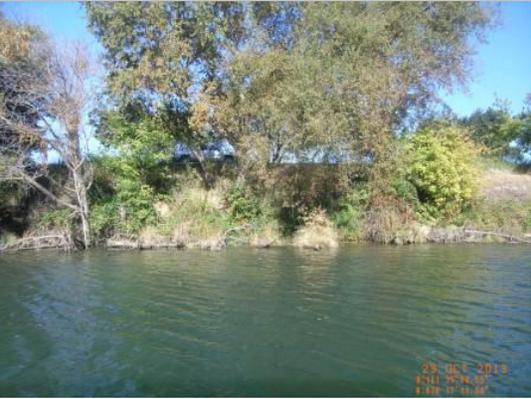
Photo 1 of 1 : FA\_2014\_RD0349\_205\_26\_20141008\_00011.jpg

Item	USACE Erosion Survey			38.288727 °	38.286475 °
				-121.583823 °	-121.585026 °
DWR ID	DWR_RD0349_02_f_2014_26				
Action/Comments					
Inspector Comments: 1997 - Erosion of very sandy levee behind large stand of riparian vegetation on top right bank. Dry ravel of sand. 1999 - Quarry waste rock was dumped down the levee slope; poor repair job; still eroding in places. Eroding at midslope off fabric. 2005 - Length revised, only the middle 150 - 200 ft are eroding. 2006 - Some rock/small material dumped down the bank but it is slowly unraveling. Upstream end is unraveling faster. Steep slope with poor gradation so fines are washing out. 2010 - Lots of overhanging trees and erosion pockets. 2011 - This site is upgraded to CRITICAL. Near vertical bank at the downstream end. New erosion at various locations throughout the site. 2013: No observed changes. [2013 Site ID: STM_24-7_R]

USACE 2013 Photo #1

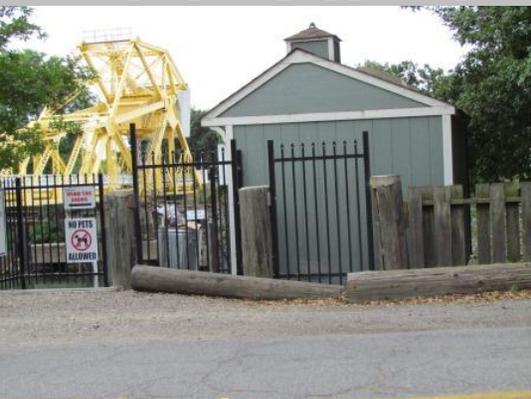
Photo 1 of 3 : FA\_2014\_RD0349\_205\_4\_20141008\_00004.jpg

Unauthorized building waterside shoulder; Unit 2 Sutter Slough.

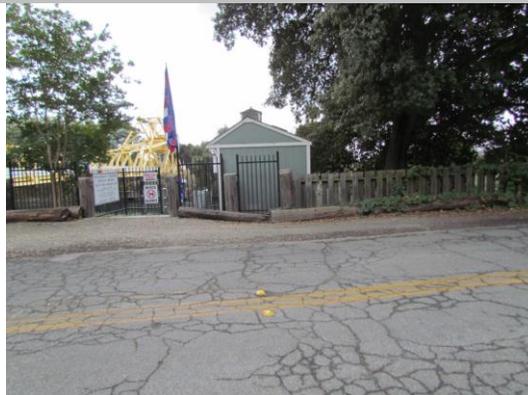
Photo 2 of 3 : FA\_2014\_RD0349\_205\_4\_20141103\_00043.jpg

No change in the condition as of 11-2014.

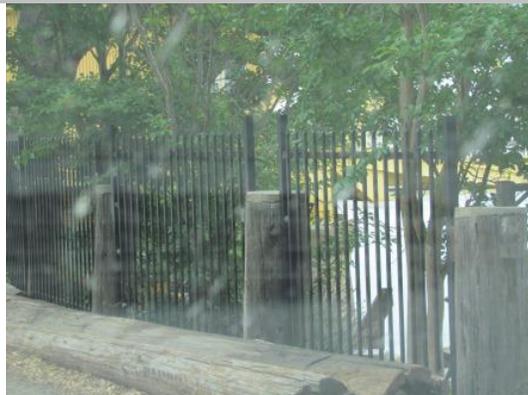
Photo 3 of 3 : FA\_2014\_RD0349\_205\_4\_20141008\_00005.jpg

Unauthorized fence adjacent to building waterside Sutter Slough.

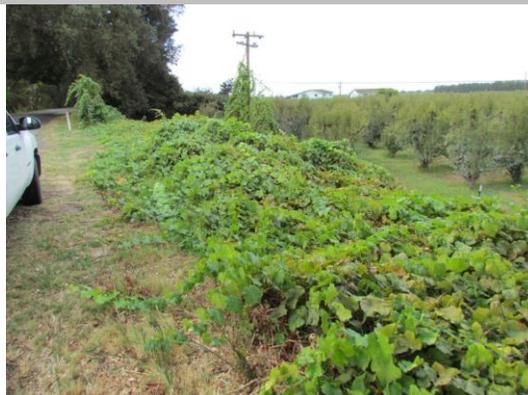
Photo 1 of 1 : FA\_2014\_RD0349\_205\_61\_20141103\_00044.jpg

LM Start	<b>0.02</b>	Rating **	U	Issue No.	<b>61</b>
LM End	<b>0.10</b>	Issue Type +	Ma	Location *	N/A
Category	Earthen Levee		GPS Latitude/Longitude		
			Start	End	
Item	Vegetation		38.305043 °	38.304635 °	
			-121.575128 °	-121.576385 °	
DWR ID	DWR_RD0349_02_f_2014_61				
Action/Comments					
Remove the wild growth other than native grasses from the levee slopes. Inspector Comments: This wild growth of grape vines blocks the view of the levee. The district or landowner needs to remove growth.

Unwanted wild grapes present on the landward levee slope and shoulder.

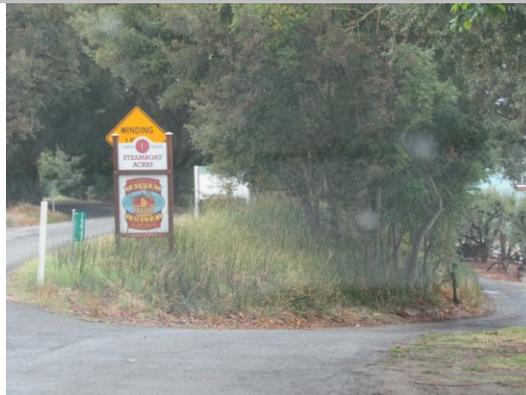
Photo 1 of 1 : FA\_2014\_RD0349\_205\_2\_20141103\_00045.jpg

Looking downstream from levee mile 0.00 tall weeds present on slope and toe landward.

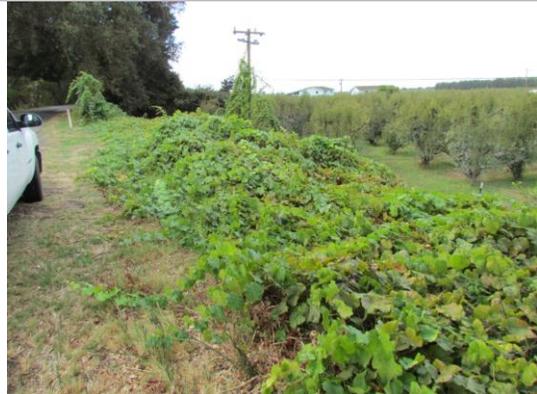
Photo 1 of 1 : FA\_2014\_RD0349\_205\_72\_20141112\_00050.jpg

Unwanted wild grapes growing on the levee shoulder and slope.

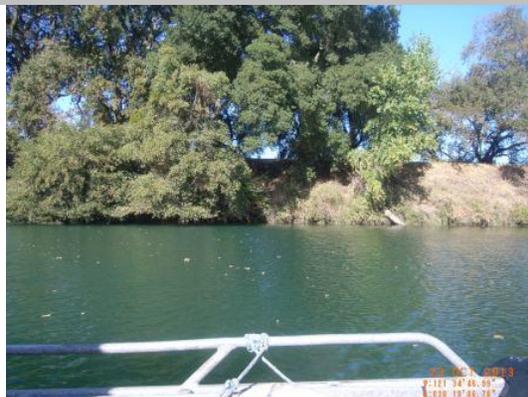
Photo 1 of 1 : FA\_2014\_RD0349\_205\_28\_20141008\_00013.jpg

LM Start	<b>0.29</b>	Rating **	M	Issue No.	<b>28</b>
LM End	<b>0.29</b>	Issue Type +	Ma	Location *	WS
Category	Supplemental		GPS Latitude/Longitude		
			Start	End	
Item	USACE Erosion Survey		38.301772 °	38.302358 °	
			-121.580093 °	-121.579707 °	
DWR ID	DWR_RD0349_02_f_2014_28				
Action/Comments					
Inspector Comments: 2007 - Slow erosion, probably due to wave wash and fluvial erosion. Site has likely been here for awhile but was unseen due to boats parked in front. 2013: No observed changes. [2013 Site ID: STM_25-8_R]

USACE 2013 Photo #1

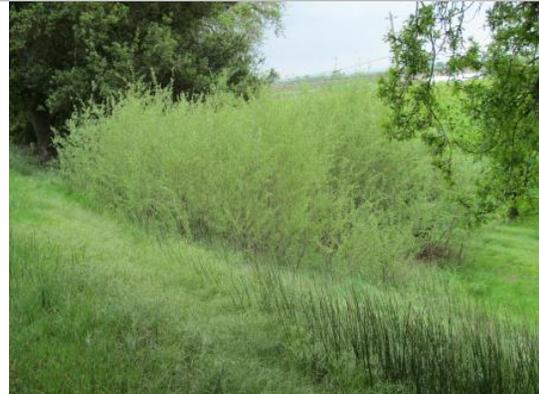
Photo 1 of 1 : FA\_2014\_RD0349\_205\_95\_20141008\_00029.jpg

Unwanted wild growth of willow trees on landside slope and toe.

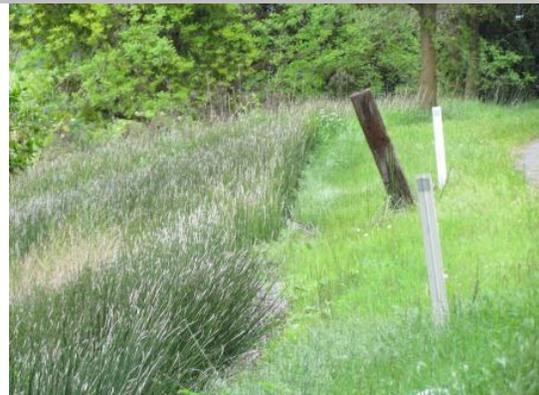
Photo 1 of 1 : FA\_2014\_RD0349\_205\_13\_20141008\_00006.jpg

LM Start	<b>0.36</b>	Rating **	U	Issue No.	<b>13</b>
LM End	<b>0.46</b>	Issue Type +	Ma	Location *	LS
Category	Earthen Levee		GPS Latitude/Longitude		
			Start	End	
Item	Vegetation		38.302201 °	38.300838 °	
			-121.580149 °	-121.580776 °	
DWR ID	DWR_RD0349_02_f_2013_13				
Action/Comments					
Remove the wild growth other than native grasses from the levee slopes. Inspector Comments: Wild vegetation on landward slope need to be maintained.

Unwanted tall reed grasses out of control on the landside slope.

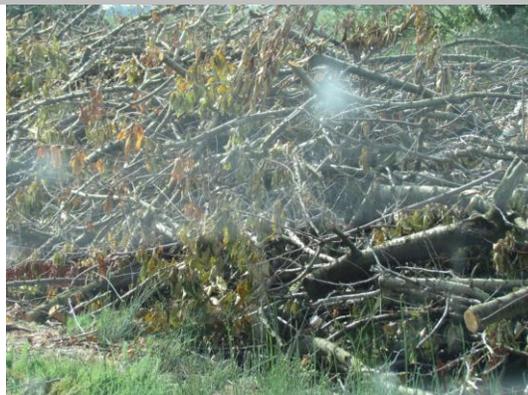
Photo 1 of 1 : FA\_2014\_RD0349\_205\_77\_20141112\_00048.jpg

LM Start	<b>0.84</b>	Rating **	U	Issue No.	<b>77</b>
LM End	<b>0.96</b>	Issue Type +	Ma	Location *	N/A
Category	Earthen Levee		GPS Latitude/Longitude		
			Start	End	
Item	Vegetation		38.295708 °	38.294014 °	
			-121.582920 °	-121.583411 °	
DWR ID	DWR_RD0349_02_s_2014_77				
Action/Comments					
Remove the wild growth other than native grasses from the levee slopes. Inspector Comments: This brush piled on the landward slope needs to be burned or removed. The metals in the pile will not burn.

Unwanted tree clippings piled on the slope creating a burn site. There are metals present in this brush pile.

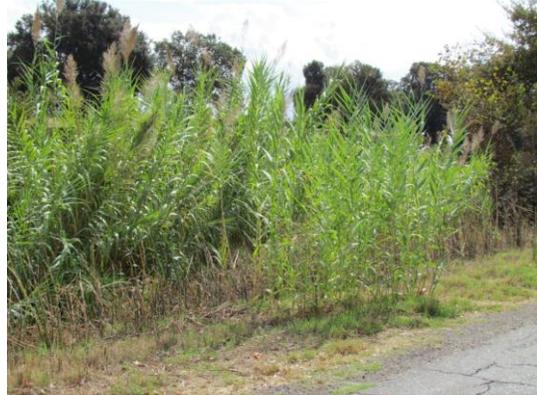
Photo 1 of 1 : FA\_2014\_RD0349\_205\_63\_20141112\_00049.jpg

Arundo present on the waterward levee section needs removing.

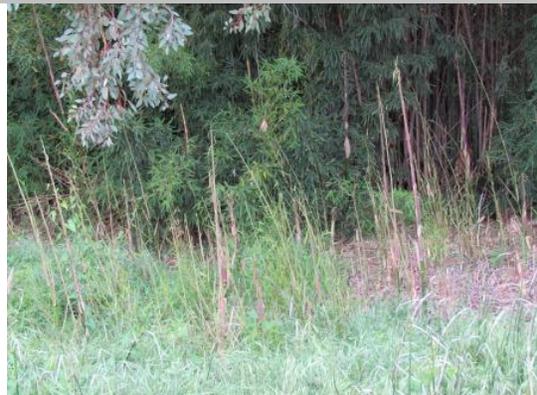
Photo 1 of 1 : FA\_2014\_RD0349\_205\_78\_20141008\_00020.jpg

Wild growth blocking view of the landside levee slope and toe.

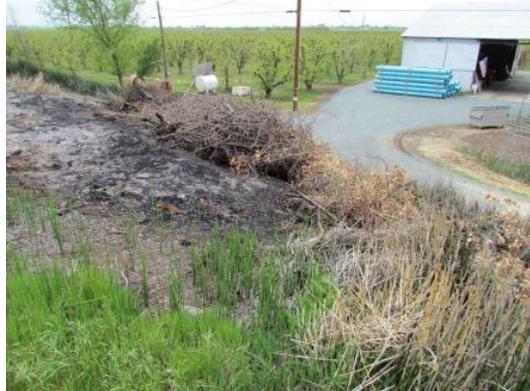
Photo 1 of 2 : FA\_2014\_RD0349\_205\_79\_20141008\_00021.jpg

LM Start	<b>1.00</b>	Rating **	<b>U</b>	Issue No.	<b>79</b>
LM End	<b>1.06</b>	Issue Type +	<b>Ma</b>	Location *	<b>LS</b>
Category	Earthen Levee		GPS Latitude/Longitude		
			Start	End	
Item	Slope Stability		38.293383 °	38.292592 °	
			-121.583570 °	-121.583861 °	
DWR ID	DWR_RD0349_02_s_2014_79				
Action/Comments					
Repair slope instability. Inspector Comments: The erosion was covered over by the piles of tree trimmings, now that they are being burned the erosion can be seen.

Another view of the erosion along the slope. The erosion was blocked from view by the burn pile.

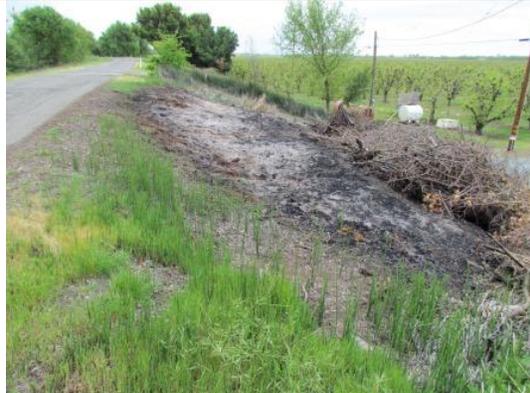
Photo 2 of 2 : FA\_2014\_RD0349\_205\_79\_20141008\_00022.jpg

At this burn site the bank has some erosion occurring.

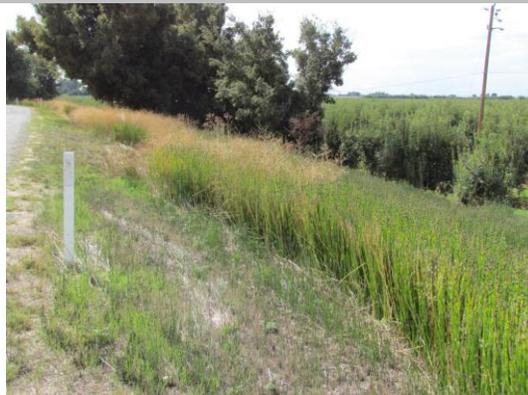
Photo 1 of 1 : FA\_2014\_RD0349\_205\_64\_20141112\_00051.jpg

At this location snap grasses have completely blocked the view of the landward levee slope.

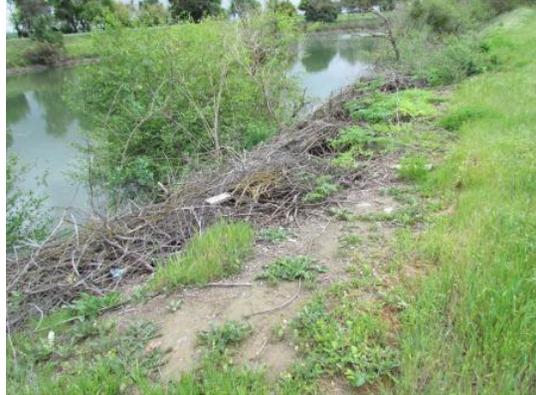
Photo 1 of 1 : FA\_2014\_RD0349\_205\_82\_20141008\_00023.jpg

Tree trimmings at water's edge blocking view of bank. No new photo was taken of this issue. No change since last inspection.

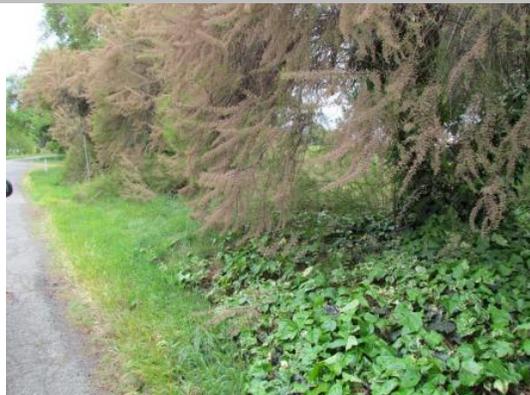
Photo 1 of 1 : FA\_2014\_RD0349\_205\_83\_20141008\_00024.jpg

Woody tree growth blocks view of landside levee section.

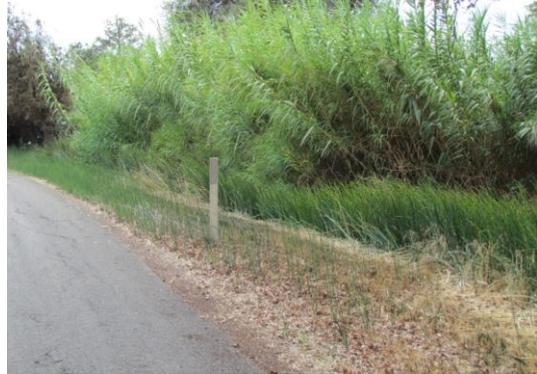
Photo 1 of 1 : FA\_2014\_RD0349\_205\_88\_20141104\_00046.jpg

Levee slope and toe covered with arundo and horse tail.

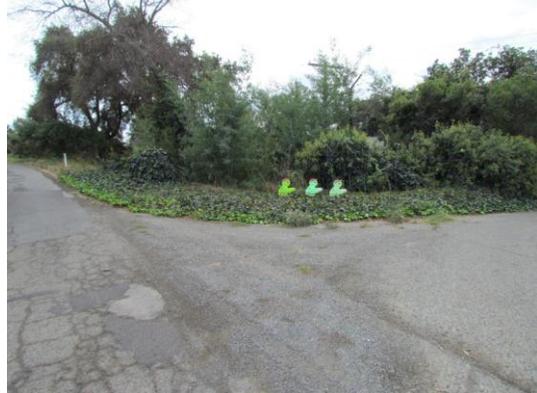
Photo 1 of 1 : FA\_2014\_RD0349\_205\_94\_20141104\_00047.jpg

Woody tree growth and vines present on the landward levee section.

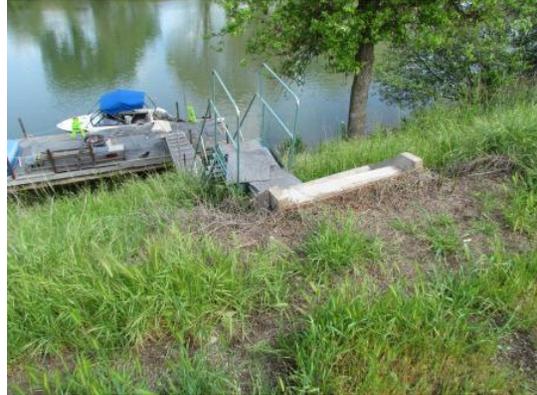
Photo 1 of 2 : FA\_2014\_RD0349\_205\_1\_20141008\_00001.jpg

Unsatisfactory steps placed on waterward slope and toe.

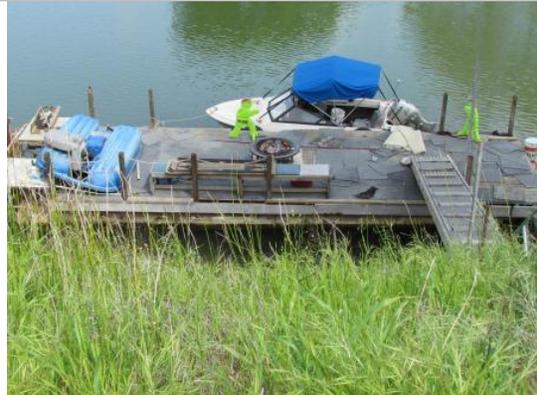
Photo 2 of 2 : FA\_2014\_RD0349\_205\_1\_20141008\_00002.jpg

Unauthorized boat dock at end of steps.

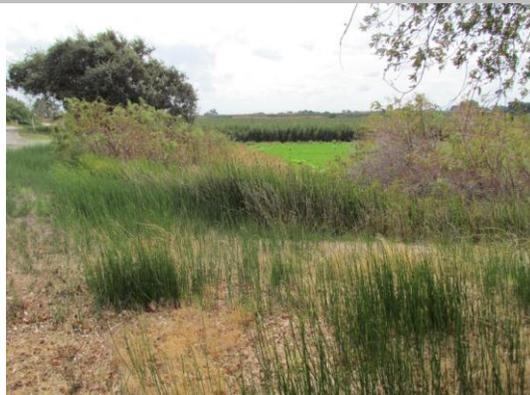
Photo 1 of 1 : FA\_2014\_RD0349\_205\_91\_20141112\_00052.jpg

Unsatisfactory wild growth wild weeds and wild roses present on the landward levee section.

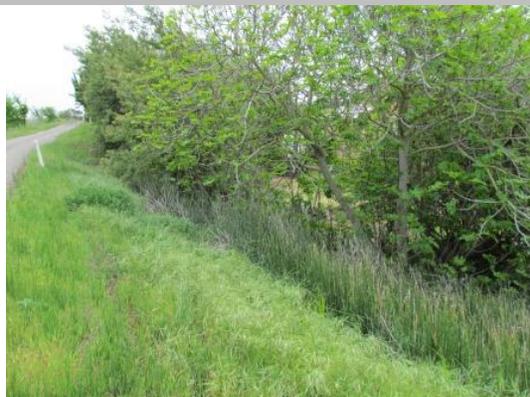
Photo 1 of 1 : FA\_2014\_RD0349\_205\_92\_20141008\_00027.jpg

Woody tree growth blocking view of landward levee section.

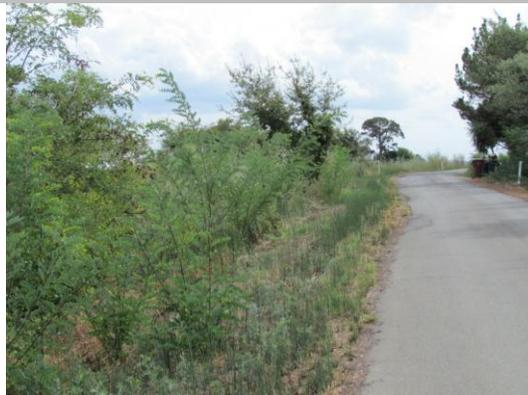
Photo 1 of 1 : FA\_2014\_RD0349\_205\_66\_20141112\_00053.jpg

Wild weeds present on the waterside shoulder and slope.

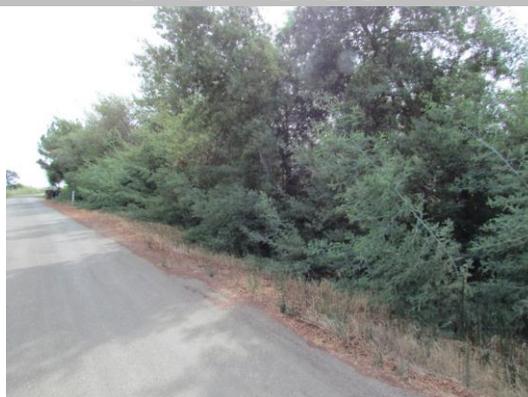
Photo 1 of 1 : FA\_2014\_RD0349\_205\_53\_20141112\_00054.jpg

Woody tree growth on the landward shoulder and slope unable to see levee section.

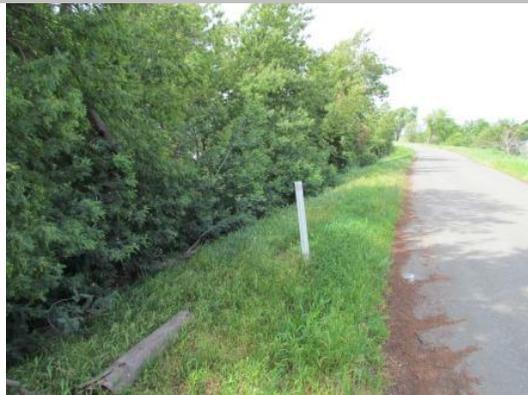
Photo 1 of 1 : FA\_2014\_RD0349\_205\_47\_20141008\_00014.jpg

Woody tree growth completely blocking view of landward levee slope.

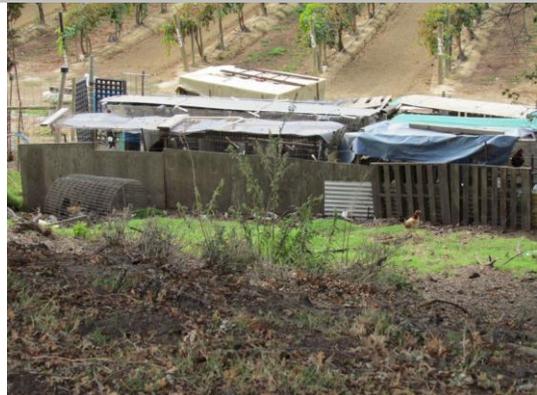
Photo 1 of 2 : FA\_2014\_RD0349\_205\_59\_20141112\_00055.jpg

Unpermitted fences and animal storage pens on the landward slope and toe.

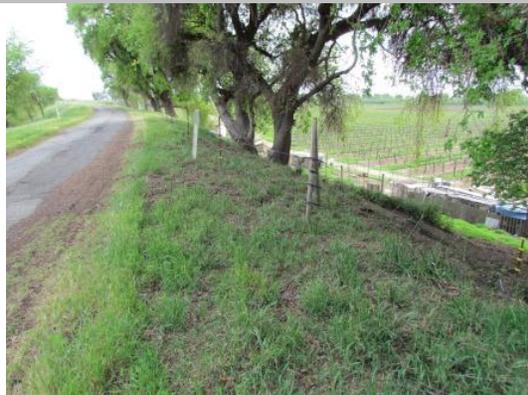
Photo 2 of 2 : FA\_2014\_RD0349\_205\_59\_20141008\_00016.jpg

Unpermitted fence on landside shoulder and slope of levee section.

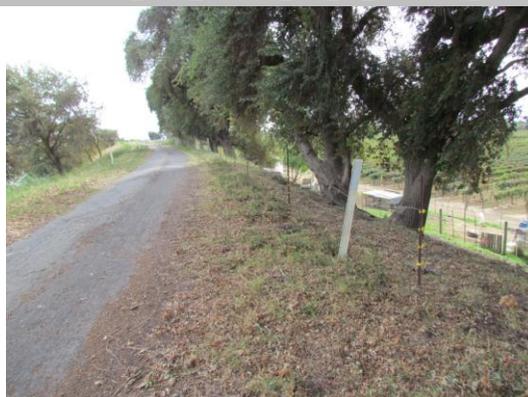
Photo 1 of 1 : FA\_2014\_RD0349\_205\_69\_20141112\_00056.jpg

Unauthorized electric wire fence placed on the landside shoulder and slope.

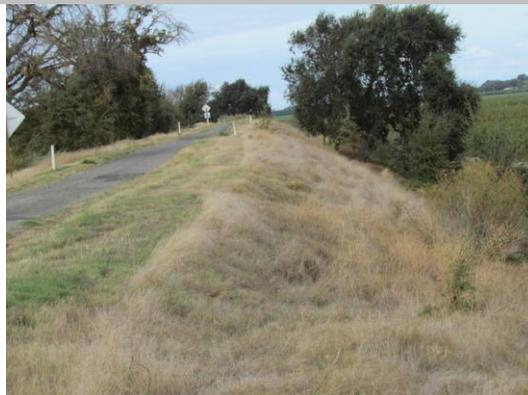
Photo 1 of 1 : FA\_2014\_RD0349\_206\_6\_20141112\_00033.jpg

Unit 3 looking downstream from the landside slope levee mile 0.00 tall dead weeds on the slope and toe.

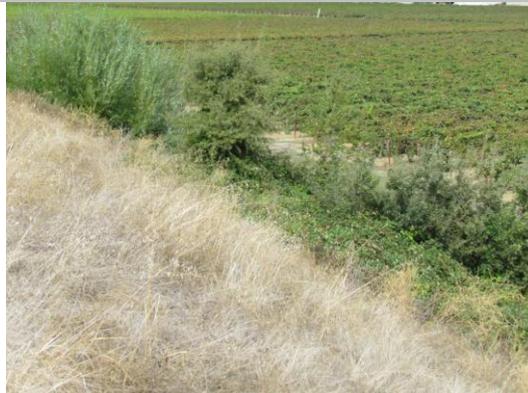
Photo 1 of 1 : FA\_2014\_RD0349\_206\_7\_20141112\_00034.jpg

Woody tree growth on landward slope and wild berries on landward toe.

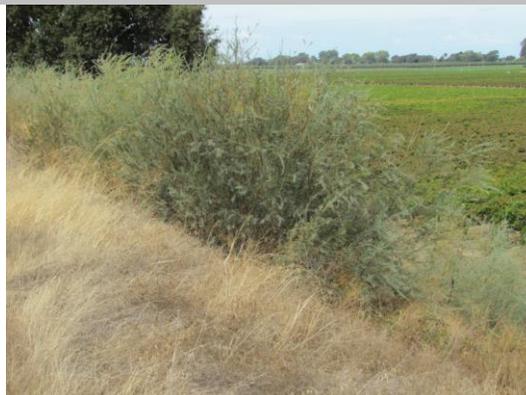
Photo 1 of 1 : FA\_2014\_RD0349\_206\_57\_20141112\_00036.jpg

Unwanted tree growth on the landward slope and toe.

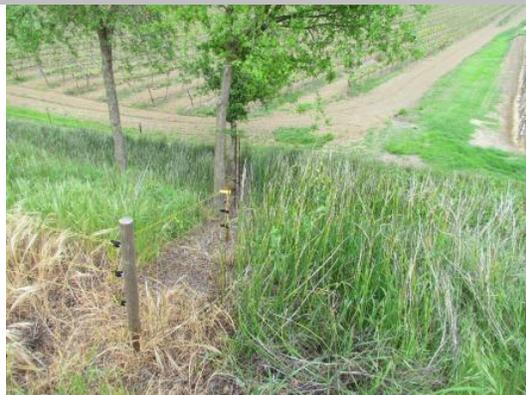
Photo 1 of 2 : FA\_2014\_RD0349\_206\_60\_20141008\_00006.jpg

View of fence along the levee slope from shoulder to levee toe running along downstream. Spring 2014

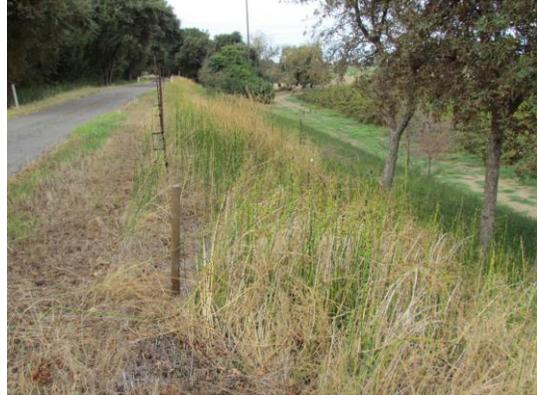
Photo 2 of 2 : FA\_2014\_RD0349\_206\_60\_20141112\_00037.jpg

Unauthorized electric wire fence at this location. Fall 2014

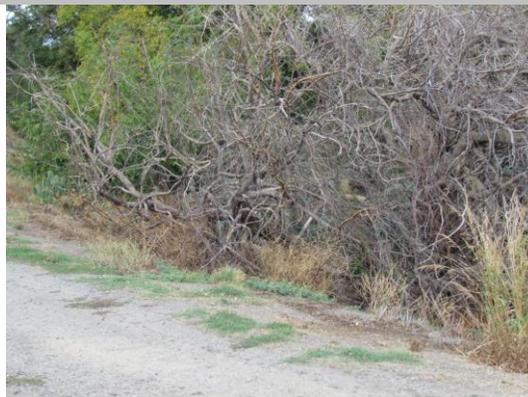
Photo 1 of 1 : FA\_2014\_RD0349\_206\_971\_20141112\_00040.jpg

Woody tree growth on landward levee slope.

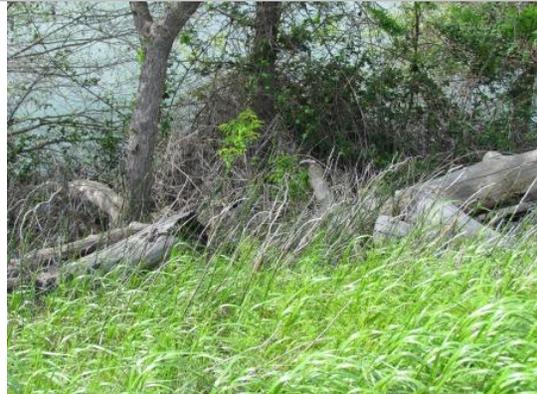
Photo 1 of 1 : FA\_2014\_RD0349\_206\_64\_20141008\_00009.jpg

Cut up fallen tree on waterside slope.

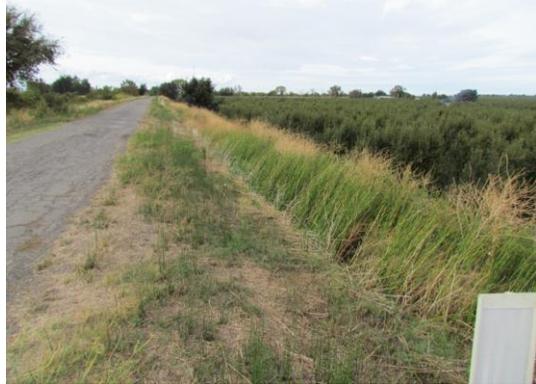
Photo 1 of 1 : FA\_2014\_RD0349\_206\_71\_20141112\_00038.jpg

Unsatisfactory tall snap grasses on the landward levee section. Weeds are taller than 24-inches.

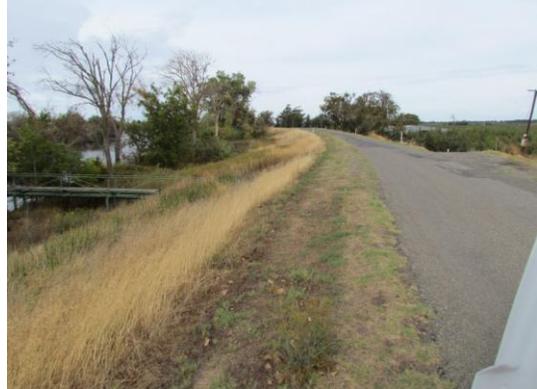
Photo 1 of 1 : FA\_2014\_RD0349\_206\_65\_20141112\_00041.jpg

Wild growth of tall grasses on the waterward levee slope.

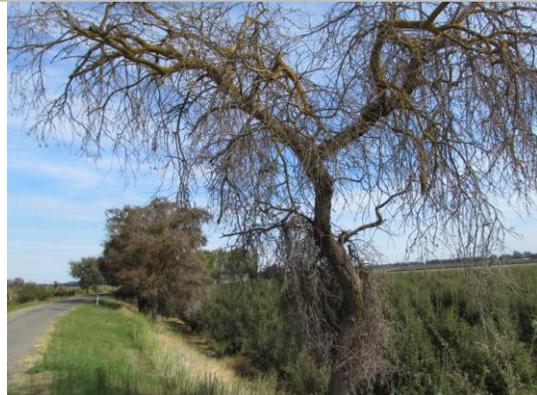
Photo 1 of 2 : FA\_2014\_RD0349\_206\_73\_20141112\_00042.jpg

Dead tree above crown roadway landward.

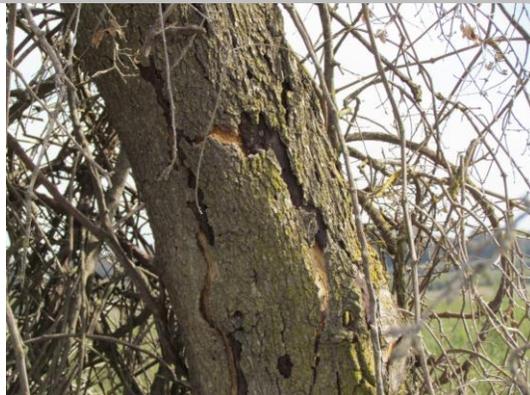
Photo 2 of 2 : FA\_2014\_RD0349\_206\_73\_20141112\_00043.jpg

Close up view of dead tree standing above crown roadway.

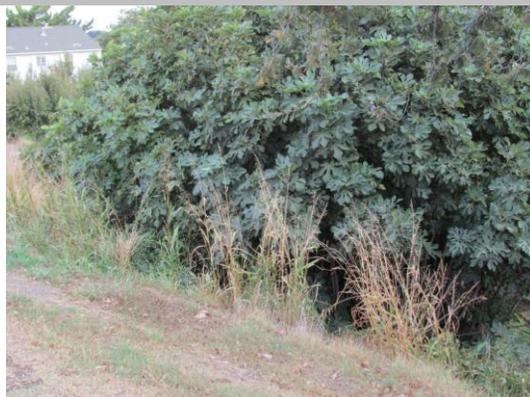
Photo 1 of 1 : FA\_2014\_RD0349\_206\_69\_20141112\_00044.jpg

Woody tree growth on the landward slope and toe of the levee section.

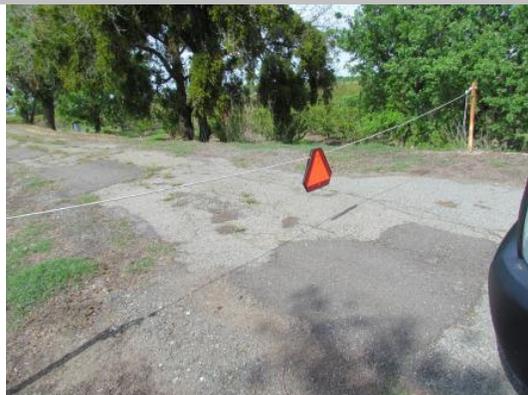
Photo 1 of 1 : FA\_2014\_RD0349\_206\_25\_20141008\_00004.jpg

Cable crossings has been banned. They are unauthorized. No new photo.

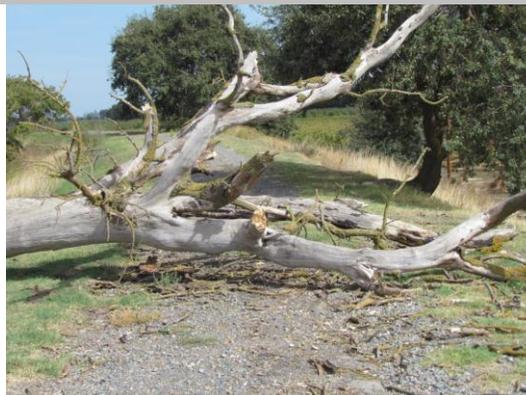
Photo 1 of 2 : FA\_2014\_RD0349\_206\_82\_20141112\_00045.jpg

Dead tree fallen across levee crown roadway, access blocked off.

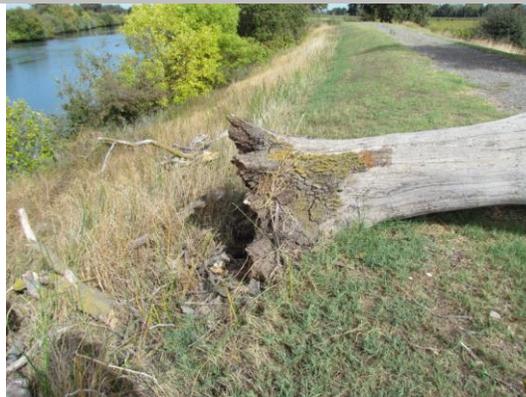
Photo 2 of 2 : FA\_2014\_RD0349\_206\_82\_20141112\_00046.jpg

Dead tree completely up rooted from the ground.

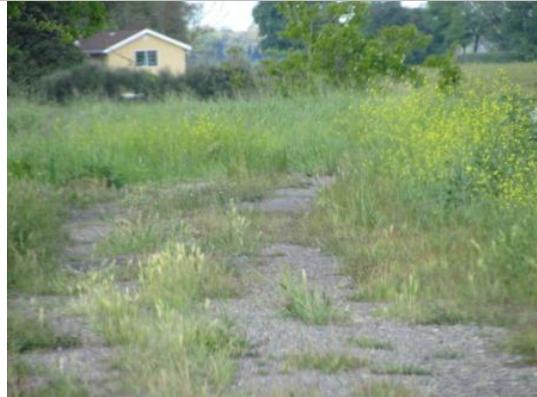
Photo 1 of 1 : FA\_2014\_RD0349\_206\_24\_20141008\_00003.jpg

Tall weeds has completely taken over crown roadway.
