**Flood Control Project Maintenance  
Levee Inspections**

**Fall 2015 Levee Maintenance Deficiency Summary Report  
Overall LMA & Unit Ratings, including USACE Erosion Survey**

**Reclamation District No. 0349 Sutter Island**

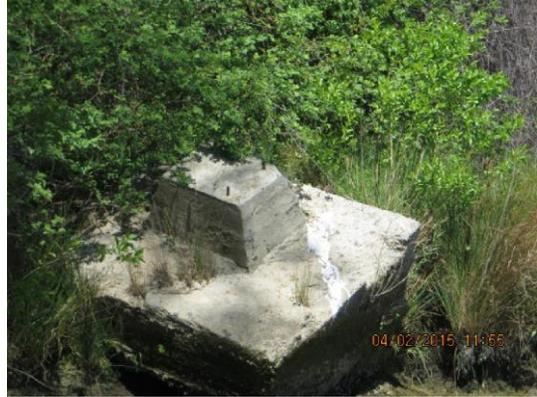
Photo 1 of 3 : UCIP\_FA\_2015\_5845.jpg

Item	DWR UCIP Field Study			38.326133 °	38.326133 °
				-121.577141 °	-121.577141 °
DWR ID					
Action/Comments					
Inspector Comments: FS_ID:44303 DS_ID:24137 EP_NO: N/A FS_HLM: 0.0621 Repair Type: Non-Urgent Crossing Status: Indicator Found UCIP Comments: Pipe appears to be abandoned and if so should be done so properly. Electromagnetic survey indicated a crossing at this location. FIELD_STRUCT_DESC: *ABANDONED* 10-inch pipe through the levee, 3.8 feet below the crown. Power pole and anchor on the landward side. Deteriorated concrete box at the LS toe. Concrete debris on WS toe good indicator of pump location (USACE-1960). This entry matches the Drainage or Irrigation Structure referenced in O&M manual (HLM 2.74). FS Date: 04/02/2015

Concrete debris on WS toe is a good indicator of pump location.

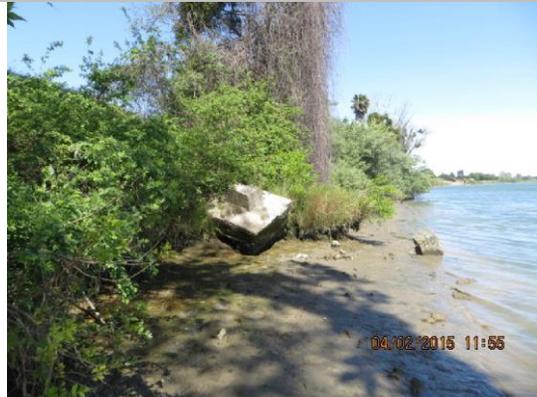
Photo 2 of 3 : UCIP\_FA\_2015\_5846.jpg

Concrete debris on WS toe is a good indicator of pump location.

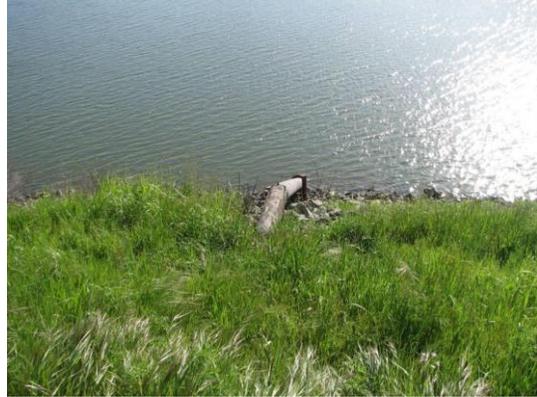
Photo 2 of 2 : UCIP\_FA\_2015\_0710.jpg

Item	DWR UCIP Field Study			38.320476 °	38.320476 °
				-121.578616 °	-121.578616 °
DWR ID					
<b>Action/Comments</b>					
Inspector Comments: FS_ID:39871 DS_ID:24139 EP_NO: N/A FS_HLM: 0.466 Repair Type: Urgent Crossing Status: Found UCIP Comments: Exposed section of levee slope on landward side--need to contact owner and DWR inspector. Burrow activity noticed at crossing 10 inch holes. Dense vegetation limits the inspector's visibility to identify signs of pipe failure (leaks) along the slope. Recommend removing vegetation along pipe alignment to conduct proper inspection of structure and appurtenances. Note date on photos should be 3/18/09 not 7/26/08 camera metadata is incorrect. FIELD_STRUCT_DESC: 8-inch steel pipe measured (instead of 10-inch) sleeved through a 12-inch steel pipe, 6.6 feet below the crown. Annular gap grouted at both ends. Active centrifugal pump on platform at landward toe. Inactive slant pump on steel platform on waterward slope. Exposed section pipe on waterward slope. Service pole on the landward slope. (USACE-1959). This entry matches the Drainage or Irrigation Structure referenced in O&M manual (HLM 0.5). 10-inch pipe sleeved through pre-existing pipe under Permit No. 3382 (1960). 12-inch pipe sleeved was authorized under Permint No. 951 in 1944. FS Date: 03/18/2009

View of pipe on waterward side with rip rap on toe--dense vegetation on slope.

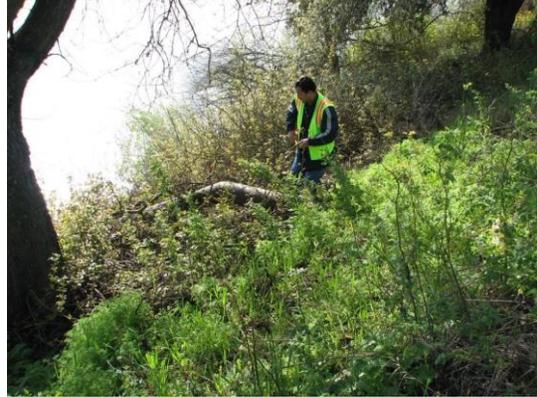
Photo 2 of 3 : UCIP\_FA\_2015\_0718.jpg

Item	DWR UCIP Field Study			38.314672 °	38.314672 °
				-121.579102 °	-121.579102 °
DWR ID					
Action/Comments					
Inspector Comments: FS_ID:21572 DS_ID:24521 EP_NO: N/A FS_HLM: 0.873 Repair Type: Non-Urgent Crossing Status: Found UCIP Comments: No records were found during intial desk study--need to contact owner to obtain permit number authorizing work. If crossing is no longer used by owner, the owner will need to coordinate with DWR Inspector and CVFPB to remove crossing according to Title 23 requirements. Dense vegetation limits the inspector's visibility to identify signs of pipe failure (leaks) along the slope. Recommend removing vegetation along pipe alignment to conduct proper inspection of structure and appurtenances. Note date on photos should be 3/18/09 not 7/26/08 camera metadata is incorrect. FIELD_STRUCT_DESC: Abandoned 8-inch pipe through the levee, 13.9 feet below the crown. Pump on platform at landward toe. Service pole on landward slope. FS Date: 03/18/2009

View of pipe crossing located on waterward side--dense vegetation on levee slope.

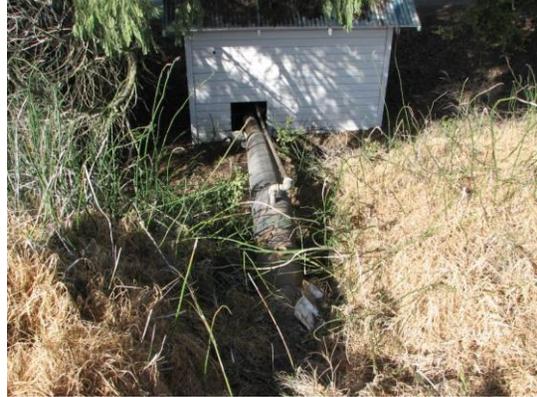
Photo 1 of 3 : UCIP\_FA\_2015\_0711.jpg

Inspector Comments: FS\_ID:39872  
 DS\_ID:24140  
 EP\_NO: N/A  
 FS\_HLM: 1.026  
 Repair Type: Urgent  
 Crossing Status: Found  
 UCIP Comments: Exposed section of levee slope on landward side--need to contact owner and DWR inspector. Dense vegetation limits the inspector's visibility to identify signs of pipe failure (leaks) along the slope. Recommend removing vegetation along pipe alignment to conduct proper inspection of structure and appurtenances. Note date on photos should be 3/18/09 not 7/26/08 camera metadata is incorrect.  
 FIELD\_STRUCT\_DESC: 14-inch pipe (waterward shoulder) and 12-inch pipe (landward shoulder) through the levee, 4.7 feet below the crown. Gate valve on the waterward slope. Pump in pumphouse on landward slope. Pressure breaker behind pumphouse. Pipe exposed on waterward slope. (USACE-1959). This entry matches the Drainage or Irrigation Structure referenced in O&M manual (HLM 1.1).

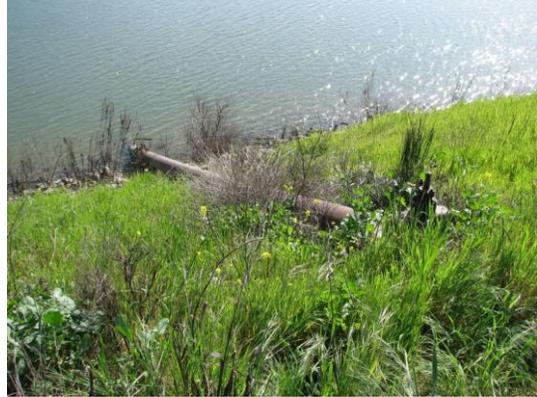
Photo 2 of 3 : UCIP\_FA\_2015\_0712.jpg

Inspector Comments: FS\_ID:39872  
 DS\_ID:24140  
 EP\_NO: N/A  
 FS\_HLM: 1.026  
 Repair Type: Urgent  
 Crossing Status: Found  
 UCIP Comments: Exposed section of levee slope on landward side-- need to contact owner and DWR inspector. Dense vegetation limits the inspector's visibility to identify signs of pipe failure (leaks) along the slope. Recommend removing vegetation along pipe alignment to conduct proper inspection of structure and appurtenances. Note date on photos should be 3/18/09 not 7/26/08 camera metadata is incorrect. FIELD\_STRUCT\_DESC: 14-inch pipe (waterward shoulder) and 12-inch pipe (landward shoulder) through the levee, 4.7 feet below the crown. Gate valve on the waterward slope. Pump in pumphouse on landward slope. Pressure breaker behind pumphouse. Pipe exposed on waterward slope. (USACE-1959). This entry matches the Drainage or Irrigation Structure referenced in O&M manual (HLM 1.1).

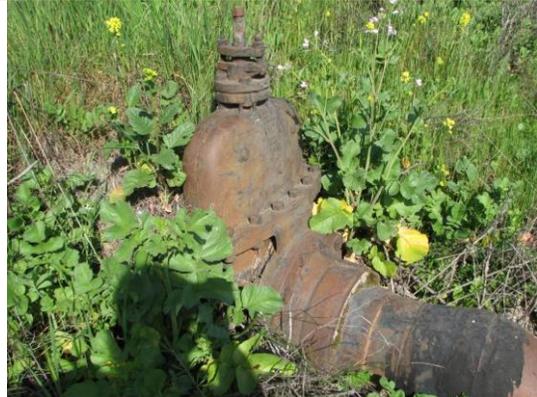
Photo 3 of 3 : UCIP\_FA\_2015\_0713.jpg

LM Start	1.03	Rating **	U	Issue No.	25 (cont)
LM End	1.03	Issue Type +	En	Location *	LS
Category	Supplemental			GPS Latitude/Longitude	
				Start	End
Item	DWR UCIP Field Study			38.312496 °	38.312496 °
				-121.578625 °	-121.578625 °
DWR ID					
Action/Comments					
Inspector Comments: FS_ID:39872 DS_ID:24140 EP_NO: N/A FS_HLM: 1.026 Repair Type: Urgent Crossing Status: Found UCIP Comments: Exposed section of levee slope on landward side--need to contact owner and DWR inspector. Dense vegetation limits the inspector's visibility to identify signs of pipe failure (leaks) along the slope. Recommend removing vegetation along pipe alignment to conduct proper inspection of structure and appurtenances. Note date on photos should be 3/18/09 not 7/26/08 camera metadata is incorrect. FIELD_STRUCT_DESC: 14-inch pipe (waterward shoulder) and 12-inch pipe (landward shoulder) through the levee, 4.7 feet below the crown. Gate valve on the waterward slope. Pump in pumphouse on landward slope. Pressure breaker behind pumphouse. Pipe exposed on waterward slope. (USACE-1959). This entry matches the Drainage or Irrigation Structure referenced in O&M manual (HLM 1.1). FS Date: 03/18/2009

View of gate with missing handle located on waterward slope.

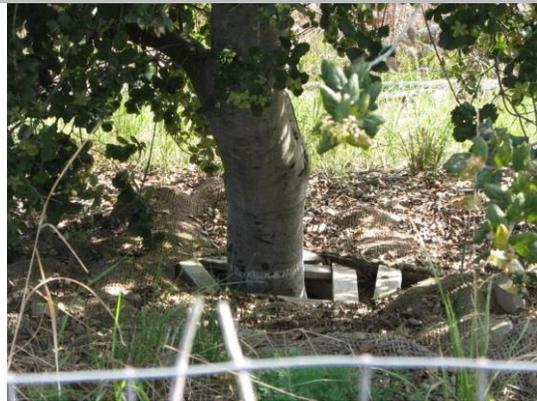
Photo 1 of 3 : UCIP\_FA\_2015\_0724.jpg

Item	DWR UCIP Field Study			38.310287 °	38.310287 °
				-121.577669 °	-121.577669 °
DWR ID					
Action/Comments					
Inspector Comments: FS_ID:44304 DS_ID:24141 EP_NO: N/A FS_HLM: 1.188 Repair Type: Non-Urgent Crossing Status: Found UCIP Comments: 2007 DWR erosion repair site location?--need to find out fate of crossing. Dense vegetation limits the inspector's visibility to identify signs of pipe failure (leaks) along the slope. Recommend removing vegetation along pipe alignment to conduct proper inspection of structure and appurtenances. Note date on photos should be 3/18/09 not 7/26/08 camera metadata is incorrect. FIELD_STRUCT_DESC: Pumphouse at landward toe. Pressure breaker on landward side. Electromagnetic Survey indicated a crossing at this location as well. FS Date: 04/02/2015

Geotech fabric and protective frame at tree--design features of erosion repair site 2007-2009.

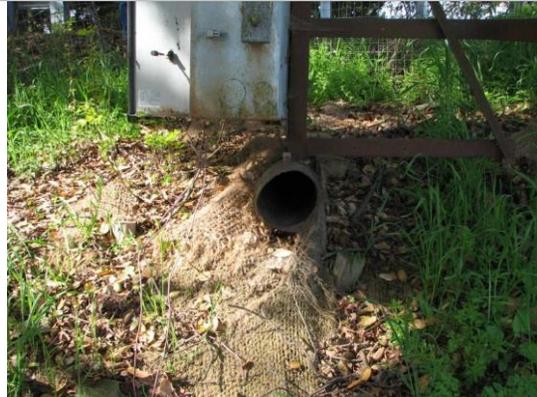
Photo 1 of 3 : UCIP\_FA\_2015\_0714.jpg

Item	DWR UCIP Field Study		38.306760 °	38.306760 °	
			-121.575312 °	-121.575312 °	
DWR ID					
Action/Comments					
Inspector Comments: FS_ID:44214 DS_ID:24143 EP_NO: 12005 FS_HLM: 1.468 Repair Type: Non-Urgent Crossing Status: Found UCIP Comments: Pipe open on WS slope. 2007 Erosion Repair Site location?--Need to contact owner to determine if crossing is still in use. Dense vegetation limits the inspector's visibility to identify signs of pipe failure (leaks) along the slope. Recommend removing vegetation along pipe alignment to conduct proper inspection of structure and appurtenances. Note date on photos should be 3/18/09 not 7/26/08 camera metadata is incorrect. FIELD_STRUCT_DESC: 6-inch steel irrigation pipe, 4.0 feet below the crown. Siphon breaker and protective housing at levee shoulder. Pump on waterward side. Pipe exposed on waterward slope, extending to pump. Discharge structure at landward toe. (Permit No. 12005-1977) FS Date: 04/02/2015

View of pipe at waterward shoulder with control box.

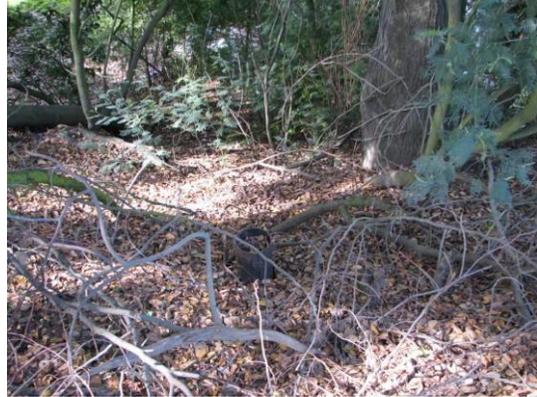
Photo 2 of 3 : UCIP\_FA\_2015\_0715.jpg

Pipe located on landward side--unable to determine whether it belongs to crossing.

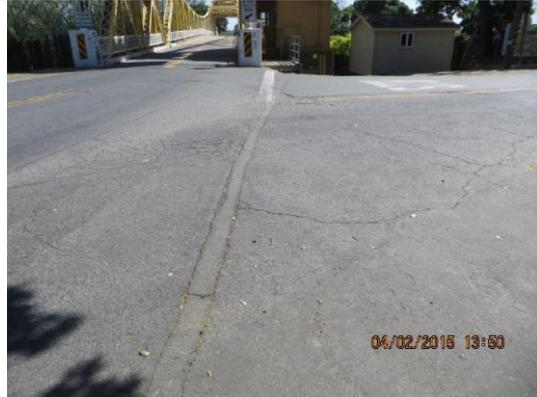
Photo 1 of 3 : UCIP\_FA\_2015\_5975.jpg

LM Start	<b>0.00</b>	Rating **	M	Issue No.	<b>88</b>
LM End	<b>0.00</b>	Issue Type +	En	Location *	WS
Category	Supplemental			GPS Latitude/Longitude	
				Start	End
Item	DWR UCIP Field Study			38.305124 °	38.305124 °
				-121.574772 °	-121.574772 °
DWR ID					
Action/Comments					
Inspector Comments: FS_ID:46168 DS_ID:25096 EP_NO: N/A FS_HLM: 0 Repair Type: Non-Urgent Crossing Status: Indicator Found UCIP Comments: Need to identify permit for crossing. FIELD_STRUCT_DESC: 2-inch waterline through the levee at an unknown depth below crown. Pipe provides service to bridge and beach (per landowner). FS Date: 04/09/2015

Cut in pavement good indicator of pipe location.

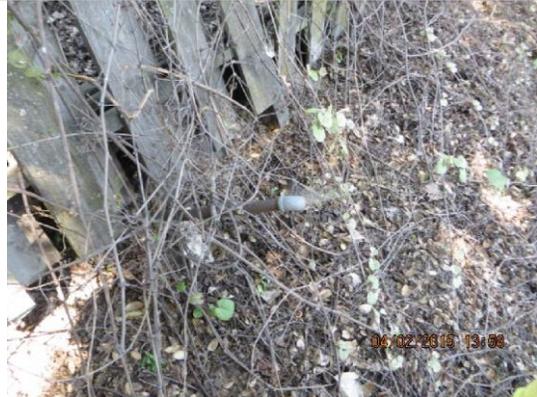
Photo 1 of 3 : UCIP\_FA\_2015\_5978.jpg

Pipe visible at base of fence on WS shoulder.

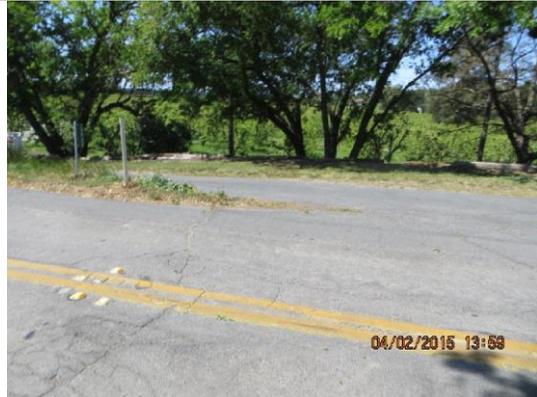
Photo 3 of 3 : UCIP\_FA\_2015\_5980.jpg

Approximate location of pipe alignment on LS of crown.

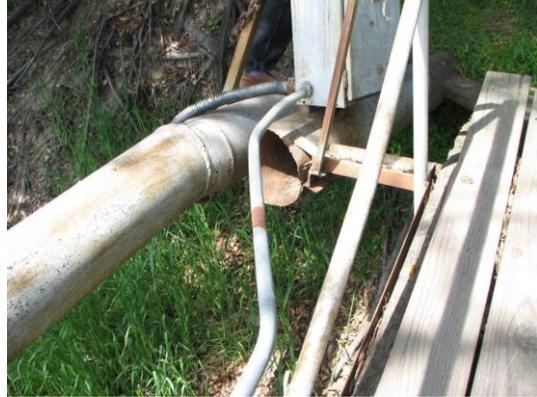
Photo 2 of 3 : UCIP\_FA\_2015\_2408.jpg

Action/Comments					
Inspector Comments: FS_ID:21576 DS_ID:24145 EP_NO: N/A FS_HLM: 0.096 Repair Type: Non-Urgent Crossing Status: Found UCIP Comments: No connection present--need to contact owner to determine if owner plans to use. If crossing is no longer in use owner will need to coordinate with DWR inspector and CVFPB to remove according to Title 23 requirements. Dense vegetation limits the inspector's visibility to identify signs of pipe failure (leaks) along the slope. Recommend removing vegetation along pipe alignment to conduct proper inspection of structure and appurtenances. Unable to determine if crossing is in use. Note date on photos should be 3/18/09 not 7/26/08 camera metadata is incorrect. FIELD_STRUCT_DESC: Abandoned 10-inch pipe through the levee, 6.0 feet below the crown. Pump and slide gate on the waterward slope. Concrete pipe riser and distribution box at the landward toe. Service pole and anchor on the landward slope. FS Date: 03/18/2009

Pipes through levee at waterward slope.

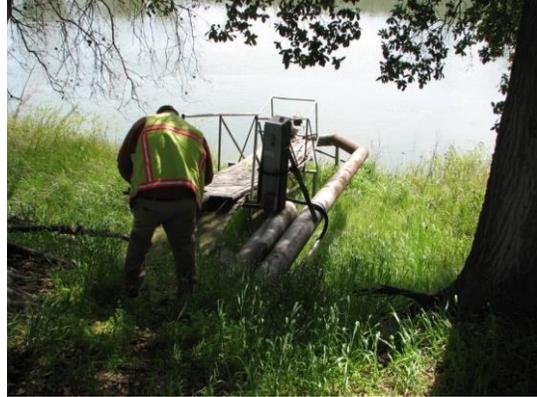
Photo 3 of 3 : UCIP\_FA\_2015\_2409.jpg

Dense vegetation on waterward slope--2 pipes and 1 conduit.

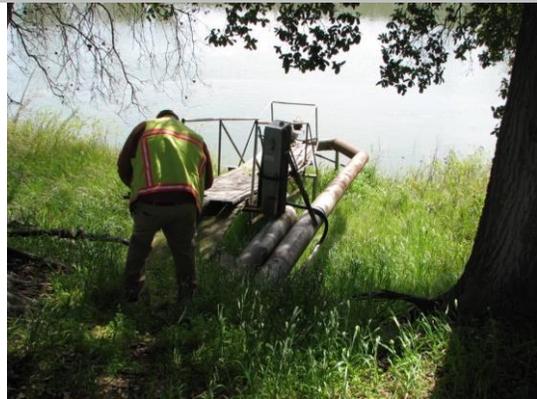
Photo 2 of 3 : UCIP\_FA\_2015\_2411.jpg

Dense vegetation on waterward slope-2 pipes and 1 conduit.

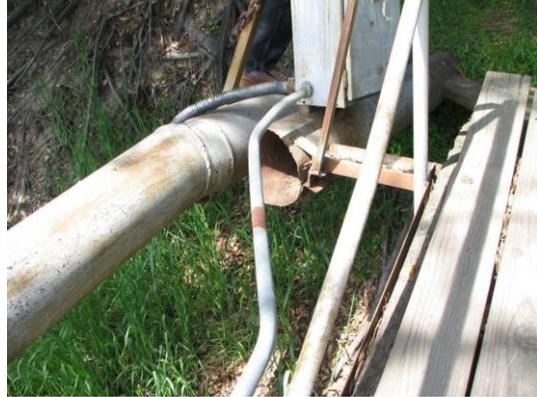
Photo 3 of 3 : UCIP\_FA\_2015\_2412.jpg

Pipes through levee at waterward slope.

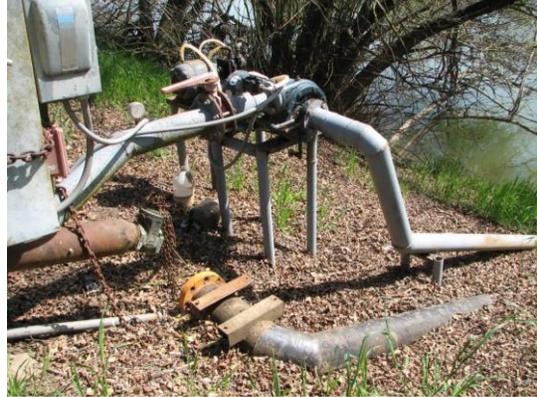
Photo 1 of 3 : UCIP\_FA\_2015\_0703.jpg

Action/Comments					
Inspector Comments: FS_ID:21614 DS_ID:24148 EP_NO: 12006 FS_HLM: 0.28 Repair Type: Non-Urgent Crossing Status: Found UCIP Comments: Altered crossing--contact owner to obtain new permit authoring work. Debris remains on site. Dense vegetation limits the inspector's visibility to identify signs of pipe failure (leaks) along the slope. Recommend removing vegetation along pipe alignment to conduct proper inspection of structure and appurtenances. Note date on photos should be 3/18/09 not 7/26/08 camera metadata is incorrect. FIELD_STRUCT_DESC: 6-inch steel irrigation pipe through the levee, 4.0 feet below the crown. 3-inch conduit through levee to service pump. Steel cutoff wall around pipe at center of levee. Siphon breaker in concrete riser at landward shoulder. Gate valve on landward side. Pump on concrete pad on waterward slope. Discharge structure at landward toe. (Permit No. 12006-1977) FS Date: 03/18/2009

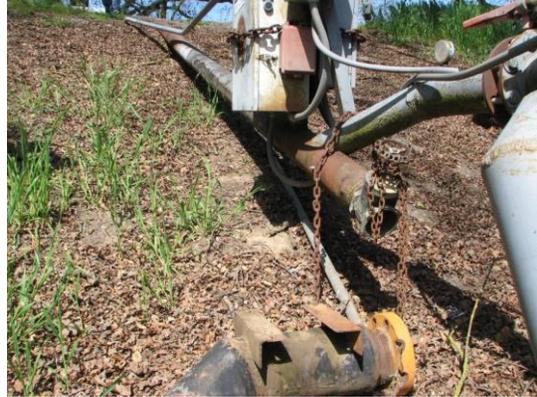
Photo 2 of 3 : UCIP\_FA\_2015\_0704.jpg

Crossing has been altered--abandoned pipe through levee slope remains.

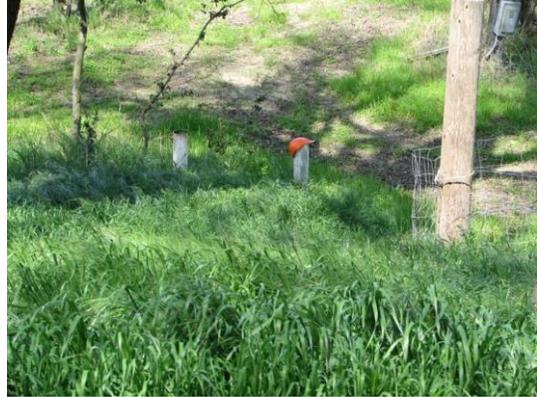
Photo 3 of 3 : UCIP\_FA\_2015\_0705.jpg

View of landward side--unable to inspect.

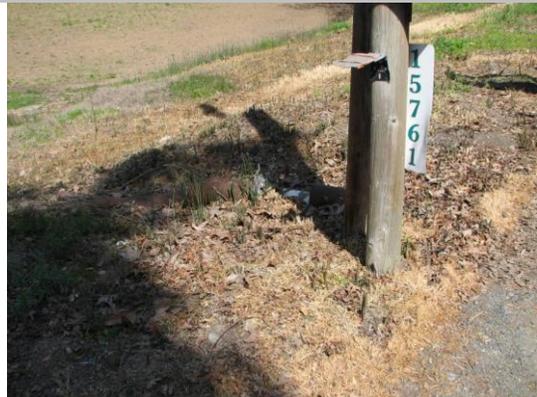
Photo 2 of 3 : UCIP\_FA\_2015\_0707.jpg

View of landward shoulder--service pole and pipe section through slope.

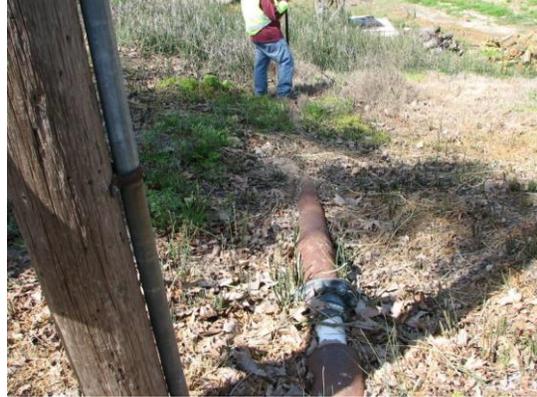
Photo 3 of 3 : UCIP\_FA\_2015\_0708.jpg

View of landward side--it appears PVC pipe was sleeved through existing crossing.

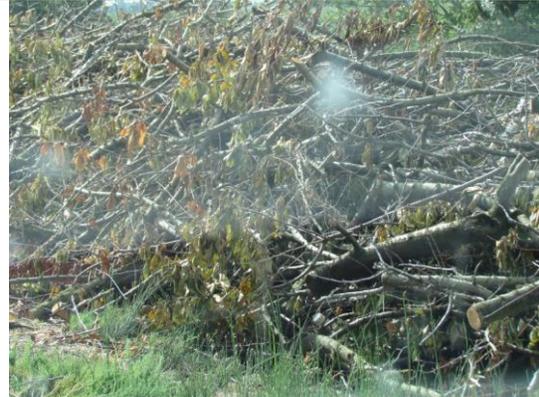
Photo 1 of 1 : FA\_2015\_RD0349\_205\_77\_20150915\_00027.jpg

Unwanted tree clippings piled on the slope creating a burn site. There are metals present in this brush pile.

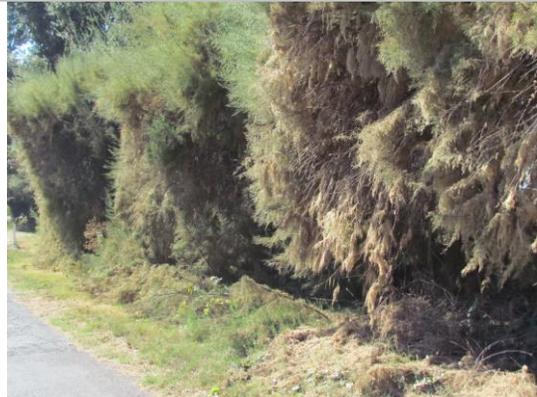
Photo 1 of 1 : FA\_2015\_RD0349\_205\_61\_20151012\_00057.jpg

Looking downstream from levee mile 1.33-1.35 woody tree growth completely blocking the view of the levee.

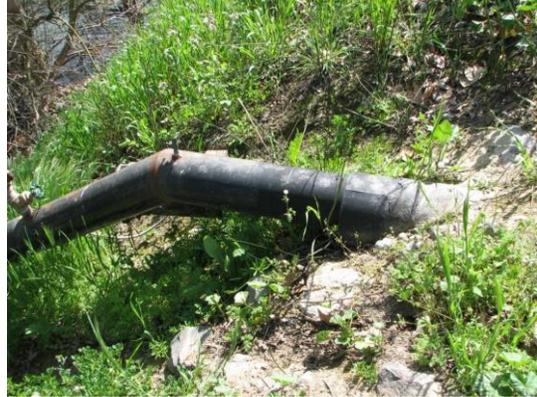
Photo 1 of 3 : UCIP\_FA\_2015\_2495.jpg

Smaller pipe sleeved through larger pipe that goes through levee.

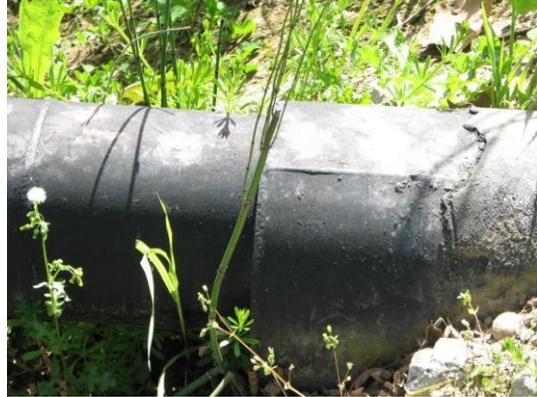
Photo 3 of 3 : UCIP\_FA\_2015\_2497.jpg

Pipe sleeved through larger pipe.

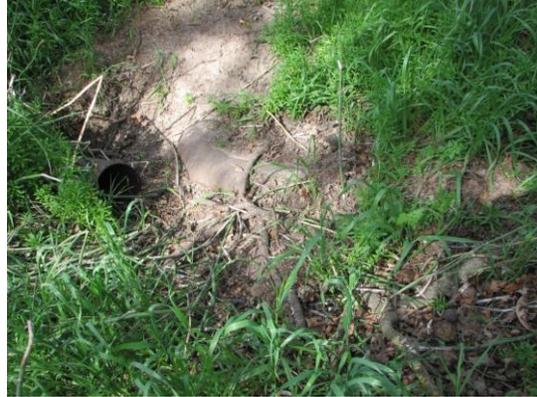
Photo 2 of 3 : UCIP\_FA\_2015\_2511.jpg

Action/Comments					
Inspector Comments: FS_ID:21609 DS_ID:24157 EP_NO: N/A FS_HLM: 2.159 Repair Type: Non-Urgent Crossing Status: Found UCIP Comments: Debris scattered--need to contact owner. If crossing is not in used will need to coordinate with DWR Inspector and CVFPB to remove per Title 23 requirements. Dense vegetation limits the inspector's visibility to identify signs of pipe failure (leaks) along the slope. Recommend removing vegetation along pipe alignment to conduct proper inspection of structure and appurtenances. Note date on photos should be 3/18/09 not 7/26/08 camera metadata is incorrect. FIELD_STRUCT_DESC: 8-inch pipe sleeved through 12-inch pipe through the levee, 4.0 feet below the crown. Annular gap not grouted. Service pole on the waterward shoulder. Pump on the waterward side. Concrete distribution box at landward toe. (USACE-1959). This entry matches the Drainage or Irrigation Structure referenced in O&M manual (HLM 2.3). FS Date: 03/18/2009

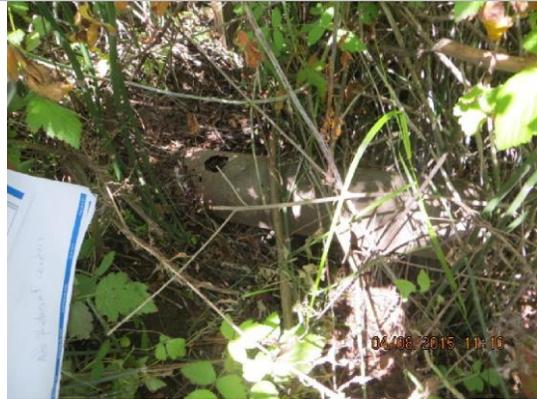
Photo 1 of 2 : UCIP\_FA\_2015\_5906.jpg

Abandoned pipe visible on slope in vegetation behind new pipe on WS slope.

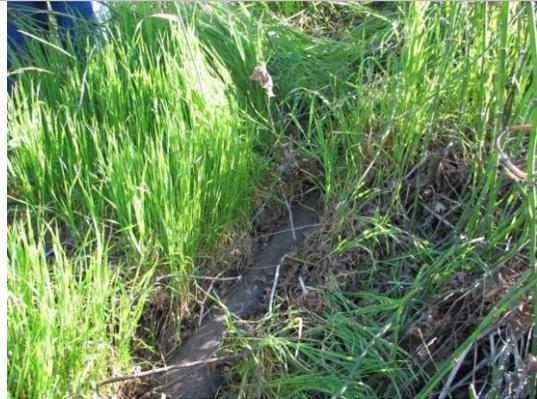
Photo 1 of 3 : UCIP\_FA\_2015\_1660.jpg

Pipe covered by dense vegetation.

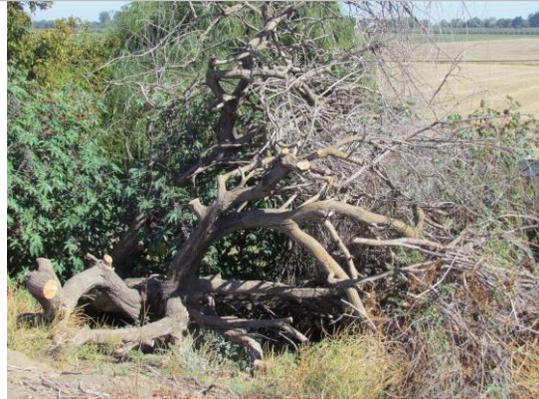
Photo 1 of 1 : FA\_2015\_RD0349\_206\_971\_20151012\_00043.jpg

The dead tree listed in last inspection has not been completely removed, nor has the woody tree growth been thinned out.

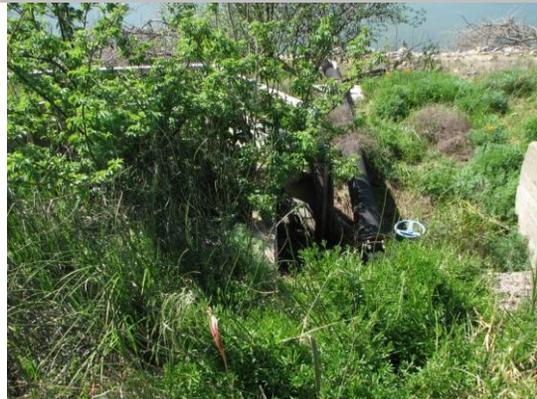
Photo 2 of 3 : UCIP\_FA\_2015\_2371.jpg

Waterward side--appears to be an erosion repair site. New pipe on waterward side and damaged pipe on landward side.

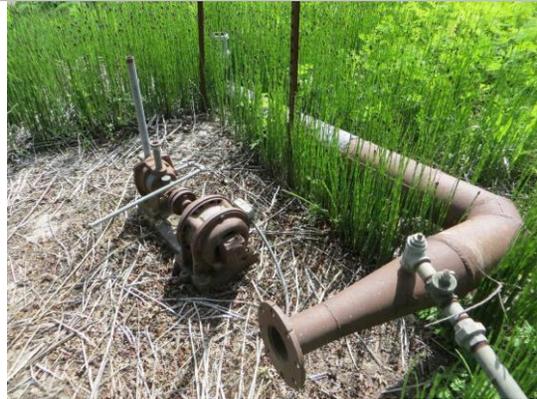
Photo 1 of 3 : UCIP\_FA\_2015\_5913.jpg

Abandoned pump at LS toe.

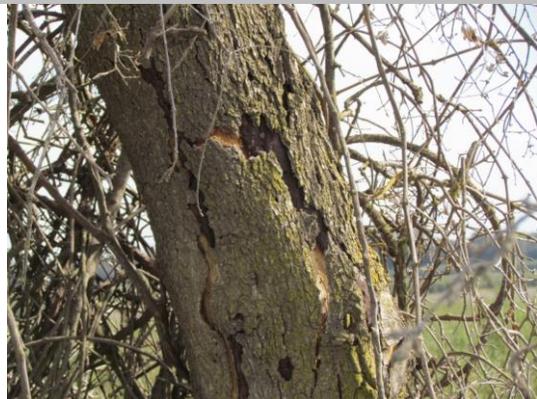
Photo 1 of 2 : FA\_2015\_RD0349\_206\_73\_20150915\_00012.jpg

Close up view of dead tree standing above crown roadway.

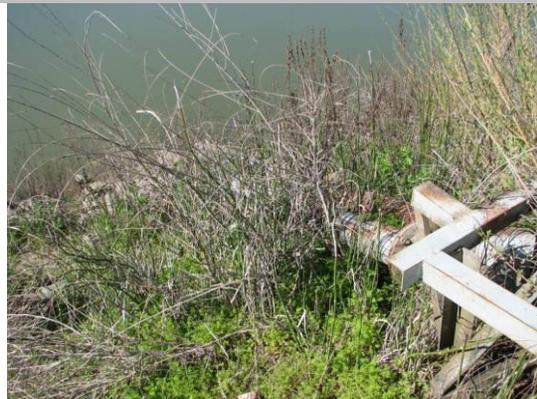
Photo 2 of 3 : UCIP\_FA\_2015\_2318.jpg

Waterward side--pipe visible through dense vegetation.

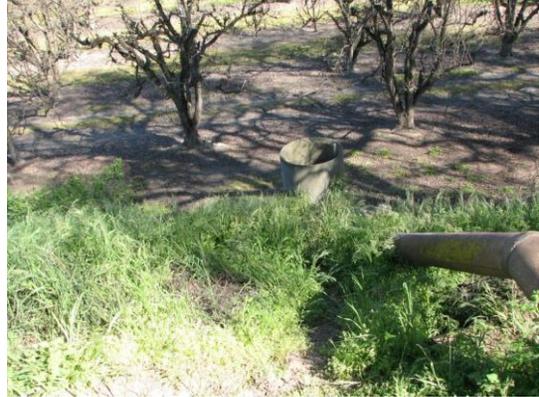
Photo 1 of 2 : UCIP\_FA\_2015\_2329.jpg

Action/Comments					
Inspector Comments: FS_ID:43436 DS_ID:24190 EP_NO: 16077 FS_HLM: 5.626 Repair Type: Urgent Crossing Status: Found UCIP Comments: Soil disturbed on landward slope--need to contact owner. Also vegetation limits the inspector's visibility to identify signs of pipe failure (leaks) along the slope. Recommend removing vegetation along pipe alignment to conduct proper inspection of structure and appurtenances. Note date on photos should be 3/18/09 not 7/26/08 camera metadata is incorrect. FIELD_STRUCT_DESC: 10-inch pipe through the levee, 3.8 feet below the crown. Pump in pumphouse on waterward side. Service pole on waterward slope. Concrete standpipe and distribution box at waterward toe. Pipe is exposed on both slopes. (USACE-1959). This entry matches the Drainage or Irrigation Structure referenced in O&M manual (HLM 5.9). Section of pipe under crown, between shoulders, removed and replaced with 10-inch steel pipe under Permit No. 16077 (2000). FS Date: 03/19/2009
