**Flood Control Project Maintenance  
Levee Inspections  
LMA District Cover Sheet  
Spring 2011 Levee Inspection Results**

**Reclamation District No. 0349 Sutter Island**

**Levee Inspection Report By Mile - Spring 2011**

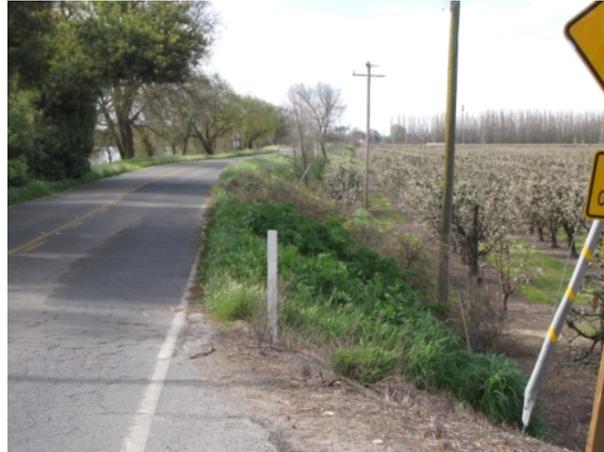
Levee Mile Report Line	1
Start Levee Mile	0.00
End Levee Mile	0.00
Location	Land Side
Category	Earthen Levee
Item	Vegetation
Standing on landside looking downstream from levee mile 0.00. Photo taken 3-30-2011.	
phillips_s_20110330_221.jpg

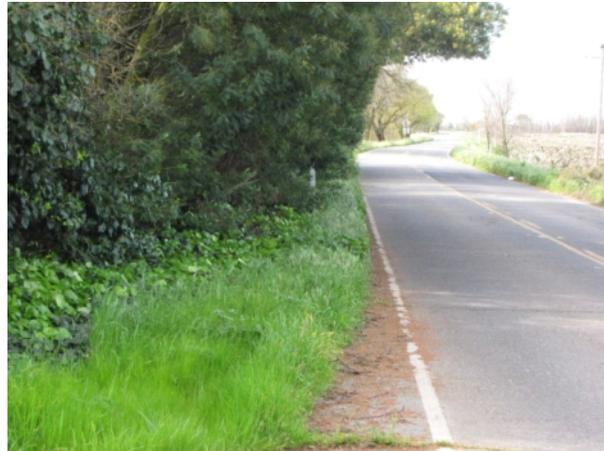
Levee Mile Report Line	2
Start Levee Mile	0.00
End Levee Mile	0.00
Location	Water Side
Category	Earthen Levee
Item	Vegetation
Standing at levee mile 0.00 looking stream in RD 349. This photo taken 3-30-2011.	
phillips_s_20110330_222.jpg

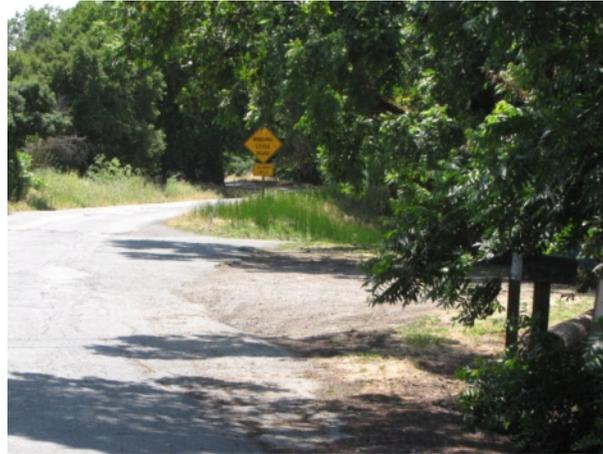
Levee Mile Report Line	1
Start Levee Mile	0.00
End Levee Mile	0.00
Location	Land Side
Category	Earthen Levee
Item	Vegetation
Unit 2 levee mile 0.00 landward looking downstream. 5-23-2011	
phillips_s_20110527_316.jpg

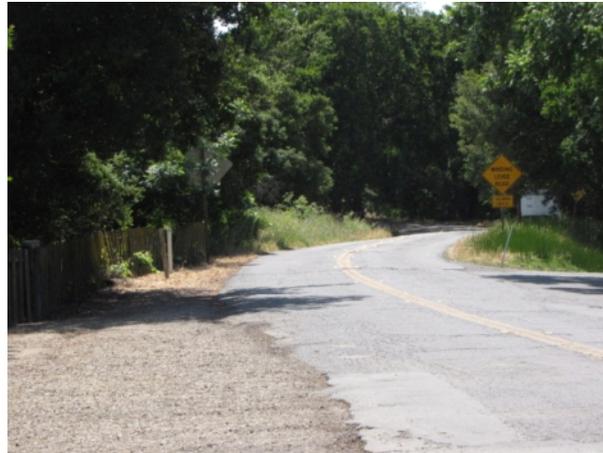
Levee Mile Report Line	2
Start Levee Mile	0.00
End Levee Mile	0.00
Location	Water Side
Category	Earthen Levee
Item	Vegetation
Unit 2 looking downstream from levee mile 0.00 Photo taken 5-23-2011	
phillips_s_20110527_317.jpg

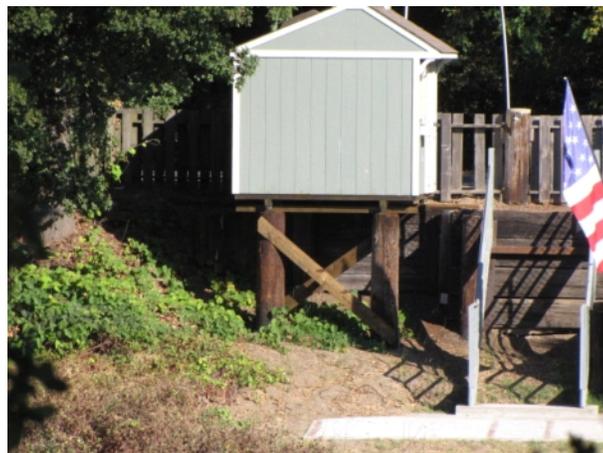
Levee Mile Report Line	3
Start Levee Mile	0.02
End Levee Mile	0.02
Location	Water Side
Category	Earthen Levee
Item	Encroachments
This is viewed from across channel RD 3. Building sitting on Pilings water side.	
phillips_s_20110228_038.jpg

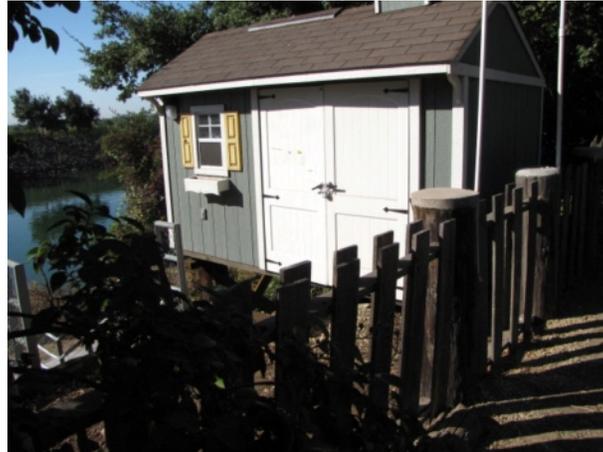
Levee Mile Report Line	3
Start Levee Mile	0.02
End Levee Mile	0.02
Location	Water Side
Category	Earthen Levee
Item	Encroachments
Unauthorized Building on water side levee mile 0.02 RD 349 Unit 2.	
phillips_s_20110228_039.jpg

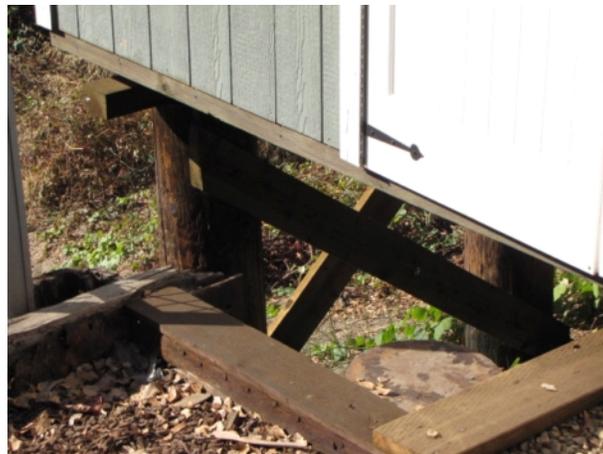
Levee Mile Report Line	3
Start Levee Mile	0.02
End Levee Mile	0.02
Location	Water Side
Category	Earthen Levee
Item	Encroachments
This photo shows the piling that the building is resting upon.	
phillips_s_20110228_040.jpg

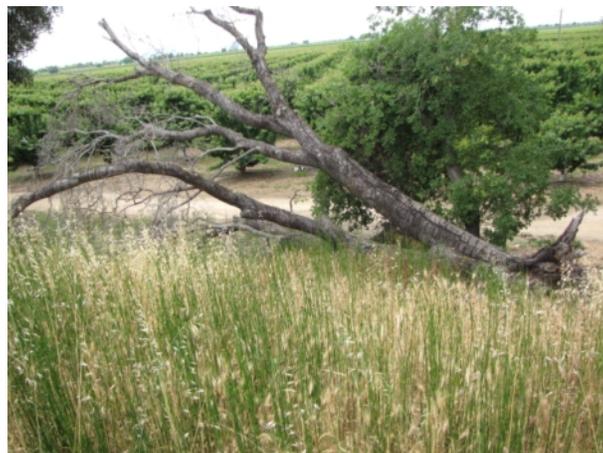
Levee Mile Report Line	14
Start Levee Mile	1.63
End Levee Mile	1.63
Location	Land Side
Category	Earthen Levee
Item	Encroachments
This tree was on the levee slope during my last inspection, the District has been told to remove it, it still remains today. No attempt has been made to remove.	
phillips_s_20110228_046.jpg

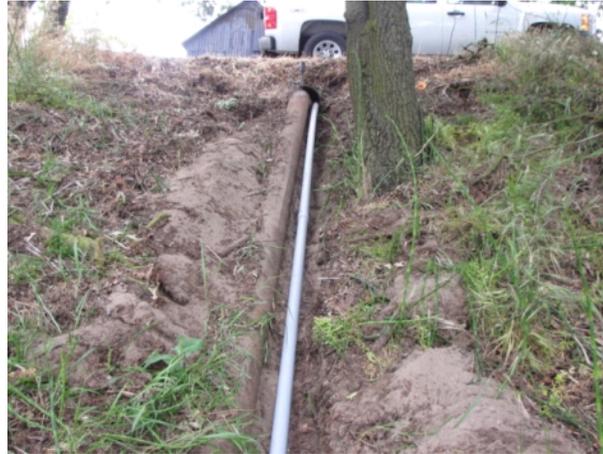
Levee Mile Report Line	17
Start Levee Mile	2.13
End Levee Mile	2.13
Location	Land Side
Category	Earthen Levee
Item	Encroachments
View from landward at unauthorized pipe installation at levee mile 2.13. photo taken 5-23,-2011	
phillips_s_20110527_318.jpg

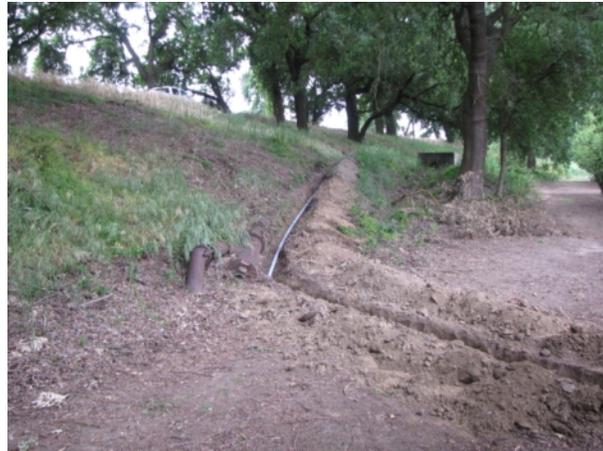
Levee Mile Report Line	17
Start Levee Mile	2.13
End Levee Mile	2.13
Location	Land Side
Category	Earthen Levee
Item	Encroachments
view from landside of unauthorized pipe installation. Photo taken 5-23,-2011	
phillips_s_20110527_319.jpg

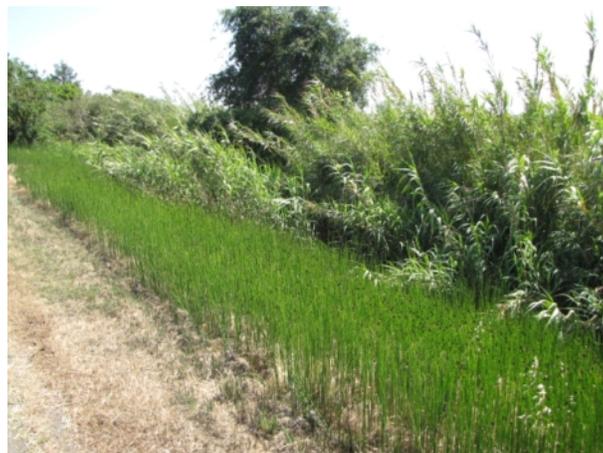
Levee Mile Report Line	19
Start Levee Mile	2.41
End Levee Mile	2.43
Location	Land Side
Category	Earthen Levee
Item	Vegetation
Standing on landward slope looking downstream, unsatisfactory growth of bambo on solpe and slope. 5-23-2011	
phillips_s_20110527_315.jpg

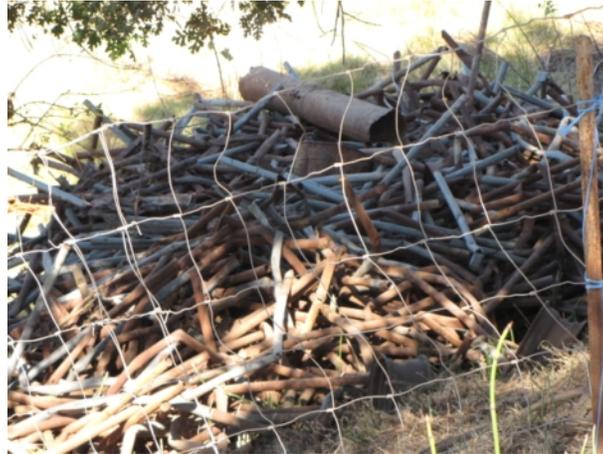
Levee Mile Report Line	22
Start Levee Mile	3.39
End Levee Mile	3.40
Location	Land Side
Category	Earthen Levee
Item	Encroachments
Old pipe stocked on land ward slope unit 2 levee mile 3.39-3.40.	
phillips_s_20110228_037.jpg

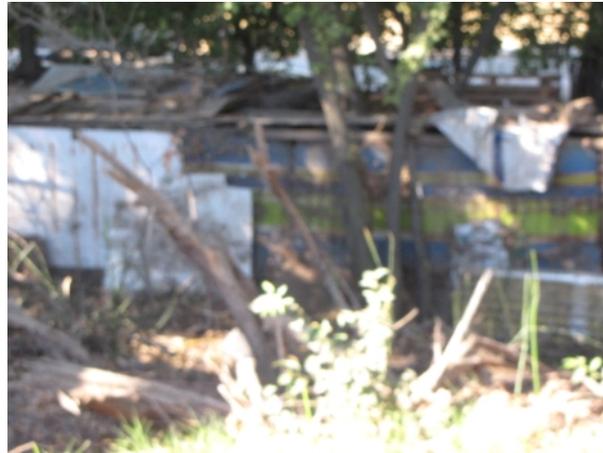
Levee Mile Report Line	27
Start Levee Mile	3.75
End Levee Mile	3.77
Location	Land Side
Category	Earthen Levee
Item	Encroachments
Building , chicken pins and goat pins at toe of levee 3.74- 3.78	
phillips_s_20110228_042.jpg

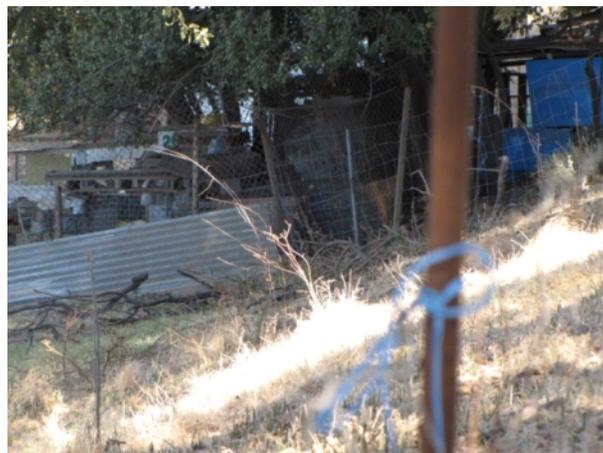
Levee Mile Report Line	27
Start Levee Mile	3.75
End Levee Mile	3.77
Location	Land Side
Category	Earthen Levee
Item	Encroachments
This photo shows fence at right bottom and the tin in back ground is part of another pin. The top right side of photo shows the corner of a building of slope. The equipment is shown in back side of fence.	
phillips_s_20110228_043.jpg

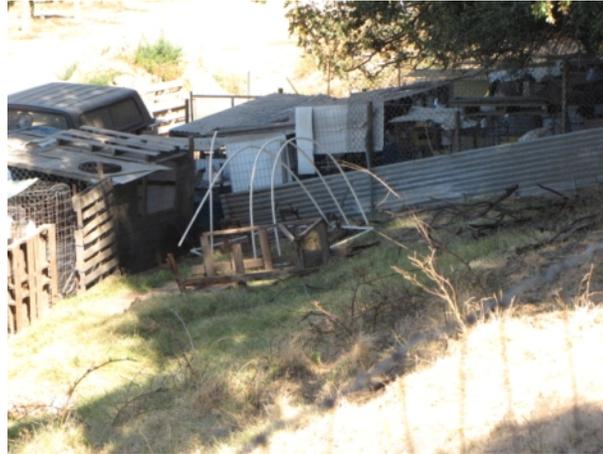
Levee Mile Report Line	27
Start Levee Mile	3.75
End Levee Mile	3.77
Location	Land Side
Category	Earthen Levee
Item	Encroachments
<p>This photo shows the material on slope along with cages for goats and chickens.</p>	
<p>phillips_s_20110228_044.jpg</p>

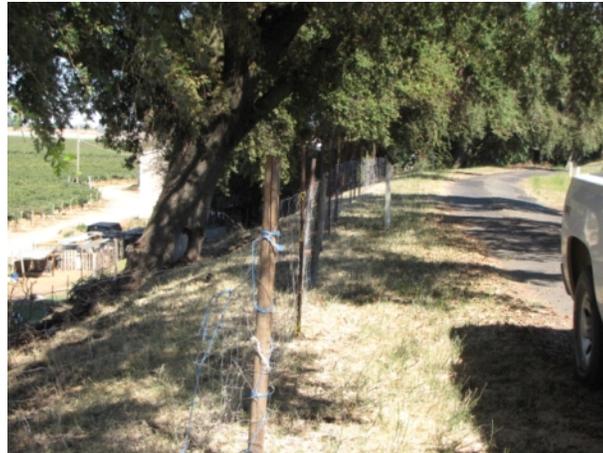
Levee Mile Report Line	29
Start Levee Mile	3.78
End Levee Mile	3.78
Location	Land Side
Category	Earthen Levee
Item	Encroachments
<p>This fence has no permit, the land owner moves it from time to time he keeps goats inside of it..</p>	
<p>phillips_s_20110228_045.jpg</p>

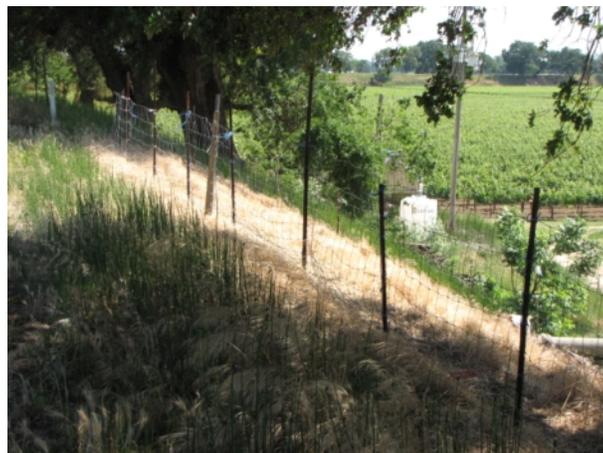
Levee Mile Report Line	30
Start Levee Mile	3.80
End Levee Mile	3.84
Location	Land Side
Category	Earthen Levee
Item	Encroachments
<p>Unauthorized fence remains on levee slope landward levee mile 3.80-3.84. Photo taken 5-23-2011.</p>	
<p>phillips_s_20110527_320.jpg</p>

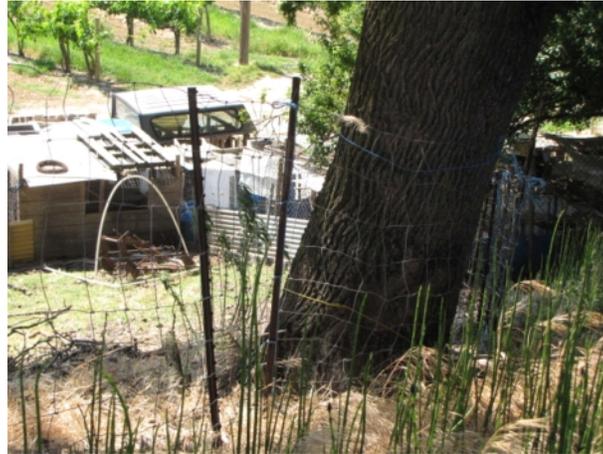
Levee Mile Report Line	30
Start Levee Mile	3.80
End Levee Mile	3.84
Location	Land Side
Category	Earthen Levee
Item	Encroachments

View of fence and other structures at toe of levee section. Photo taken 5-23-2011.

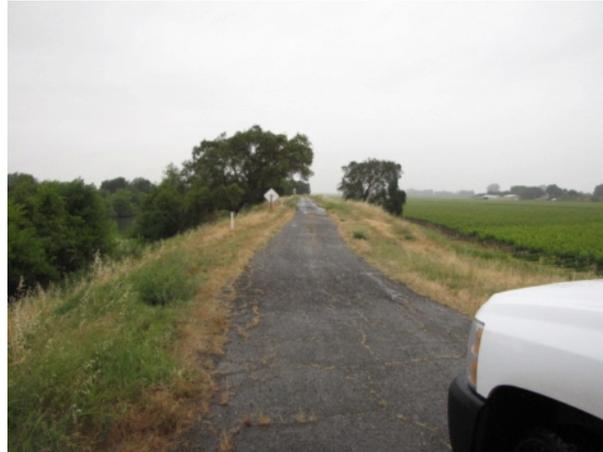
Levee Mile Report Line	1
Start Levee Mile	0.00
End Levee Mile	0.00
Location	Crown
Category	Earthen Levee
Item	Vegetation
Standing at levee mile 0.00 looking downstream of Unit 3. Photo taken 5-23-2011	
phillips_s_20110527_322.jpg

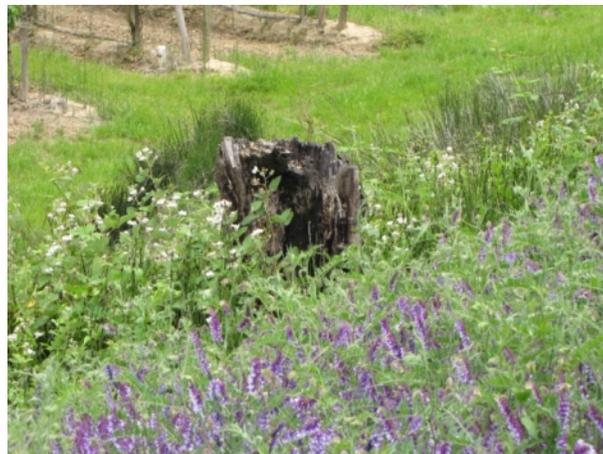
Levee Mile Report Line	9
Start Levee Mile	0.62
End Levee Mile	0.62
Location	Land Side
Category	Earthen Levee
Item	Trim / Thin Trees
This stump is located on the landward slope.	
phillips_s_20110228_050.jpg

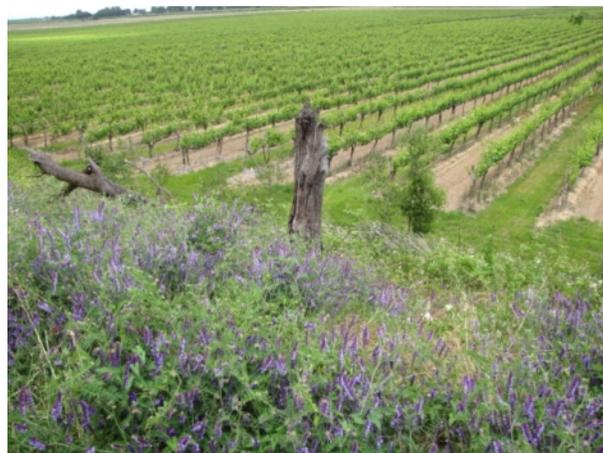
Levee Mile Report Line	10
Start Levee Mile	0.63
End Levee Mile	0.63
Location	Land Side
Category	Earthen Levee
Item	Trim / Thin Trees
Broken tree with stump on landward slope, broken top portion of this tree is resting on the landward toe. District is aware of this encroachment.	
phillips_s_20110228_049.jpg

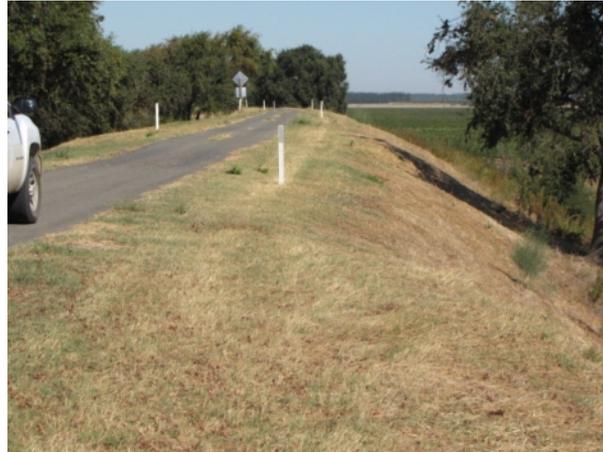
Levee Mile Report Line	12
Start Levee Mile	0.81
End Levee Mile	0.81
Location	Land Side
Category	Earthen Levee
Item	Encroachments
Unit 3 levee mile 0.00 land side looking down stream.	
phillips_s_20110228_047.jpg

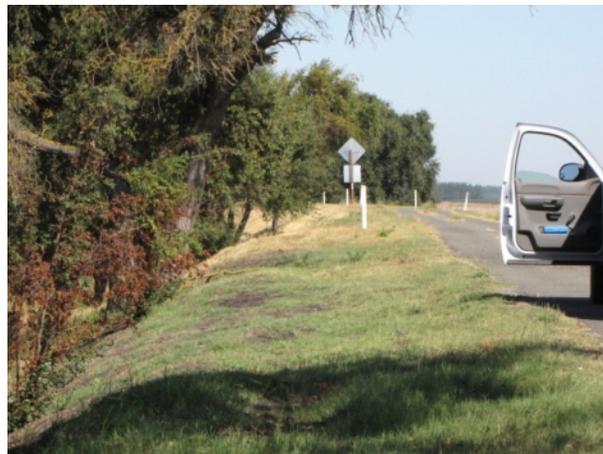
Levee Mile Report Line	12
Start Levee Mile	0.81
End Levee Mile	0.81
Location	Land Side
Category	Earthen Levee
Item	Encroachments
Unit 3 water side looking downstream Rd 349.	
phillips_s_20110228_048.jpg

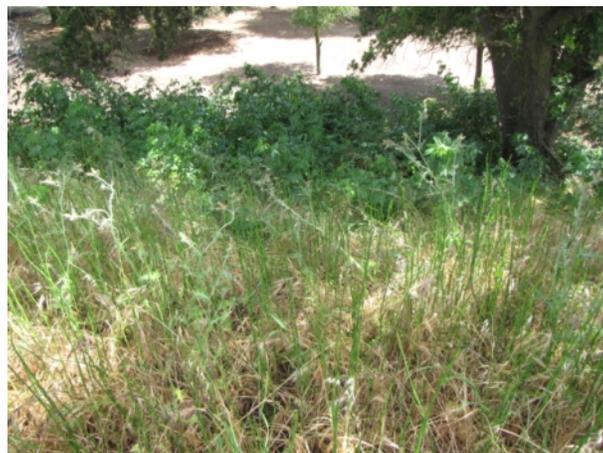
Levee Mile Report Line	33
Start Levee Mile	5.13
End Levee Mile	5.31
Location	Land Side
Category	Earthen Levee
Item	Vegetation
Wild growth on landward slope and toe of levee section. Photo taken 5-23-2011	
phillips_s_20110527_323.jpg

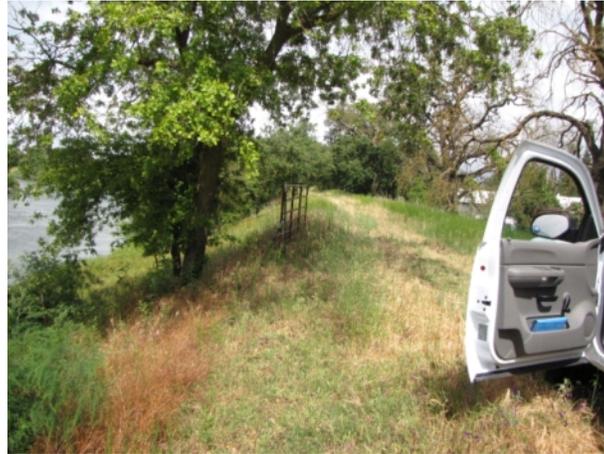
Levee Mile Report Line	33
Start Levee Mile	5.13
End Levee Mile	5.31
Location	Land Side
Category	Earthen Levee
Item	Vegetation
Another view of wild growth on levee section looking downstream. Photo taken 5-23-2011.	
phillips_s_20110527_324.jpg

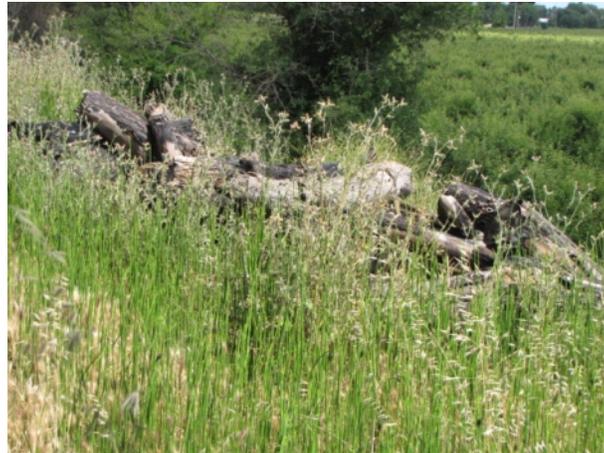
Levee Mile Report Line	35
Start Levee Mile	5.71
End Levee Mile	5.74
Location	Land Side
Category	Earthen Levee
Item	Encroachments
Fire wood on levee slope not removed from fall inspection 2010. Photo taken 5-23-2011	
phillips_s_20110527_325.jpg
