**Flood Control Project Maintenance
Levee Inspections**
LMA District Cover Sheet
Spring 2015 Levee Inspection Results

Reclamation District No. 0349 Sutter Island

Spring 2015 Levee Inspection Results

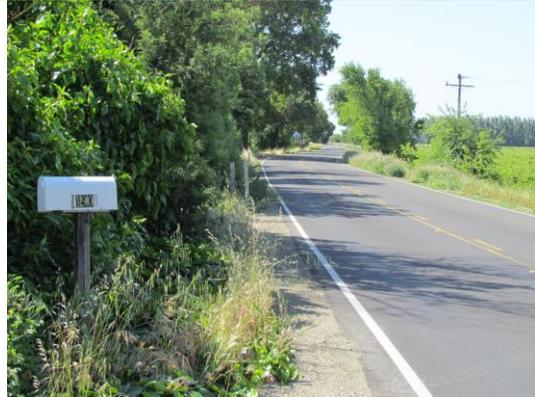
Photo 1 of 1 : SP_2015_RD0349_204_2_20150415_00130.jpg

Looking downstream at unsatisfactory wild growth on the waterside shoulder.

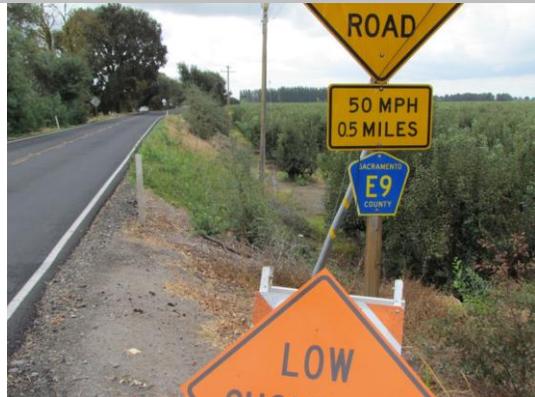
Photo 1 of 1 : SP_2015_RD0349_204_1_20150312_00001.jpg

LM Start	0.01	Rating **	U	Issue No.	1
LM End	0.97	Issue Type +	Ma	Location *	LS
Category	Earthen Levee		GPS Latitude/Longitude		
			Start	End	
Item	Vegetation		38.327037 °	38.313367 °	
			-121.576978 °	-121.578807 °	
DWR ID	DWR_RD0349_01_f_2014_1				
Action/Comments					
Remove the wild growth other than native grasses from the levee slopes. Inspector Comments: Tall weeds need to be removed from levee section.

Unit 1 levee mile 0.00 landside unwanted tall weeds on levee slope.

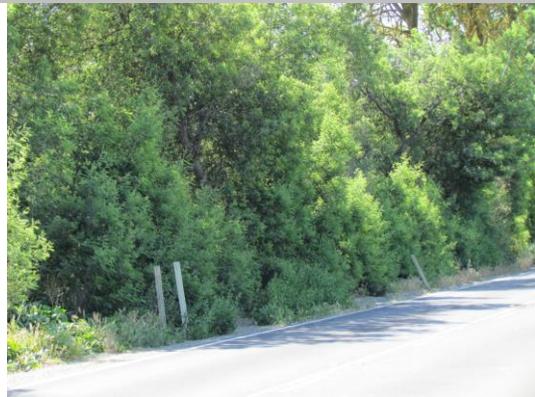
Photo 1 of 1 : SP_2015_RD0349_204_5_20150415_00131.jpg

LM Start	0.01	Rating **	U	Issue No.	5
LM End	0.06	Issue Type +	Ma	Location *	WS
Category	Earthen Levee		GPS Latitude/Longitude		
			Start	End	
Item	Trim / Thin Trees		38.327037 °	38.326287 °	
			-121.576980 °	-121.577076 °	
DWR ID	DWR_RD0349_01_f_2014_5				
Action/Comments					
Thin trees to allow visibility of the ground and room to flood fight. Inspector Comments: Growth completely blocks visibility of levee section.

Looking downstream at the waterside. The slope is not visible through the woody tree growth.

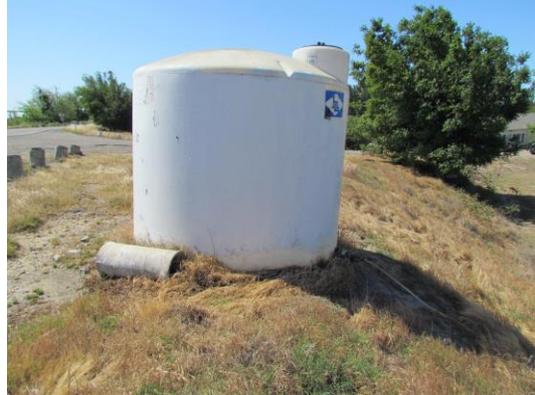
Photo 1 of 1 : SP_2015_RD0349_204_119_20150415_00132.jpg

Unauthorized tank placement on the waterside shoulder of RD 349 Unit 1.

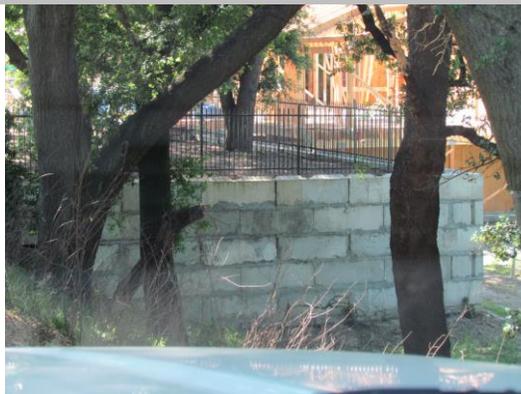
Photo 1 of 1 : SP_2015_RD0349_204_12_20150415_00135.jpg

View along the landside of the levee, landowner has fill, block wall, and is constructing a building on the landward levee toe.

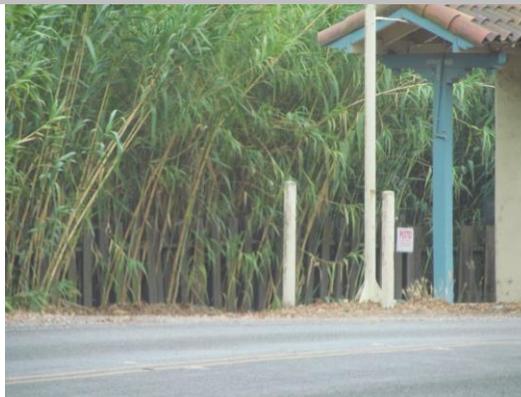
Photo 1 of 1 : SP_2015_RD0349_204_13_20150312_00005.jpg

LM Start	1.56	Rating **	U	Issue No.	13
LM End	1.58	Issue Type +	Ma	Location *	WS
Category	Earthen Levee			GPS Latitude/Longitude	
				Start	End
Item	Vegetation			38.305450 °	38.305162 °
				-121.574687 °	-121.574750 °
DWR ID	DWR_RD0349_01_f_2014_13				
Action/Comments					
Remove the wild growth other than native grasses from the levee slopes. Inspector Comments: This arundo present on the waterward section is blocking the view of the levee section. No new photo for this issue was taken in spring 2015.

Unwanted arundo has completely blocked the view of waterward levee slope and shoulder.

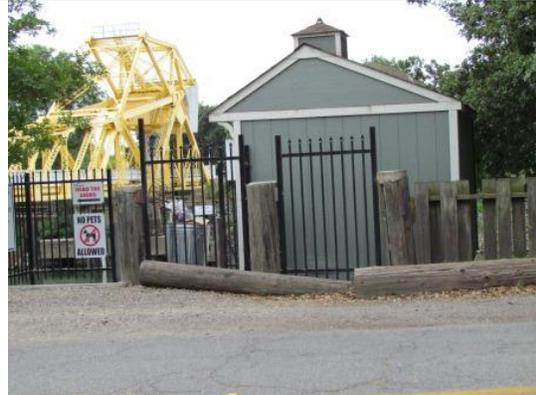
Photo 1 of 3 : SP_2015_RD0349_205_4_20150312_00005.jpg

Unauthorized building waterside shoulder; Unit 2 Sutter Slough. No new photo taken spring 2015.

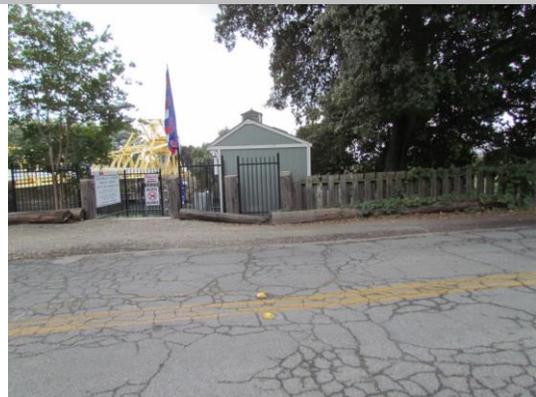
Photo 2 of 3 : SP_2015_RD0349_205_4_20150312_00006.jpg

No change in the condition as of 11-2014. No new photo taken spring 2015.

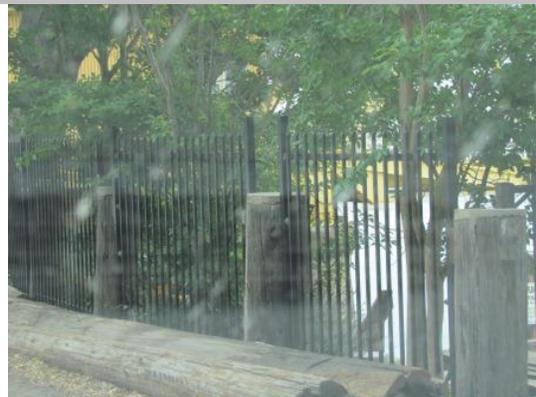
Photo 3 of 3 : SP_2015_RD0349_205_4_20150312_00007.jpg

Unauthorized fence adjacent to building waterside Sutter Slough. No new photo taken spring 2015.

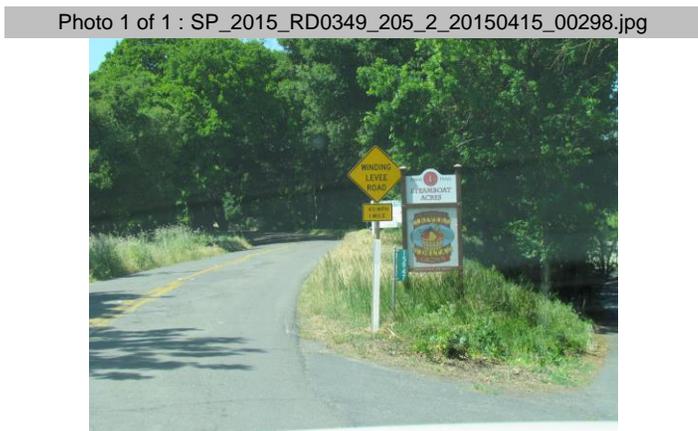
LM Start	0.01	Rating **	M	Issue No.	2
LM End	0.02	Issue Type +	Ma	Location *	LS
Category	Earthen Levee		GPS Latitude/Longitude		
			Start	End	
Item	Vegetation		38.305097 °	38.305024 °	
			-121.574930 °	-121.575155 °	
DWR ID	DWR_RD0349_02_s_2012_2				
Action/Comments					
Remove the wild growth other than native grasses from the levee slopes. Inspector Comments: Remove the wild growth of tall grasses from the landside levee slope.

Looking downstream at weeds present on landside slope and toe.

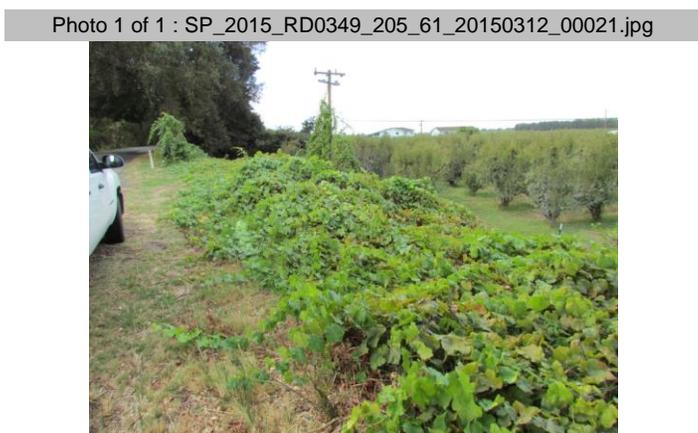
LM Start	0.02	Rating **	U	Issue No.	61
LM End	0.10	Issue Type +	Ma	Location *	LS
Category	Earthen Levee		GPS Latitude/Longitude		
			Start	End	
Item	Vegetation		38.305043 °	38.304635 °	
			-121.575128 °	-121.576385 °	
DWR ID	DWR_RD0349_02_f_2014_61				
Action/Comments					
Remove the wild growth other than native grasses from the levee slopes. Inspector Comments: This wild growth of grape vines blocks the view of the levee. The district or landowner needs to remove growth.

Unwanted wild grapes present on the landward levee slope and shoulder.

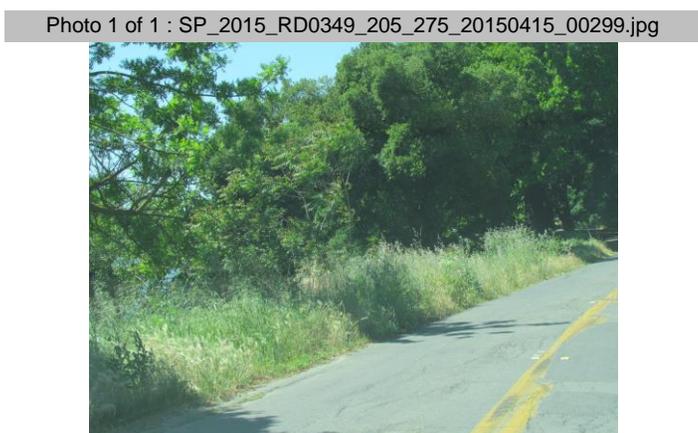
LM Start	0.04	Rating **	U	Issue No.	275
LM End	0.09	Issue Type +	Ma	Location *	WS
Category	Earthen Levee		GPS Latitude/Longitude		
			Start	End	
Item	Vegetation		38.304840 °	38.304685 °	
			-121.575363 °	-121.576205 °	
DWR ID	DWR_RD0349_02_s_2015_275				
Action/Comments					
Control annual grass and weeds on the levee slopes and easements. Inspector Comments: Control the tall weeds and brush on the waterside levee section.

The waterside shoulder and slope covered with unsatisfactory tall weed growth. Unit 2 RD 349.

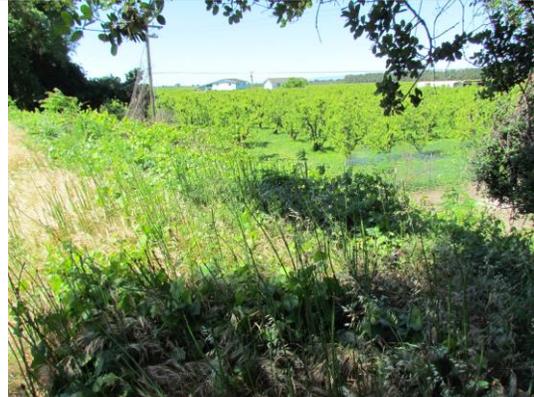
Photo 1 of 1 : SP_2015_RD0349_205_274_20150415_00300.jpg

Unsatisfactory growth of wild grapes present on the landward shoulder and slope.

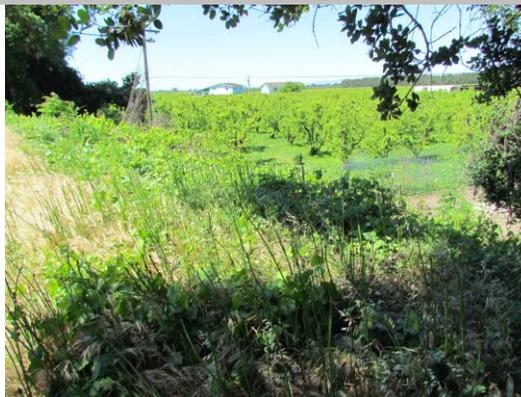
Photo 1 of 1 : SP_2015_RD0349_205_276_20150519_00309.jpg

Wild growth on the landside levee slope and shoulder.

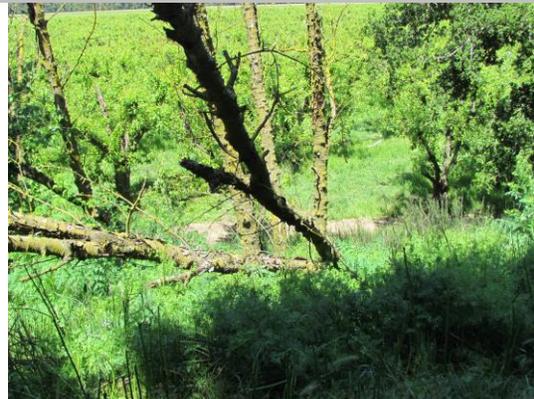
Photo 1 of 1 : SP_2015_RD0349_205_14_20150415_00301.jpg

Dead cherry trees on the landside toe and on the slope.

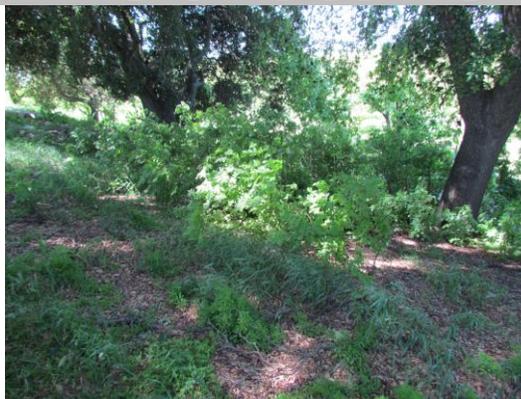
Photo 1 of 1 : SP_2015_RD0349_205_95_20150415_00302.jpg

Unwanted wild growth on the landside slope and toe.

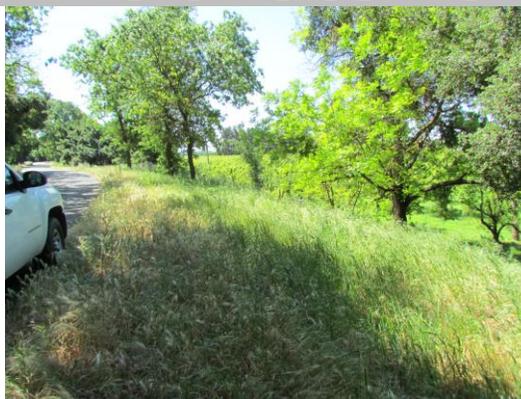
Photo 1 of 1 : SP_2015_RD0349_205_13_20150415_00303.jpg

Unwanted wild snap grasses growing on the landside levee slope.

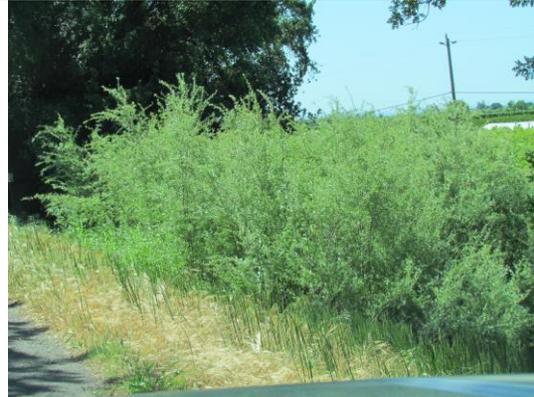
Photo 1 of 1 : SP_2015_RD0349_205_278_20150415_00304.jpg

Unwanted growth of wild young willow trees present on the slope and toe landward.

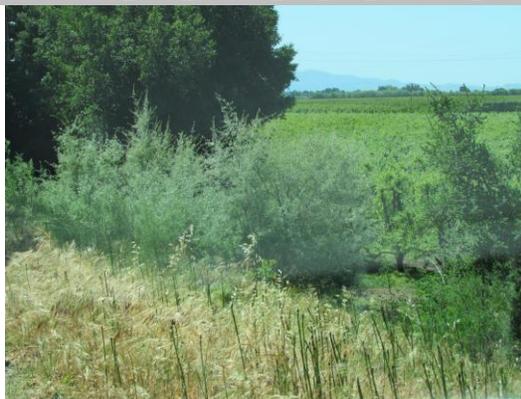
Photo 1 of 1 : SP_2015_RD0349_205_279_20150415_00305.jpg

Unwanted wild growth of willow trees on the landside slope and toe of the levee section.

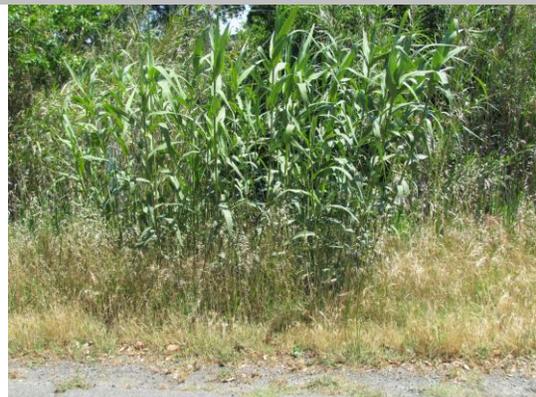
Photo 1 of 1 : SP_2015_RD0349_205_63_20150415_00306.jpg

Unwanted growth of arundo growing on the waterside slope.

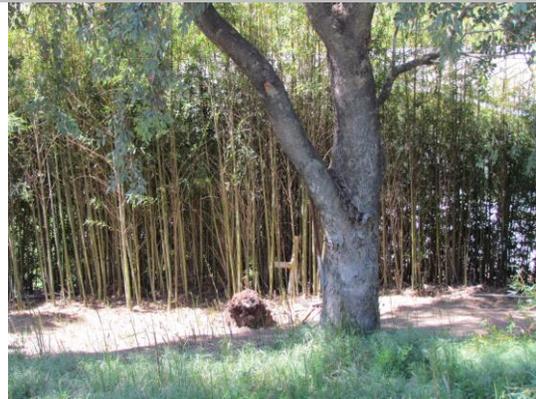
Photo 1 of 1 : SP_2015_RD0349_205_78_20150415_00307.jpg

Unwanted growth of arundo on the landward levee section and levee toe.

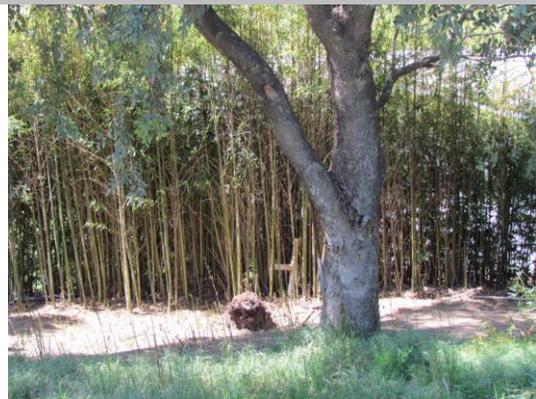
Photo 1 of 1 : SP_2015_RD0349_205_77_20150519_00310.jpg

Mature growth of arundo on the levee toe, the landowner has been slowly removing some of this growth.

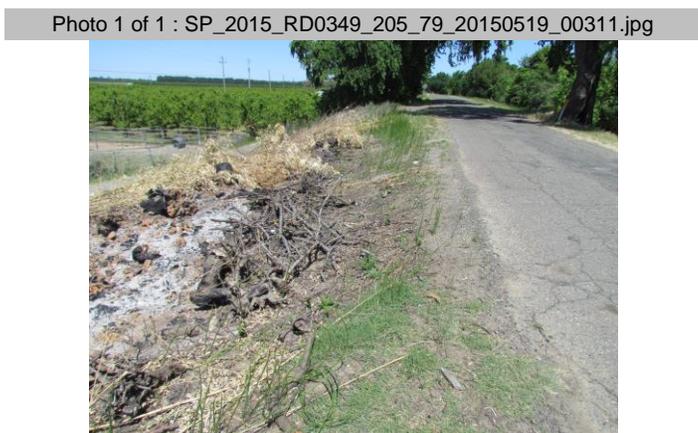
LM Start	1.06	Rating **	U	Issue No.	79
LM End	1.07	Issue Type +	Ma	Location *	LS
Category	Earthen Levee		GPS Latitude/Longitude		
			Start	End	
Item	Slope Stability		38.292623 °	38.292460 °	
			-121.583847 °	-121.583872 °	
DWR ID	DWR_RD0349_02_s_2014_79				
Action/Comments					
Repair slope instability. Inspector Comments: The erosion was covered over by the piles of tree trimmings, now that they are being burned the erosion can be seen.

The erosion was covered up from view by the bruned brush pile.

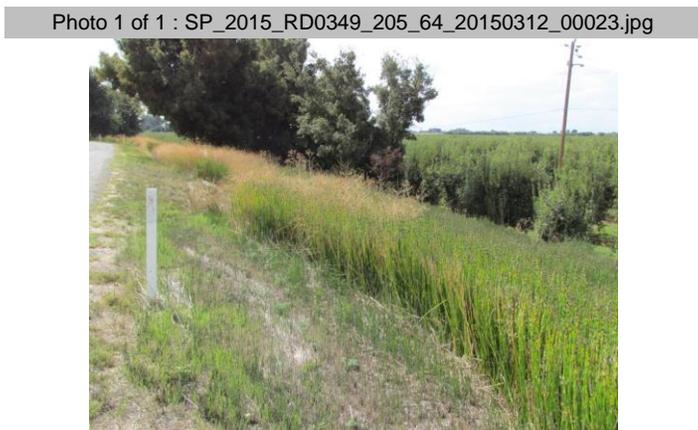
LM Start	1.08	Rating **	U	Issue No.	64
LM End	1.30	Issue Type +	Ma	Location *	LS
Category	Earthen Levee		GPS Latitude/Longitude		
			Start	End	
Item	Vegetation		38.292297 °	38.289090 °	
			-121.583972 °	-121.584080 °	
DWR ID	DWR_RD0349_02_f_2014_64				
Action/Comments					
Remove the wild growth other than native grasses from the levee slopes. Inspector Comments: View of levee slope has been blocked by the wild growth of snap grasses.

At this location snap grasses have completely blocked the view of the landward levee slope.

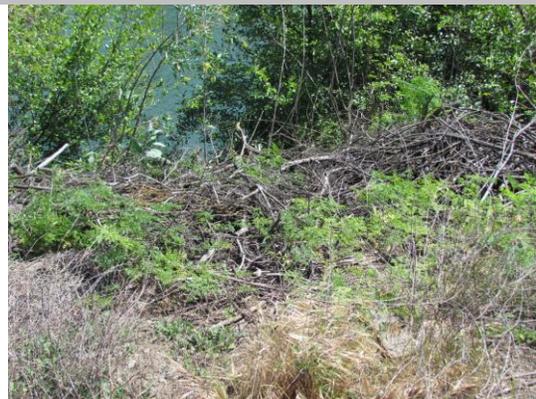
Photo 1 of 1 : SP_2015_RD0349_205_82_20150519_00312.jpg

Tree trimmings at the water's edge blocks the view of the bank.

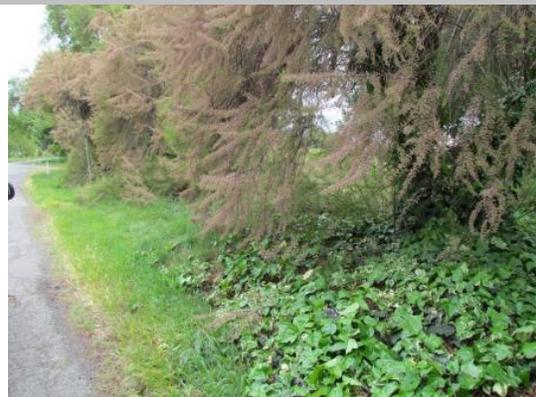
Photo 1 of 1 : SP_2015_RD0349_205_83_20150312_00032.jpg

Woody tree growth blocks view of landside levee section.

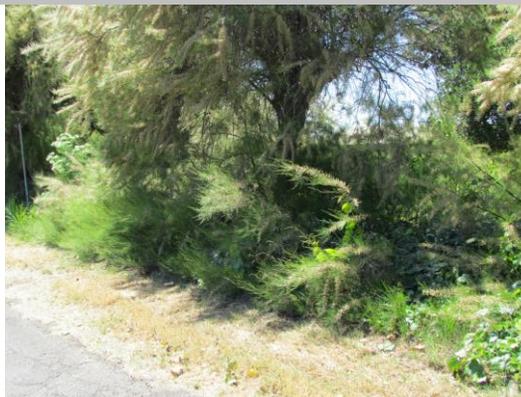
Photo 1 of 1 : SP_2015_RD0349_205_9_20150519_00308.jpg

Wild tree growth blocks view of landside levee slope.

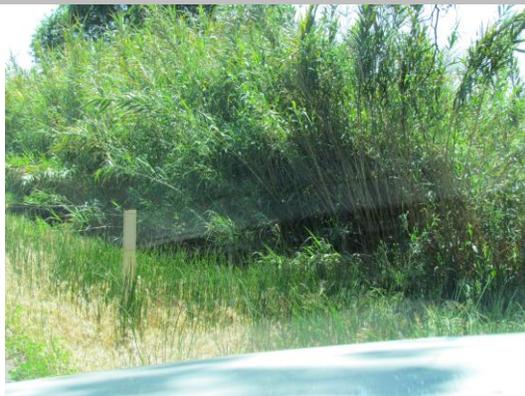
Photo 1 of 1 : SP_2015_RD0349_205_94_20150519_00313.jpg

Arundo on the landside blocking view of the slope.

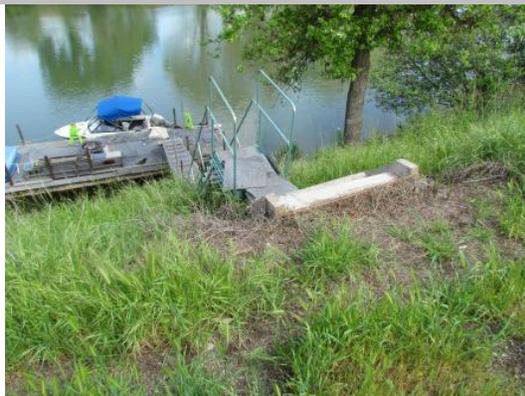
Photo 1 of 2 : SP_2015_RD0349_205_1_20150312_00001.jpg

Unsatisfactory steps placed on waterward slope and toe. No new photo.

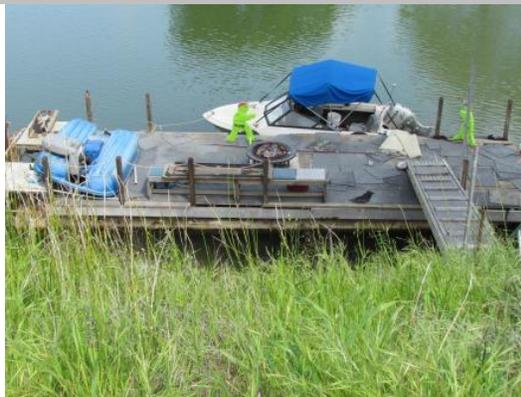
Photo 2 of 2 : SP_2015_RD0349_205_1_20150312_00002.jpg

Unauthorized boat dock at end of steps. No new photo.

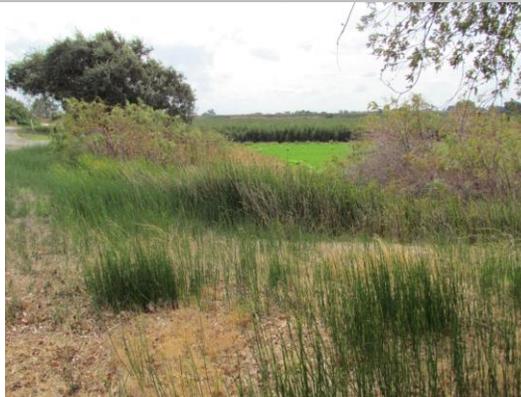
Photo 1 of 1 : SP_2015_RD0349_205_91_20150312_00034.jpg

Unsatisfactory wild growth wild weeds and wild roses present on the landward levee section.

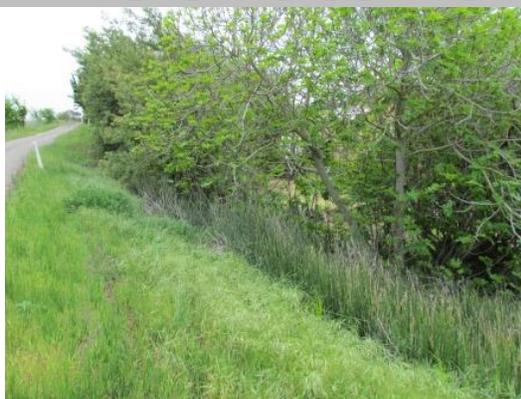
Photo 1 of 1 : SP_2015_RD0349_205_92_20150312_00035.jpg

Woody tree growth blocking view of landward levee section.

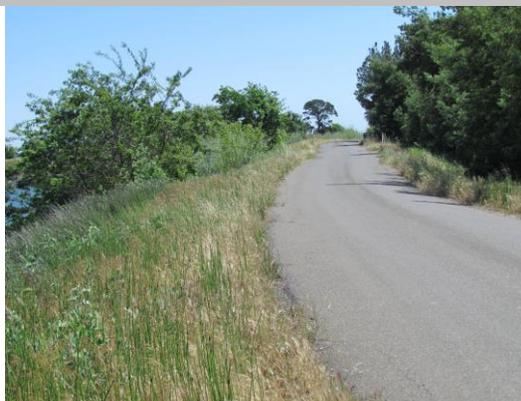
Photo 1 of 1 : SP_2015_RD0349_205_66_20150519_00314.jpg

Wild growth of tall weeds on the waterside slope.

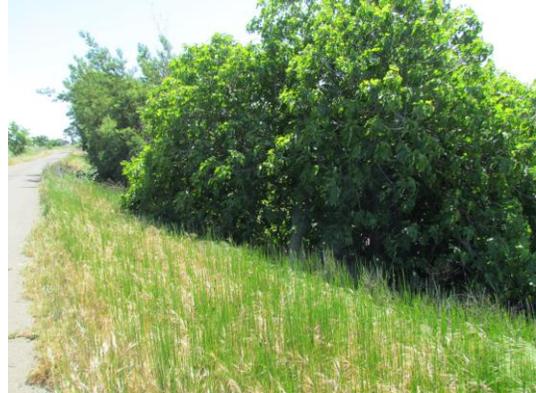
Photo 1 of 1 : SP_2015_RD0349_205_53_20150519_00315.jpg

Woody tree growth blocks the view of the shoulder and slope.

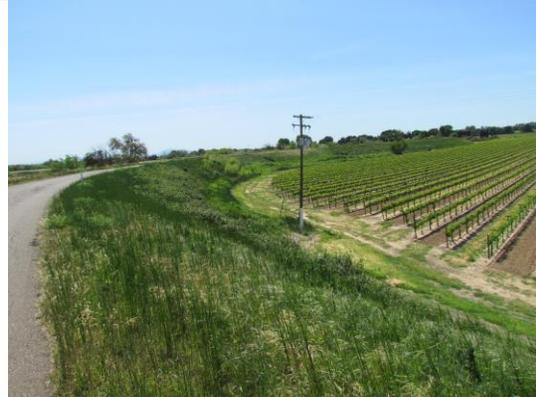
Photo 1 of 1 : SP_2015_RD0349_205_40_20150519_00316.jpg

Tall snap grass covering the landside slope.

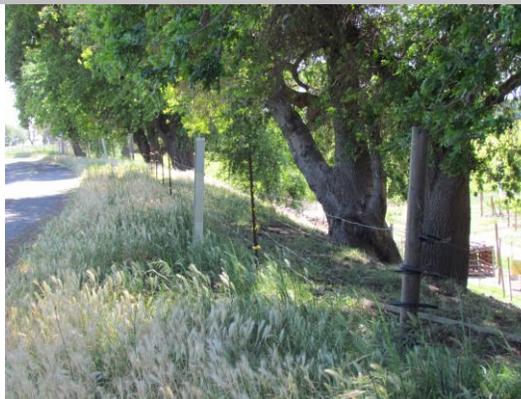
Photo 1 of 1 : SP_2015_RD0349_205_69_20150519_00317.jpg

Unauthorized electric wire fence placed on the landside shoulder and slope.

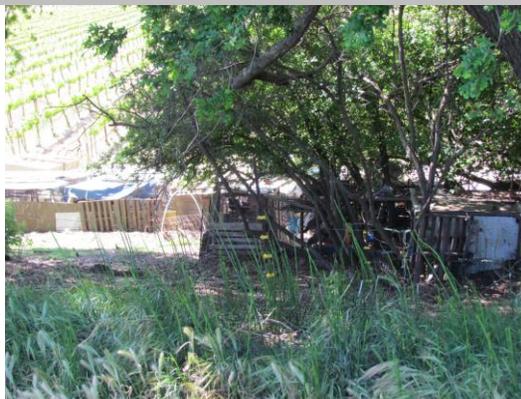
Photo 1 of 1 : SP_2015_RD0349_205_59_20150519_00318.jpg

Unauthorized fences and animal storage pens on the landside slope and toe.

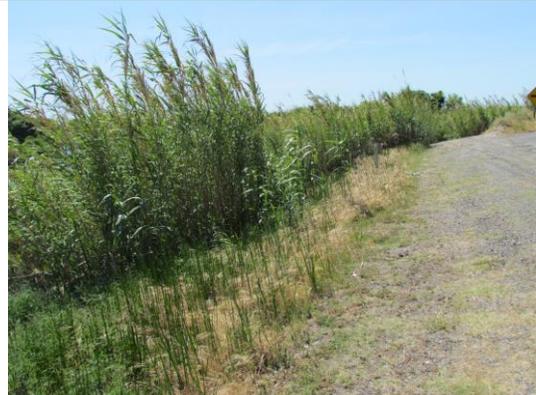
Photo 1 of 1 : SP_2015_RD0349_205_60_20150519_00319.jpg

Arundo on the waterside levee shoulder and slope.

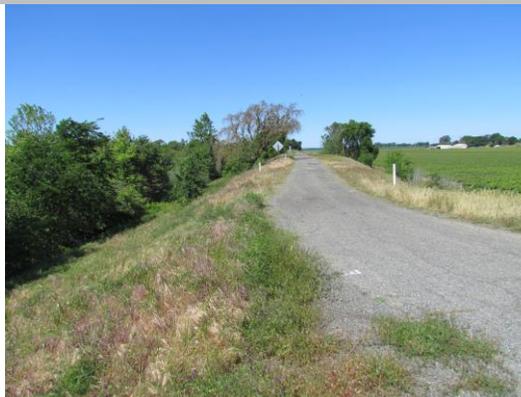
Photo 1 of 1 : SP_2015_RD0349_206_1_20150520_00355.jpg

Looking downstream from waterside at tall weeds.

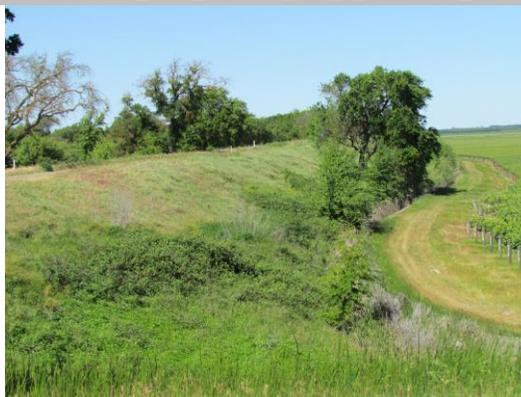
Photo 1 of 1 : SP_2015_RD0349_206_6_20150520_00353.jpg

View downstream at the landside slope with tall weeds and wild berries present on the levee slope and toe.

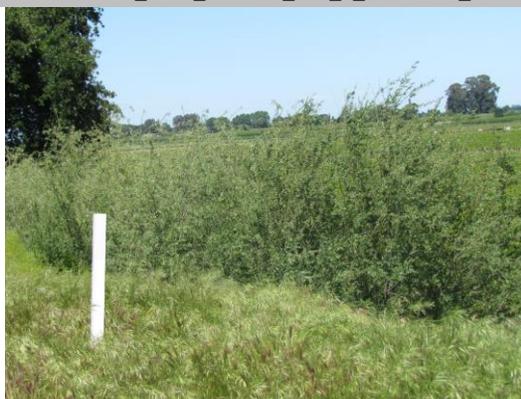
Photo 1 of 1 : SP_2015_RD0349_206_7_20150520_00354.jpg

Wild growth of trees and other vegetation on the landside slope and toe.

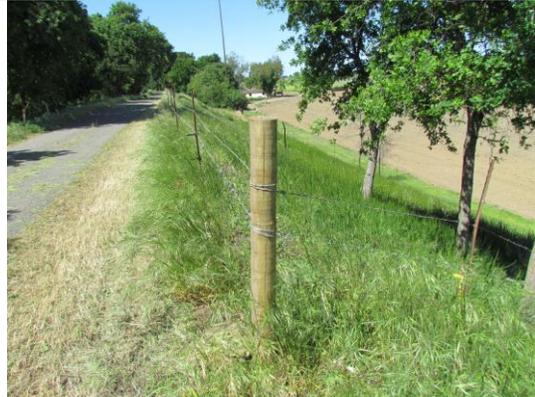
Photo 1 of 2 : SP_2015_RD0349_206_60_20150520_00356.jpg

View of an unauthorized electric wire fence stretching downstream along the landside shoulder.

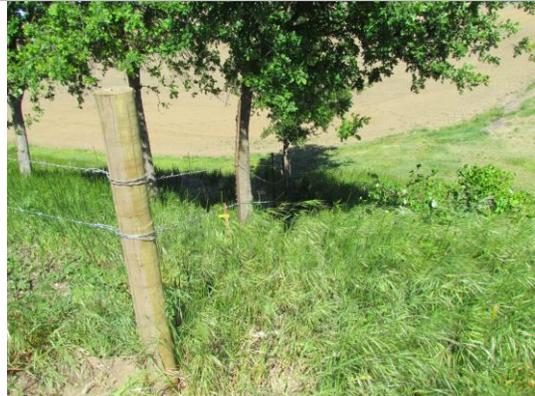
Photo 2 of 2 : SP_2015_RD0349_206_60_20150520_00357.jpg

View of the fence down the landside slope to toe of levee.

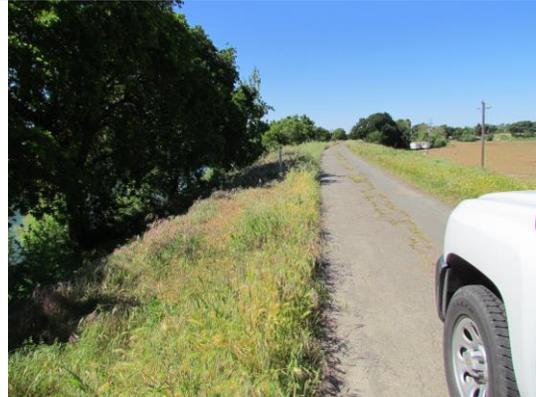
Photo 1 of 1 : SP_2015_RD0349_206_18_20150520_00358.jpg

Unacceptable tall weeds on the waterside shoulder and slope.

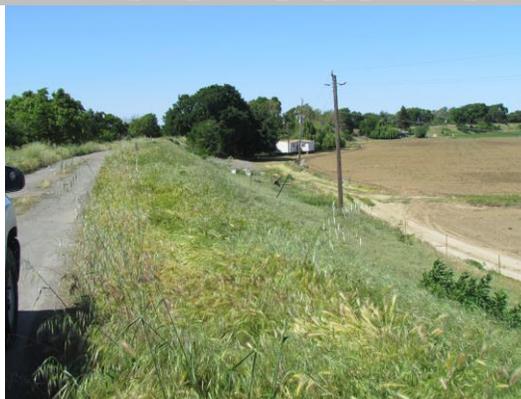
Photo 1 of 1 : SP_2015_RD0349_206_57_20150520_00359.jpg

Looking downstream of the landside shoulder and slope covered with tall weeds.

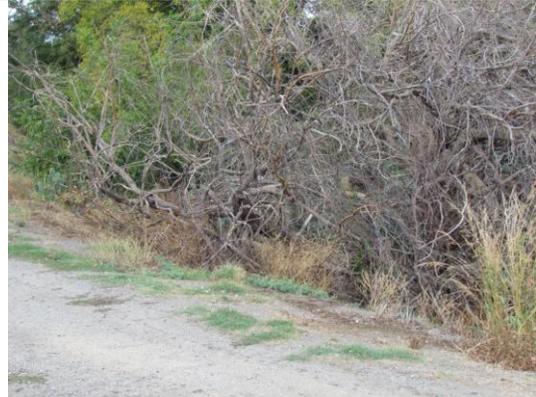
Photo 1 of 1 : SP_2015_RD0349_206_971_20150312_00017.jpg

Woody tree growth on landward levee slope.

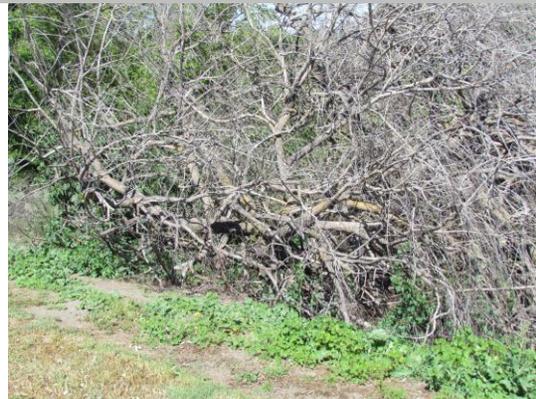
Photo 1 of 1 : SP_2015_RD0349_206_331_20150520_00360.jpg

Looking along the levee slope at a cluster of dead trees blocking the view of the levee and making it hard to do flood fight.

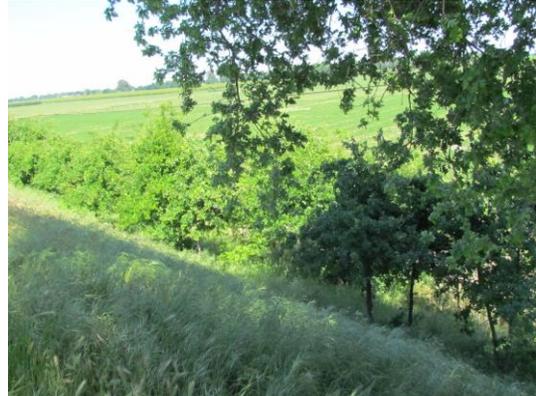
Photo 1 of 1 : SP_2015_RD0349_206_332_20150520_00361.jpg

Small oak trees present along the toe of the landside levee slope.

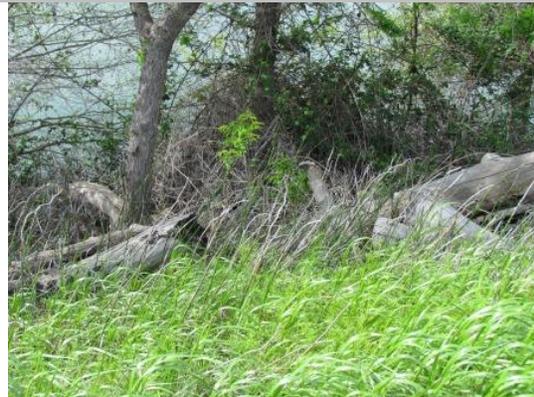
Photo 1 of 1 : SP_2015_RD0349_206_64_20150312_00009.jpg

Cut up fallen tree on waterside slope.

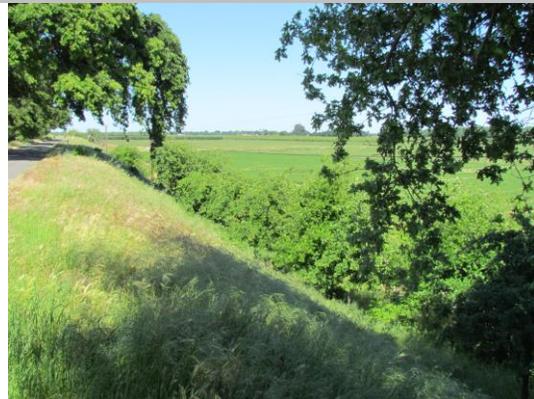
Photo 1 of 1 : SP_2015_RD0349_206_333_20150522_00363.jpg

Tall weeds on the landside levee slope and wild growth on the landside toe.

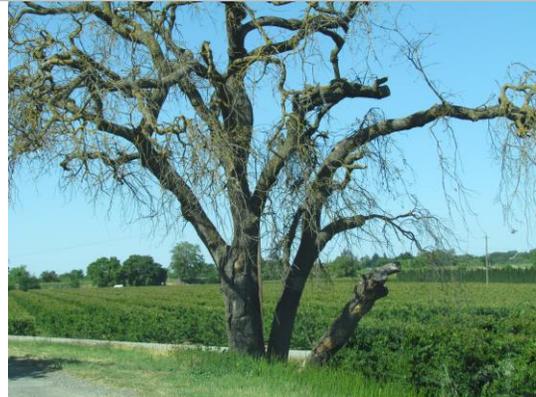
Photo 1 of 1 : SP_2015_RD0349_206_73_20150522_00365.jpg

Remove this dead tree from the landside levee slope. If it falls it will block the levee crown roadway.

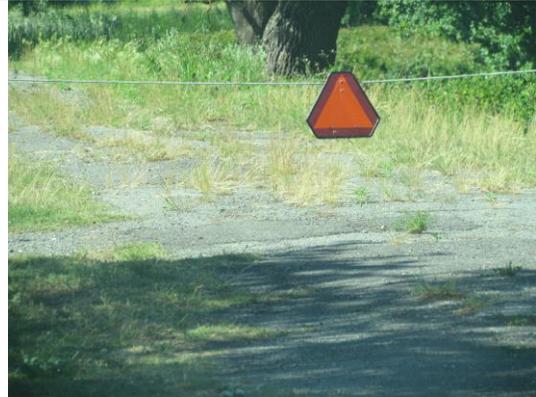
Photo 1 of 1 : SP_2015_RD0349_206_25_20150527_00370.jpg

View of an unauthorized cable gate.

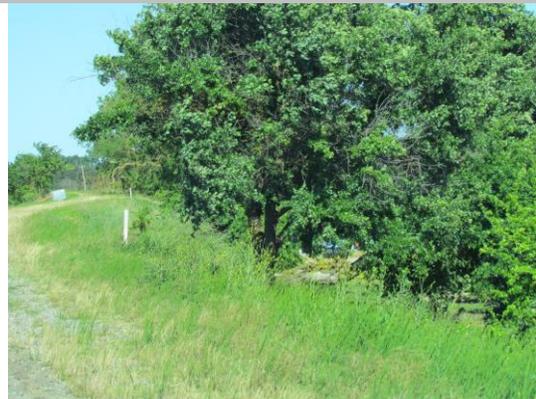
Photo 1 of 1 : SP_2015_RD0349_206_336_20150522_00366.jpg

Unsatisfactory tall weed growth on the landside levee shoulder and slope.

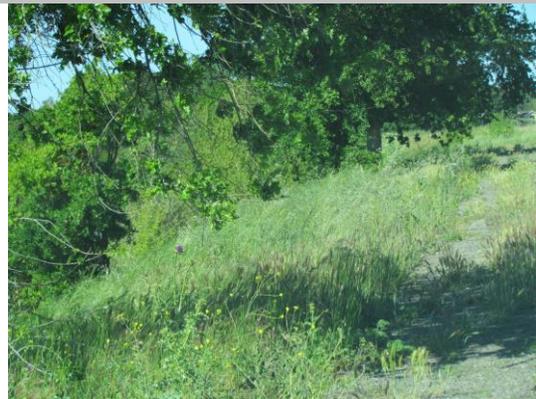
Photo 1 of 1 : SP_2015_RD0349_206_339_20150522_00367.jpg

View of unwanted tall weed growth on the waterside levee slope, shoulder, and crown roadway.
