**Flood Control Project Maintenance  
Levee Inspections**

**Fall 2010 Levee Maintenance Deficiency Summary Report**

**Reclamation District No. 0369 Libby McNeil**

**Levee Inspection Report By Mile - Fall 2010**

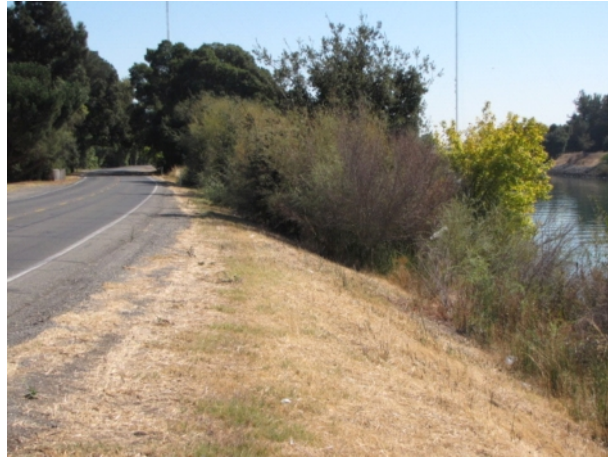
Levee Mile Report Line	1
Start Levee Mile	0.00
End Levee Mile	0.00
Location	Land Side
Category	Earthen Levee
Item	Vegetation
RD 369 Levee mile 0.00 looking downstream on water side, remove the wild growth from the slope. 10-13-2010	
phillips_f_20101018_291.jpg

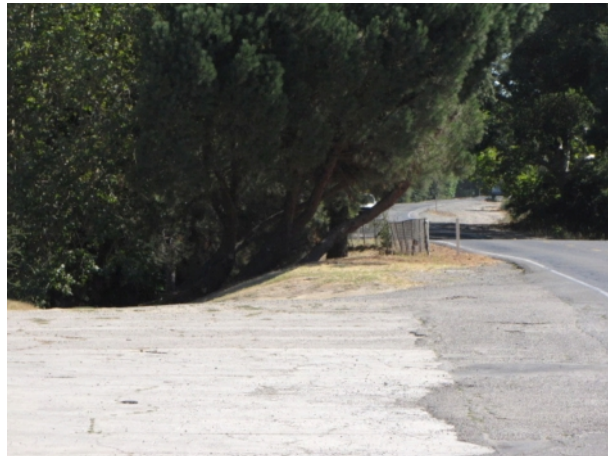
Levee Mile Report Line	1
Start Levee Mile	0.00
End Levee Mile	0.00
Location	Land Side
Category	Earthen Levee
Item	Vegetation
RD 369 standing on levee mile 0.00 land side looking downstream. New 10-13-2010.	
phillips_f_20101018_292.jpg
