**Flood Control Project Maintenance
Levee Inspections**

Fall 2011 Levee Maintenance Deficiency Summary Report

Reclamation District No. 0369 Libby McNeil

Levee Inspection Report By Mile - Fall 2011

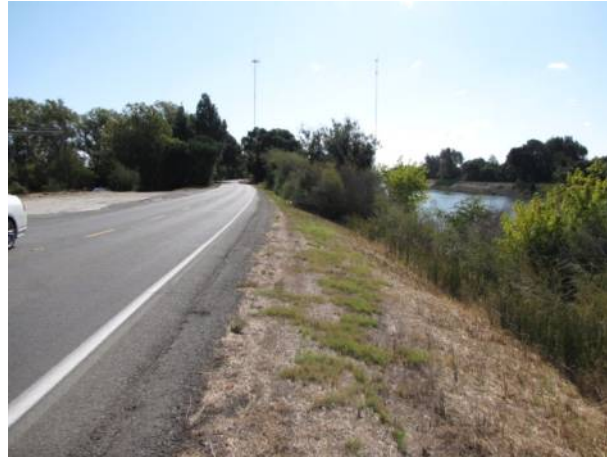
phillips_f_20111013_018.jpg

Levee Mile Report Line	1
Start Levee Mile	0.00
End Levee Mile	0.00
Location	Water Side
Category	Earthen Levee
Item	Vegetation

Standing on the waterward shoulder RD 369 L/M 0.00 looking downstream. Photo taken 10-05-2011.

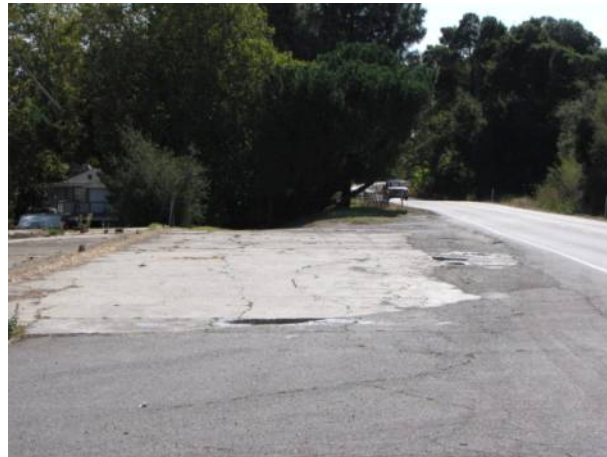
phillips_f_20111013_017.jpg

Levee Mile Report Line	2
Start Levee Mile	0.00
End Levee Mile	0.00
Location	Land Side
Category	Earthen Levee
Item	Vegetation

Standing on landward shoulder on RD 369 looking downstream from L/M 0.00. This photo was taken 10-05-2011
