**Flood Control Project Maintenance
Levee Inspections**

Fall 2012 Levee Maintenance Deficiency Summary Report

Reclamation District No. 0369 Libby McNeil

Waterway			Bank	Unit Miles
Unit No. 01 Steamboat Slough			Left	0.80
	Spring (March - May)	Summer (June - August)	(September - November) Fall	Winter (December - February)
Unit Maintenance Rating (Fall Only)			U	
Date of Inspection	03/15/2012 - 03/15/2012		09/20/2012 - 09/20/2012	
DWR Inspector	Herman Phillips		Herman Phillips	
Accompanied By	Clarence Chu Reclamation 369		Clarence Chu Reclamation 369

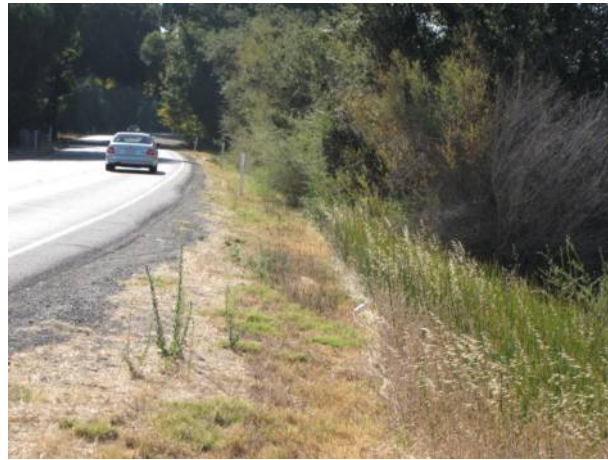
Levee Mile Report Line	4
Start Levee Mile	0.00
End Levee Mile	0.00
Location	Water Side
Category	Earthen Levee
Item	Vegetation

RD 369 looking downstream water side slope levee mile 0.00. Photo taken 9-20-2012.

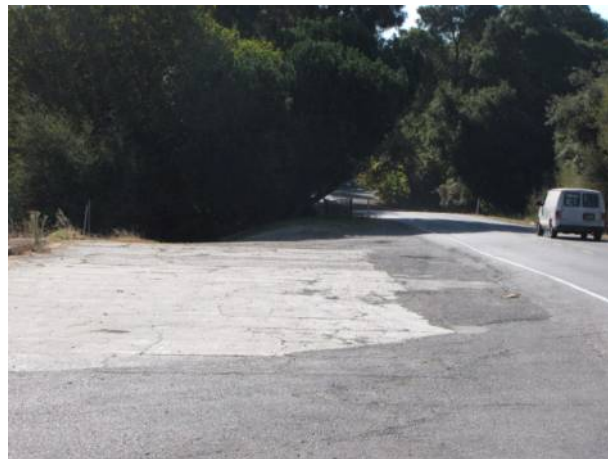
Levee Mile Report Line	5
Start Levee Mile	0.00
End Levee Mile	0.00
Location	Land Side
Category	Earthen Levee
Item	Vegetation

RD 369 looking downstream from levee mile 0.00. Photo taken 9-20-2012
