**Flood Control Project Maintenance  
Levee Inspections**

**Fall 2013 Levee Maintenance Deficiency Summary Report**

**Reclamation District No. 0369 Libby McNeil**

**Levee Inspection Report By Mile - Fall 2013**

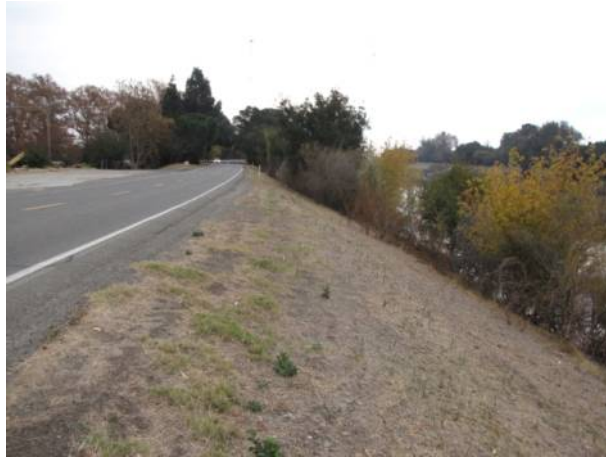
Levee Mile Report Line	4
Start Levee Mile	0.00
End Levee Mile	0.58
Location	Water Side
Category	Earthen Levee
Item	Vegetation

RD 369 Looking downstream from levee mile 0.00 The goats has done a good job of removing the unwanted weed growth form the levee slope. Photo taken 11-14-2013.
