**Flood Control Project Maintenance
Levee Inspections**

Fall 2014 Levee Maintenance Deficiency Summary Report

Reclamation District No. 0369 Libby McNeil

Waterway		Bank	Unit Miles
Unit No. 01 Steamboat Slough		Left	0.78
	Spring (March - May)	Summer (June - August)	(September - November) Fall Winter (December - February)
Unit Maintenance Rating (Fall Only)			U
Date of Inspection	03/19/2014 - 03/19/2014		11/21/2014 - 11/21/2014
DWR Inspector	Herman Phillips		Herman Phillips
Accompanied By

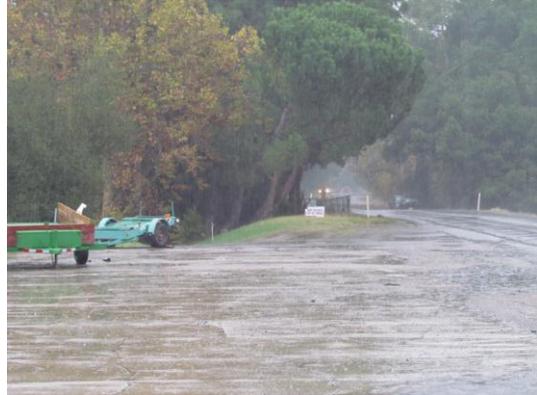
Photo 1 of 1 : FA_2014_RD0369_207_18_20141125_00002.jpg

LM Start	0.00	Rating **	A	Issue No.	18
LM End	0.00	Issue Type +	Ma	Location *	LS
Category	Earthen Levee		GPS Latitude/Longitude		
			Start	End	
Item	Vegetation		38.258904 °	38.258904 °	
			-121.517900 °	-121.517900 °	
DWR ID	DWR_RD0369_01_f_2014_18				
Action/Comments					
Control annual grass and weeds on the levee slopes and easements.

Looking downstream from levee mile 0.00 RD 369 landward levee slope.
