**Flood Control Project Maintenance
Levee Inspections**

Fall 2015 Levee Maintenance Deficiency Summary Report

Reclamation District No. 0369 Libby McNeil

Waterway			Bank	Unit Miles
Unit No. 01 Sacramento River			Left	0.78
	Spring (March - May)	Summer (June - August)	(September - November) Fall	Winter (December - February)
Unit Maintenance Rating (Fall Only)			M	
Date of Inspection	04/16/2015 - 04/16/2015		09/25/2015 - 09/25/2015	
DWR Inspector	Herman Phillips		Herman Phillips	
Accompanied By			Clarence Chu RD 369

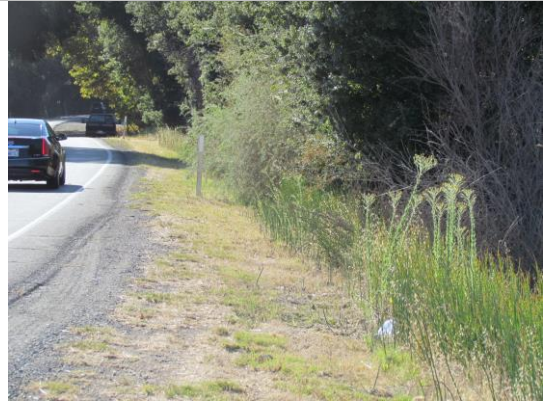
Photo 1 of 1 : FA_2015_RD0369_207_6_20150928_00002.jpg

LM Start	0.02	Rating **	M	Issue No.	6
LM End	0.10	Issue Type +	Ma	Location *	WS
Category	Earthen Levee			GPS Latitude/Longitude	
				Start	End
Item	Vegetation			38.258645 °	38.257842 °
				-121.517580 °	-121.516463 °
DWR ID	DWR_RD0369_01_f_2015_6				
Action/Comments					
Control annual grass and weeds on the levee slopes and easements. Inspector Comments: Downstream from where this photo was taken we met the goat contractor with goats working this waterside slope and shoulder. From here to levee mile 0.78 waterside is good.

RD 369 Looking downstream at the waterside levee section.

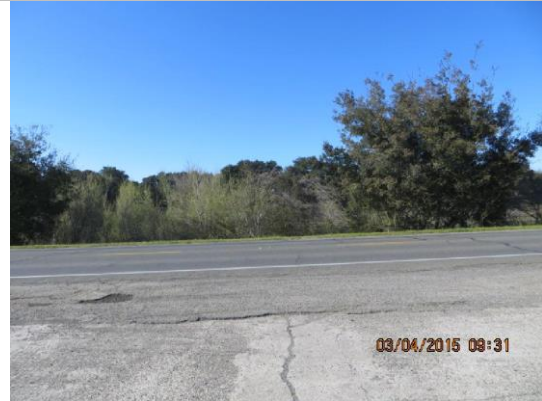
Photo 1 of 3 : UCIP_FA_2015_6025.jpg

Action/Comments					
Inspector Comments: FS_ID:43625 DS_ID:18971 EP_NO: 8555 FS_HLM: 0.0469 Repair Type: Non-Urgent Crossing Status: Found UCIP Comments: Pipe corroded through on LS at retaining wall. May not go all the way through the levee. Appears abandoned and if so should be done so properly. FIELD_STRUCT_DESC: 2 of 2: 4-inch steel pipe through the levee, 4-feet below the crown. Pipe visible on LS at retaining wall (Permit No. 8555 - Jordan Investment Co.) FS Date: 03/04/2015

View of WS. Pipe not found on WS.

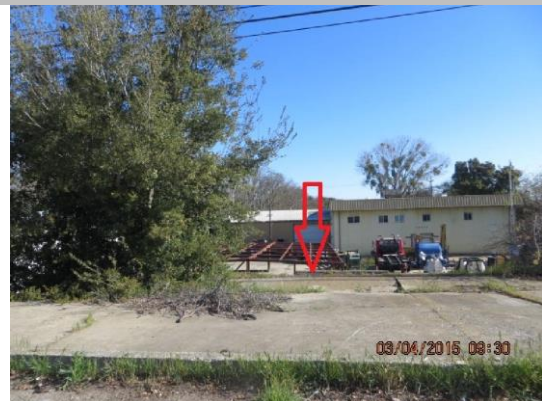
Photo 2 of 3 : UCIP_FA_2015_6026.jpg

Pipe visible on retaining wall at LS toe.

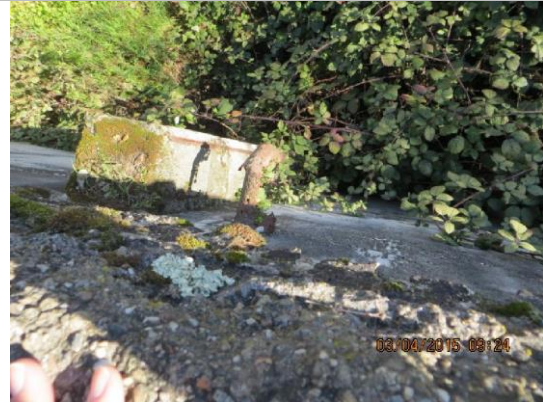
Photo 3 of 3 : UCIP_FA_2015_6027.jpg

Pipe visible on retaining wall at LS toe.

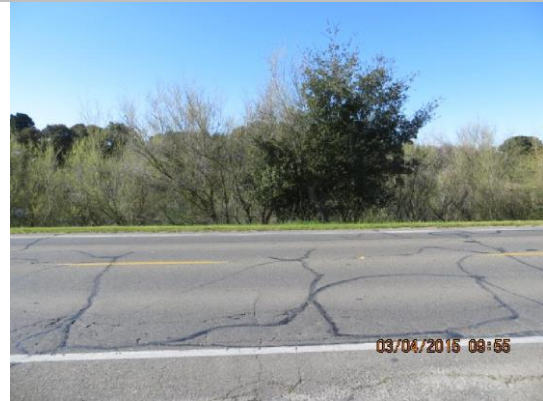
Photo 1 of 3 : UCIP_FA_2015_6022.jpg

LM Start	0.05	Rating **	M	Issue No.	30
LM End	0.05	Issue Type +	En	Location *	WS
Category	Supplemental			GPS Latitude/Longitude	
				Start	End
Item	DWR UCIP Field Study			38.258347 °	38.258347 °
				-121.517169 °	-121.517169 °
DWR ID					
Action/Comments					
Inspector Comments: FS_ID:43811					
DS_ID:18970					
EP_NO: N/A					
FS_HLM: 0.06					
Repair Type: Non-Urgent					
Crossing Status: Found					
UCIP Comments: Pipe appears abandoned and is filled with soil.					
Appears abandoned and if so should be done so properly.					
FIELD_STRUCT_DESC: 8-inch steel drainpipe through the levee, 8-					
feet below the crown. Hole in concrete retaining wall on LS slope					
measures 10-inches in diameter.					
FS Date: 03/04/2015

View of WS. No pipe found.

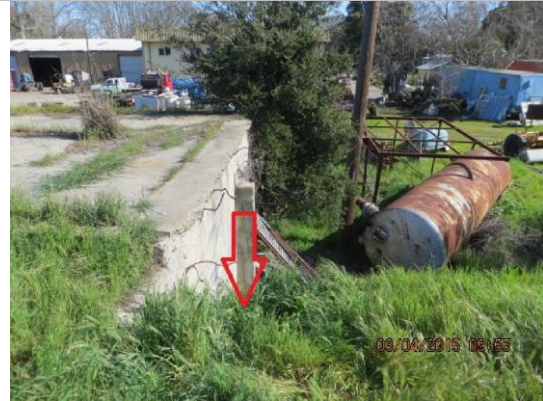
Photo 2 of 3 : UCIP_FA_2015_6023.jpg

10-inch hole in concrete retaining wall likely for this pipe. Visible on LS toe.

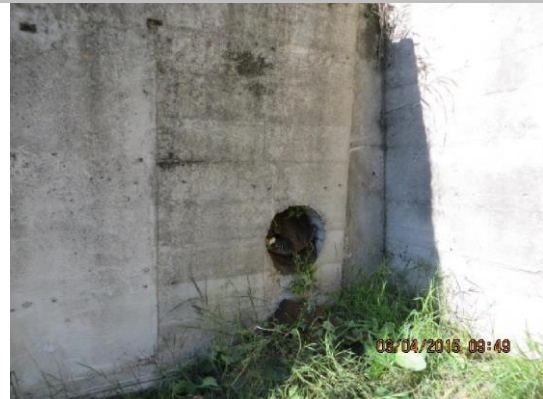
Photo 3 of 3 : UCIP_FA_2015_6024.jpg

10-inch hole in concrete retaining wall likely for this pipe. Visible on LS toe. Portion of pipe visible.

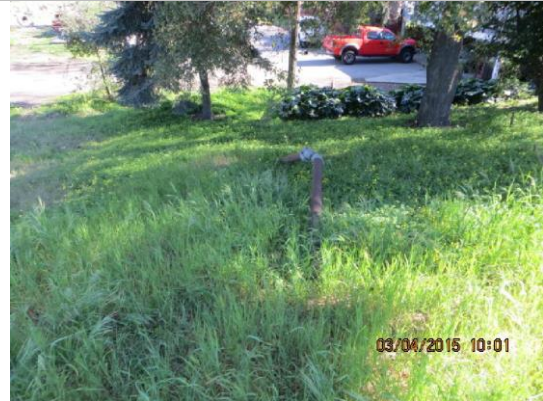
Photo 1 of 3 : UCIP_FA_2015_6107.jpg

LM Start	0.09	Rating **	U	Issue No.	31
LM End	0.09	Issue Type +	En	Location *	WS
Category	Supplemental			GPS Latitude/Longitude	
				Start	End
Item	DWR UCIP Field Study			38.257953 °	38.257953
				-121.516613 °	-121.516613
DWR ID					
Action/Comments					
Inspector Comments: FS_ID:43812					
DS_ID:25084					
EP_NO: N/A					
FS_HLM: 0.1					
Repair Type: Urgent					
Crossing Status: Found

Pipe visible on LS slope.

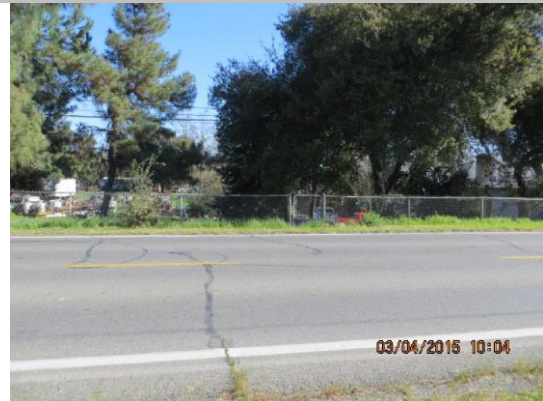
Photo 2 of 3 : UCIP_FA_2015_6108.jpg

Pipe visible at gate on LS shoulder.

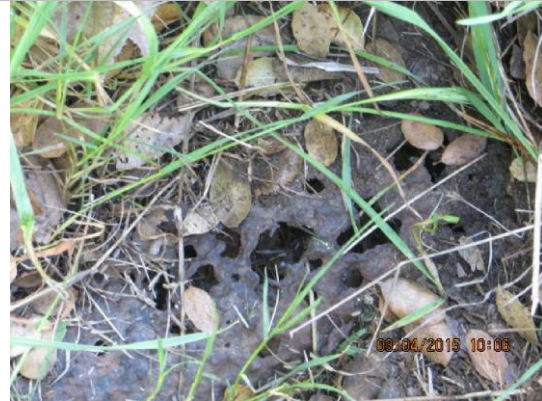
Photo 3 of 3 : UCIP_FA_2015_6109.jpg

Severe corrosion and holes in pipe on LS shoulder.

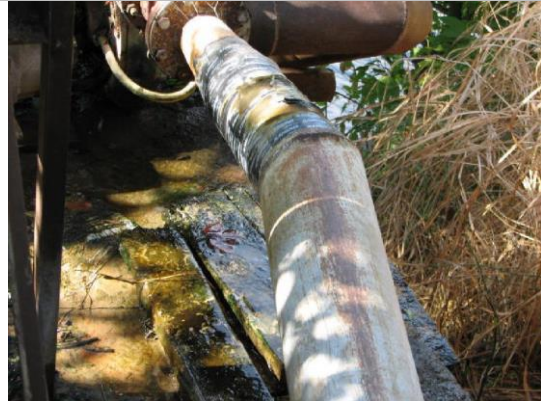
Photo 1 of 3 : UCIP_FA_2015_0167.jpg

Inspector Comments: FS_ID:43814
 DS_ID:18972
 EP_NO: 11117
 FS_HLM: 0.36
 Repair Type: Non-Urgent
 Crossing Status: Found
 UCIP Comments: Siphon breaker on LS slope needs protection. Water is leaking from pump station. Abandoned concrete structure found on WS. 10-inch abandoned pipe found on WS. Should be removed 6-inch abandoned pipe found on WS. Should be removed.
 FIELD_STRUCT_DESC: 10-inch steel irrigation pipe through the levee 4.5-feet below the crown. Pump and Gate valve on WS shoulder. Siphon breaker on LS slope. O&M Manual Sac 111, May 1959, Revision Year 2011 RM 27.63
 FS Date: 10/15/2012

Waterside view: water leaking pump station.

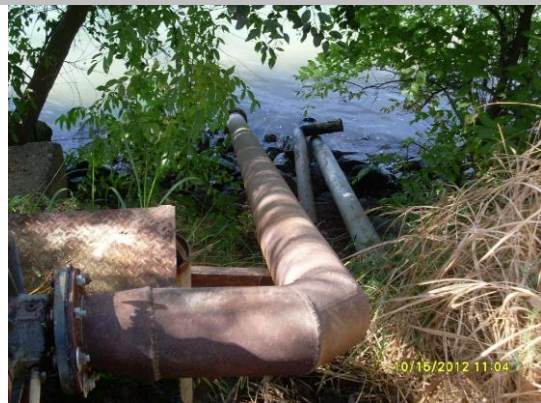
Photo 2 of 3 : UCIP_FA_2015_0168.jpg

Waterside view: overview of active pipe and two abandoned pipes.

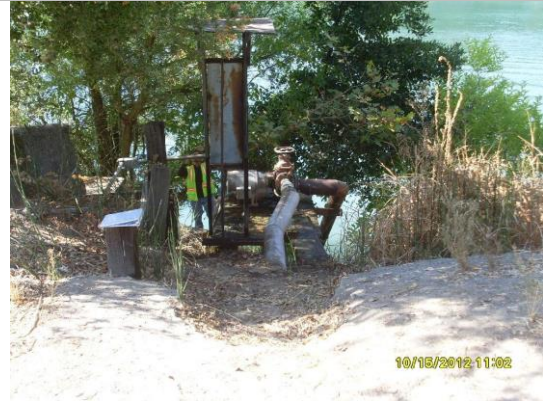
Photo 3 of 3 : UCIP_FA_2015_0169.jpg

Waterside view: overview of pipe & pump and abandoned concrete structure (left). Shutoff Valve.

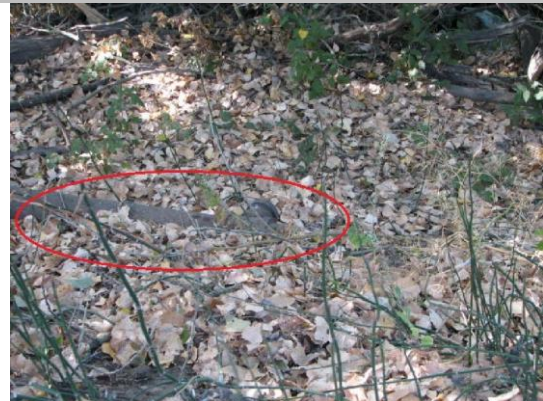
Photo 1 of 2 : UCIP_FA_2015_6090.jpg

LM Start	0.50	Rating **	M	Issue No.	33
LM End	0.50	Issue Type +	En	Location *	LS
Category	Supplemental			GPS Latitude/Longitude	
				Start	End
Item	DWR UCIP Field Study			38.253468 °	38.253468 °
				-121.511654 °	-121.511654 °
DWR ID					
Action/Comments					
Inspector Comments: FS_ID:43815					
DS_ID:18981					
EP_NO: N/A					
FS_HLM: 0.51					
Repair Type: Non-Urgent					
Crossing Status: Indicator Found					
UCIP Comments: Found abandoned pipe laying on WS levee slope.					
Pipe purpose and status should be determined. further investigation required.					
FIELD_STRUCT_DESC: 8-inch steel pipe running parallel with levee crown on WS slope.					
FS Date: 03/04/2015

Pipe on WS slope running parallel to levee crown.

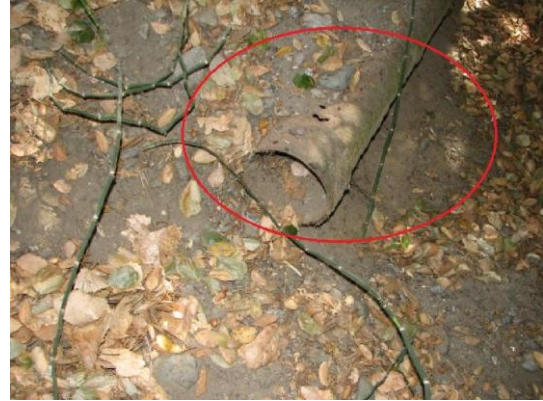
Photo 2 of 2 : UCIP_FA_2015_6091.jpg

Pipe visible on WS slope running parallel to crown.

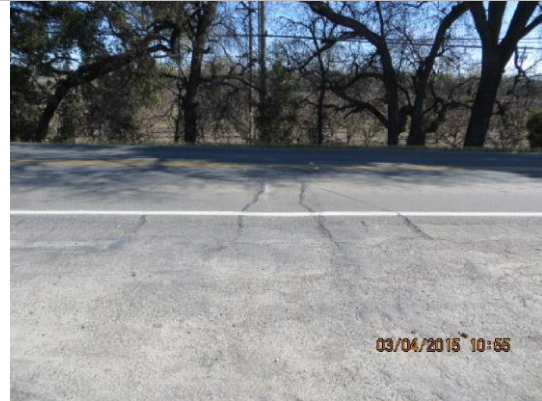
Photo 1 of 3 : UCIP_FA_2015_6029.jpg

LM Start	0.60	Rating **	U	Issue No.	35
LM End	0.60	Issue Type +	En	Location *	LS
Category	Supplemental			GPS Latitude/Longitude	
				Start	End
Item	DWR UCIP Field Study			38.252176 °	38.252176 °
				-121.510833 °	-121.510833 °
DWR ID					
Action/Comments					
Inspector Comments: FS_ID:43816					
DS_ID:18977					
EP_NO: 14313					
FS_HLM: 0.613					
Repair Type: Urgent					
Crossing Status: Indicator Found					
UCIP Comments: Septic line appears to be leaking at LS toe. Erosion of soil and wet soil visible at LS toe. No septic smell accompanied other evidence at site.					
FIELD_STRUCT_DESC: 1 of 3: 2-inch-diameter galvanized steel sewer line through the left bank levee of the Sacramento River. A metal cutoff placed around the pipeline near the centerline of the levee. 4' x 6' CC box at LS toe (Permit No. 14313).					
FS Date: 03/04/2015

View at crossing through crown on LS shoulder from WS shoulder.
Evidence of trench visible at cut in pavement.

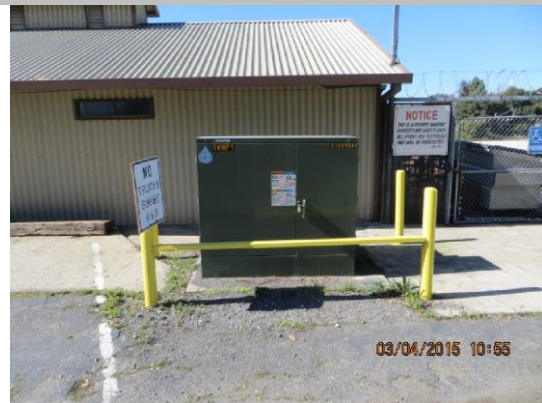
Photo 2 of 3 : UCIP_FA_2015_6030.jpg

Waterside view. Unclear if there is a sewer cleanout or other evidence of pipe location on WS shoulder.

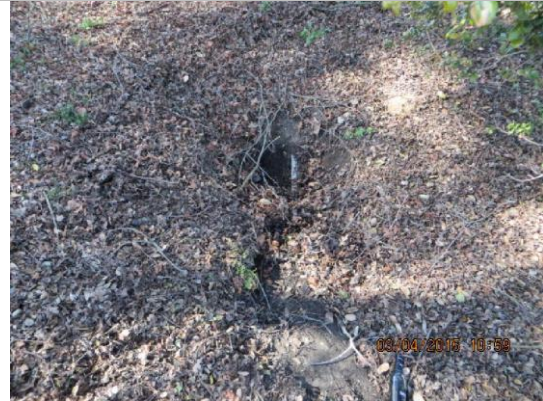
Photo 3 of 3 : UCIP_FA_2015_6031.jpg

Septic line leaking at LS toe. Erosion of soil at toe visible.

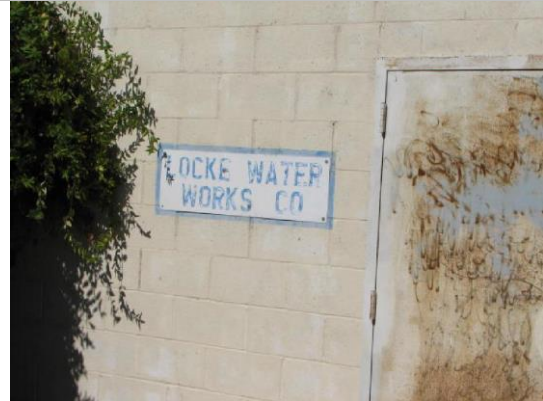
Photo 1 of 2 : UCIP_FA_2015_0170.jpg

Inspector Comments: FS_ID:43756
 DS_ID:18984
 EP_NO: 12944
 FS_HLM: 0.8
 Repair Type: Urgent
 Crossing Status: Indicator Found
 UCIP Comments: WS shoulder is saturated do to a water leak either at this backflow preventer or due to another waterline in the area. Leak needs to be repaired.
 FIELD_STRUCT_DESC: 1 of 2: 4-inch Galvanized steel domestic water line through the levee 1.5-feet below the crown. Provides service to town of lock down center of Levee Street. Concrete Block pump house on WS at south end of boathouse. Gate valves and Backflow device visible at south side of Boathouse (Permit No. 12944, 1982).
 FS Date: 10/15/2012

Waterside view: Locke Water Works Co. pump house.

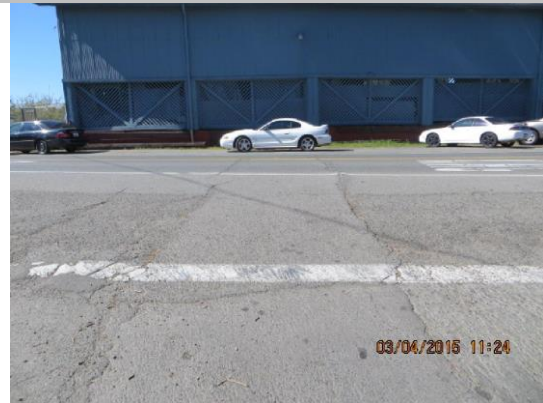
Photo 2 of 2 : UCIP_FA_2015_6085.jpg

Cut in pavement still visible at crossing near centerline of Levee Street.
