**Flood Control Project Maintenance
Levee Inspections**

Fall 2016 Levee Maintenance Deficiency Summary Report

Reclamation District No. 0369 Libby McNeil

Levee Inspection Report By Mile - Fall 2016

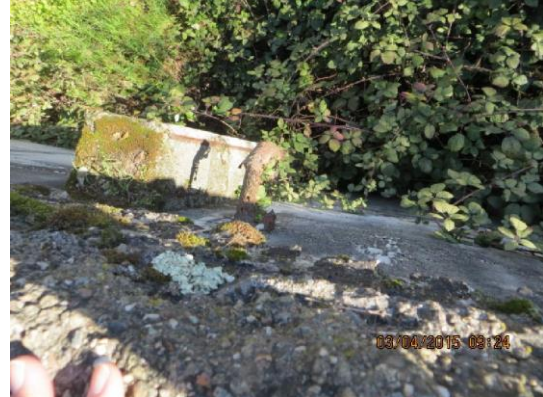
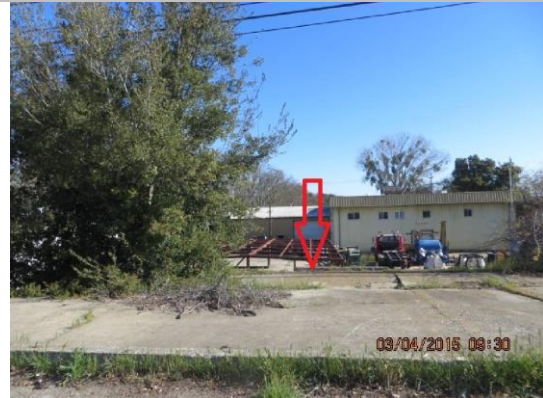
Photo 1 of 2 : UCIP_FA_2016_50105_73165.jpg

LM Start	0.04	Rating **	M	Issue No.	32
LM End	0.04	Issue Type +	En	Location *	WS
Category	Supplemental			GPS Latitude/Longitude	
				Start	End
Item	DWR UCIP Field Study			38.258434 °	38.258434 °
				-121.517283 °	-121.517283 °
DWR ID

Comment Code					
Inspector Comment					
FS_ID:50105 DS_ID:18971 EP_NO: 8555 Repair Type: Non-Urgent Crossing Status: Found UCIP Comments: 03/04/2015 Pipe corroded through on LS at retaining wall. May not go all the way through the levee. Appears abandoned and if so should be done so properly. FIELD_STRUCT_DESC: *ABANDONED* 2 of 2: 4-inch steel pipe through the levee with an unknown purpose, 4 feet below the crown. Pipe visible on the landside (LS) at a retaining wall (Automatic Board Order (ABO) issued as Permit No. 8555, 1973 - Jordan Investment Co.). [Additional Reference(s): DWR Levee Log, 2002. USACE Sacramento O&M Manual 111, May 1959 (RM 28.87)]. FS Date: 3/4/2015 4:11:00 PM

Pipe visible on retaining wall at LS toe.

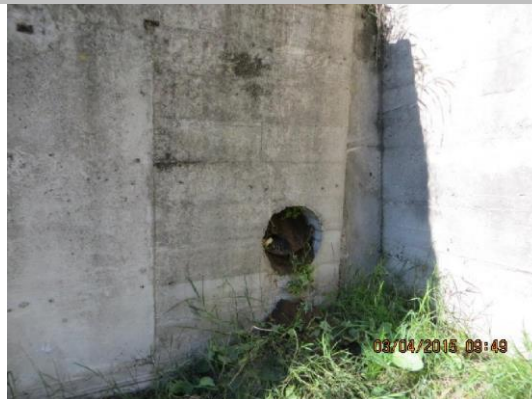
Photo 1 of 2 : UCIP_FA_2016_43811_73162.jpg

LM Start	0.05	Rating **	M	Issue No.	29
LM End	0.05	Issue Type +	En	Location *	WS
Category	Supplemental			GPS Latitude/Longitude	
				Start	End
Item	DWR UCIP Field Study			38.258347 °	38.258347 °
				-121.517169 °	-121.517169 °
DWR ID					
Comment Code					
Inspector Comment					
FS_ID:43811 DS_ID:18970 EP_NO: N/A Repair Type: Non-Urgent Crossing Status: Found UCIP Comments: 03/04/2015 Pipe appears abandoned and is filled with soil. Appears abandoned and if so should be done so properly. FIELD_STRUCT_DESC: *ABANDONED* 8-inch steel drainage pipe through the levee, 8 feet below the crown. Hole in concrete retaining wall on the landside (LS) slope measures 10 inches in diameter. [Additional Reference(s): DWR Levee Log, 2002]. FS Date: 3/4/2015 4:41:00 PM

10-inch hole in concrete retaining wall likely for this pipe. Visible on LS toe. Portion of pipe visible.

10-inch hole in concrete retaining wall likely for this pipe. Visible on LS toe.

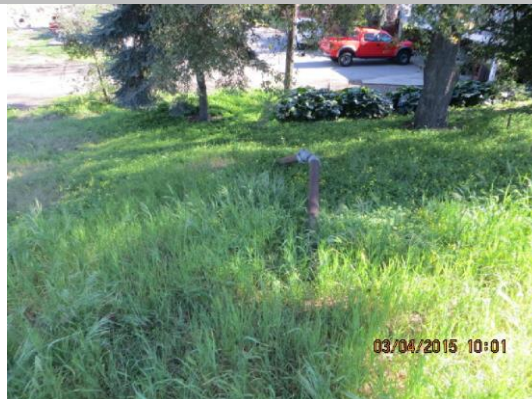
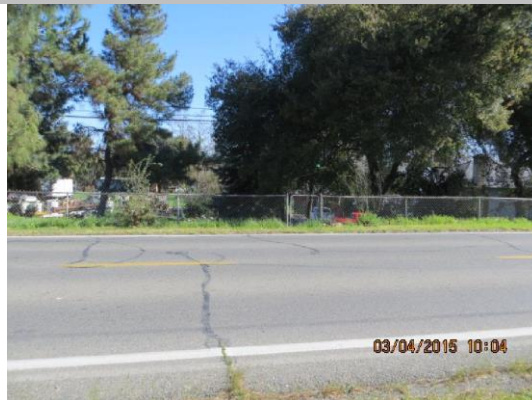
Photo 1 of 2 : UCIP_FA_2016_50158_73331.jpg

LM Start	0.09	Rating **	U	Issue No.	33
LM End	0.09	Issue Type +	En	Location *	WS
Category	Supplemental			GPS Latitude/Longitude	
				Start	End
Item	DWR UCIP Field Study			38.257953 °	38.257953 °
				-121.516613 °	-121.516613 °
DWR ID					
Comment Code					
Inspector Comment					
FS_ID:50158 DS_ID:25084 EP_NO: N/A Repair Type: Urgent Crossing Status: Found UCIP Comments: 06/01/2016 Same as last inspection. (K. Fazel - UCIP)03/04/2015 Severe corrosion and holes visible in pipe on LS shoulder. Pipe appears abandoned and should be done so properly. (W. Wyle - FPIIB) FIELD_STRUCT_DESC: *ABANDONED* 4-inch steel pipe through the levee, of an unknown purpose, 1 foot below the crown. Pipe is visible on the landside (LS) slope just in front of the gate on the LS shoulder. [Additional Reference(s): USACE Sacramento O&M Manual 111, May 1959 (RM 27.87)]. FS Date: 6/1/2016

Pipe visible on LS slope.

Pipe visible at gate on LS shoulder.

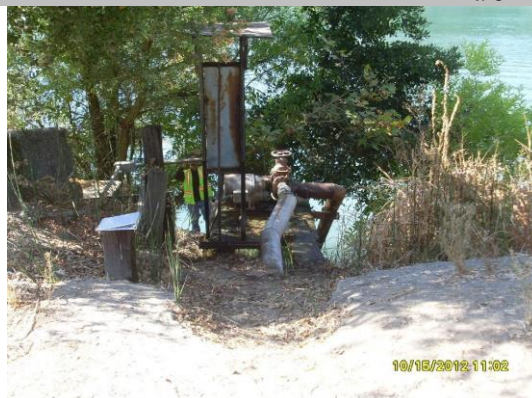
Photo 1 of 2 : UCIP_FA_2016_43814_10460.jpg

Comment Code					
Inspector Comment					
FS_ID:43814 DS_ID:18972 EP_NO: 11117 Repair Type: Non-Urgent Crossing Status: Found UCIP Comments: 10/15/2012 Siphon breaker on LS slope needs protection. Water is leaking from pump station. Abandoned concrete structure found on WS. 10-inch abandoned pipe found on WS. Should be removed. 6-inch abandoned pipe found on WS. Should be removed. FIELD_STRUCT_DESC: *ABANDONED* 10-inch steel irrigation pipe through the levee, 4.5 feet below the crown. Pump and gate valve on the waterside (WS) shoulder. Siphon breaker on the landside (LS) slope. 6-inch abandoned pipe also found on WS. [Additional Reference(s): DWR Levee Log, 2002. USACE Sacramento O&M Manual 111, May 1959 (RM 27.63)]. FS Date: 10/15/2012 4:11:00 PM

Waterside view: overview of pipe & pump and abandoned concrete structure (left). Shutoff Valve.

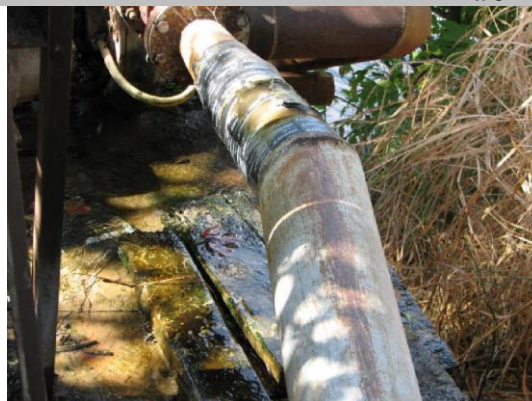
Photo 2 of 2 : UCIP_FA_2016_43814_10456.jpg

Comment Code						
Inspector Comment						
FS_ID:43814 DS_ID:18972 EP_NO: 11117 Repair Type: Non-Urgent Crossing Status: Found UCIP Comments: 10/15/2012 Siphon breaker on LS slope needs protection. Water is leaking from pump station. Abandoned concrete structure found on WS. 10-inch abandoned pipe found on WS. Should be removed. 6-inch abandoned pipe found on WS. Should be removed. FIELD_STRUCT_DESC: *ABANDONED* 10-inch steel irrigation pipe through the levee, 4.5 feet below the crown. Pump and gate valve on the waterside (WS) shoulder. Siphon breaker on the landside (LS) slope. 6-inch abandoned pipe also found on WS. [Additional Reference(s): DWR Levee Log, 2002. USACE Sacramento O&M Manual 111, May 1959 (RM 27.63)]. FS Date: 10/15/2012 4:11:00 PM

Waterside view: water leaking pump station.

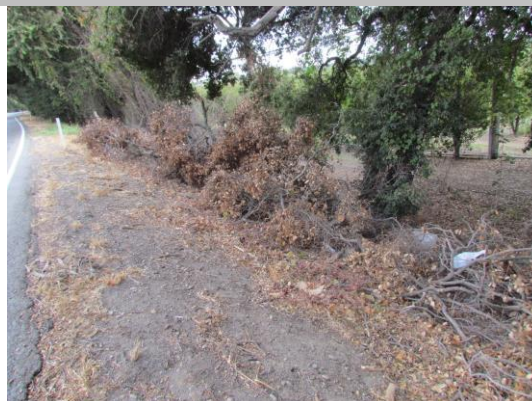
Photo 1 of 1 : FA_2016_RD0369_207_14_20160921_00025.jpg

LM Start	0.50	Rating **	U	Issue No.	14
LM End	0.50	Issue Type +	Ma	Location *	LS
Category	Earthen Levee			GPS Latitude/Longitude	
				Start	End
Item	Encroachments			38.253468 °	38.253468 °
				-121.511692 °	-121.511692 °
DWR ID	DWR_RD0369_01_s_2016_14				
Comment Code					
TR : Tree or limb					
Inspector Comment					
These tree limbs were placed here by the County Fire Department. The storm caused the limbs to break and block traffic. This brush was causing a safety hazard to highway traffic. The County Fire Dept. cut the limbs up and drug them off the HWY. The District must remove the unwanted brush pile from the levee section.

Cut up dead tree limbs remain on the landside levee shoulder and slope since last December.

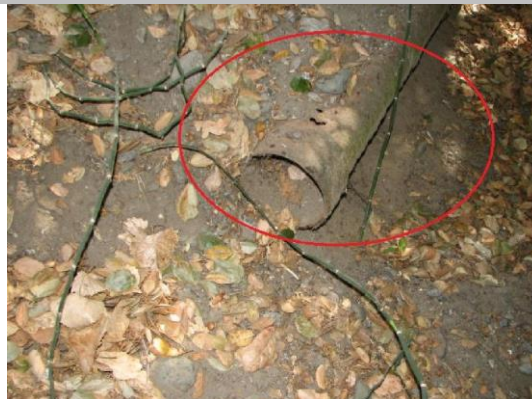
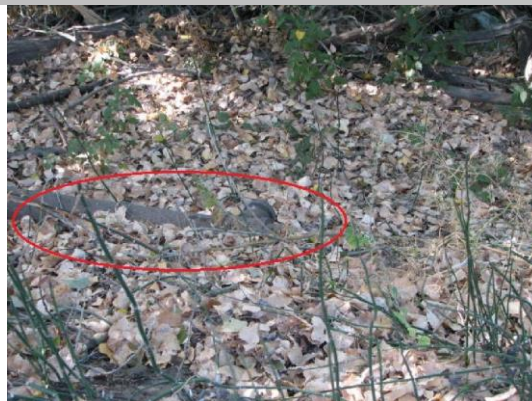
Photo 1 of 2 : UCIP_FA_2016_43815_73301.jpg

FS_ID:43815
DS_ID:18981
EP_NO: N/A
Repair Type: Non-Urgent
Crossing Status: Indicator Found
UCIP Comments: Found abandoned pipe laying on WS levee slope. Pipe purpose and status should be determined. further investigation required.
FIELD_STRUCT_DESC: 8-inch steel pipe running parallel with levee crown on WS slope.
FS Date: 3/4/2015

Pipe visible on WS slope running parallel to crown.

Pipe on WS slope running parallel to levee crown.

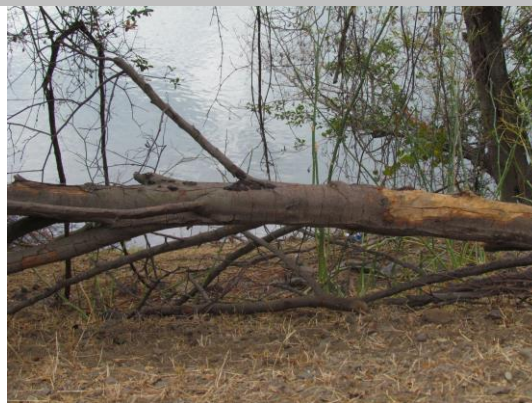
Photo 1 of 1 : FA_2016_RD0369_207_16_20160921_00024.jpg

LM Start	0.53	Rating **	M	Issue No.	16
LM End	0.53	Issue Type +	Ma	Location *	WS
Category	Earthen Levee			GPS Latitude/Longitude	
				Start	End
Item	Encroachments			38.253095 °	38.253095 °
				-121.511387 °	-121.511387 °
DWR ID	DWR_RD0369_01_s_2016_16				
Comment Code					
TR : Tree or limb					
Inspector Comment					
Cut up and remove the dead tree from the waterside slope. This tree was reported during spring inspection 2016.

RD 369 Levee mile 0.53 waterside levee slope.

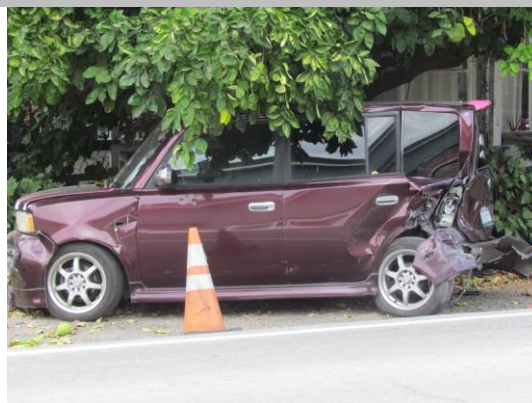
Photo 1 of 1 : FA_2016_RD0369_207_20_20160921_00023.jpg

RD 369 Levee mile 0.74 wrecked vehicle landside shoulder.
