**Flood Control Project Maintenance  
Levee Inspections**

**Fall 2017 Levee Maintenance Deficiency Summary Report**

**Reclamation District No. 0369 Libby McNeil**

**Levee Inspection Report By Mile - Fall 2017**

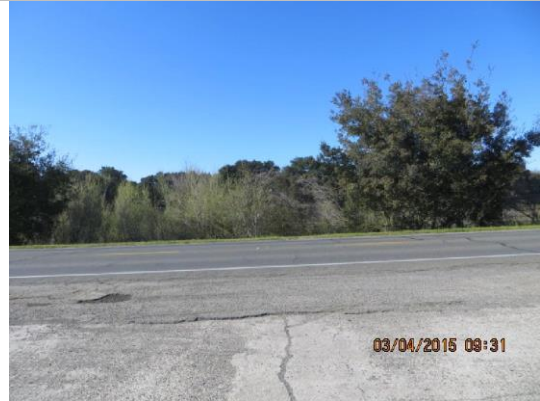
Photo 3 of 3 : UCIP\_FA\_2017\_50105\_73163.jpg

Comment Code						
Inspector Comment						
FS_ID:50105 DS_ID:18971 EP_NO: 8555 Repair Type: Non-Urgent Crossing Status: Found UCIP Comments: 03/04/2015 Pipe corroded through on LS at retaining wall. May not go all the way through the levee. Appears abandoned and if so should be done so properly. FIELD_STRUCT_DESC: *ABANDONED* 2 of 2: 4-inch steel pipe through the levee with an unknown purpose, 4 feet below the crown. Pipe visible on the landside (LS) at a retaining wall (Automatic Board Order (ABO) issued as Permit No. 8555, 1973 - Jordan Investment Co.). [Additional Reference(s): DWR Levee Log, 2002. USACE Sacramento O&M Manual 111, May 1959 (RM 28.87)]. FS Date: 3/4/2015 4:11:00 PM

View of WS. Pipe not found on WS.

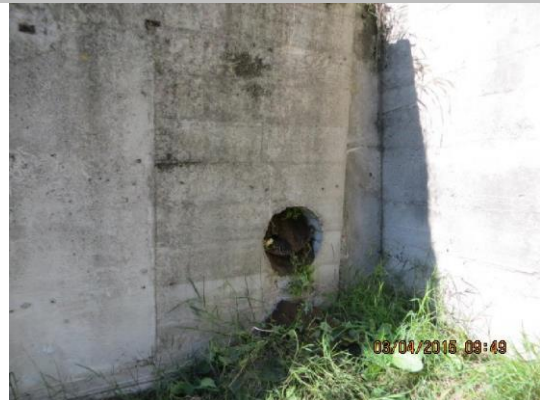
Photo 1 of 3 : UCIP\_FA\_2017\_43811\_73162.jpg

LM Start	0.05	Rating **	M	Issue No.	30
LM End	0.05	Issue Type +	En	Location *	
Category	Supplemental			GPS Latitude/Longitude	
				Start	End
Item	DWR UCIP Field Study			38.258347 °	38.258347 °
				-121.517169 °	-121.517169 °
DWR ID					
Comment Code					
Inspector Comment					
FS_ID:43811 DS_ID:18970 EP_NO: N/A Repair Type: Non-Urgent Crossing Status: Found UCIP Comments: 03/04/2015 Pipe appears abandoned and is filled with soil. Appears abandoned and if so should be done so properly. FIELD_STRUCT_DESC: *ABANDONED* 8-inch steel drainage pipe through the levee, 8 feet below the crown. Hole in concrete retaining wall on the landside (LS) slope measures 10 inches in diameter. [Additional Reference(s): DWR Levee Log, 2002]. FS Date: 3/4/2015 4:41:00 PM

10-inch hole in concrete retaining wall likely for this pipe. Visible on LS toe. Portion of pipe visible.

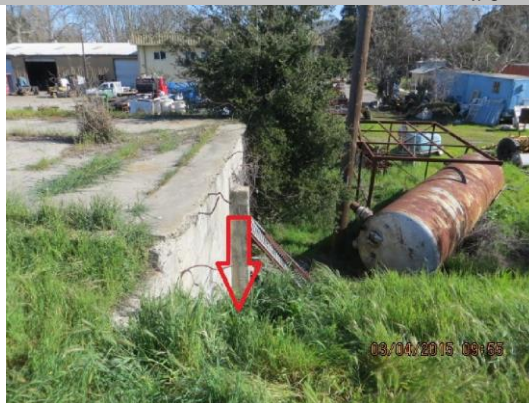
Photo 2 of 3 : UCIP\_FA\_2017\_43811\_73161.jpg

LM Start	0.05	Rating **	M	Issue No.	30 (cont)	
LM End	0.05	Issue Type +	En	Location *		
Category	Supplemental			GPS Latitude/Longitude		
				Start	End	
Item	DWR UCIP Field Study			38.258347 °	38.258347 °	
				-121.517169 °	-121.517169 °	
DWR ID						
Comment Code						
Inspector Comment						
FS_ID:43811						
DS_ID:18970						
EP_NO: N/A						
Repair Type: Non-Urgent						
Crossing Status: Found						
UCIP Comments: 03/04/2015 Pipe appears abandoned and is filled with soil. Appears abandoned and if so should be done so properly.						
FIELD_STRUCT_DESC: *ABANDONED* 8-inch steel drainage pipe through the levee, 8 feet below the crown. Hole in concrete retaining wall on the landside (LS) slope measures 10 inches in diameter.						
[Additional Reference(s): DWR Levee Log, 2002].						
FS Date: 3/4/2015 4:41:00 PM

10-inch hole in concrete retaining wall likely for this pipe. Visible on LS toe.

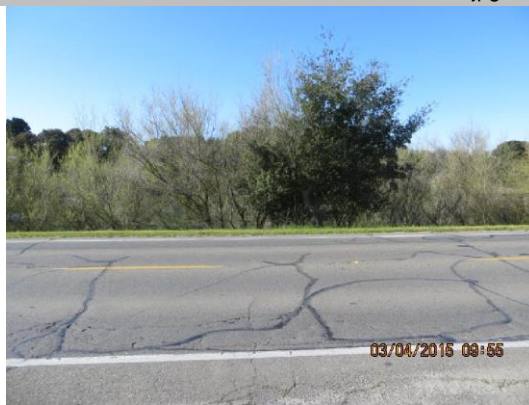
Photo 3 of 3 : UCIP\_FA\_2017\_43811\_73160.jpg

View of WS. No pipe found.

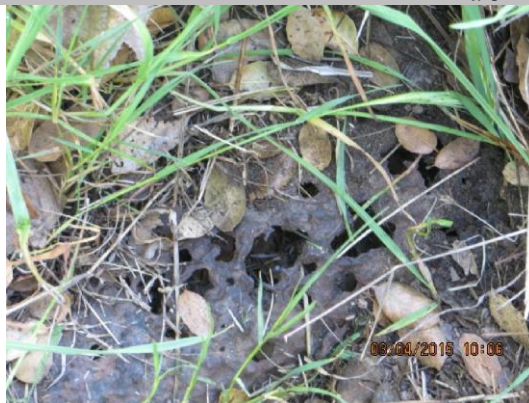
Photo 3 of 3 : UCIP\_FA\_2017\_50158\_73333.jpg

Comment Code						
Inspector Comment						
FS_ID:50158 DS_ID:25084 EP_NO: N/A Repair Type: Urgent Crossing Status: Found UCIP Comments: 06/01/2016 Same as last inspection. (K. Fazel - UCIP)03/04/2015 Severe corrosion and holes visible in pipe on LS shoulder. Pipe appears abandoned and should be done so properly. (W. Wyle - FPIIB) FIELD_STRUCT_DESC: *ABANDONED* 4-inch steel pipe of unknown purpose through the levee, of an unknown purpose, 1 foot below the crown. Pipe is visible on the landside (LS) slope just in front of the gate on the LS shoulder. [Additional Reference(s): USACE Sacramento O&M Manual 111, May 1959 (RM 27.87)]. FS Date: 6/1/2016

LS slope: severe corrosion and holes in pipe at upper end of pipe (near crown).

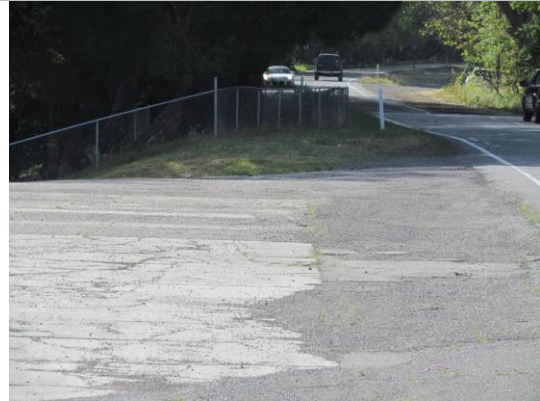
Photo 1 of 1 : FA\_2017\_RD0369\_207\_10\_20171002\_00004.jpg

LM Start	0.16	Rating **	M	Issue No.	10
LM End	0.23	Issue Type +	Ma	Location *	LS
Category	Earthen Levee			GPS Latitude/Longitude	
				Start	End
Item	Vegetation			38.257292 °	38.256660 °
				-121.515690 °	-121.514710 °
DWR ID	DWR_RD0369_01_s_2017_10				
Comment Code					
V2 : Remove the wild growth other than native grasses from the levee slopes.					
Inspector Comment					
Spray or mow the weeds along the landside levee slope.

Looking downstream from the landside shoulder.

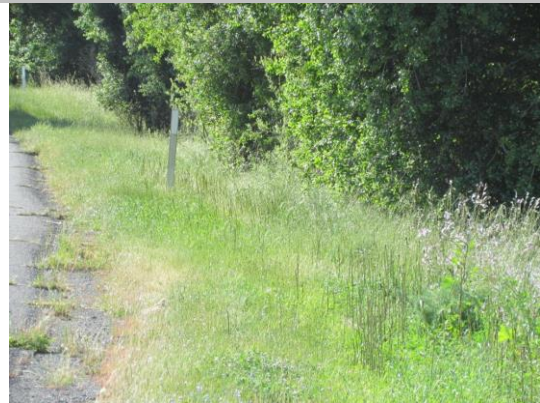
Photo 1 of 1 : FA\_2017\_RD0369\_207\_9\_20171002\_00003.jpg

LM Start	0.16	Rating **	M	Issue No.	9
LM End	0.57	Issue Type +	Ma	Location *	WS
Category	Earthen Levee			GPS Latitude/Longitude	
				Start	End
Item	Vegetation			38.257292 °	38.252597 °
				-121.515690 °	-121.511130 °
DWR ID	DWR_RD0369_01_s_2017_9				
Comment Code					
V2 : Remove the wild growth other than native grasses from the levee slopes.					
Inspector Comment					
Spray the weed growth along the waterside levee slope.

Looking downstream from the waterside shoulder.

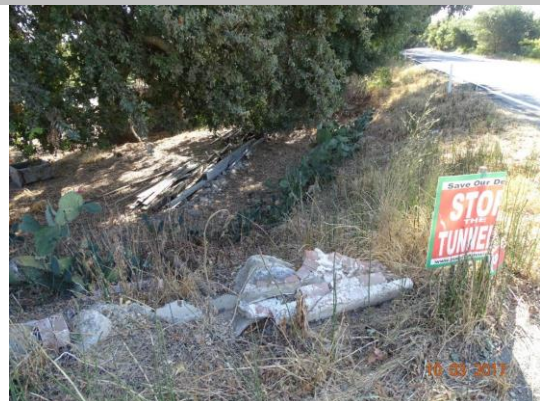
Photo 1 of 1 : FA\_2017\_RD0369\_207\_11\_20171003\_00024.jpg

LM Start	0.16	Rating **	U	Issue No.	11
LM End	0.16	Issue Type +	En	Location *	LS
Category	Earthen Levee			GPS Latitude/Longitude	
				Start	End
Item	Encroachments			38.257346 °	38.257346 °
				-121.515523 °	-121.515523 °
DWR ID	DWR_RD0369_01_f_2017_11				
Comment Code					
DE : Debris					
Inspector Comment					
Remove irrigation pipes, broken concrete and woody debris from land side slope and toe south of driveway to allow visibility and access.

10/03/2017: Irrigation pipes, lumber, woody debris and broken concrete should be removed from land side slope and toe.

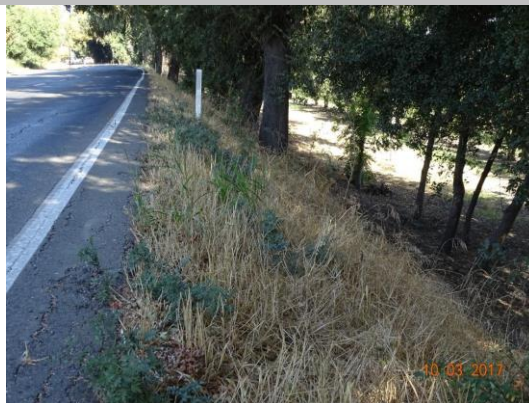
Photo 1 of 1 : FA\_2017\_RD0369\_207\_13\_20171003\_00023.jpg

LM Start	0.28	Rating **	A/W	Issue No.	13
LM End	0.34	Issue Type +	Ma	Location *	LS
Category	Earthen Levee			GPS Latitude/Longitude	
				Start	End
Item	Trim / Thin Trees			38.256087 °	38.255438 °
				-121.514068 °	-121.513362 °
DWR ID	DWR_RD0369_01_f_2016_13				
Comment Code					
T2 : Thin trees to allow visibility of the ground and room to flood fight.					
Inspector Comment					
Thin out the tree growth along the landside slope.

10/03/2017: Vines and low branches and heavy weed growth have been removed. Visibility and access are improved.

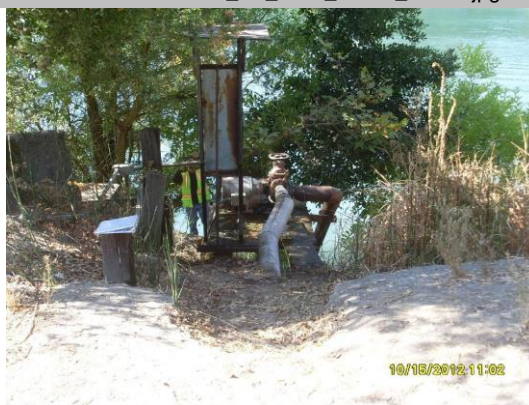
Photo 1 of 3 : UCIP\_FA\_2017\_43814\_10460.jpg

Comment Code					
Inspector Comment					
FS_ID:43814 DS_ID:18972 EP_NO: 11117 Repair Type: Non-Urgent Crossing Status: Found UCIP Comments: 10/15/2012 Siphon breaker on LS slope needs protection. Water is leaking from pump station. Abandoned concrete structure found on WS. 10-inch abandoned pipe found on WS. Should be removed. 6-inch abandoned pipe found on WS. Should be removed. FIELD_STRUCT_DESC: *ABANDONED* 10-inch steel irrigation pipe through the levee, 4.5 feet below the crown. Pump and gate valve on the waterside (WS) shoulder. Siphon breaker on the landside (LS) slope. 6-inch abandoned pipe also found on WS. [Additional Reference(s): DWR Levee Log, 2002. USACE Sacramento O&M Manual 111, May 1959 (RM 27.63)]. FS Date: 10/15/2012 4:11:00 PM

Waterside view: overview of pipe & pump and abandoned concrete structure (left). Shutoff Valve.

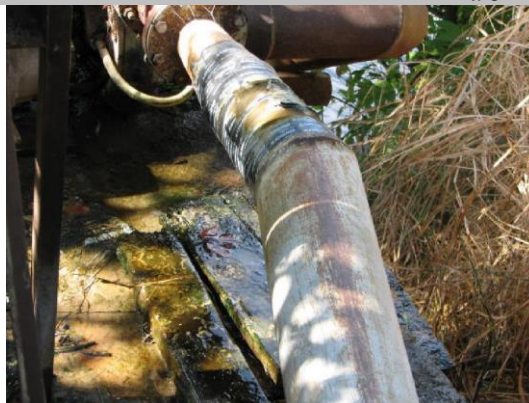
Photo 2 of 3 : UCIP\_FA\_2017\_43814\_10456.jpg

FS\_ID:43814  
DS\_ID:18972  
EP\_NO: 11117  
Repair Type: Non-Urgent  
Crossing Status: Found  
UCIP Comments: 10/15/2012 Siphon breaker on LS slope needs protection. Water is leaking from pump station. Abandoned concrete structure found on WS. 10-inch abandoned pipe found on WS. Should be removed. 6-inch abandoned pipe found on WS. Should be removed.  
FIELD\_STRUCT\_DESC: \*ABANDONED\* 10-inch steel irrigation pipe through the levee, 4.5 feet below the crown. Pump and gate valve on the waterside (WS) shoulder. Siphon breaker on the landside (LS) slope. 6-inch abandoned pipe also found on WS. [Additional Reference(s): DWR Levee Log, 2002. USACE Sacramento O&M Manual 111, May 1959 (RM 27.63)].  
FS Date: 10/15/2012 4:11:00 PM

Waterside view: water leaking pump station.

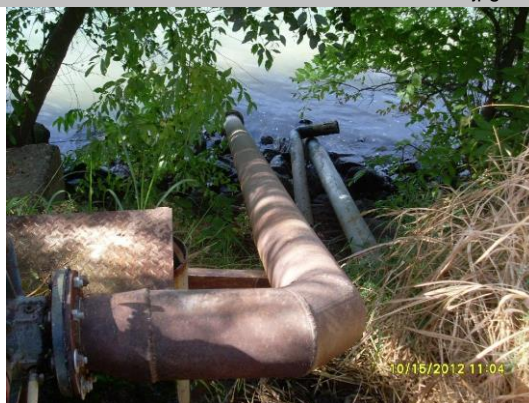
Photo 3 of 3 : UCIP\_FA\_2017\_43814\_10459.jpg

Waterside view: overview of active pipe and two abandoned pipes.

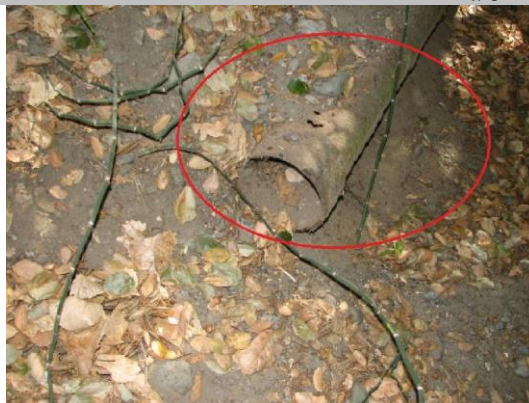
Photo 1 of 2 : UCIP\_FA\_2017\_43815\_73301.jpg

LM Start	0.50	Rating **	M	Issue No.	33
LM End	0.50	Issue Type +	En	Location *	
Category	Supplemental			GPS Latitude/Longitude	
				Start	End
Item	DWR UCIP Field Study			38.253468 °	38.253468 °
				-121.511654 °	-121.511654 °
DWR ID					
Comment Code					
Inspector Comment					
FS_ID:43815					
DS_ID:18981					
EP_NO: N/A					
Repair Type: Non-Urgent					
Crossing Status: Indicator Found					
UCIP Comments: Found abandoned pipe laying on WS levee slope.					
Pipe purpose and status should be determined. further investigation required.					
FIELD_STRUCT_DESC: 8-inch steel pipe running parallel with levee crown on WS slope.					
FS Date: 3/4/2015

Pipe visible on WS slope running parallel to crown.

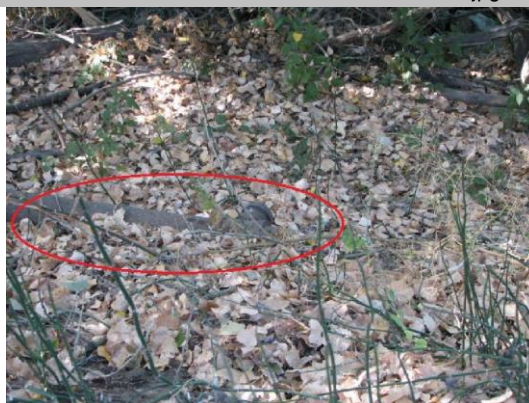
Photo 2 of 2 : UCIP\_FA\_2017\_43815\_73300.jpg

Pipe on WS slope running parallel to levee crown.

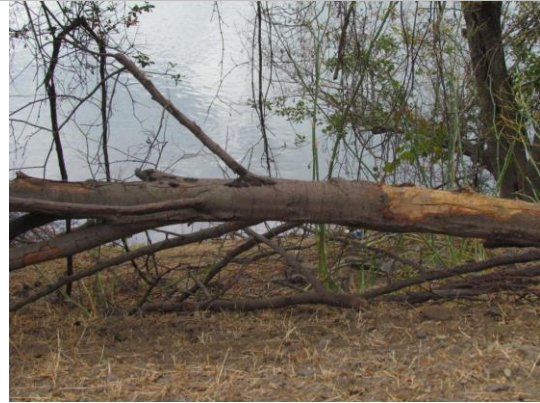
Photo 1 of 1 : FA\_2017\_RD0369\_207\_16\_20171002\_00005.jpg

LM Start	0.53	Rating **	M	Issue No.	16
LM End	0.53	Issue Type +	Ma	Location *	WS
Category	Earthen Levee			GPS Latitude/Longitude	
				Start	End
Item	Encroachments			38.253095 °	38.253095 °
				-121.511387 °	-121.511387 °
DWR ID	DWR_RD0369_01_s_2016_16				
Comment Code					
TR : Tree or limb					
Inspector Comment					
Cut up and remove the dead tree from the waterside slope. This tree was reported during spring inspection 2016.

RD 369 Levee mile 0.53 waterside levee slope.

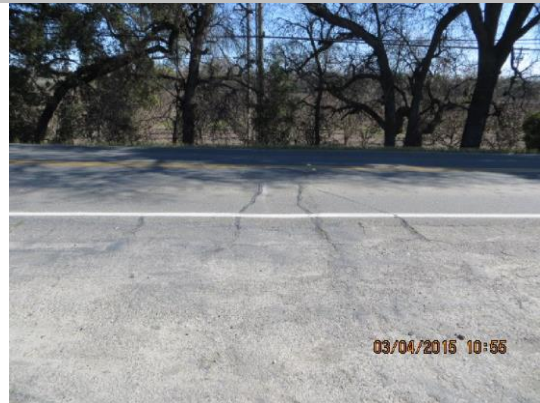
Photo 1 of 3 : UCIP\_FA\_2017\_50159\_73166.jpg

Comment Code						
Inspector Comment						
FS_ID:50159 DS_ID:18977 EP_NO: 14313 Repair Type: Urgent Crossing Status: Indicator Found UCIP Comments: 06/01/2016 Could not locate pipe. Likely buried next to leach box. Could not find signs of leaking or presence of water or erosion. Pipe may still be leaking but buried. (K. Fazel - UCIP)03/04/2015 Septic line appears to be leaking at LS toe. Erosion of soil and wet soil visible at LS toe. No septic smell accompanied other evidence at site. (W. Wylie - FPIIB) FIELD_STRUCT_DESC: 3 of 3: 2-inch galvanized steel sewer pipe through the levee, 1 foot below the crown. A metal cutoff placed around the pipe near the centerline of the levee. 4-foot by 6-foot concrete box at the landside (LS) toe. Pipe runs through the district president, Clarence Chu's property: ckchu52@comcast.net 916-776-1684, 916-813-7037. (Permit No. 14313, 1986 - Schmiedel) (Additional Related Permit(s): Permit No. 13783, 1988 - Schmiedel, mentions the leach line for septic system). FS Date: 3/4/2015 4:48:00 PM

View at crossing through crown on LS shoulder from WS shoulder.  
Evidence of trench visible at cut in pavement.

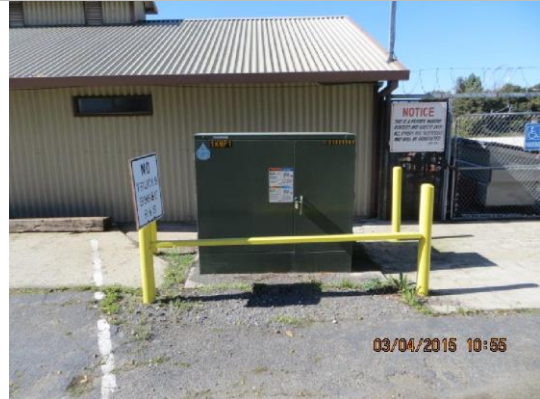
Photo 2 of 3 : UCIP\_FA\_2017\_50159\_73167.jpg

Comment Code						
Inspector Comment						
FS_ID:50159 DS_ID:18977 EP_NO: 14313 Repair Type: Urgent Crossing Status: Indicator Found UCIP Comments: 06/01/2016 Could not locate pipe. Likely buried next to leach box. Could not find signs of leaking or presence of water or erosion. Pipe may still be leaking but buried. (K. Fazel - UCIP)03/04/2015 Septic line appears to be leaking at LS toe. Erosion of soil and wet soil visible at LS toe. No septic smell accompanied other evidence at site. (W. Wylie - FPIIB) FIELD_STRUCT_DESC: 3 of 3: 2-inch galvanized steel sewer pipe through the levee, 1 foot below the crown. A metal cutoff placed around the pipe near the centerline of the levee. 4-foot by 6-foot concrete box at the landside (LS) toe. Pipe runs through the district president, Clarence Chu's property: ckchu52@comcast.net 916-776-1684, 916-813-7037. (Permit No. 14313, 1986 - Schmiedel) (Additional Related Permit(s): Permit No. 13783, 1988 - Schmiedel, mentions the leach line for septic system). FS Date: 3/4/2015 4:48:00 PM

Waterside view. Unclear if there is a sewer cleanout or other evidence of pipe location on WS shoulder.

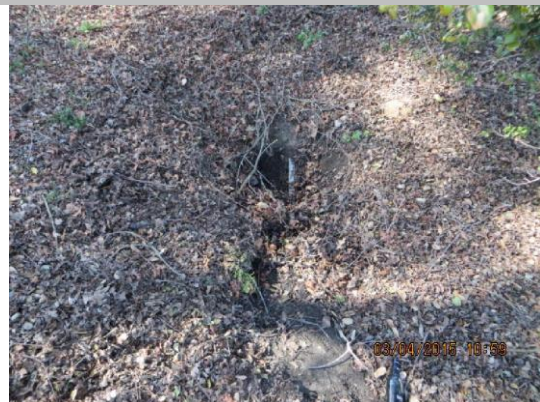
Photo 3 of 3 : UCIP\_FA\_2017\_50159\_73168.jpg

Septic line leaking at LS toe. Erosion of soil at toe visible.

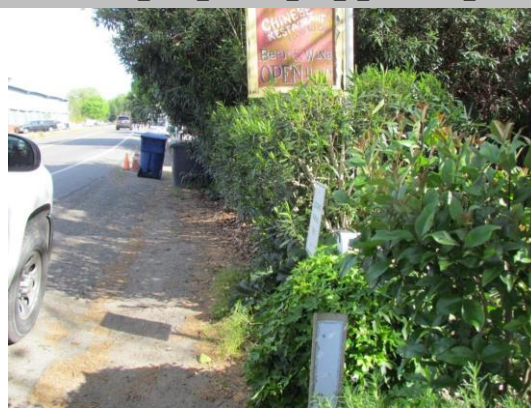
Photo 1 of 2 : FA\_2017\_RD0369\_207\_8\_20171002\_00001.jpg

LM Start	0.75	Rating **	U	Issue No.	8
LM End	0.77	Issue Type +	En	Location *	LS
Category	Earthen Levee			GPS Latitude/Longitude	
				Start	End
Item	Vegetation			38.250215 °	38.249930 °
				-121.509990 °	-121.509880 °
DWR ID	DWR_RD0369_01_s_2017_8				
Comment Code					
V6 : Landscaping					
Inspector Comment					
Landscaping needs to be thinned and maintained to allow inspection and access to landside slope and toe.

Looking upstream from levee mile 0.77 to levee mile 0.75 at the woody tree and vegetation on the landside slope.

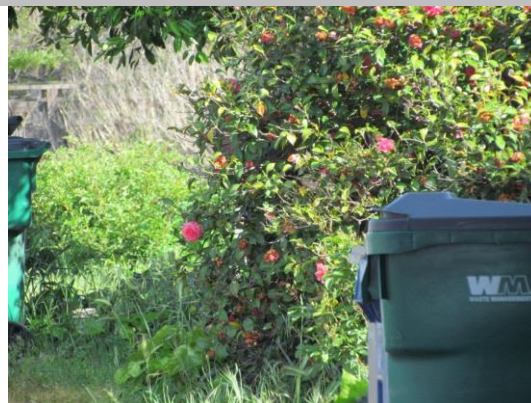
Photo 2 of 2 : FA\_2017\_RD0369\_207\_8\_20171002\_00002.jpg

Looking upstream from levee mile 0.77 to levee mile 0.75 levee slope blocked by vegetation typical view of growth along this section.
