**Flood Control Project Maintenance  
Levee Inspections**

**Fall 2018 Levee Maintenance Deficiency Summary Report**

**Reclamation District No. 0369 Libby McNeil**

Waterway	Bank	Unit Miles	Inspection Start/End	Inspector
Unit No. 01 Sacramento River	Left	0.78	11/02/2018 11/02/2018	David Julian

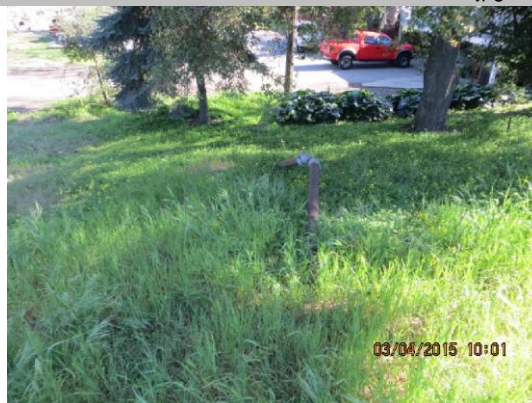
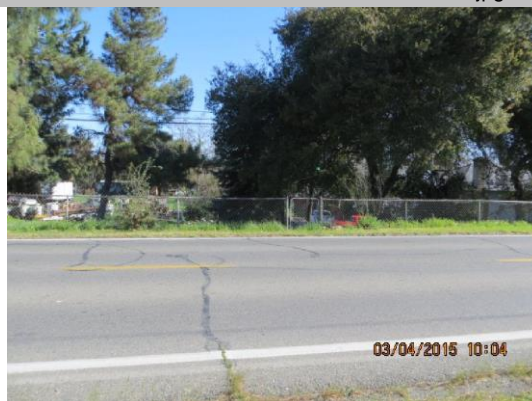
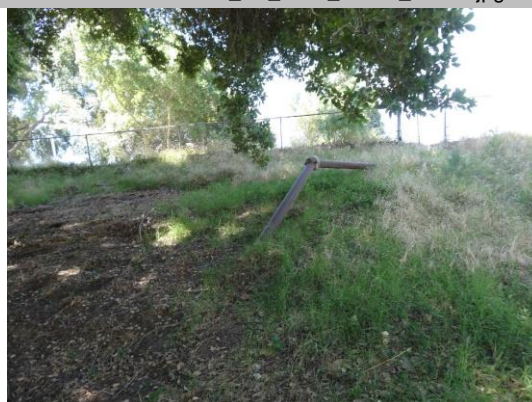
Comment Code						
Inspector Comment						
FS_ID:53396 DS_ID:25084 EP_NO: N/A Repair Type: Urgent Crossing Status: Found UCIP Comments: 07/12/2018 Pipe shows more signs of corrosion. Unable to find pipe on WS. (O.Yakimov-DWR UCIP)06/01/2016 Same as last inspection. (K. Fazel - UCIP)03/04/2015 Severe corrosion and holes visible in pipe on LS shoulder. Pipe appears abandoned and should be done so properly. (W. Wyle - FPIIB) FIELD_STRUCT_DESC: *ABANDONED* 4-inch steel pipe of an unknown purpose through the levee, 1 foot below the crown. Pipe visible on the landside (LS) slope just in front of the gate on the LS shoulder. [Additional Reference(s): USACE Sacramento O&M Manual 111, May 1959, (RM 27.87), O&M Manual misidentifies this location as RM 28.87]. FS Date: 7/1/2018

Pipe visible on LS slope.

Pipe visible at gate on LS shoulder.

LS slope: view of pipe.

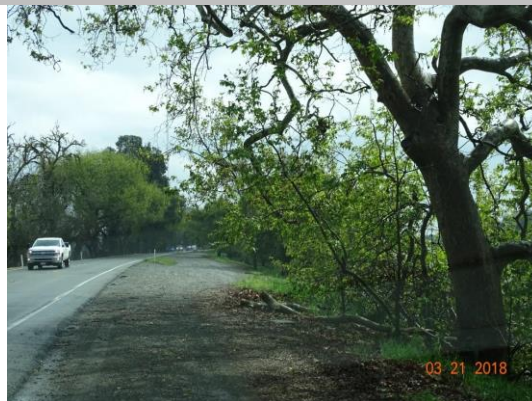
LM Start	0.15	Rating **	M	Issue No.	12
LM End	0.15	Issue Type +	Ma	Location *	WS
Category	Earthen Levee			GPS Latitude/Longitude	
				Start	End
Item	Encroachments			38.257380 °	38.257380 °
				-121.515787 °	-121.515787 °
DWR ID	DWR_RD0369_01_s_2018_12				
Comment Code					
TR : Tree or limb					
Inspector Comment					
Cut tree branches should be removed from waterside shoulder.

Remove tree branches from waterside shoulder.

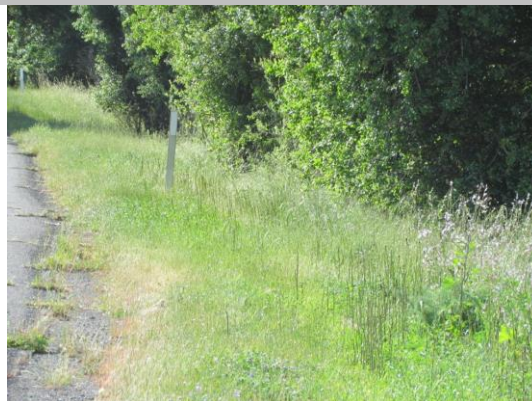
LM Start	0.25	Rating **	A/W	Issue No.	9
LM End	0.57	Issue Type +	Ma	Location *	WS
Category	Earthen Levee			GPS Latitude/Longitude	
				Start	End
Item	Vegetation			38.256372 °	38.252597 °
				-121.514504 °	-121.511130 °
DWR ID	DWR_RD0369_01_s_2017_9				
Comment Code					
V2 : Remove the wild growth other than native grasses from the levee slopes.					
Inspector Comment					
Spray the weed growth along the waterside slope to 20' from crown.

Looking downstream from the waterside shoulder.

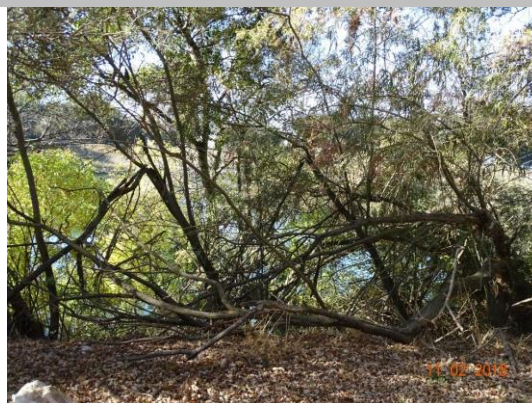
View of relatively thick tree branches on the water side slope (November 2018).

LM Start	0.27	Rating **	M	Issue No.	17
LM End	0.27	Issue Type +	Ma	Location *	WS
Category	Earthen Levee			GPS Latitude/Longitude	
				Start	End
Item	Trim / Thin Trees			38.256133°	38.256133°
				-121.514162°	-121.514162°
DWR ID	DWR_RD0369_01_f_2018_17				
Comment Code					
T2 : Thin trees to allow visibility of the ground and room to flood fight.					
Inspector Comment					
Remove some tree branches to allow better visibility and access

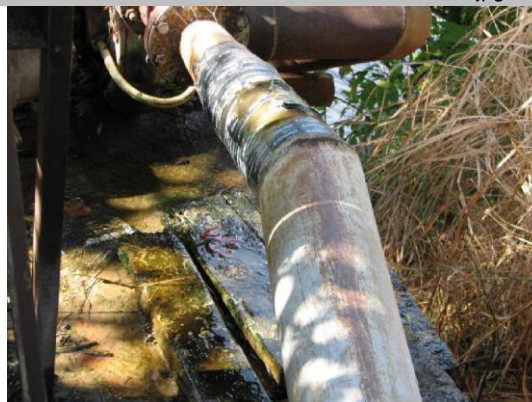
Comment Code						
Inspector Comment						
FS_ID:43814 DS_ID:18972 EP_NO: 11117 Repair Type: Non-Urgent Crossing Status: Found UCIP Comments: 10/15/2012 Siphon breaker on LS slope needs protection. Water is leaking from pump station. Abandoned concrete structure found on WS. 10-inch abandoned pipe found on WS. Should be removed. 6-inch abandoned pipe found on WS. Should be removed. FIELD_STRUCT_DESC: *ABANDONED* 10-inch steel irrigation discharge pipe through the levee, 4.5 feet below the crown. Pump and gate valve on the waterside (WS) shoulder. Siphon breaker on the landside (LS) slope. 6-inch abandoned pipe also found on the WS. (Retention of a 10-inch pipe through the levee, 4.5 feet below the crown, and a pump in a pump house on the WS slope authorized under Automatic Board Order (ABO) issued as Permit No. 11117, 1975 - Erma E. Locke, et al.). [Additional Reference(s): DWR Levee Log, 2005. USACE Sacramento O&M Manual 111, May 1959, (RM 27.63), referenced as invert elevation 3.8 feet below the crown]. FS Date: 10/15/2012 4:11:00 PM

Waterside view: overview of pipe & pump and abandoned concrete structure (left). Shutoff Valve.

Waterside view: water leaking pump station.

Waterside view: overview of active pipe and two abandoned pipes.

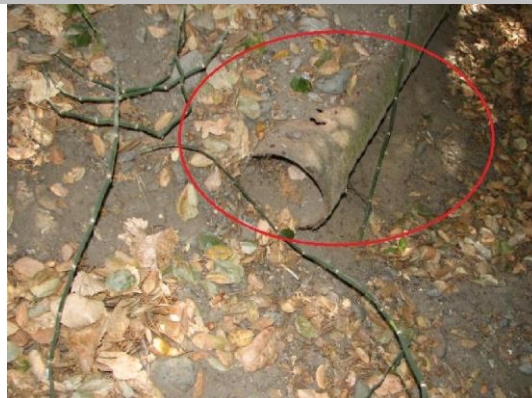
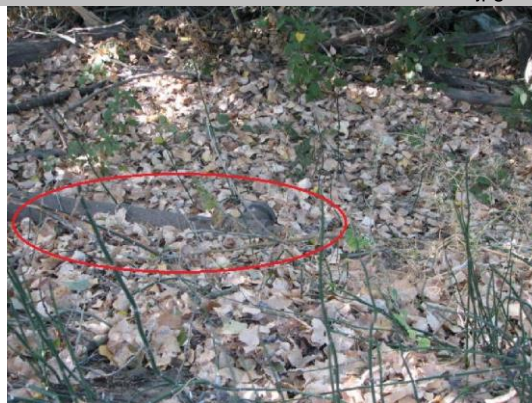
LM Start	0.50	Rating **	M	Issue No.	33	
LM End	0.50	Issue Type +	En	Location *		
Category	Supplemental			GPS Latitude/Longitude		
				Start	End	
Item	DWR UCIP Field Study			38.253468 °	38.253468 °	
				-121.511654 °	-121.511654 °	
DWR ID	18981					
Comment Code						
Inspector Comment						
FS_ID:43815						
DS_ID:18981						
EP_NO: N/A						
Repair Type: Non-Urgent						
Crossing Status: Indicator Found						
UCIP Comments: Found abandoned pipe laying on WS levee slope.						
Pipe purpose and status should be determined. further investigation required.						
FIELD_STRUCT_DESC: 8-inch steel pipe of an unknown purpose						
running parallel to the levee crown on the waterside (WS) slope, 4.5						
feet below the crown. This pipe was field discovered.						
FS Date: 3/4/2015

Pipe visible on WS slope running parallel to crown.

Pipe on WS slope running parallel to levee crown.

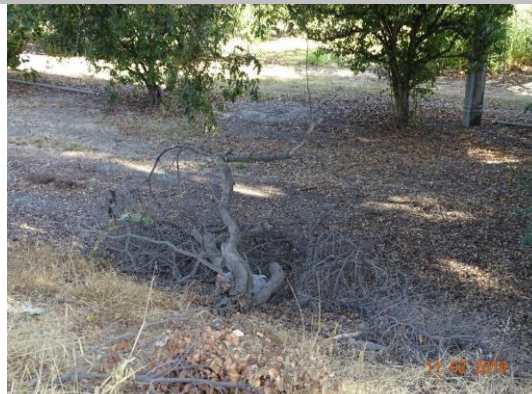
View of tree limb on the land side slope (November 2018).

LM Start	0.52	Rating **	M	Issue No.	19
LM End	0.52	Issue Type +	Ma	Location *	LS
Category	Earthen Levee			GPS Latitude/Longitude	
				Start	End
Item	Encroachments			38.253273 °	38.253273 °
				-121.511505 °	-121.511505 °
DWR ID	DWR_RD0369_01_f_2018_19				
Comment Code					
TR : Tree or limb					
Inspector Comment					
Remove tree limb from land side slope

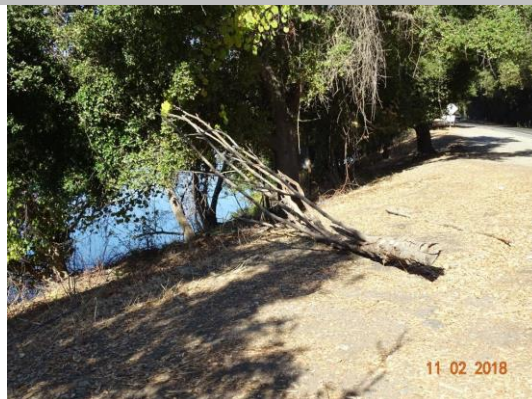
View of tree limb on the water side shoulder (November 2018).

LM Start	0.54	Rating **	M	Issue No.	10
LM End	0.54	Issue Type +	Ma	Location *	WS
Category	Earthen Levee			GPS Latitude/Longitude	
				Start	End
Item	Encroachments			38.252985 °	38.252985 °
				-121.511346 °	-121.511346 °
DWR ID	DWR_RD0369_01_s_2018_10				
Comment Code					
TR : Tree or limb					
Inspector Comment					
Remove cut tree limb from waterside shoulder.

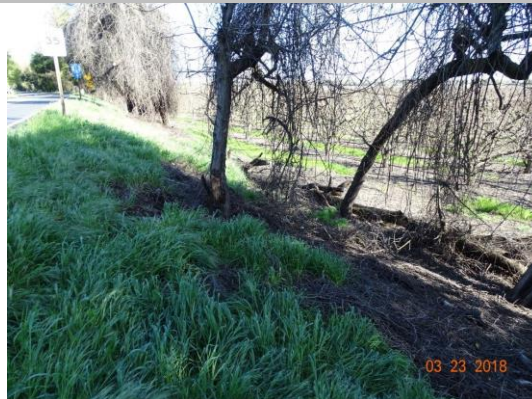
LM Start	0.58	Rating **	M	Issue No.	14
LM End	0.58	Issue Type +	Ma	Location *	LS
Category	Earthen Levee			GPS Latitude/Longitude	
				Start	End
Item	Encroachments			38.252494 °	38.252494 °
				-121.510961 °	-121.510961 °
DWR ID	DWR_RD0369_01_s_2018_14				
Comment Code					
TR : Tree or limb					
Inspector Comment					
Fallen tree and branches should be removed from landside toe.

Remove fallen tree and brabches from landside toe.

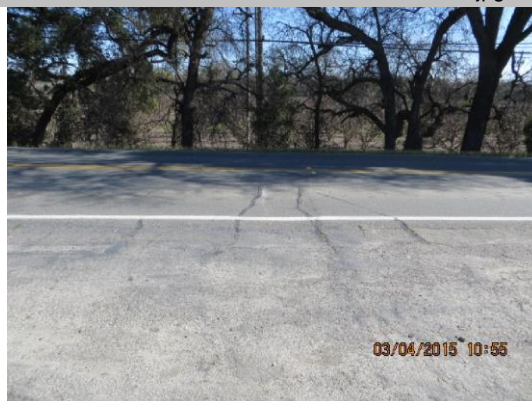
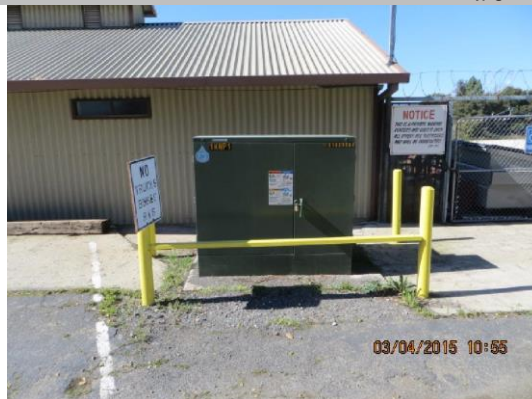
FS\_ID:53524  
DS\_ID:18977  
EP\_NO: 14313  
Repair Type: Urgent  
Crossing Status: Indicator Found  
UCIP Comments: 07/12/2018 Pipe is covered by thick layer of dry debris on LS. Patch repair along pipe alignment is visible on levee crown. (O.Yakimov-DWR UCIP)06/01/2016 Could not locate pipe. Likely buried next to leach box. Could not find signs of leaking or presence of water or erosion. Pipe may still be leaking but buried. (K. Fazel - UCIP)03/04/2015 Septic line appears to be leaking at LS toe. Erosion of soil and wet soil visible at LS toe. No septic smell accompanied other evidence at site. (W. Wylie - FPIIB)  
FIELD\_STRUCT\_DESC: 3 of 3: 2-inch galvanized steel sewer line through the levee, 1 foot below the crown. Metal cutoff wall placed around the pipe near the centerline of the levee. 4-foot by 6-foot concrete box at the landside (LS) toe. Sewer line runs through the property of the district president, Clarence Chu, at ckchu52@comcast.net, (916) 776-1684, and (916) 813-7037. (Plans to install three utility pipes through the levee authorized under Permit No. 14313, 1986 - Frank and Genie Schmiedel. Plans to construct a 59-covered-berth addition to an existing boat dock, extending approximately 60 feet into the Sacramento River, authorized under Permit No. 13783, 1984 - Frank and Genie Schmiedel, mentions the leach line for the septic system).

View at crossing through crown on LS shoulder from WS shoulder.  
Evidence of trench visible at cut in pavement.

Waterside view. Unclear if there is a sewer cleanout or other evidence of pipe location on WS shoulder.

Septic line leaking at LS toe. Erosion of soil at toe visible.

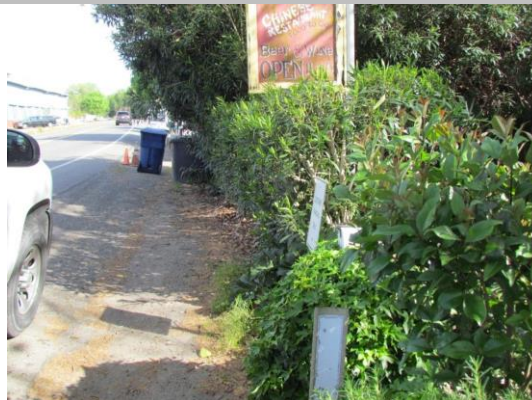
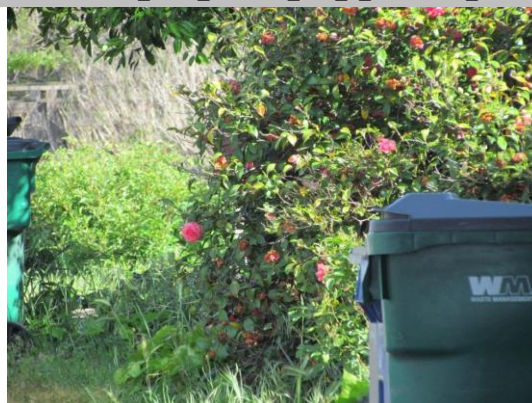
Looking upstream from levee mile 0.77 to levee mile 0.75 at the woody tree and vegetation on the landside slope.

Looking upstream from levee mile 0.77 to levee mile 0.75 levee slope blocked by vegetation typical view of growth along this section.
