**Flood Control Project Maintenance
Levee Inspections**

Fall 2019 Levee Maintenance Deficiency Summary Report

Levee Inspection Report By Mile - Fall 2019

Reclamation District No. 0369 Libby McNeil

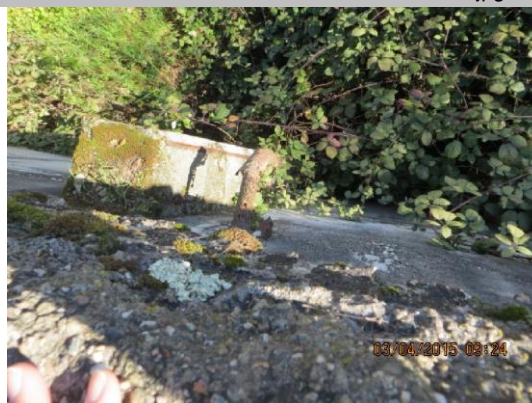
Photo 1 of 3 : UCIP_FA_2019_50105_73165.jpg

Comment Code					
Inspector Comment					
DS_ID:18971 FS_ID:50105 EP_NO: 8555 Repair Type: Non-Urgent Crossing Status: Found UCIP Comments: 03/04/2015 Pipe corroded through on LS at retaining wall. May not go all the way through the levee. Appears abandoned and if so should be done so properly. FIELD_STRUCT_DESC: *ABANDONED* 2 of 2: 4-inch steel pipe of an unknown purpose through the levee, 4 feet below the crown. Pipe visible on the landside (LS) at a retaining wall. (Retention of a 6-inch pipe and a 4-inch pipe through the levee authorized under Automatic Board Order (ABO) issued as Permit No. 8555, 1973 - Jordon Investment Company, care of Walter E. Herman). [Additional Reference(s): DWR Levee Log, 2005. USACE Sacramento O&M Manual 111, May 1959, (RM 27.87), O&M Manual misidentifies this location as RM 28.87]. FS Date: 3/4/2015 4:11:00 PM

Pipe visible on retaining wall at LS toe.

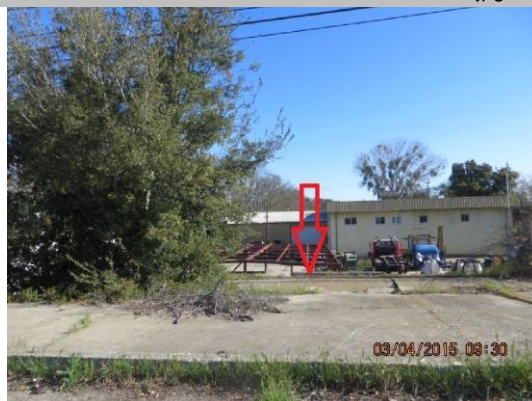
Photo 2 of 3 : UCIP_FA_2019_50105_73164.jpg

Comment Code						
Inspector Comment						
DS_ID:18971 FS_ID:50105 EP_NO: 8555 Repair Type: Non-Urgent Crossing Status: Found UCIP Comments: 03/04/2015 Pipe corroded through on LS at retaining wall. May not go all the way through the levee. Appears abandoned and if so should be done so properly. FIELD_STRUCT_DESC: *ABANDONED* 2 of 2: 4-inch steel pipe of an unknown purpose through the levee, 4 feet below the crown. Pipe visible on the landside (LS) at a retaining wall. (Retention of a 6-inch pipe and a 4-inch pipe through the levee authorized under Automatic Board Order (ABO) issued as Permit No. 8555, 1973 - Jordon Investment Company, care of Walter E. Herman). [Additional Reference(s): DWR Levee Log, 2005. USACE Sacramento O&M Manual 111, May 1959, (RM 27.87), O&M Manual misidentifies this location as RM 28.87]. FS Date: 3/4/2015 4:11:00 PM

Pipe visible on retaining wall at LS toe.

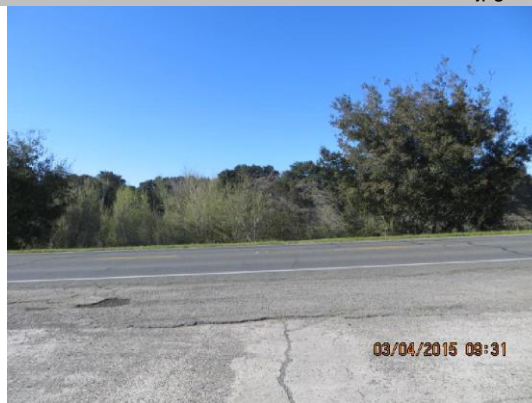
Photo 3 of 3 : UCIP_FA_2019_50105_73163.jpg

View of WS. Pipe not found on WS.

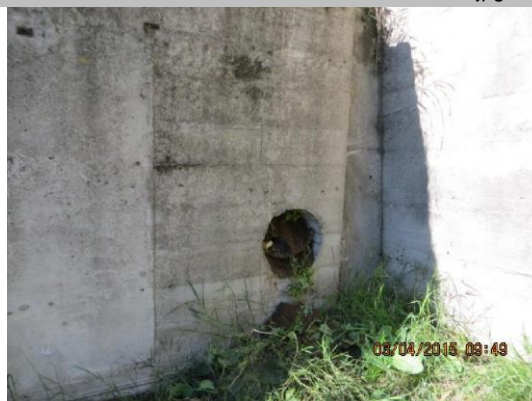
Photo 1 of 3 : UCIP_FA_2019_43811_73162.jpg

LM Start	0.05	Rating **	M	Issue No.	31	
LM End	0.05	Issue Type +	En	Location *		
Category	Supplemental			GPS Latitude/Longitude		
				Start	End	
Item	DRAFT DWR UCIP Field Study			38.258347 °	38.258347 °	
				-121.517169 °	-121.517169 °	
DWR ID	18970					
Comment Code						
Inspector Comment						
DS_ID:18970 FS_ID:43811 EP_NO: N/A Repair Type: Non-Urgent Crossing Status: Found UCIP Comments: 03/04/2015 Pipe appears abandoned and is filled with soil. Appears abandoned and if so should be done so properly. FIELD_STRUCT_DESC: *ABANDONED* 8-inch steel gravity drainage pipe through the levee, 8 feet below the crown. Hole in the concrete retaining wall on the landside (LS) slope, measures 10 inches in diameter. [Additional Reference(s): DWR Levee Log, 2005]. FS Date: 3/4/2015 4:41:00 PM

10-inch hole in concrete retaining wall likely for this pipe. Visible on LS toe. Portion of pipe visible.

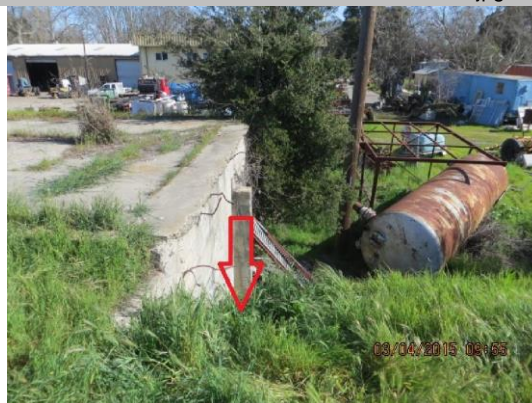
Photo 2 of 3 : UCIP_FA_2019_43811_73161.jpg

10-inch hole in concrete retaining wall likely for this pipe. Visible on LS toe.

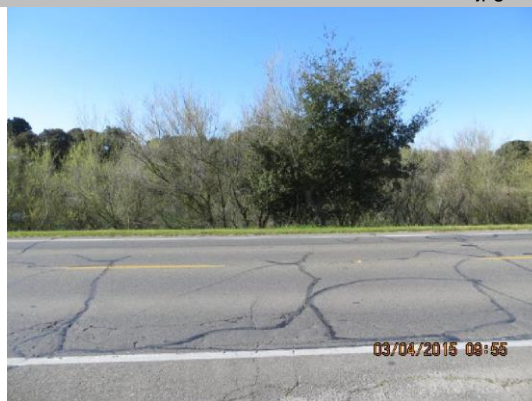
Photo 3 of 3 : UCIP_FA_2019_43811_73160.jpg

View of WS. No pipe found.

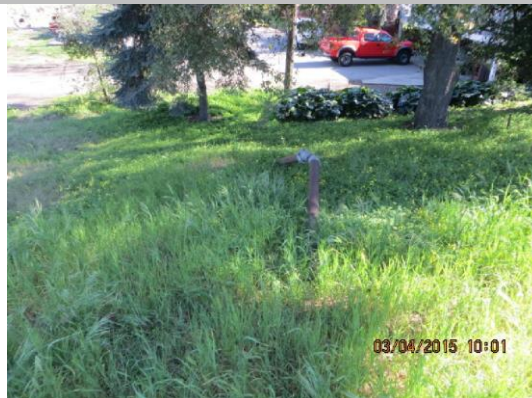
Photo 1 of 3 : UCIP_FA_2019_53396_73331.jpg

Comment Code						
Inspector Comment						
DS_ID:25084 FS_ID:53396 EP_NO: N/A Repair Type: Urgent Crossing Status: Found UCIP Comments: 07/12/2018 Pipe shows more signs of corrosion. Unable to find pipe on WS. (O.Yakimov-DWR UCIP)06/01/2016 Same as last inspection. (K. Fazel - UCIP)03/04/2015 Severe corrosion and holes visible in pipe on LS shoulder. Pipe appears abandoned and should be done so properly. (W. Wyle - FPIIB) FIELD_STRUCT_DESC: *ABANDONED* 4-inch steel pipe of an unknown purpose through the levee, 1 foot below the crown. Pipe visible on the landside (LS) slope just in front of the gate on the LS shoulder. [Additional Reference(s): USACE Sacramento O&M Manual 111, May 1959, (RM 27.87), O&M Manual misidentifies this location as RM 28.87]. FS Date: 7/1/2018

Pipe visible on LS slope.

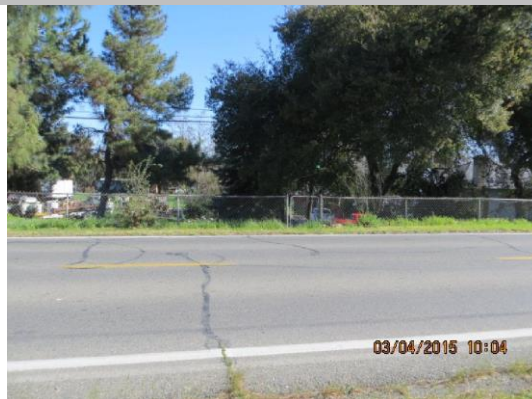
Photo 2 of 3 : UCIP_FA_2019_53396_73332.jpg

Pipe visible at gate on LS shoulder.

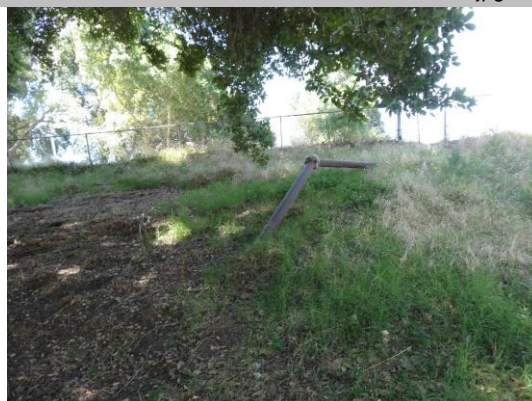
Photo 3 of 3 : UCIP_FA_2019_53396_75199.jpg

LS slope: view of pipe.

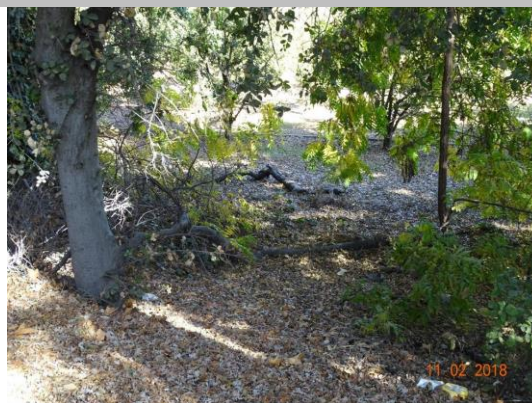
Photo 1 of 1 : FA_2019_RD0369_207_21_20190826_00008.jpg

LM Start	0.13	Rating **	M	Issue No.	21
LM End	0.13	Issue Type +	Ma	Location *	LS
Category	Earthen Levee			GPS Latitude/Longitude	
				Start	End
Item	Encroachments			38.257673 °	38.257673 °
				-121.516052 °	-121.516052 °
DWR ID	DWR_RD0369_01_f _ 2018_21				
Comment Code					
TR : Tree or limb					
Inspector Comment					
Remove tree limb from the landside slope.

View of tree limb on the landside slope (November 2018).

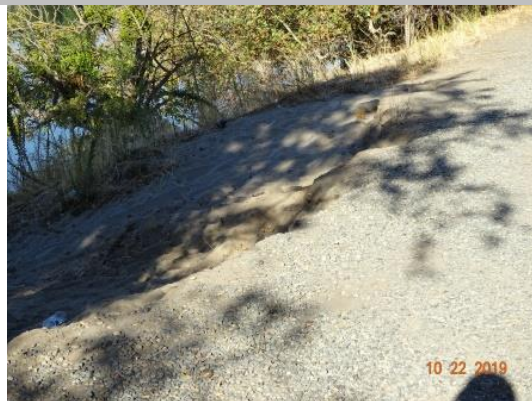
Photo 1 of 1 : FA_2019_RD0369_207_10_20191024_00031.jpg

LM Start	0.18	Rating **	M	Issue No.	10
LM End	0.18	Issue Type +	Ma	Location *	WS
Category	Earthen Levee			GPS Latitude/Longitude	
				Start	End
Item	Slope Stability			38.257137 °	38.257137 °
				-121.515407 °	-121.515407 °
DWR ID	DWR_RD0369_01_f_2019_10				
Comment Code					
S2 : Repair the levee slope damaged by foot traffic and prevent access where possible.					
Inspector Comment					
Large path created by fishermen. Levee is extra wide in this section

View looking slightly upstream erosion due to foot traffic on the waterside slope (Fall 2019).

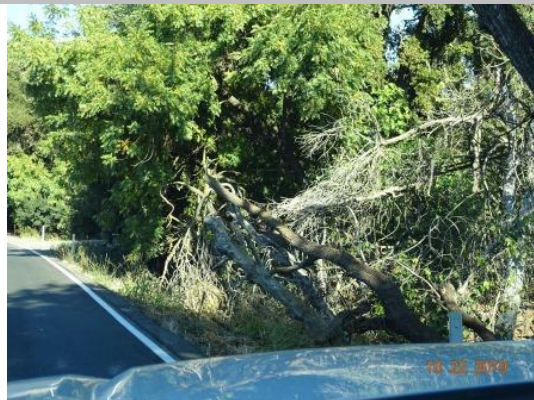
Photo 1 of 1 : FA_2019_RD0369_207_18_20191024_00033.jpg

LM Start	0.19	Rating **	U	Issue No.	18
LM End	0.19	Issue Type +	Ma	Location *	LS
Category	Earthen Levee			GPS Latitude/Longitude	
				Start	End
Item	Trim / Thin Trees			38.257027°	38.257027°
				-121.515188°	-121.515188°
DWR ID	DWR_RD0369_01_s_2019_18				
Comment Code					
T1 : Trim trees to at least five feet above ground level.					
Inspector Comment

View looking upstream at landscaping trees on the landside slope (Fall 2019).

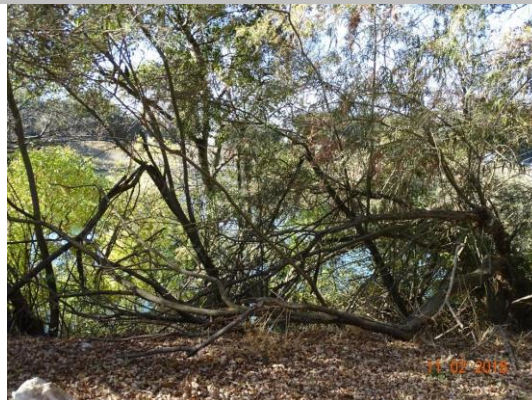
Photo 1 of 1 : FA_2019_RD0369_207_17_20190826_00006.jpg

LM Start	0.27	Rating **	M	Issue No.	17
LM End	0.27	Issue Type +	Ma	Location *	WS
Category	Earthen Levee			GPS Latitude/Longitude	
				Start	End
Item	Trim / Thin Trees			38.256133°	38.256133°
				-121.514162°	-121.514162°
DWR ID	DWR_RD0369_01_f_2018_17				
Comment Code					
T2 : Thin trees to allow visibility of the ground and room to flood fight.					
Inspector Comment					
Remove some tree branches to allow better visibility and access.

View of relatively thick tree branches on the waterside slope (November 2018).

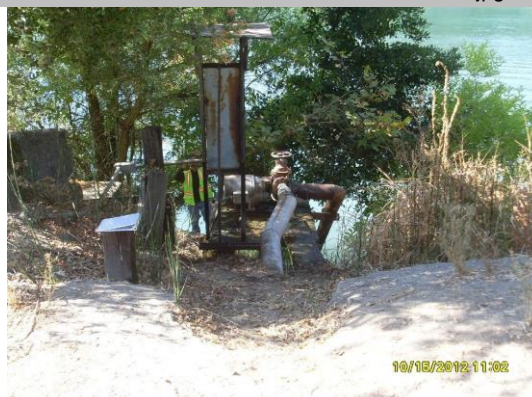
Photo 1 of 3 : UCIP_FA_2019_43814_10460.jpg

Comment Code						
Inspector Comment						
DS_ID:18972 FS_ID:43814 EP_NO: 11117 Repair Type: Non-Urgent Crossing Status: Found UCIP Comments: 10/15/2012 Siphon breaker on LS slope needs protection. Water is leaking from pump station. Abandoned concrete structure found on WS. 10-inch abandoned pipe found on WS. Should be removed. 6-inch abandoned pipe found on WS. Should be removed. FIELD_STRUCT_DESC: *ABANDONED* 10-inch steel irrigation discharge pipe through the levee, 4.5 feet below the crown. Pump and gate valve on the waterside (WS) shoulder. Siphon breaker on the landside (LS) slope. 6-inch abandoned pipe also found on the WS. (Retention of a 10-inch pipe through the levee, 4.5 feet below the crown, and a pump in a pump house on the WS slope authorized under Automatic Board Order (ABO) issued as Permit No. 11117, 1975 - Erma E. Locke, et al.). [Additional Reference(s): DWR Levee Log, 2005. USACE Sacramento O&M Manual 111, May 1959, (RM 27.63), referenced as invert elevation 3.8 feet below the crown]. FS Date: 10/15/2012 4:11:00 PM

Waterside view: overview of pipe & pump and abandoned concrete structure (left). Shutoff Valve.

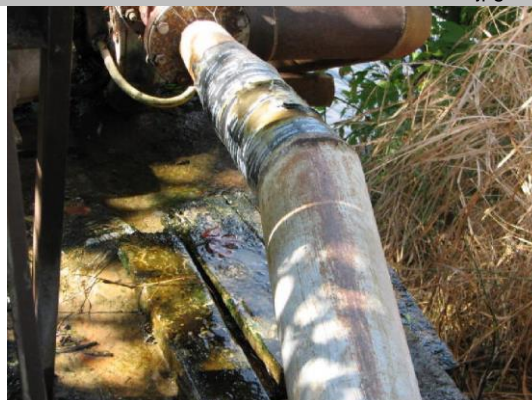
Photo 2 of 3 : UCIP_FA_2019_43814_10456.jpg

Waterside view: water leaking pump station.

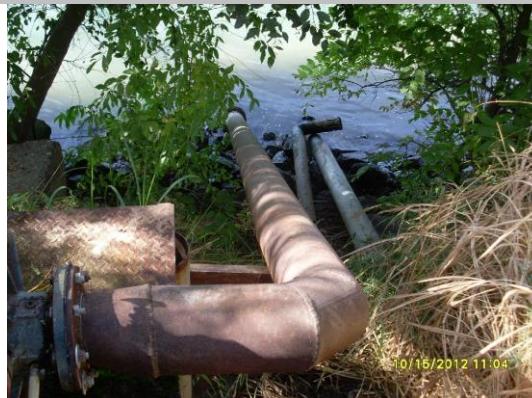
Photo 3 of 3 : UCIP_FA_2019_43814_10459.jpg

Waterside view: overview of active pipe and two abandoned pipes.

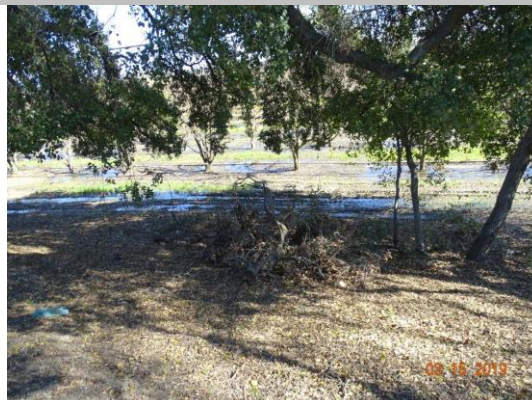
Photo 1 of 1 : FA_2019_RD0369_207_11_20190826_00004.jpg

LM Start	0.35	Rating **	M	Issue No.	11
LM End	0.35	Issue Type +	Ma	Location *	LS
Category	Earthen Levee			GPS Latitude/Longitude	
				Start	End
Item	Encroachments			38.255250 °	38.255250 °
				-121.513207 °	-121.513207 °
DWR ID	DWR_RD0369_01_s_2019_11				
Comment Code					
TR : Tree or limb					
Inspector Comment					
Remove fallen tree limbs from the landside slope.

View of fallen limbs on the landside slope (Spring 2019).

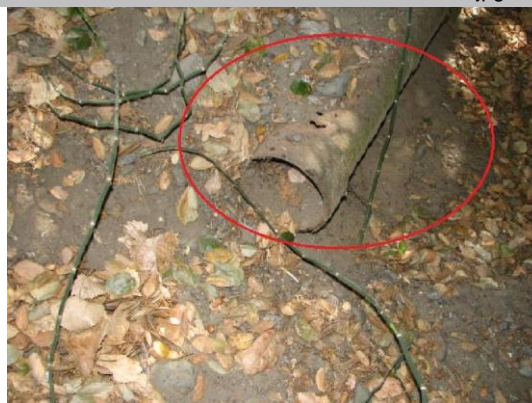
Photo 1 of 2 : UCIP_FA_2019_43815_73301.jpg

LM Start	0.50	Rating **	M	Issue No.	34
LM End	0.50	Issue Type +	En	Location *	
Category	Supplemental			GPS Latitude/Longitude	
				Start	End
Item	DRAFT DWR UCIP Field Study			38.253468 °	38.253468 °
				-121.511654 °	-121.511654 °
DWR ID	18981				
Comment Code					
Inspector Comment					
DS_ID:18981 FS_ID:43815 EP_NO: N/A Repair Type: Non-Urgent Crossing Status: Indicator Found UCIP Comments: Found abandoned pipe laying on WS levee slope. Pipe purpose and status should be determined. further investigation required. FIELD_STRUCT_DESC: 8-inch steel pipe of an unknown purpose running parallel to the levee crown on the waterside (WS) slope, 4.5 feet below the crown. This pipe was field discovered. FS Date: 3/4/2015

Pipe visible on WS slope running parallel to crown.

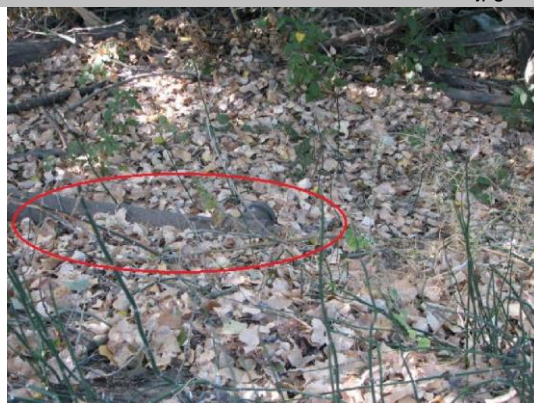
Photo 2 of 2 : UCIP_FA_2019_43815_73300.jpg

Pipe on WS slope running parallel to levee crown.

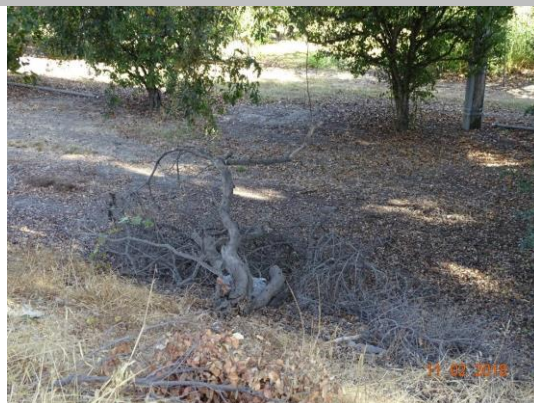
Photo 1 of 1 : FA_2019_RD0369_207_19_20190826_00007.jpg

LM Start	0.52	Rating **	M	Issue No.	19
LM End	0.52	Issue Type +	Ma	Location *	LS
Category	Earthen Levee			GPS Latitude/Longitude	
				Start	End
Item	Encroachments			38.253273 °	38.253273 °
				-121.511505 °	-121.511505 °
DWR ID	DWR_RD0369_01_f_2018_19				
Comment Code					
TR : Tree or limb					
Inspector Comment					
Remove tree limb from the landside slope.

View of tree limb on the land sideslope (November 2018).

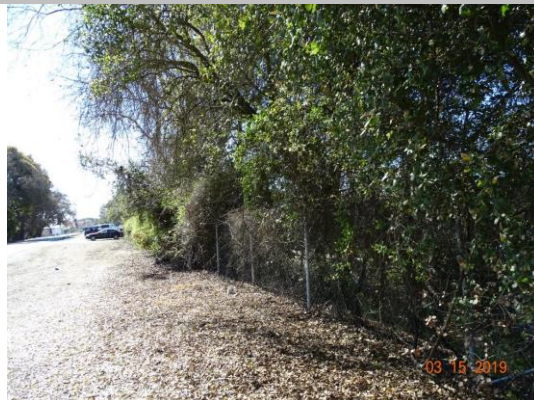
Photo 1 of 1 : FA_2019_RD0369_207_25_20190826_00011.jpg

LM Start	0.57	Rating **	M	Issue No.	25
LM End	0.60	Issue Type +	En	Location *	WS
Category	Earthen Levee			GPS Latitude/Longitude	
				Start	End
Item	Encroachments			38.252662 °	38.252247 °
				-121.511138 °	-121.510922 °
DWR ID	DWR_RD0369_01_s_2019_25				
Comment Code					
FE : Fence					
Inspector Comment					
A chainlink fence is located on the waterside slope.

View looking downstream at chainlink fence on the waterside slope (Spring 2019).

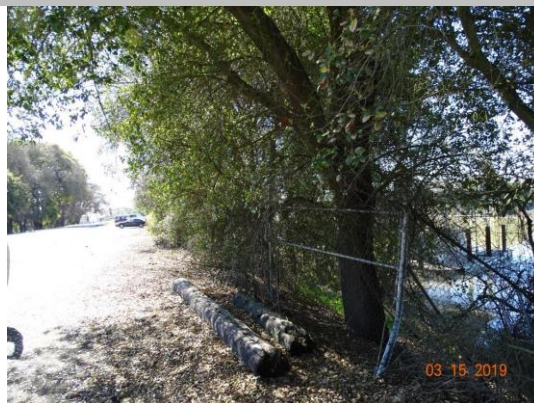
Photo 1 of 1 : FA_2019_RD0369_207_26_20190826_00012.jpg

LM Start	0.57	Rating **	U	Issue No.	26
LM End	0.60	Issue Type +	Ma	Location *	WS
Category	Earthen Levee			GPS Latitude/Longitude	
				Start	End
Item	Vegetation			38.252662 °	38.252247 °
				-121.511138 °	-121.510922 °
DWR ID	DWR_RD0369_01_s_2019_26				
Comment Code					
V2 : Remove the wild growth other than native grasses from the levee slopes.					
Inspector Comment					
Vegetation on chainlink fence is blocking view down waterside slope.

View looking downstream at the chainlink on the waterside shoulder and slope (Spring 2019).

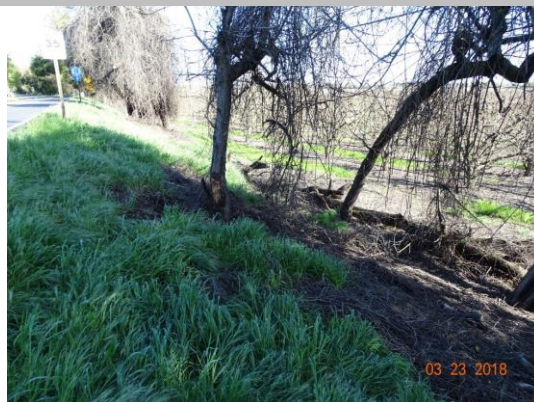
Photo 1 of 1 : FA_2019_RD0369_207_14_20190826_00005.jpg

LM Start	0.58	Rating **	M	Issue No.	14
LM End	0.58	Issue Type +	Ma	Location *	LS
Category	Earthen Levee			GPS Latitude/Longitude	
				Start	End
Item	Encroachments			38.252494 °	38.252494 °
				-121.510961 °	-121.510961 °
DWR ID	DWR_RD0369_01_s_2018_14				
Comment Code					
TR : Tree or limb					
Inspector Comment					
Fallen tree and branches should be removed from landside toe.

Remove fallen tree and branches from landside toe.

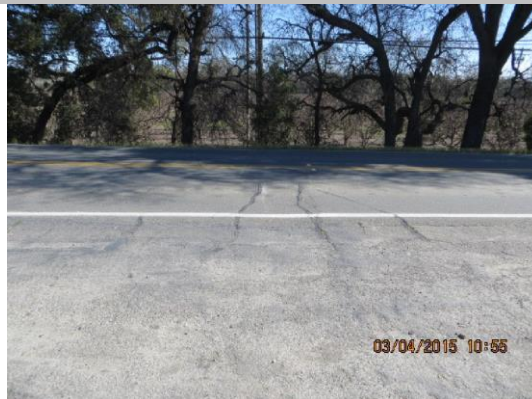
Photo 1 of 3 : UCIP_FA_2019_53524_73166.jpg

DS_ID:18977
FS_ID:53524
EP_NO: 14313
Repair Type: Urgent
Crossing Status: Indicator Found
UCIP Comments: 07/12/2018 Pipe is covered by thick layer of dry debris on LS. Patch repair along pipe alignment is visible on levee crown. (O.Yakimov-DWR UCIP)06/01/2016 Could not locate pipe. Likely buried next to leach box. Could not find signs of leaking or presence of water or erosion. Pipe may still be leaking but buried. (K. Fazel - UCIP)03/04/2015 Septic line appears to be leaking at LS toe. Erosion of soil and wet soil visible at LS toe. No septic smell accompanied other evidence at site. (W. Wylie - FPIIB)
FIELD_STRUCT_DESC: 3 of 3: 2-inch galvanized steel sewer line through the levee, 1 foot below the crown. Metal cutoff wall placed around the pipe near the centerline of the levee. 4-foot by 6-foot concrete box at the landside (LS) toe. Sewer line runs through the property of the district president, Clarence Chu, at ckchu52@comcast.net, (916) 776-1684, and (916) 813-7037. (Plans to install three utility pipes through the levee authorized under Permit No. 14313, 1986 - Frank and Genie Schmiedel. Plans to construct a 59-covered-berth addition to an existing boat dock, extending approximately 60 feet into the Sacramento River, authorized under Permit No. 13783, 1984 - Frank and Genie Schmiedel, mentions the leach line for the septic system).

View at crossing through crown on LS shoulder from WS shoulder.
Evidence of trench visible at cut in pavement.

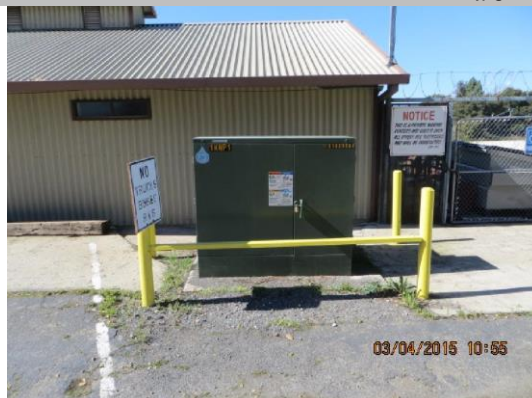
Photo 2 of 3 : UCIP_FA_2019_53524_73167.jpg

Waterside view. Unclear if there is a sewer cleanout or other evidence of pipe location on WS shoulder.

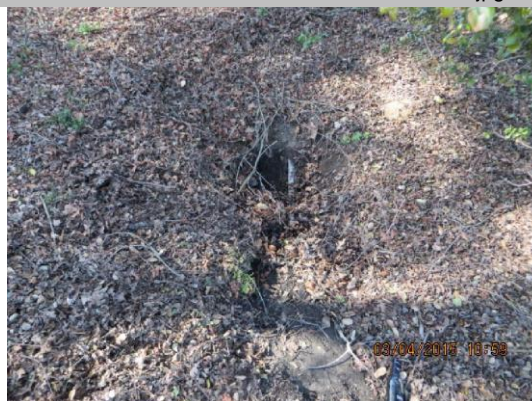
Photo 3 of 3 : UCIP_FA_2019_53524_73168.jpg

Comment Code						
Inspector Comment						
DS_ID:18977 FS_ID:53524 EP_NO: 14313 Repair Type: Urgent Crossing Status: Indicator Found UCIP Comments: 07/12/2018 Pipe is covered by thick layer of dry debris on LS. Patch repair along pipe alignment is visible on levee crown. (O.Yakimov-DWR UCIP)06/01/2016 Could not locate pipe. Likely buried next to leach box. Could not find signs of leaking or presence of water or erosion. Pipe may still be leaking but buried. (K. Fazel - UCIP)03/04/2015 Septic line appears to be leaking at LS toe. Erosion of soil and wet soil visible at LS toe. No septic smell accompanied other evidence at site. (W. Wylie - FPIIB) FIELD_STRUCT_DESC: 3 of 3: 2-inch galvanized steel sewer line through the levee, 1 foot below the crown. Metal cutoff wall placed around the pipe near the centerline of the levee. 4-foot by 6-foot concrete box at the landside (LS) toe. Sewer line runs through the property of the district president, Clarence Chu, at ckchu52@comcast.net, (916) 776-1684, and (916) 813-7037. (Plans to install three utility pipes through the levee authorized under Permit No. 14313, 1986 - Frank and Genie Schmiedel. Plans to construct a 59-covered-berth addition to an existing boat dock, extending approximately 60 feet into the Sacramento River, authorized under Permit No. 13783, 1984 - Frank and Genie Schmiedel, mentions the leach line for the septic system). FS Date: 7/12/2018

Septic line leaking at LS toe. Erosion of soil at toe visible.

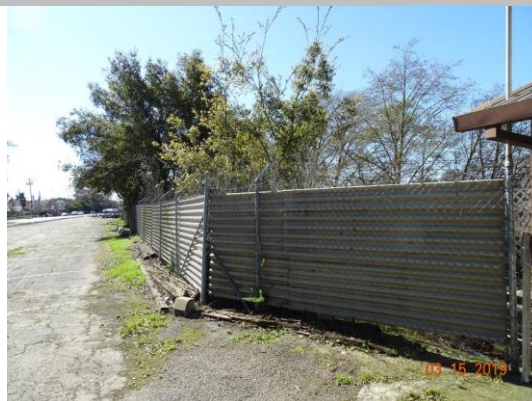
Photo 1 of 1 : FA_2019_RD0369_207_29_20190826_00013.jpg

LM Start	0.62	Rating **	U	Issue No.	29
LM End	0.67	Issue Type +	En	Location *	WS
Category	Earthen Levee			GPS Latitude/Longitude	
				Start	End
Item	Encroachments			38.251982 °	38.251267 °
				-121.510853 °	-121.510480 °
DWR ID	DWR_RD0369_01_s_2019_29				
Comment Code					
FE : Fence					
Inspector Comment					
A fence is blocking the view of the waterside slope.

View of fence on the waterside shoulder (Spring 2019).

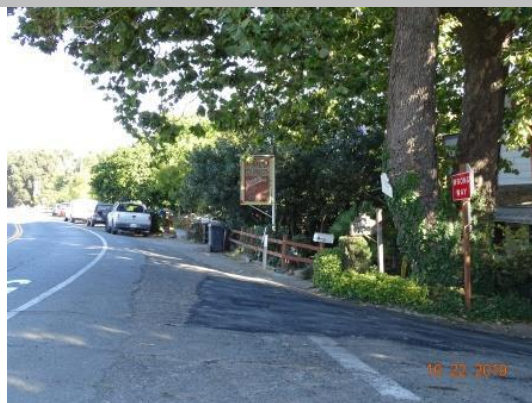
Photo 1 of 1 : FA_2019_RD0369_207_8_20191024_00032.jpg

LM Start	0.74	Rating **	M	Issue No.	8
LM End	0.77	Issue Type +	En	Location *	LS
Category	Earthen Levee			GPS Latitude/Longitude	
				Start	End
Item	Vegetation			38.250340 °	38.249930 °
				-121.510135 °	-121.509880 °
DWR ID	DWR_RD0369_01_s_2017_8				
Comment Code					
V6 : Landscaping					
Inspector Comment					
Landscaping needs to be thinned and maintained to allow inspection and access to landside slope and toe.

View looking upstream at landscaping on the landside slope (Fall 2019).
