Flood Control Project Maintenance Levee Inspections

Fall 2020 Levee Maintenance Deficiency Summary Report

Sacramento River Basin

Reclamation District No. 0369 Libby McNeil

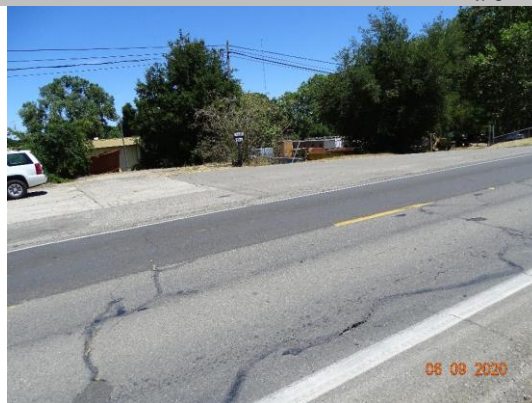
Photo 1 of 3 : UCIP_FA_2020_60724_88049.jpg

Comment Code					
Inspector Comment					
DS_ID:18970 FS_ID:60724 EP_NO: N/A Repair Type: Non-Urgent EVAL Issue: Unauthorized Encroachment, installed decades prior Crossing Status: Found UCIP Comments: 06/09/2020 Record remains Non-Urgent. Crossing appears abandoned. Tree branches have grown through abandoned hole in retaining wall plugging it completely. Unable to find pipe on waterside. Unauthorized encroachment recorded in Levee Log prior to 2011. (O.Yakimov - DWR UCIP) 03/04/2015 Pipe appears abandoned and is filled with soil. Appears abandoned and if so should be done so properly. FIELD_STRUCT_DESC: 8-inch steel gravity drainage pipe through the levee, 8 feet below the crown. Hole in the concrete retaining wall on the landside (LS) slope, measures 10 inches in diameter. (6-inch pipe [HLM 0.06] authorized under Automatic Board Order (ABO) issued as Permit No. 8555, 1973 - Jordan Investment Co. c/o Walter E. Herman). [Additional Reference(s): DWR Levee Log, 2005 (HLM 0.05), listed as 8-inch pipe]. FS Date: 6/9/2020 8:37:50 AM

Top of Levee: View of levee crown looking towards landside

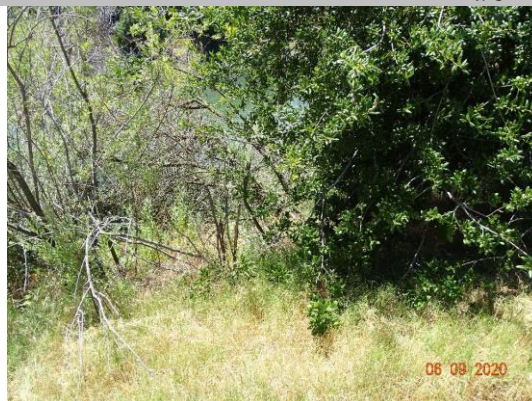
Photo 2 of 3 : UCIP_FA_2020_60724_88050.jpg

Water-Side: View of levee slope looking from crown. No pipe found on waterside

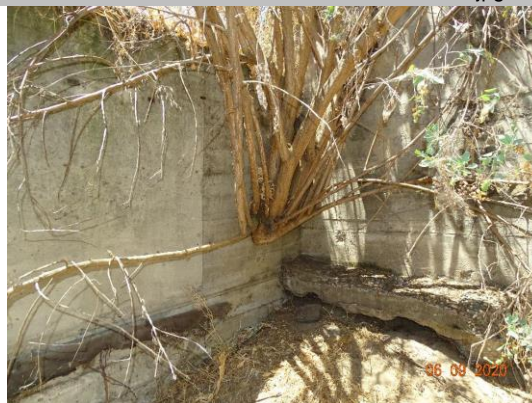
Photo 3 of 3 : UCIP_FA_2020_60724_88048.jpg

Land-Side: View of retaining wall on landside. Tree branches are plugging this hole completely

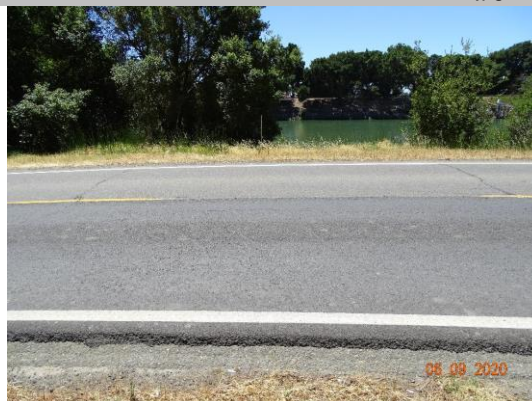
Photo 1 of 3 : UCIP_FA_2020_60725_88053.jpg

Comment Code					
Inspector Comment					
DS_ID:25084 FS_ID:60725 EP_NO: N/A Repair Type: Urgent EVAL Issue: Pipe Integrity Crossing Status: Found UCIP Comments: 06/09/2020 Record remains Urgent. Through holes in pipe on landside slope. Crossing appears abandoned. No pipe found on waterside. No permit has been identified authorizing pipe. Need to have CVFPB review ABO and determine current owner. (O.Yakimov - DWR UCIP) 07/12/2018 Pipe shows more signs of corrosion. Unable to find pipe on WS. (O.Yakimov-DWR UCIP)06/01/2016 Same as last inspection. (K. Fazel - UCIP)03/04/2015 Severe corrosion and holes visible in pipe on LS shoulder. Pipe appears abandoned and should be done so properly. (W. Wyle - FPIIB) FIELD_STRUCT_DESC: 4-inch steel pipe of an unknown purpose through the levee, 1 foot below the crown. Pipe visible on the landside (LS) slope just in front of the gate on the LS shoulder. (4-inch pipe [HLM 0.08] authorized under Automatic Board Order (ABO) issued as Permit No. 8555, 1973 - Jordan Investment Co. c/o Walter E. Herman). [Additional Reference(s): DWR Levee Log, 2005 (HLM 0.08). USACE Sacramento O&M Manual, Unit 111, May 1959, Revised 29 December 2016, (RM 27.87 - O&M Manual misidentifies this location as RM 28.87), listed as 4-inch pipe. USACE As-Built Drawing No. 06-13-1100, Sheet 15, upstream of 'L' 1663+96, January 1933]. FS Date: 6/9/2020 9:26:37 AM

Top of Levee: View of levee crown looking towards waterside

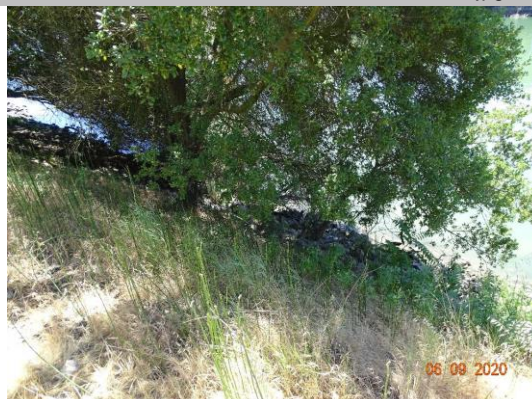
Photo 2 of 3 : UCIP_FA_2020_60725_88054.jpg

Water-Side: View of levee slope looking from crown

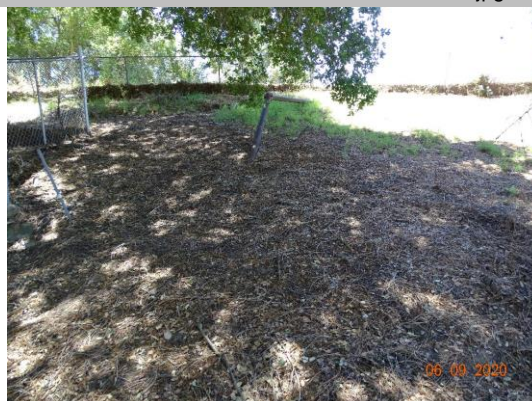
Photo 3 of 3 : UCIP_FA_2020_60725_88051.jpg

Land-Side: View of levee slope looking from toe

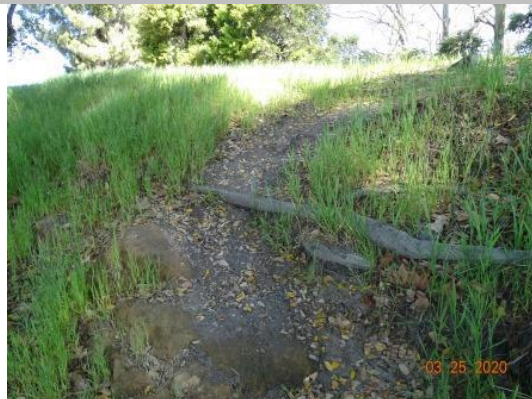
Photo 1 of 1 : FA_2020_RD0369_207_9_20201009_00003.jpg

LM Start	0.11	Rating **	M	Issue No.	9
LM End	0.11	Issue Type +	Ma	Location *	WS
Category	Earthen Levee			GPS Latitude/Longitude	
				Start	End
Item	Slope Stability			38.257757 °	38.257757 °
				-121.516347 °	-121.516347 °
DWR ID	DWR_RD0369_01_s_2020_9				
Comment Code					
S2 : Repair the levee slope damaged by foot traffic and prevent access where possible.					
Inspector Comment

View of footpath down the waterside slope (Spring 2020).

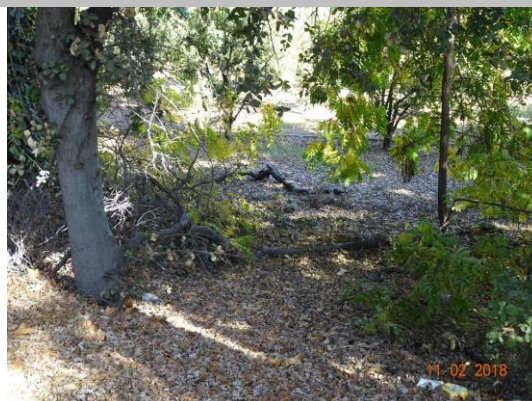
Photo 1 of 1 : FA_2020_RD0369_207_21_20201009_00010.jpg

LM Start	0.13	Rating **	M	Issue No.	21
LM End	0.13	Issue Type +	Ma	Location *	LS
Category	Earthen Levee			GPS Latitude/Longitude	
				Start	End
Item	Encroachments			38.257673 °	38.257673 °
				-121.516052 °	-121.516052 °
DWR ID	DWR_RD0369_01_f_2018_21				
Comment Code					
TR : Tree or limb					
Inspector Comment					
Remove tree limb from the landside slope.

View of tree limb on the landside slope (November 2018).

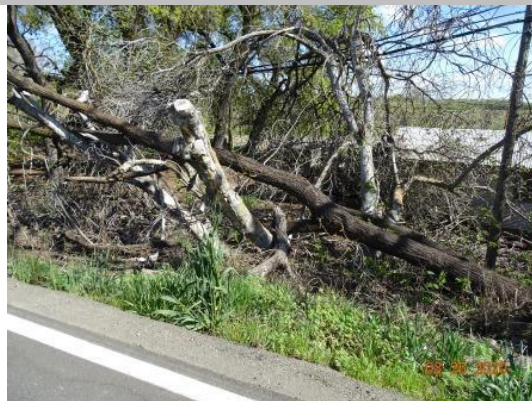
Photo 1 of 1 : FA_2020_RD0369_207_12_20201009_00006.jpg

LM Start	0.20	Rating **	U	Issue No.	12
LM End	0.20	Issue Type +	En	Location *	LS
Category	Earthen Levee			GPS Latitude/Longitude	
				Start	End
Item	Encroachments			38.256953 °	38.256953 °
				-121.515067 °	-121.515067 °
DWR ID	DWR_RD0369_01_f_2019_12				
Comment Code					
TR : Tree or limb					
Inspector Comment

View of down tree on the landside slope (Spring 2020).

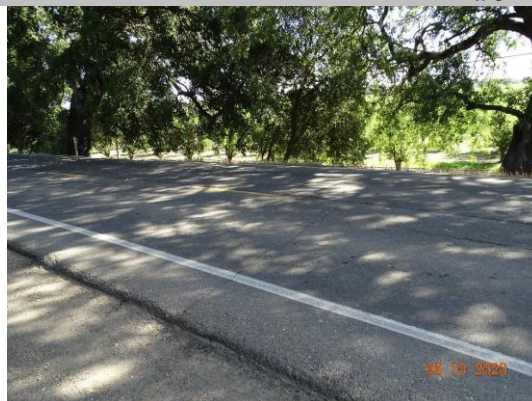
Photo 1 of 3 : UCIP_FA_2020_60752_88063.jpg

DS_ID:18972
FS_ID:60752
EP_NO: 11117
Repair Type: Urgent
EVAL Issue: Pipe Integrity
Crossing Status: Found
UCIP Comments: 06/10/2020 Record updated from Non-Urgent to Urgent. Hole in pipe on waterside slope above pump. Pipe is running - leak through the hole poses a threat to waterside levee slope. 6-inch pipe installed on landside slope right after siphon breaker. Levee slope was disturbed at this location. 6-inch pipe is running down diagonally on landside slope towards PVC pipe connection at the toe. Unable to find a permit for modification. No permit has been identified authorizing pipe through the levee. Need to have CVFPB review ABO and determine current owner. (O.Yakimov - DWR UCIP)
10/15/2012 Siphon breaker on LS slope needs protection. Water is leaking from pump station. Abandoned concrete structure found on WS. 10-inch abandoned pipe found on WS. Should be removed. 6-inch abandoned pipe found on WS. Should be removed.

FIELD_STRUCT_DESC: 10-inch steel irrigation discharge pipe through the levee, 4.5 feet below the crown. Pump and gate valve on the waterside (WS) shoulder. Siphon breaker on the landside (LS) slope. Electric meter, panel at landside toe, 1.5-inch electrical conduit at same location. Abandoned concrete standpipe at landside levee toe. (10-inch pipe [HLM 0.36] authorized under Automatic Board Order (ABO) issued as Permit No. 11117, 1975 - Erma E. Locke et al). [Additional Reference(s): DWR Levee Log, 2005 (HLM 0.36). USACE Sacramento O&M Manual, Unit 111, May 1959, Revised 29 December 2016, (RM 27.63), listed as 10-inch pipe. USACE As-Built Drawing No. 50-04-2983, Sheets 2 and 3, Station 5+83, March 1954. USACE As-Built Drawing No. 06-13-1100, Sheet 15, downstream of 'L' 1671+00, January 1933].
FS Date: 6/10/2020 10:27:02 AM

Top of Levee: View of levee crown looking towards landside

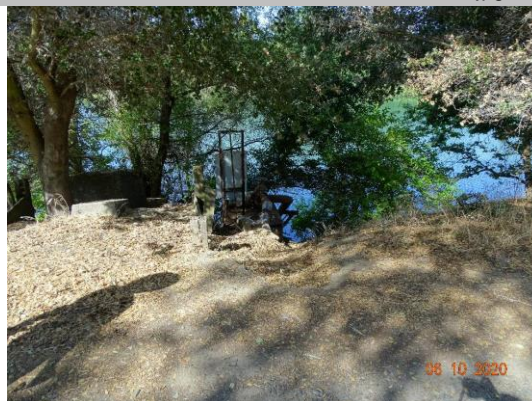
Photo 2 of 3 : UCIP_FA_2020_60752_88064.jpg

Water-Side: View of levee slope looking from crown

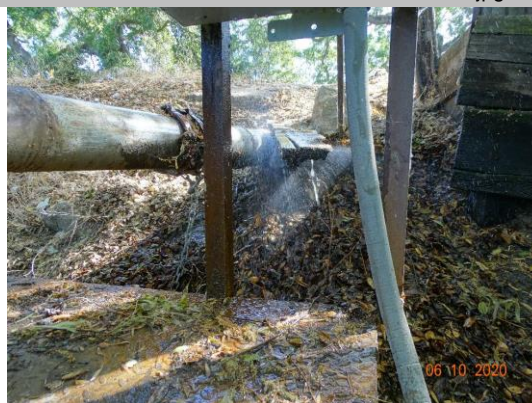
Photo 3 of 3 : UCIP_FA_2020_60752_88065.jpg

Water-Side: Pipe leak on levee slope above pump

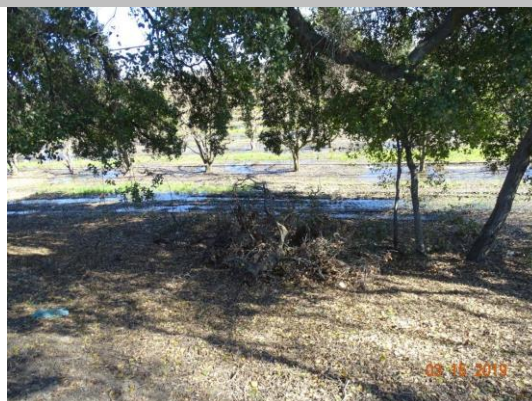
Photo 1 of 1 : FA_2020_RD0369_207_11_20201009_00005.jpg

LM Start	0.35	Rating **	M	Issue No.	11
LM End	0.35	Issue Type +	Ma	Location *	LS
Category	Earthen Levee			GPS Latitude/Longitude	
				Start	End
Item	Encroachments			38.255250 °	38.255250 °
				-121.513207 °	-121.513207 °
DWR ID	DWR_RD0369_01_s_2019_11				
Comment Code					
TR : Tree or limb					
Inspector Comment					
Remove fallen tree limbs from the landside slope.

View of fallen limbs on the landside slope (Spring 2019).

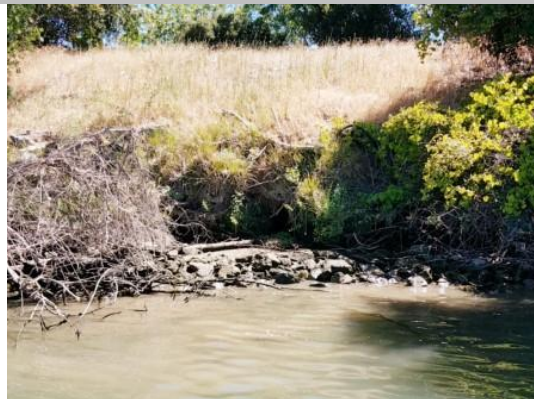
Photo 1 of 1 : FA_2020_RD0369_207_2_20201009_00001.jpg

LM Start	0.40	Rating **	U	Issue No.	2
LM End	0.40	Issue Type +	Ma	Location *	WS
Category	Earthen Levee			GPS Latitude/Longitude	
				Start	End
Item	Animal Control			38.254530 °	38.254530 °
				-121.512930 °	-121.512930 °
DWR ID	DWR_RD0369_01_s_2020_2				
Comment Code					
A3 : No rodents visible, but rodent burrows visible; need to backfill and compact or grout burrows.					
Inspector Comment					
Large animal burrow into the wateride toe that is sometimes submerged.

View from the channel at animal hole burrowed into the waterside toe (Summer 2020).

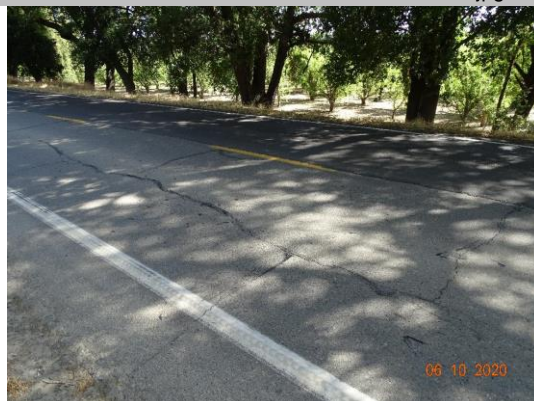
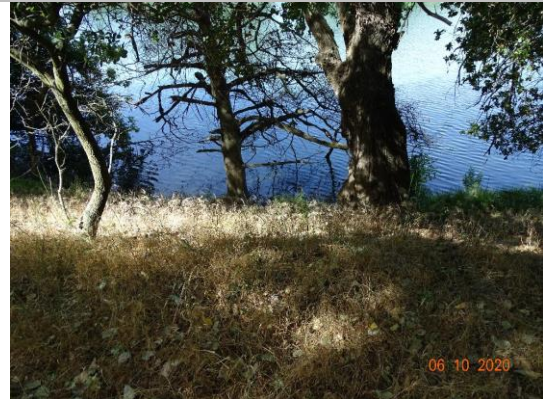
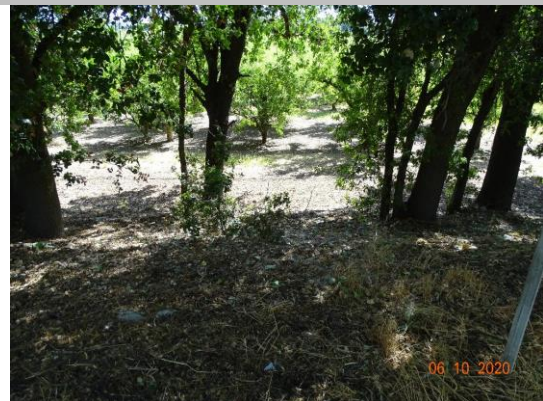
Comment Code						
Inspector Comment						
DS_ID:18980 FS_ID:60764 EP_NO: N/A Repair Type: Non-Urgent EVAL Issue: Pipe Not Found Crossing Status: Not Found UCIP Comments: 06/10/2020 Record updated from No Action Needed to Non-Urgent. Crossing not found. 6-inch pipe debris found on waterside slope downstream of this crossing. No permit has been identified authorizing pipe. (O.Yakimov - DWR UCIP) FIELD_STRUCT_DESC: 6-inch irrigation discharge pipe of an unknown material through the levee, at an unknown depth. Pump and gate valve on the waterside (WS). Additional Reference(s): USACE Sacramento O&M Manual, Unit 111, May 1959, Revised 29 December 2016, (RM 27.51), listed as 6-inch pipe. USACE As-Built Drawing No. 06-13-1100, Sheet 15, upstream of 'L' 1686+35, January 1933]. FS Date: 6/10/2020 10:57:57 AM

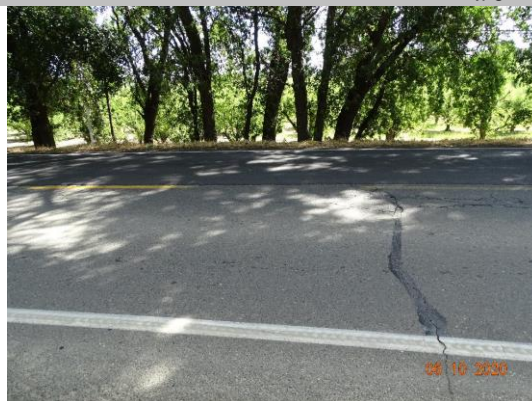
Photo 1 of 3 : UCIP_FA_2020_60775_88087.jpg

DS_ID:18981
FS_ID:60775
EP_NO: N/A
Repair Type: Non-Urgent
EVAL Issue: Unauthorized Encroachment
Crossing Status: Not Found
UCIP Comments: 06/10/2020 Record remains Non-Urgent. Crossing not found. Field measured 6-inch pipe debris on waterside slope parallel to levee crown might be coming from not found pipe DSID 18980 just upstream of this site. No evidence of pipe found on landside. No permit has been found authorizing this pipe through the levee at this location. (O.Yakimov - DWR UCIP)
03/04/2015 Found abandoned pipe laying on WS levee slope. Pipe purpose and status should be determined. further investigation required. (W.Wylie - DWR UCIP)
FIELD_STRUCT_DESC: 8-inch steel pipe of an unknown purpose running parallel to the levee crown on the waterside (WS) slope, 4.5 feet below the crown. This pipe was field discovered.
FS Date: 6/10/2020 11:11:31 AM

Top of Levee: View of levee crown looking towards landside

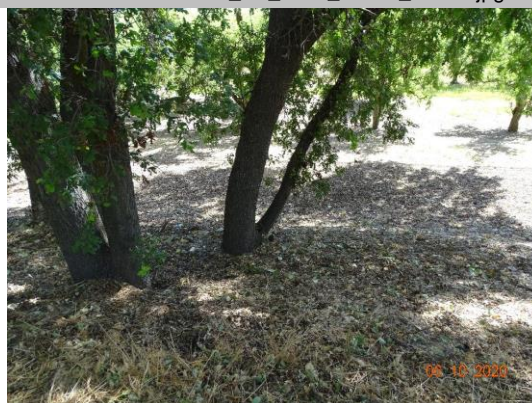
Photo 2 of 3 : UCIP_FA_2020_60775_88088.jpg

Land-Side: View of levee slope looking from crown

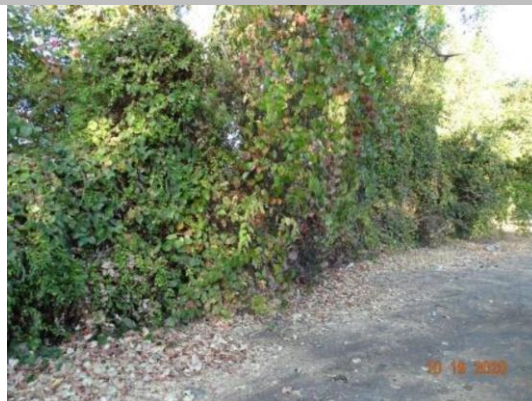
Photo 1 of 1 : FA_2020_RD0369_207_26_20201019_00034.jpg

LM Start	0.57	Rating **	U	Issue No.	26
LM End	0.60	Issue Type +	En	Location *	WS
Category	Earthen Levee			GPS Latitude/Longitude	
				Start	End
Item	Vegetation			38.252662 °	38.252247 °
				-121.511138 °	-121.510922 °
DWR ID	DWR_RD0369_01_s_2019_26				
Comment Code					
V6 : Landscaping					
Inspector Comment					
Vegetation on chainlink fence is blocking view down waterside slope.

View of thick vegetation on the waterside shoulder and slope (Fall 2020).

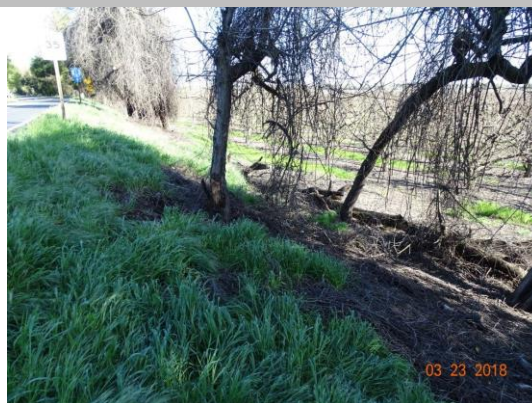
Photo 1 of 1 : FA_2020_RD0369_207_14_20201009_00007.jpg

LM Start	0.58	Rating **	M	Issue No.	14
LM End	0.58	Issue Type +	Ma	Location *	LS
Category	Earthen Levee			GPS Latitude/Longitude	
				Start	End
Item	Encroachments			38.252494 °	38.252494 °
				-121.510961 °	-121.510961 °
DWR ID	DWR_RD0369_01_s_2018_14				
Comment Code					
TR : Tree or limb					
Inspector Comment					
Fallen tree and branches should be removed from landside toe.

Remove fallen tree and branches from landside toe.

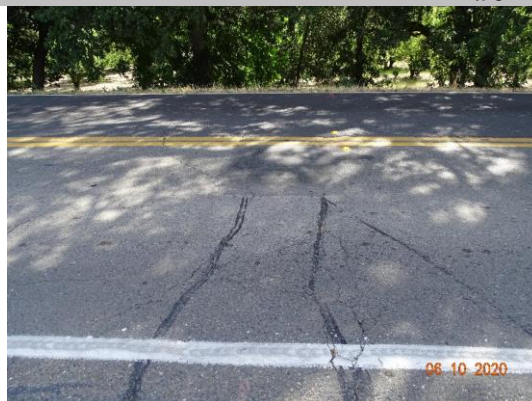
Photo 1 of 3 : UCIP_FA_2020_60848_88154.jpg

DS_ID:18977
 FS_ID:60848
 EP_NO: 14313
 Repair Type: Non-Urgent
 EVAL Issue: Limited Inspection/No UCIP Evaluation
 Crossing Status: Indicator Found
 UCIP Comments: 06/10/2020 Record updated from Urgent to Non-Urgent. Unable to evaluate landside levee slope condition due to thick layer of leaves on levee slope. No septic smell or wet spot on landside detected. Unable to access waterside since it's gated. (O.Yakimov - DWR UCIP)
 07/12/2018 Pipe is covered by thick layer of dry debris on LS. Patch repair along pipe alignment is visible on levee crown. (O.Yakimov-DWR UCIP)06/01/2016 Could not locate pipe. Likely buried next to leach box. Could not find signs of leaking or presence of water or erosion. Pipe may still be leaking but buried. (K. Fazel - UCIP)03/04/2015 Septic line appears to be leaking at LS toe. Erosion of soil and wet soil visible at LS toe. No septic smell accompanied other evidence at site. (W. Wylie - FPIIB)

Top of Levee: View of levee crown looking towards landside

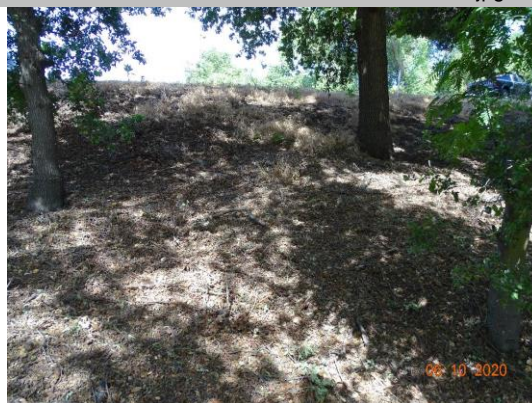
Photo 3 of 3 : UCIP_FA_2020_60848_88155.jpg

Land-Side: View of levee slope looking from toe

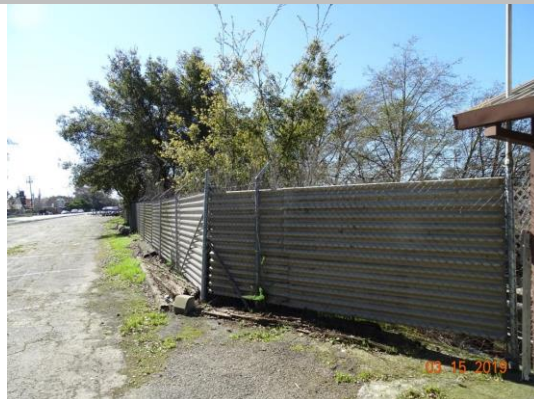
Photo 1 of 1 : FA_2020_RD0369_207_29_20201009_00014.jpg

View of fence on the waterside shoulder (Spring 2019).

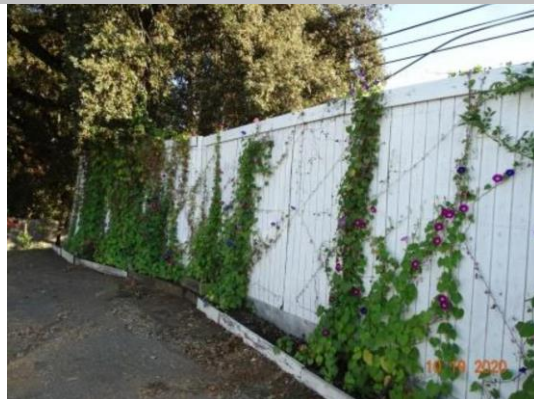
Photo 1 of 1 : FA_2020_RD0369_207_15_20201019_00035.jpg

LM Start	0.66	Rating **	U	Issue No.	15
LM End	0.66	Issue Type +	En	Location *	LS
Category	Earthen Levee			GPS Latitude/Longitude	
				Start	End
Item	Encroachments			38.251403 °	38.251403 °
				-121.510532 °	-121.510532 °
DWR ID	DWR_RD0369_01_s_2012_15				
Comment Code					
FE : Fence					
Inspector Comment					
A tall, white, solid fence is blocking the view of the landside levee slope.

View of white fence on the landside shoulder (Fall 2020).

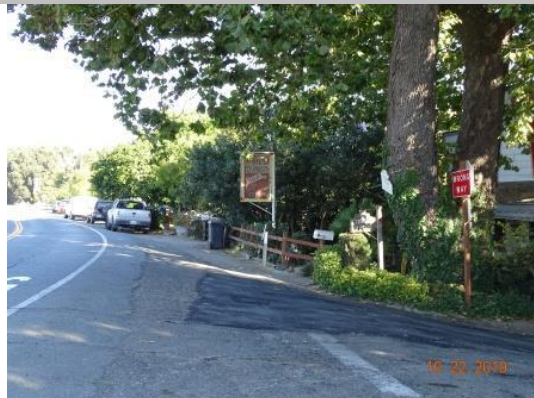
Photo 1 of 1 : FA_2020_RD0369_207_8_20201009_00002.jpg

LM Start	0.74	Rating **	M	Issue No.	8
LM End	0.77	Issue Type +	En	Location *	LS
Category	Earthen Levee			GPS Latitude/Longitude	
				Start	End
Item	Vegetation			38.250340 °	38.249930 °
				-121.510135 °	-121.509880 °
DWR ID	DWR_RD0369_01_s_2017_8				
Comment Code					
V6 : Landscaping					
Inspector Comment					
Landscaping needs to be thinned and maintained to allow inspection and access to landside slope and toe.

View looking upstream at landscaping on the landside slope (Fall 2019).
