## Flood Control Project Maintenance Levee Inspections

### Fall 2021 Levee Maintenance Deficiency Summary Report

#### Sacramento River Basin

**Reclamation District No. 0369 Libby McNeil**

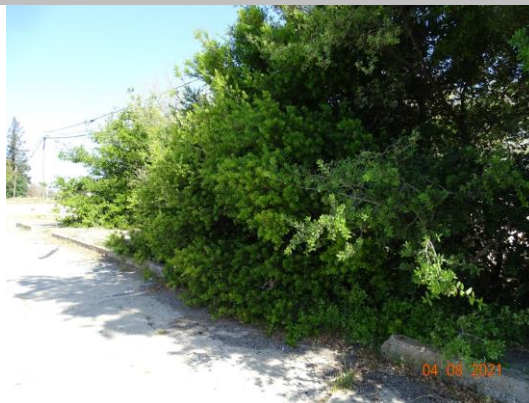
Photo 1 of 1 : FA\_2021\_RD0369\_207\_24\_20210830\_00013.jpg

LM Start	0.03	Rating **	U	Issue No.	24
LM End	0.03	Issue Type +	Ma	Location *	LS
Category	Earthen Levee			GPS Latitude/Longitude	
				Start	End
Item	Trim / Thin Trees			38.258599 °	38.258599 °
				-121.517315 °	-121.517315 °
DWR ID	DWR_RD0369_01_s_2021_24				
Comment Code					
T2 : Thin trees to allow visibility of the ground and room to flood fight.					
Inspector Comment

View of thick tree on the landside slope (Spring 2021).

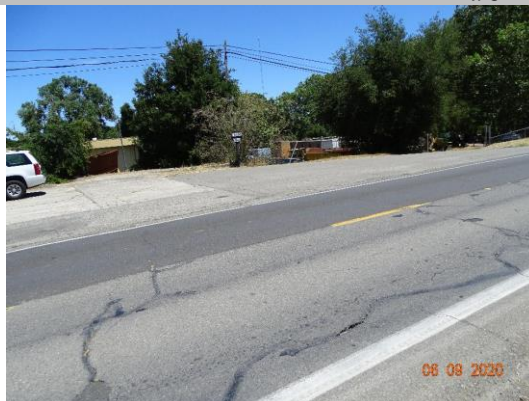
Photo 1 of 3 : UCIP\_FA\_2021\_60724\_88049.jpg

Comment Code					
Inspector Comment					
DS_ID:18970 FS_ID:60724 EP_NO: N/A Repair Type: Non-Urgent EVAL Issue: Unauthorized Encroachment, installed decades prior Crossing Status: Found UCIP Comments: 06/09/2020 Record remains Non-Urgent. Crossing appears abandoned. Tree branches have grown through abandoned hole in retaining wall plugging it completely. Unable to find pipe on waterside. Unauthorized encroachment recorded in Levee Log prior to 2011. (O.Yakimov - DWR UCIP) 03/04/2015 Pipe appears abandoned and is filled with soil. Appears abandoned and if so should be done so properly. FIELD_STRUCT_DESC: 8-inch steel gravity drainage pipe through the levee, 8 feet below the crown. Hole in the concrete retaining wall on the landside (LS) slope, measures 10 inches in diameter. (6-inch pipe [HLM 0.06] authorized under Automatic Board Order (ABO) issued as Permit No. 8555, 1973 - Jordan Investment Co. c/o Walter E. Herman). [Additional Reference(s): DWR Levee Log, 2005 (HLM 0.05), listed as 8-inch pipe]. FS Date: 6/9/2020 8:37:50 AM

Top of Levee: View of levee crown looking towards landside

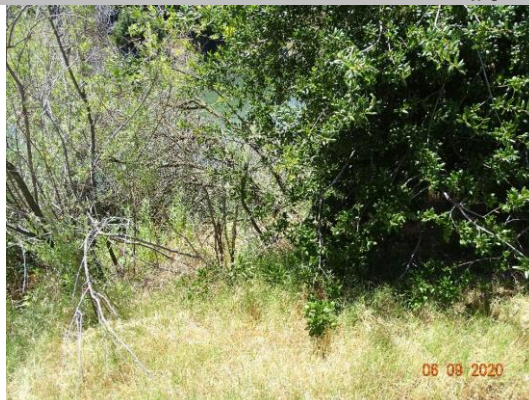
Photo 2 of 3 : UCIP\_FA\_2021\_60724\_88050.jpg

Water-Side: View of levee slope looking from crown. No pipe found on waterside

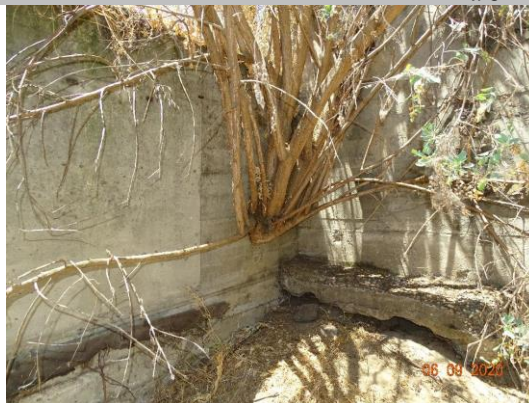
Photo 3 of 3 : UCIP\_FA\_2021\_60724\_88048.jpg

Land-Side: View of retaining wall on landside. Tree branches are plugging this hole completely

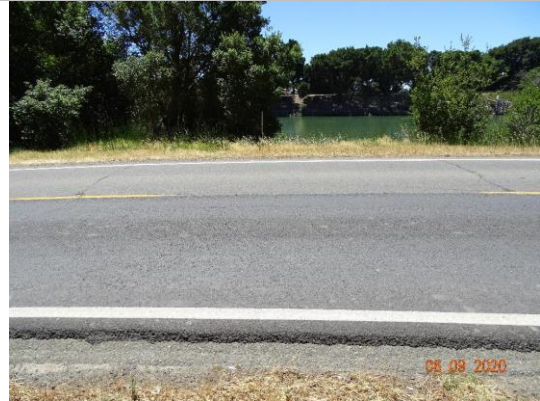
Photo 1 of 3 : UCIP\_FA\_2021\_60725\_88053.jpg

DS\_ID:25084  
FS\_ID:60725  
EP\_NO: N/A  
Repair Type: Urgent  
EVAL Issue: Pipe Integrity  
Crossing Status: Found  
UCIP Comments: 06/09/2020 Record remains Urgent. Through holes in pipe on landside slope. Crossing appears abandoned. No pipe found on waterside. No permit has been identified authorizing pipe. Need to have CVFPB review ABO and determine current owner. (O.Yakimov - DWR UCIP)  
07/12/2018 Pipe shows more signs of corrosion. Unable to find pipe on WS. (O.Yakimov-DWR UCIP)06/01/2016 Same as last inspection.

(K. Fazel - UCIP)03/04/2015 Severe corrosion and holes visible in pipe on LS shoulder. Pipe appears abandoned and should be done so properly. (W. Wyle - FPIIB)  
FIELD\_STRUCT\_DESC: 4-inch steel pipe of an unknown purpose through the levee, 1 foot below the crown. Pipe visible on the landside (LS) slope just in front of the gate on the LS shoulder. (4-inch pipe [HLM 0.08] authorized under Automatic Board Order (ABO) issued as Permit No. 8555, 1973 - Jordan Investment Co. c/o Walter E. Herman). [Additional Reference(s): DWR Levee Log, 2005 (HLM 0.08). USACE Sacramento O&M Manual, Unit 111, May 1959, Revised 29 December 2016, (RM 27.87 - O&M Manual misidentifies this location as RM 28.87), listed as 4-inch pipe. USACE As-Built Drawing No. 06-13-1100, Sheet 15, upstream of 'L' 1663+96, January 1933].  
FS Date: 6/9/2020 9:26:37 AM

Top of Levee: View of levee crown looking towards waterside

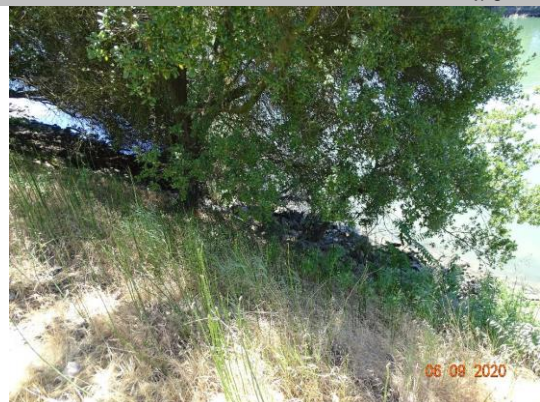
Photo 2 of 3 : UCIP\_FA\_2021\_60725\_88054.jpg

Water-Side: View of levee slope looking from crown

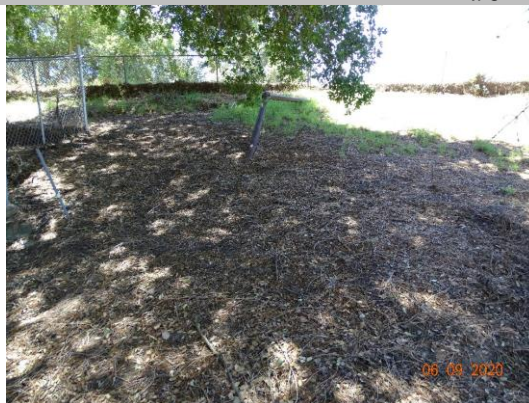
Photo 3 of 3 : UCIP\_FA\_2021\_60725\_88051.jpg

Land-Side: View of levee slope looking from toe

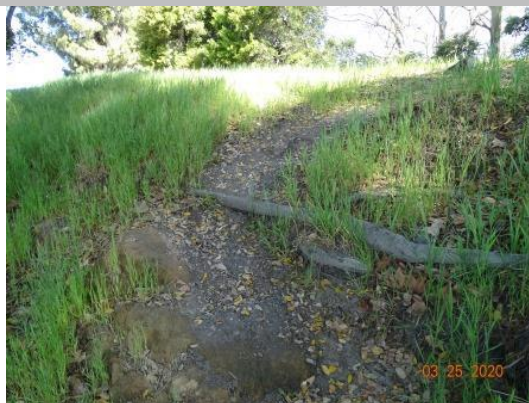
Photo 1 of 1 : FA\_2021\_RD0369\_207\_9\_20210830\_00003.jpg

LM Start	0.11	Rating **	M	Issue No.	9
LM End	0.11	Issue Type +	Ma	Location *	WS
Category	Earthen Levee			GPS Latitude/Longitude	
				Start	End
Item	Slope Stability			38.257757 °	38.257757 °
				-121.516347 °	-121.516347 °
DWR ID	DWR_RD0369_01_s_2020_9				
Comment Code					
S2 : Repair the levee slope damaged by foot traffic and prevent access where possible.					
Inspector Comment

View of footpath down the waterside slope (Spring 2020).

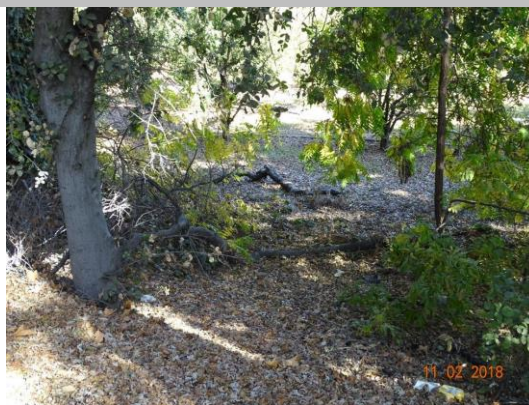
Photo 1 of 1 : FA\_2021\_RD0369\_207\_21\_20210830\_00011.jpg

View of tree limb on the landside slope (November 2018).

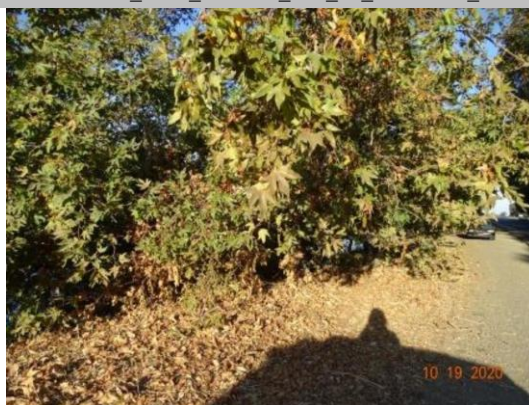
Photo 1 of 1 : FA\_2021\_RD0369\_207\_23\_20210830\_00012.jpg

LM Start	0.15	Rating **	U	Issue No.	23
LM End	0.15	Issue Type +	Ma	Location *	WS
Category	Earthen Levee			GPS Latitude/Longitude	
				Start	End
Item	Trim / Thin Trees			38.257368 °	38.257368 °
				-121.515752 °	-121.515752 °
DWR ID	DWR_RD0369_01_s_2020_23				
Comment Code					
T2 : Thin trees to allow visibility of the ground and room to flood fight.					
Inspector Comment

View of thick tree branches on the waterside slope (Fall 2020).

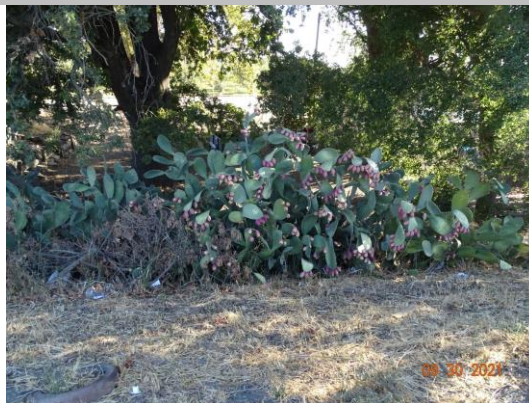
Photo 1 of 1 : FA\_2021\_RD0369\_207\_32\_20211001\_00037.jpg

View of cactus on the landside slope (Fall 2021).

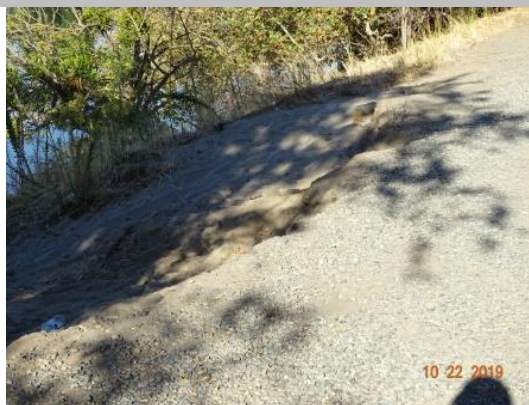
Photo 1 of 1 : FA\_2021\_RD0369\_207\_10\_20210830\_00004.jpg

LM Start	0.18	Rating **	M	Issue No.	10
LM End	0.18	Issue Type +	Ma	Location *	WS
Category	Earthen Levee			GPS Latitude/Longitude	
				Start	End
Item	Slope Stability			38.257137 °	38.257137 °
				-121.515407 °	-121.515407 °
DWR ID	DWR_RD0369_01_f_2019_10				
Comment Code					
S2 : Repair the levee slope damaged by foot traffic and prevent access where possible.					
Inspector Comment					
Large path created by fishermen. Levee is extra wide in this section.

View looking slightly upstream erosion due to foot traffic on the waterside slope (Fall 2019).

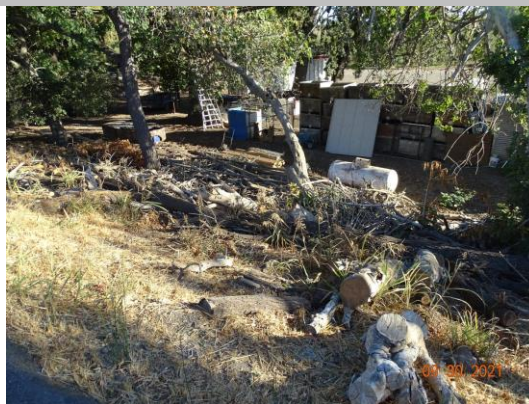
Photo 1 of 1 : FA\_2021\_RD0369\_207\_12\_20211001\_00036.jpg

LM Start	0.19	Rating **	M	Issue No.	12
LM End	0.19	Issue Type +	Ma	Location *	LS
Category	Earthen Levee			GPS Latitude/Longitude	
				Start	End
Item	Encroachments			38.257024 °	38.257024 °
				-121.515175 °	-121.515175 °
DWR ID	DWR_RD0369_01_f_2021_12				
Comment Code					
PR : Prunings					
Inspector Comment					
Remove remnants of chopped up tree.

View of chopped up tree on the landside slope (Fall 2021).

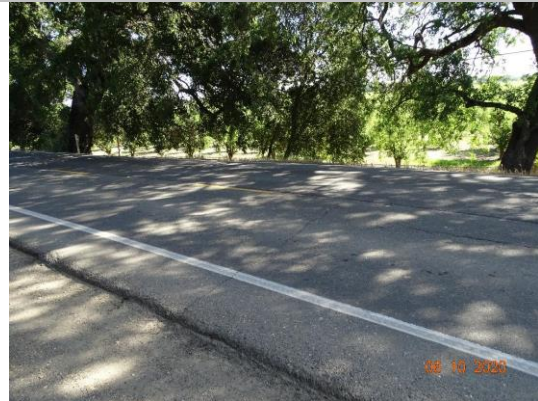
Photo 1 of 3 : UCIP\_FA\_2021\_60752\_88063.jpg

DS\_ID:18972  
 FS\_ID:60752  
 EP\_NO: 11117  
 Repair Type: Urgent  
 EVAL Issue: Pipe Integrity  
 Crossing Status: Found  
 UCIP Comments: 06/10/2020 Record updated from Non-Urgent to Urgent. Hole in pipe on waterside slope above pump. Pipe is running - leak through the hole poses a threat to waterside levee slope. 6-inch pipe installed on landside slope right after siphon breaker. Levee slope was disturbed at this location. 6-inch pipe is running down diagonally on landside slope towards PVC pipe connection at the toe. Unable to find a permit for modification. No permit has been identified authorizing pipe through the levee. Need to have CVFPB review ABO and determine current owner. (O.Yakimov - DWR UCIP)  
 10/15/2012 Siphon breaker on LS slope needs protection. Water is leaking from pump station. Abandoned concrete structure found on WS. 10-inch abandoned pipe found on WS. Should be removed. 6-inch abandoned pipe found on WS. Should be removed.

Top of Levee: View of levee crown looking towards landside

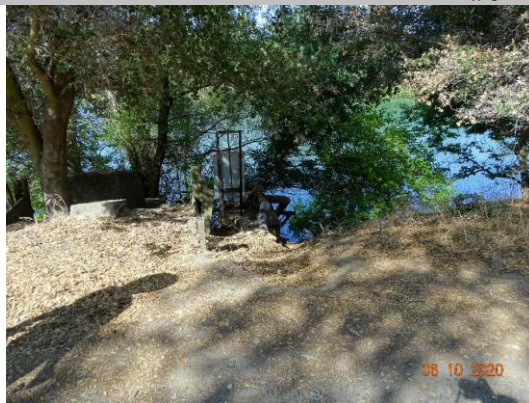
Photo 2 of 3 : UCIP\_FA\_2021\_60752\_88064.jpg

Water-Side: View of levee slope looking from crown

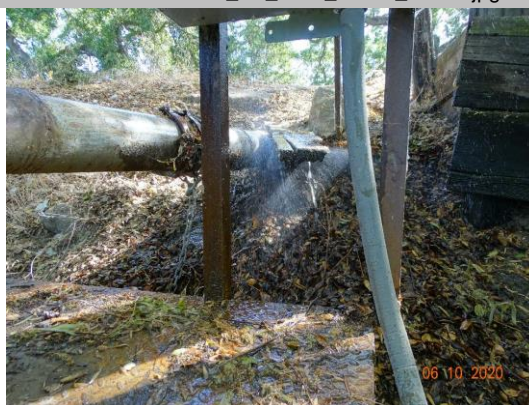
Photo 3 of 3 : UCIP\_FA\_2021\_60752\_88065.jpg

Water-Side: Pipe leak on levee slope above pump

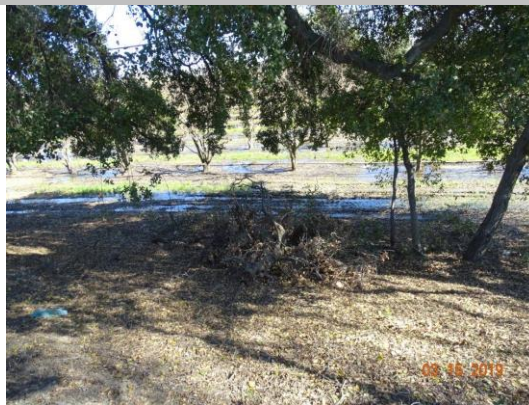
Photo 1 of 1 : FA\_2021\_RD0369\_207\_11\_20210830\_00005.jpg

LM Start	0.35	Rating **	M	Issue No.	11
LM End	0.35	Issue Type +	Ma	Location *	LS
Category	Earthen Levee			GPS Latitude/Longitude	
				Start	End
Item	Encroachments			38.255250 °	38.255250 °
				-121.513207 °	-121.513207 °
DWR ID	DWR_RD0369_01_s_2019_11				
Comment Code					
TR : Tree or limb					
Inspector Comment					
Remove fallen tree limbs from the landside slope.

View of fallen limbs on the landside slope (Spring 2019).

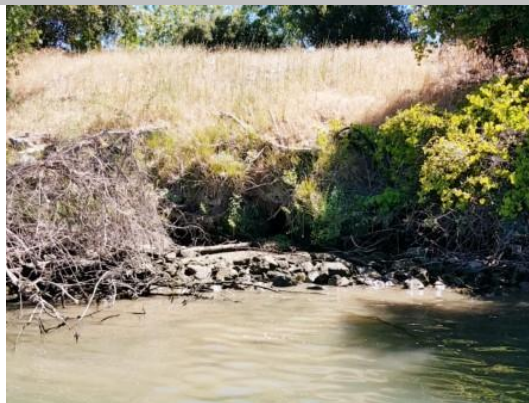
Photo 1 of 1 : FA\_2021\_RD0369\_207\_2\_20210830\_00001.jpg

View from the channel at animal hole burrowed into the waterside toe (Summer 2020).

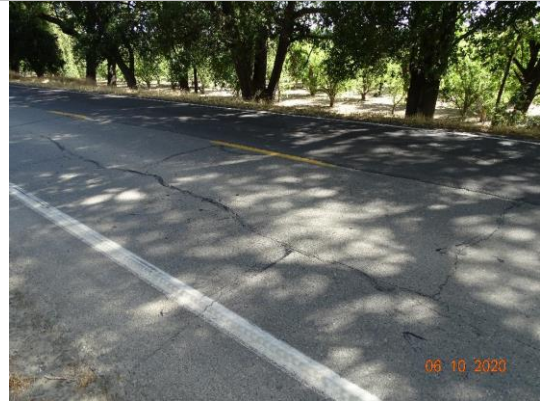
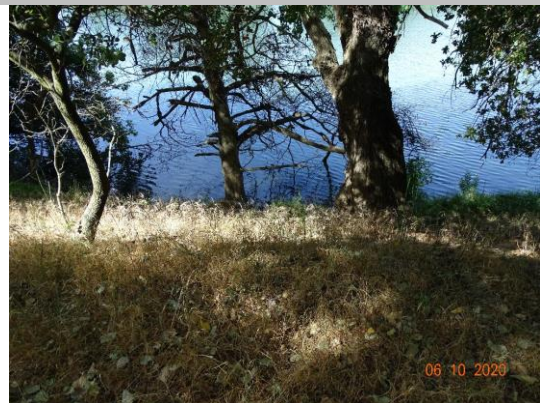
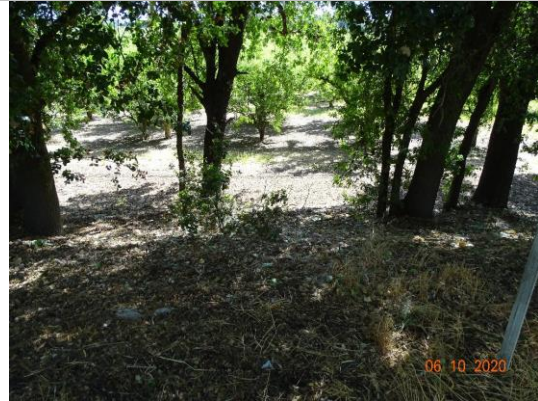
DS\_ID:18980  
FS\_ID:60764  
EP\_NO: N/A  
Repair Type: Non-Urgent  
EVAL Issue: Pipe Not Found  
Crossing Status: Not Found  
UCIP Comments: 06/10/2020 Record updated from No Action Needed to Non-Urgent. Crossing not found. 6-inch pipe debris found on waterside slope downstream of this crossing. No permit has been identified authorizing pipe. (O.Yakimov - DWR UCIP)  
FIELD\_STRUCT\_DESC: 6-inch irrigation discharge pipe of an unknown material through the levee, at an unknown depth. Pump and gate valve on the waterside (WS). Additional Reference(s): USACE Sacramento O&M Manual, Unit 111, May 1959, Revised 29 December 2016, (RM 27.51), listed as 6-inch pipe. USACE As-Built Drawing No. 06-13-1100, Sheet 15, upstream of 'L' 1686+35, January 1933].  
FS Date: 6/10/2020 10:57:57 AM

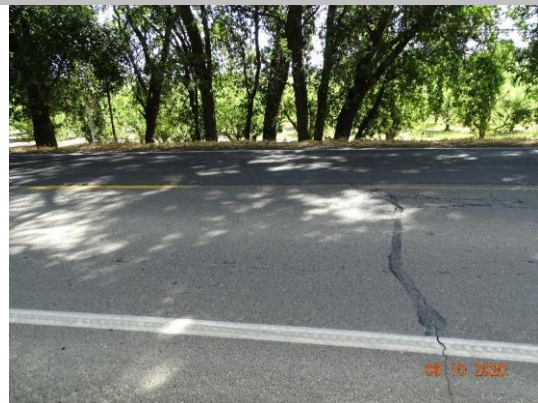
Photo 1 of 3 : UCIP\_FA\_2021\_60775\_88087.jpg

DS\_ID:18981  
FS\_ID:60775  
EP\_NO: N/A  
Repair Type: Non-Urgent  
EVAL Issue: Unauthorized Encroachment  
Crossing Status: Not Found  
UCIP Comments: 06/10/2020 Record remains Non-Urgent. Crossing not found. Field measured 6-inch pipe debris on waterside slope parallel to levee crown might be coming from not found pipe DSID 18980 just upstream of this site. No evidence of pipe found on landside. No permit has been found authorizing this pipe through the levee at this location. (O.Yakimov - DWR UCIP)  
03/04/2015 Found abandoned pipe laying on WS levee slope. Pipe purpose and status should be determined. further investigation required. (W.Wylie - DWR UCIP)  
FIELD\_STRUCT\_DESC: 8-inch steel pipe of an unknown purpose running parallel to the levee crown on the waterside (WS) slope, 4.5 feet below the crown. This pipe was field discovered.  
FS Date: 6/10/2020 11:11:31 AM

Top of Levee: View of levee crown looking towards landside

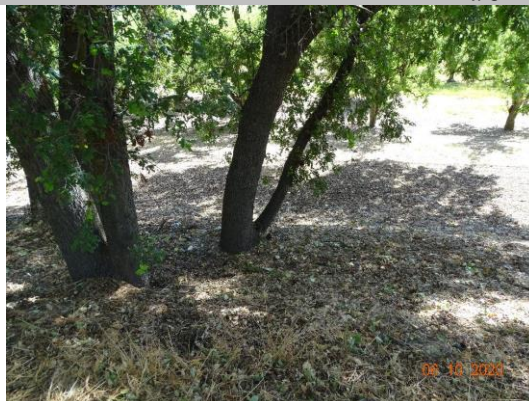
Photo 2 of 3 : UCIP\_FA\_2021\_60775\_88088.jpg

Land-Side: View of levee slope looking from crown

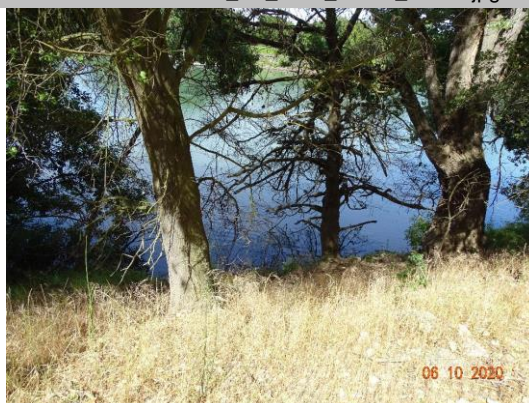
Photo 3 of 3 : UCIP\_FA\_2021\_60775\_88086.jpg

Water-Side: View of levee slope looking from crown

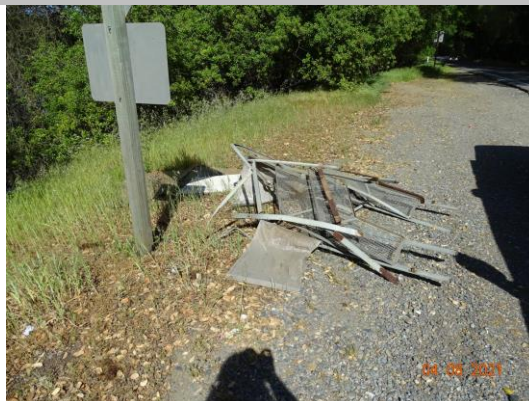
Photo 1 of 1 : FA\_2021\_RD0369\_207\_18\_20210830\_00009.jpg

LM Start	0.51	Rating **	M	Issue No.	18
LM End	0.51	Issue Type +	Ma	Location *	WS
Category	Earthen Levee			GPS Latitude/Longitude	
				Start	End
Item	Encroachments			38.253359 °	38.253359 °
				-121.511628 °	-121.511628 °
DWR ID	DWR_RD0369_01_s_2021_18				
Comment Code					
GA : Garbage					
Inspector Comment					
Remove discarded furniture from waterside slope.

View of discarded metal furniture on the waterside hinge (Spring 2021).

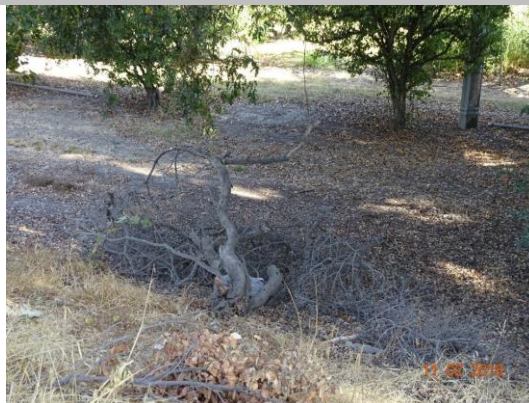
Photo 1 of 1 : FA\_2021\_RD0369\_207\_19\_20210830\_00010.jpg

View of tree limb on the landside slope (November 2018).

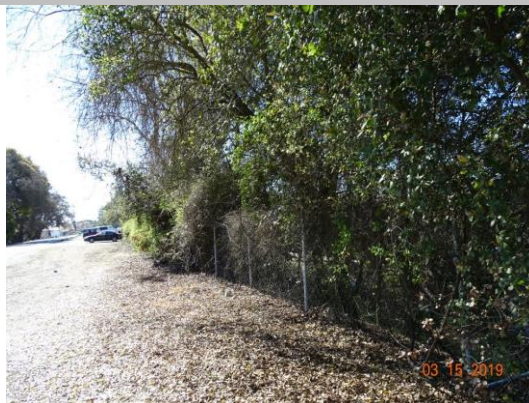
Photo 1 of 1 : FA\_2021\_RD0369\_207\_25\_20210830\_00014.jpg

LM Start	0.57	Rating **	U	Issue No.	25
LM End	0.60	Issue Type +	En	Location *	WS
Category	Earthen Levee			GPS Latitude/Longitude	
				Start	End
Item	Encroachments			38.252662 °	38.252247 °
				-121.511138 °	-121.510922 °
DWR ID	DWR_RD0369_01_s_2019_25				
Comment Code					
FE : Fence					
Inspector Comment					
A chainlink fence is located on the waterside slope.

View looking downstream at chainlink fence on the waterside slope (Spring 2019).

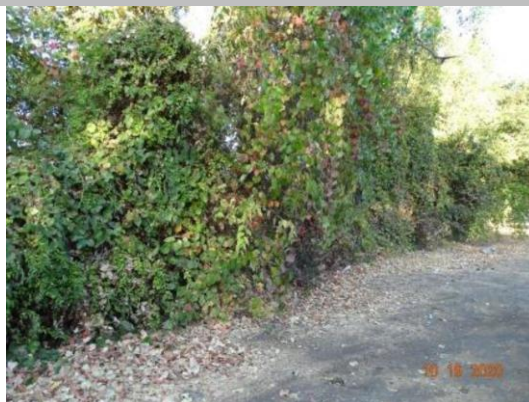
Photo 1 of 1 : FA\_2021\_RD0369\_207\_26\_20210830\_00015.jpg

LM Start	0.57	Rating **	U	Issue No.	26
LM End	0.60	Issue Type +	En	Location *	WS
Category	Earthen Levee			GPS Latitude/Longitude	
				Start	End
Item	Vegetation			38.252662 °	38.252247 °
				-121.511138 °	-121.510922 °
DWR ID	DWR_RD0369_01_s_2019_26				
Comment Code					
V6 : Landscaping					
Inspector Comment					
Vegetation on chainlink fence is blocking view down waterside slope.

View of thick vegetation on the waterside shoulder and slope (Fall 2020).

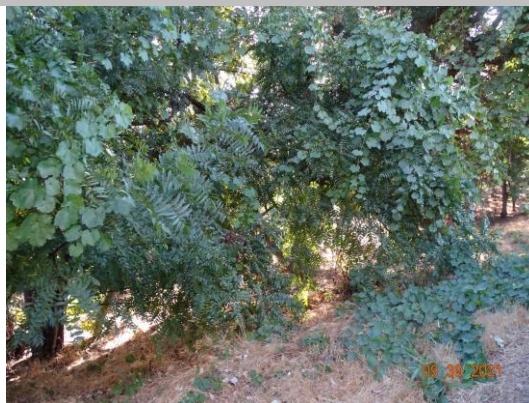
Photo 1 of 1 : FA\_2021\_RD0369\_207\_31\_20211001\_00035.jpg

LM Start	0.59	Rating **	M	Issue No.	31
LM End	0.59	Issue Type +	Ma	Location *	LS
Category	Earthen Levee			GPS Latitude/Longitude	
				Start	End
Item	Trim / Thin Trees			38.252414 °	38.252414 °
				-121.510931 °	-121.510931 °
DWR ID	DWR_RD0369_01_f_2021_31				
Comment Code					
T1 : Trim trees to at least five feet above ground level.					
Inspector Comment

View of tree needing trimming on the landside slope (Fall 2021).

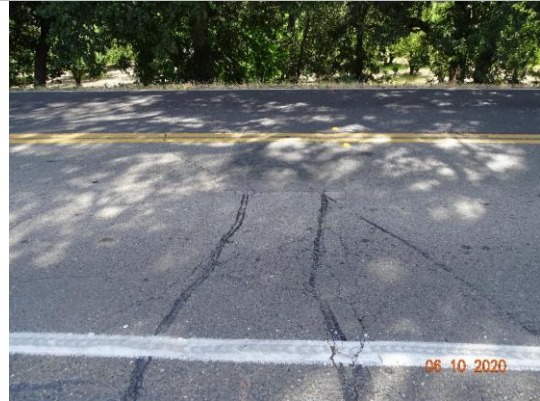
Photo 1 of 3 : UCIP\_FA\_2021\_60848\_88154.jpg

DS\_ID:18977  
FS\_ID:60848  
EP\_NO: 14313  
Repair Type: Non-Urgent  
EVAL Issue: Limited Inspection/No UCIP Evaluation  
Crossing Status: Indicator Found  
UCIP Comments: 06/10/2020 Record updated from Urgent to Non-Urgent. Unable to evaluate landside levee slope condition due to thick layer of leaves on levee slope. No septic smell or wet spot on landside detected. Unable to access waterside since it's gated. (O.Yakimov - DWR UCIP)  
07/12/2018 Pipe is covered by thick layer of dry debris on LS. Patch repair along pipe alignment is visible on levee crown. (O.Yakimov-DWR UCIP)06/01/2016 Could not locate pipe. Likely buried next to leach box. Could not find signs of leaking or presence of water or erosion. Pipe may still be leaking but buried. (K. Fazel - UCIP)03/04/2015 Septic line appears to be leaking at LS toe. Erosion of soil and wet soil visible at LS toe. No septic smell accompanied other evidence at site. (W. Wylie - FPIIB)

Top of Levee: View of levee crown looking towards landside

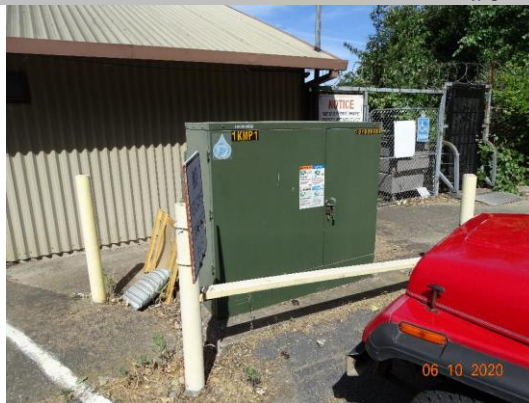
Photo 2 of 3 : UCIP\_FA\_2021\_60848\_88156.jpg

Water-Side: View of waterside standing on crown

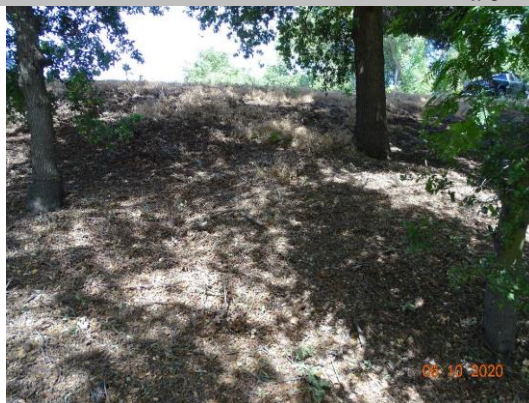
Photo 3 of 3 : UCIP\_FA\_2021\_60848\_88155.jpg

Land-Side: View of levee slope looking from toe

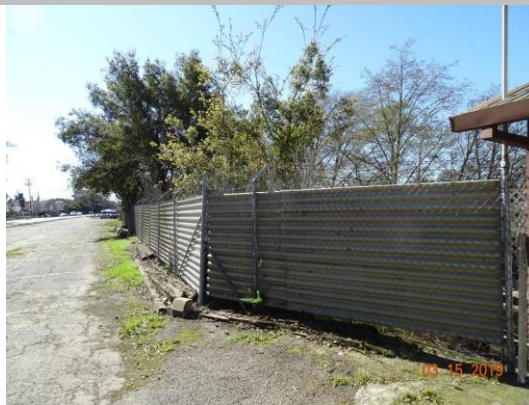
Photo 1 of 1 : FA\_2021\_RD0369\_207\_29\_20210830\_00016.jpg

LM Start	0.62	Rating **	U	Issue No.	29
LM End	0.67	Issue Type +	En	Location *	WS
Category	Earthen Levee			GPS Latitude/Longitude	
				Start	End
Item	Encroachments			38.251982 °	38.251267 °
				-121.510853 °	-121.510480 °
DWR ID	DWR_RD0369_01_s_2019_29				
Comment Code					
FE : Fence					
Inspector Comment					
A fence is blocking the view of the waterside slope.

View of fence on the waterside shoulder (Spring 2019).

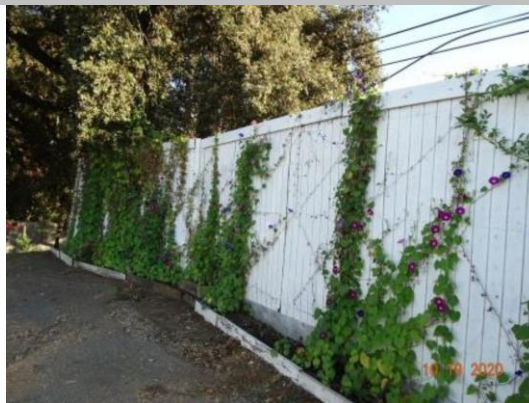
Photo 1 of 1 : FA\_2021\_RD0369\_207\_15\_20210830\_00008.jpg

View of white fence on the landside shoulder (Fall 2020).

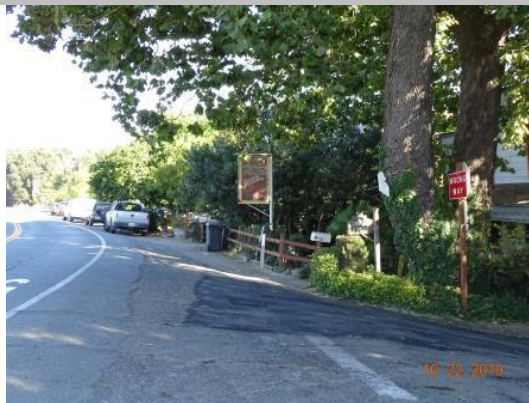
Photo 1 of 1 : FA\_2021\_RD0369\_207\_8\_20210830\_00002.jpg

View looking upstream at landscaping on the landside slope (Fall 2019).
