## Flood Control Project Maintenance Levee Inspections

### Fall 2022 Levee Maintenance Deficiency Summary Report

#### Sacramento River Basin

**Reclamation District No. 0369 Libby McNeil**

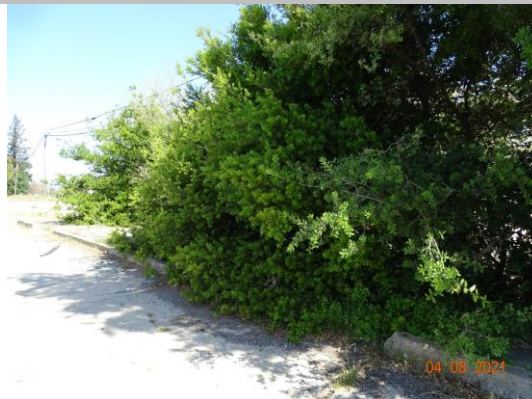
Photo 1 of 1 : FA\_2022\_RD0369\_207\_24\_20220831\_00012.jpg

LM Start	0.03	Rating **	U	Issue No.	24
LM End	0.03	Issue Type +	Ma	Location *	LS
Category	Earthen Levee			GPS Latitude/Longitude	
				Start	End
Item	Trim / Thin Trees			38.258599 °	38.258599 °
				-121.517315 °	-121.517315 °
DWR ID	DWR_RD0369_01_s_2021_24				
Comment Code					
T1 : Trim and thin trees to at least five feet above ground level to allow visibility of the ground and room to flood fight.					
Inspector Comment

View of thick tree on the landside slope (Spring 2021).

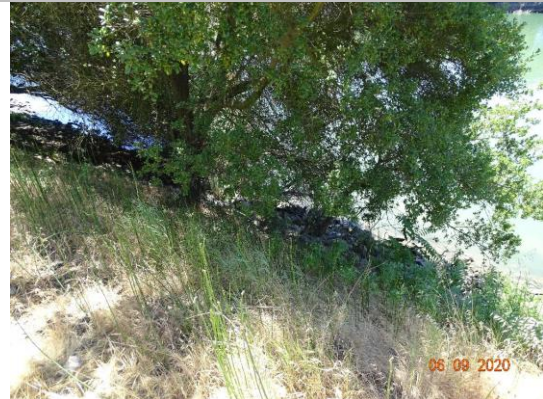
Photo 1 of 3 : UCIP\_FA\_2022\_60725\_88054.jpg

Comment Code						
Inspector Comment						
DS_ID:25084 FS_ID:60725 EP_NO: N/A Repair Type: Urgent EVAL Issue: 1, Pipe Integrity Crossing Status: Found UCIP Comments: 06/09/2020 Record remains Urgent. Through holes in pipe on landside slope. Crossing appears abandoned. No pipe found on waterside. No permit has been identified authorizing pipe. Need to have CVFPB review ABO and determine current owner. (O.Yakimov - DWR UCIP) 07/12/2018 Pipe shows more signs of corrosion. Unable to find pipe on WS. (O.Yakimov-DWR UCIP)06/01/2016 Same as last inspection. (K. Fazel - UCIP)03/04/2015 Severe corrosion and holes visible in pipe on LS shoulder. Pipe appears abandoned and should be done so properly. (W. Wyle - FPIIB) FIELD_STRUCT_DESC: 4-inch steel pipe of an unknown purpose through the levee, 1 foot below the crown. Pipe visible on the landside (LS) slope just in front of the gate on the LS shoulder. (4-inch pipe [HLM 0.08] authorized under Automatic Board Order (ABO) issued as Permit No. 8555, 1973 - Jordan Investment Co. c/o Walter E. Herman). [Additional Reference(s): DWR Levee Log, 2005 (HLM 0.08). USACE Sacramento O&M Manual, Unit 111, May 1959, Revised 29 December 2016, (RM 27.87 - O&M Manual misidentifies this location as RM 28.87), listed as 4-inch pipe. USACE As-Built Drawing No. 06-13-1100, Sheet 15, upstream of 'L' 1663+96, January 1933]. FS Date: 6/9/2020 9:26:37 AM

Water-Side: View of levee slope looking from crown

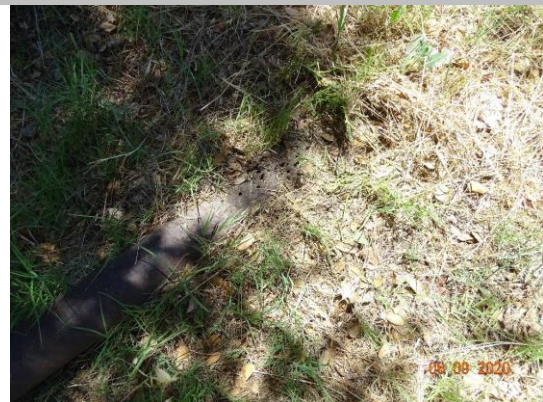
Photo 2 of 3 : UCIP\_FA\_2022\_60725\_88052.jpg

Land-Side: View of pipe with through holes on levee slope

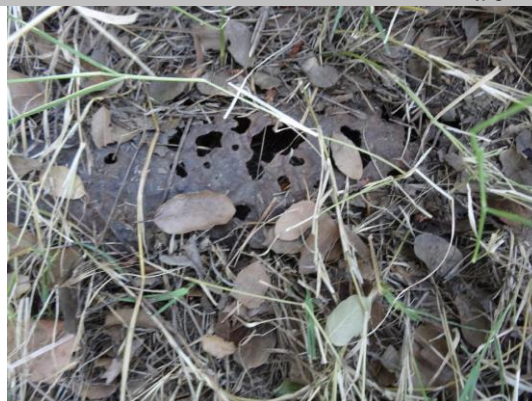
Photo 3 of 3 : UCIP\_FA\_2022\_60725\_75200.jpg

LS slope: holes in pipe still present.

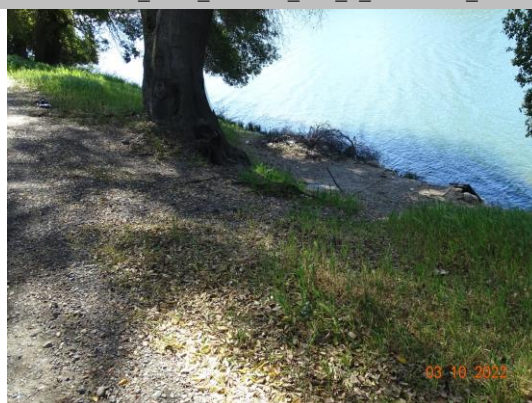
Photo 1 of 1 : FA\_2022\_RD0369\_207\_9\_20220831\_00003.jpg

LM Start	0.11	Rating **	M	Issue No.	9
LM End	0.11	Issue Type +	Ma	Location *	WS
Category	Earthen Levee			GPS Latitude/Longitude	
				Start	End
Item	Erosion / Foot Traffic			38.257757 °	38.257757 °
				-121.516347 °	-121.516347 °
DWR ID	DWR_RD0369_01_s_2020_9				
Comment Code					
E3 : Repair the levee slope damaged by foot traffic and prevent access where possible.					
Inspector Comment

View looking down footpath on the waterside slope (Spring 2022).

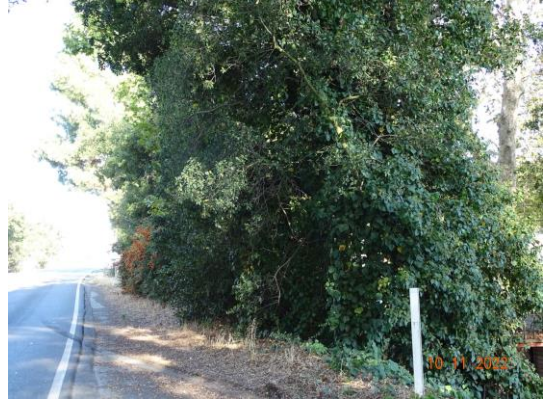
Photo 1 of 1 : FA\_2022\_RD0369\_207\_13\_20221031\_00044.jpg

LM Start	0.11	Rating **	M	Issue No.	13
LM End	0.13	Issue Type +	En	Location *	LS
Category	Earthen Levee			GPS Latitude/Longitude	
				Start	End
Item	Vegetation			38.257772 °	38.257573 °
				-121.516248 °	-121.516190 °
DWR ID	DWR_RD0369_01_f _ 2019_13				
Comment Code					
V6 : Landscaping					
Inspector Comment					
Remove ivy.

View of the ivy on the LS slope (Fall 2022).

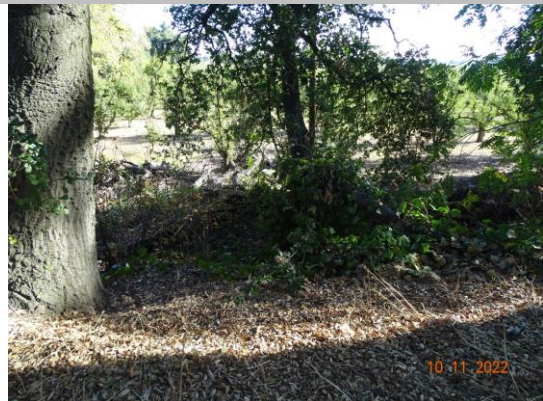
Photo 1 of 1 : FA\_2022\_RD0369\_207\_21\_20221031\_00043.jpg

LM Start	0.13	Rating **	M	Issue No.	21
LM End	0.13	Issue Type +	Ma	Location *	LS
Category	Earthen Levee			GPS Latitude/Longitude	
				Start	End
Item	Trim / Thin Trees			38.257673 °	38.257673 °
				-121.516052 °	-121.516052 °
DWR ID	DWR_RD0369_01_f _ 2018_21				
Comment Code					
T2 : Tree or limb.					
Inspector Comment					
Remove tree limbs from the landside slope and toe.

View of the tree limbs on the LS slope and toe (Fall 2022).

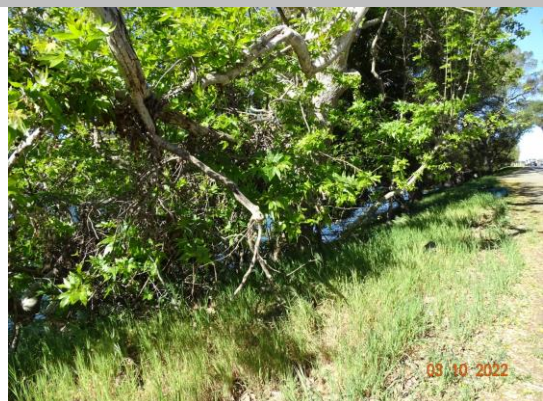
Photo 1 of 1 : FA\_2022\_RD0369\_207\_23\_20220831\_00011.jpg

LM Start	0.15	Rating **	M	Issue No.	23
LM End	0.15	Issue Type +	Ma	Location *	WS
Category	Earthen Levee			GPS Latitude/Longitude	
				Start	End
Item	Trim / Thin Trees			38.257368 °	38.257368 °
				-121.515752 °	-121.515752 °
DWR ID	DWR_RD0369_01_s_2020_23				
Comment Code					
T1 : Trim and thin trees to at least five feet above ground level to allow visibility of the ground and room to flood fight.					
Inspector Comment

View of tree on the waterside slope (Spring 2022).

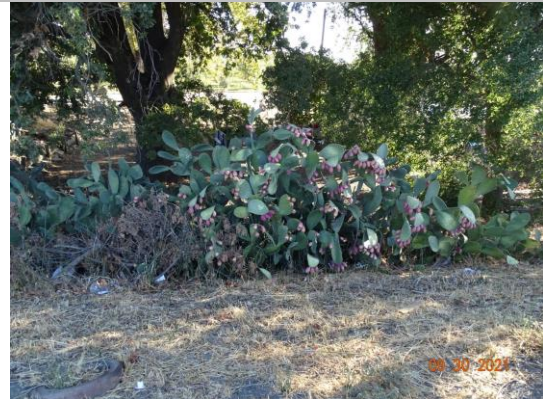
Photo 1 of 1 : FA\_2022\_RD0369\_207\_32\_20220831\_00017.jpg

LM Start	0.17	Rating **	U	Issue No.	32
LM End	0.17	Issue Type +	En	Location *	LS
Category	Earthen Levee			GPS Latitude/Longitude	
				Start	End
Item	Vegetation			38.257197 °	38.257197 °
				-121.515403 °	-121.515403 °
DWR ID	DWR_RD0369_01_f _ 2021_32				
Comment Code					
V6 : Landscaping					
Inspector Comment					
Remove cactus on the landside slope.

View of cactus on the landside slope (Fall 2021).

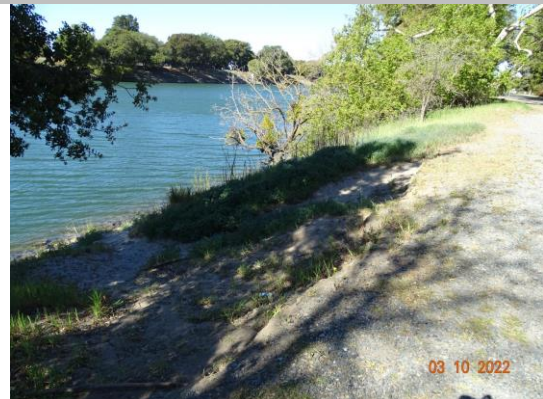
Photo 1 of 1 : FA\_2022\_RD0369\_207\_10\_20220831\_00004.jpg

LM Start	0.18	Rating **	M	Issue No.	10
LM End	0.18	Issue Type +	Ma	Location *	WS
Category	Earthen Levee			GPS Latitude/Longitude	
				Start	End
Item	Erosion / Foot Traffic			38.257137 °	38.257137 °
				-121.515407 °	-121.515407 °
DWR ID	DWR_RD0369_01_f _ 2019_10				
Comment Code					
E3 : Repair the levee slope damaged by foot traffic and prevent access where possible.					
Inspector Comment					
Large path created by fishermen. Levee is extra wide in this section.

View looking slightly upstream erosion due to foot traffic on the waterside slope (Spring 2022).

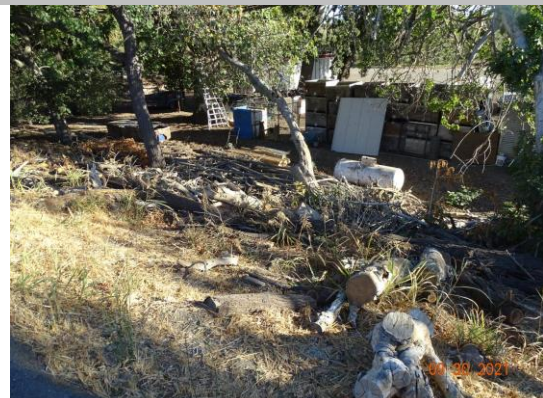
Photo 1 of 1 : FA\_2022\_RD0369\_207\_12\_20220831\_00006.jpg

LM Start	0.19	Rating **	M	Issue No.	12
LM End	0.22	Issue Type +	Ma	Location *	LS
Category	Earthen Levee			GPS Latitude/Longitude	
				Start	End
Item	Encroachments			38.257024 °	38.256757 °
				-121.515175 °	-121.514843 °
DWR ID	DWR_RD0369_01_f_2021_12				
Comment Code					
PR : Prunings					
Inspector Comment					
Remove remnants of chopped up tree.

View of chopped up tree on the landside slope (Fall 2021).

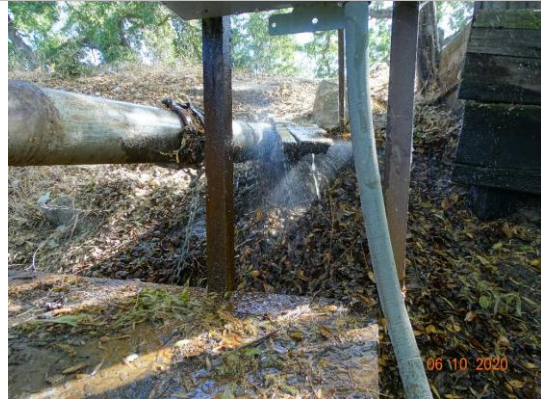
Photo 1 of 3 : UCIP\_FA\_2022\_60752\_88065.jpg

DS\_ID:18972  
FS\_ID:60752  
EP\_NO: 11117  
Repair Type: Urgent  
EVAL Issue: 1, Pipe Integrity  
Crossing Status: Found  
UCIP Comments: 06/10/2020 Record updated from Non-Urgent to Urgent. Hole in pipe on waterside slope above pump. Pipe is running - leak through the hole poses a threat to waterside levee slope. 6-inch pipe installed on landside slope right after siphon breaker. Levee slope was disturbed at this location. 6-inch pipe is running down diagonally on landside slope towards PVC pipe connection at the toe. Unable to find a permit for modification. No permit has been identified authorizing pipe through the levee. Need to have CVFPB review ABO and determine current owner. (O.Yakimov - DWR UCIP)  
10/15/2012 Siphon breaker on LS slope needs protection. Water is leaking from pump station. Abandoned concrete structure found on WS. 10-inch abandoned pipe found on WS. Should be removed. 6-inch abandoned pipe found on WS. Should be removed.

Water-Side: Pipe leak on levee slope above pump

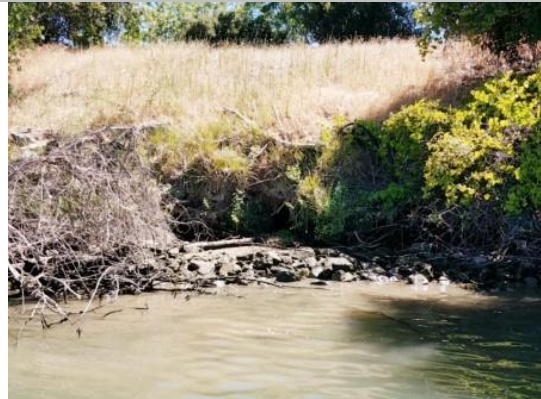
Photo 1 of 1 : FA\_2022\_RD0369\_207\_2\_20220831\_00001.jpg

LM Start	0.40	Rating **	A/W	Issue No.	2
LM End	0.40	Issue Type +	Ma	Location *	WS
Category	Earthen Levee			GPS Latitude/Longitude	
				Start	End
Item	Erosion / Bank Caving			38.254530 °	38.254530 °
				-121.512930 °	-121.512930 °
DWR ID	DWR_RD0369_01_s_2020_2				
Comment Code					
E2 : Schedule repair of erosion site prior to the next inspection.					
Inspector Comment					
LMA mentioned repair in progress last fall but could not verify due to vegetation and high tide. Fall 2022: The erosion is caused by fallen tree with root ball.

View from the channel at animal hole burrowed into the waterside toe (Summer 2020).

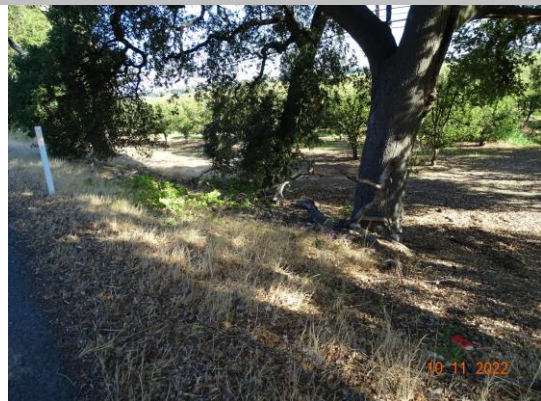
Photo 1 of 1 : FA\_2022\_RD0369\_207\_19\_20221031\_00040.jpg

LM Start	0.52	Rating **	M	Issue No.	19
LM End	0.52	Issue Type +	Ma	Location *	LS
Category	Earthen Levee			GPS Latitude/Longitude	
				Start	End
Item	Trim / Thin Trees			38.253273 °	38.253273 °
				-121.511505 °	-121.511505 °
DWR ID	DWR_RD0369_01_f_2018_19				
Comment Code					
T2 : Tree or limb.					
Inspector Comment					
Remove tree limb from the landside slope.

View of the tree limb on the LS slope (Fall 2022).

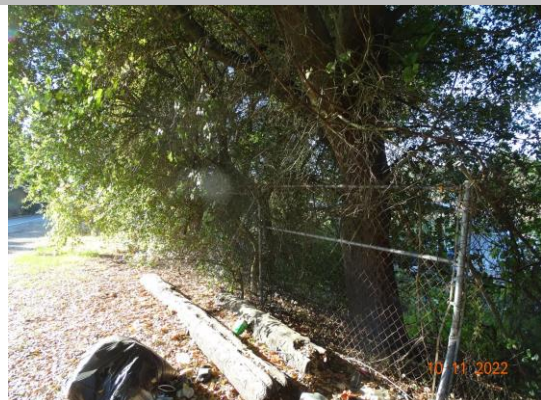
Photo 1 of 1 : FA\_2022\_RD0369\_207\_25\_20221031\_00037.jpg

LM Start	0.56	Rating **	U	Issue No.	25
LM End	0.60	Issue Type +	En	Location *	WS
Category	Earthen Levee			GPS Latitude/Longitude	
				Start	End
Item	Encroachments			38.252692 °	38.252247 °
				-121.511167 °	-121.510922 °
DWR ID	DWR_RD0369_01_s_2019_25				
Comment Code					
FE : Fence					
Inspector Comment					
A chain-link fence is located on the waterside slope.

View of the fence on the WS slope (Fall 2022).

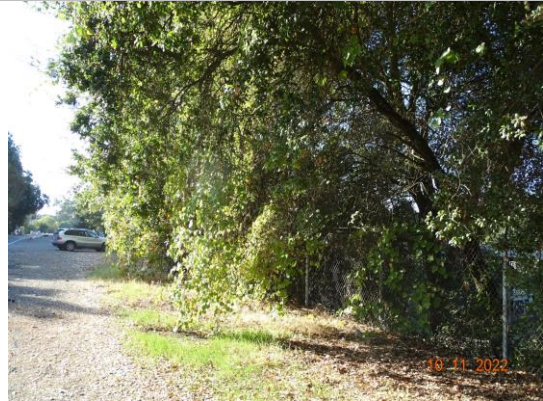
Photo 1 of 1 : FA\_2022\_RD0369\_207\_26\_20221031\_00038.jpg

LM Start	0.57	Rating **	U	Issue No.	26
LM End	0.60	Issue Type +	En	Location *	WS
Category	Earthen Levee			GPS Latitude/Longitude	
				Start	End
Item	Vegetation			38.252662 °	38.252247 °
				-121.511138 °	-121.510922 °
DWR ID	DWR_RD0369_01_s_2019_26				
Comment Code					
V6 : Landscaping					
Inspector Comment					
Vegetation on chain-link fence is blocking view down waterside slope.

View of the vegetation and fence on the WS slope (Fall 2022).

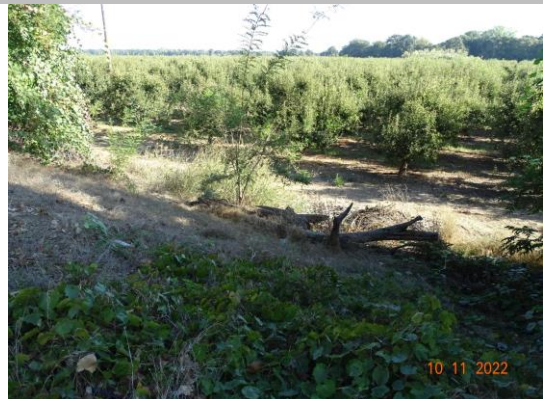
Photo 1 of 1 : FA\_2022\_RD0369\_207\_14\_20221031\_00045.jpg

LM Start	0.58	Rating **	M	Issue No.	14
LM End	0.58	Issue Type +	Ma	Location *	LS
Category	Earthen Levee			GPS Latitude/Longitude	
				Start	End
Item	Trim / Thin Trees			38.252494 °	38.252494 °
				-121.510961 °	-121.510961 °
DWR ID	DWR_RD0369_01_s_2018_14				
Comment Code					
T2 : Tree or limb.					
Inspector Comment					
Fallen tree and branches should be removed from landside toe.

View of the fallen tree on the LS toe (Fall 2022).

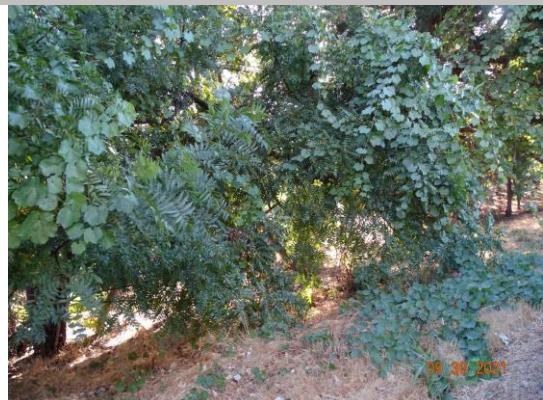
Photo 1 of 1 : FA\_2022\_RD0369\_207\_31\_20220831\_00016.jpg

LM Start	0.59	Rating **	M	Issue No.	31
LM End	0.59	Issue Type +	Ma	Location *	LS
Category	Earthen Levee			GPS Latitude/Longitude	
				Start	End
Item	Trim / Thin Trees			38.252414 °	38.252414 °
				-121.510931 °	-121.510931 °
DWR ID	DWR_RD0369_01_f_2021_31				
Comment Code					
T1 : Trim and thin trees to at least five feet above ground level to allow visibility of the ground and room to flood fight.					
Inspector Comment

View of tree needing trimming on the landside slope (Fall 2021).

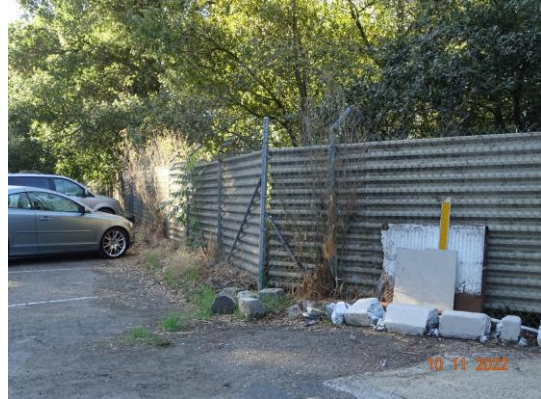
Photo 1 of 1 : FA\_2022\_RD0369\_207\_29\_20221031\_00039.jpg

LM Start	0.62	Rating **	U	Issue No.	29
LM End	0.67	Issue Type +	En	Location *	WS
Category	Earthen Levee			GPS Latitude/Longitude	
				Start	End
Item	Encroachments			38.251982 °	38.251267 °
				-121.510853 °	-121.510480 °
DWR ID	DWR_RD0369_01_s_2019_29				
Comment Code					
FE : Fence					
Inspector Comment					
A fence is blocking the view of the waterside slope.

View of the fence on the WS shoulder (Fall 2022).

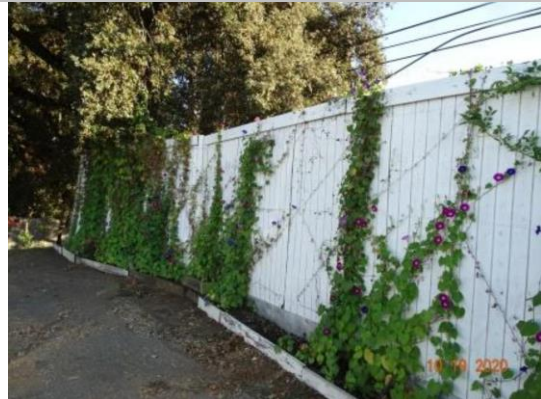
Photo 1 of 1 : FA\_2022\_RD0369\_207\_15\_20220831\_00008.jpg

LM Start	0.66	Rating **	U	Issue No.	15
LM End	0.66	Issue Type +	En	Location *	LS
Category	Earthen Levee			GPS Latitude/Longitude	
				Start	End
Item	Encroachments			38.251403 °	38.251403 °
				-121.510532 °	-121.510532 °
DWR ID	DWR_RD0369_01_s_2012_15				
Comment Code					
FE : Fence					
Inspector Comment					
A tall, white, solid fence is blocking the view of the landside levee slope.

View of white fence on the landside shoulder (Fall 2020).

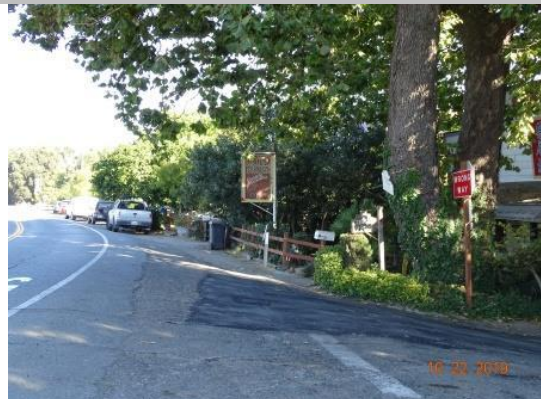
Photo 1 of 1 : FA\_2022\_RD0369\_207\_8\_20220831\_00002.jpg

LM Start	0.70	Rating **	M	Issue No.	8
LM End	0.77	Issue Type +	En	Location *	LS
Category	Earthen Levee			GPS Latitude/Longitude	
				Start	End
Item	Vegetation			38.250904 °	38.249930 °
				-121.510223 °	-121.509880 °
DWR ID	DWR_RD0369_01_s_2017_8				
Comment Code					
V6 : Landscaping					
Inspector Comment					
Landscaping needs to be thinned and maintained to allow inspection and access to landside slope and toe.

View looking upstream at landscaping on the landside slope (Fall 2019).
