**Flood Control Project Maintenance
Levee Inspections
Fall 2023 Levee Maintenance Deficiency Summary Report**

Sacramento River Basin

Reclamation District No. 0369 Libby McNeil

Levee Inspection Report By Mile - Fall 2023

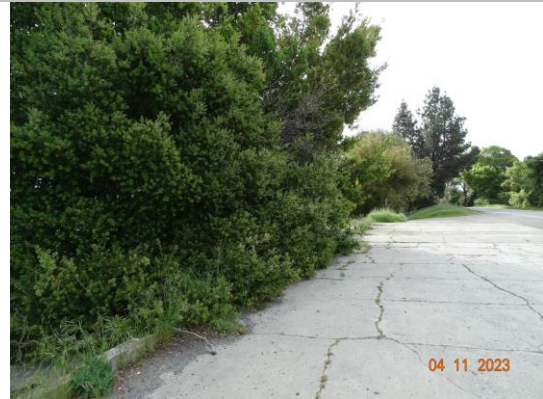
Photo 1 of 1 : FA_2023_RD0369_207_24_20231030_00011.jpg

LM Start	0.03	Rating **	U	Issue No.	24
LM End	0.03	Issue Type +	Ma	Location *	LS
Category	Earthen Levee			GPS Latitude/Longitude	
				Start	End
Item	Trim / Thin Trees			38.258599°	38.258599°
				-121.517315°	-121.517315°
DWR ID	DWR_RD0369_01_s_2021_24				
Comment Code					
T1 : Trim and thin trees to at least five feet above ground level to allow visibility of the ground and room to flood fight.					
Inspector Comment

View of the thick tree on the LS slope (Spring 2023).

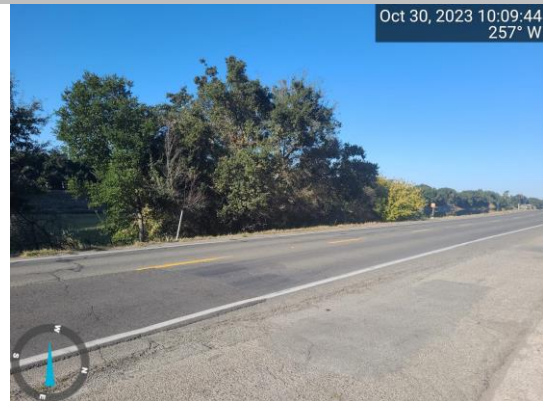
Photo 1 of 1 : FA_2023_RD0369_207_17_20231101_00022.jpg

LM Start	0.04	Rating **	M	Issue No.	17
LM End	0.04	Issue Type +	Ma	Location *	WS
Category	Earthen Levee			GPS Latitude/Longitude	
				Start	End
Item	Trim / Thin Trees			38.258386°	38.258386°
				-121.517269°	-121.517269°
DWR ID	DWR_RD0369_01_f_2021_17				
Comment Code					
T1 : Trim and thin trees to at least five feet above ground level to allow visibility of the ground and room to flood fight.					
Inspector Comment					
Trees on the waterside slope need to be trimmed to 5 feet above the waterside slope for visibility.

View of trees with low hanging branches on the waterside slope (Fall 2023).

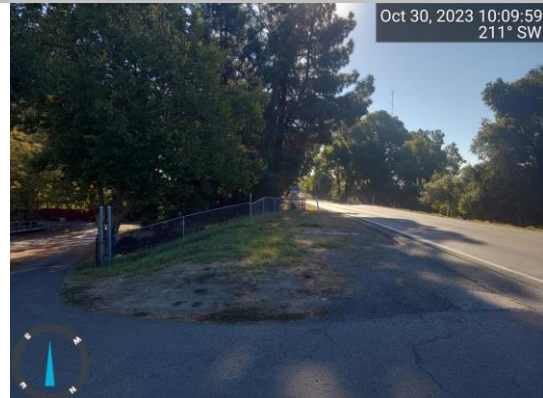
Photo 1 of 1 : FA_2023_RD0369_207_20_20231101_00023.jpg

LM Start	0.07	Rating **	M	Issue No.	20
LM End	0.10	Issue Type +	En	Location *	LS
Category	Earthen Levee			GPS Latitude/Longitude	
				Start	End
Item	Encroachments			38.258223°	38.257943°
				-121.516918°	-121.516490°
DWR ID	DWR_RD0369_01_f_2019_20				
Comment Code					
FE : Fence					
Inspector Comment					
There is a chain-link fence on the LS shoulder.

View of a chainlink fence on the landside slope (Fall 2023).

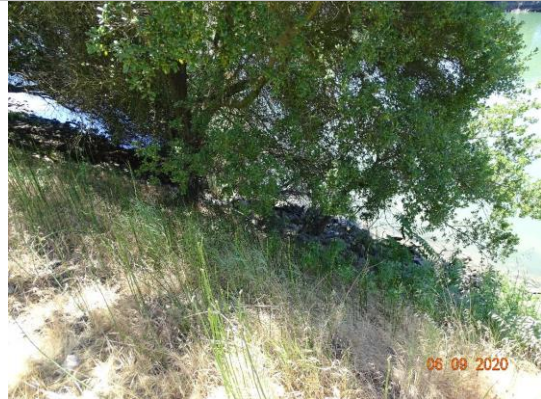
Photo 1 of 3 : UCIP_FA_2023_60725_88054.jpg

Comment Code						
Inspector Comment						
DS_ID:25084 FS_ID:60725 EP_NO: N/A Repair Type: Urgent EVAL Issue: 1, Pipe Integrity Crossing Status: Found UCIP Comments: 06/09/2020 Record remains Urgent. Through holes in pipe on landside slope. Crossing appears abandoned. No pipe found on waterside. No permit has been identified authorizing pipe. Need to have CVFPB review ABO and determine current owner. (O.Yakimov - DWR UCIP) 07/12/2018 Pipe shows more signs of corrosion. Unable to find pipe on WS. (O.Yakimov-DWR UCIP)06/01/2016 Same as last inspection. (K. Fazel - UCIP)03/04/2015 Severe corrosion and holes visible in pipe on LS shoulder. Pipe appears abandoned and should be done so properly. (W. Wyle - FPIIB) FIELD_STRUCT_DESC: 4-inch steel pipe of an unknown purpose through the levee, 1 foot below the crown. Pipe visible on the landside (LS) slope just in front of the gate on the LS shoulder. (4-inch pipe [HLM 0.08] authorized under Automatic Board Order (ABO) issued as Permit No. 8555, 1973 - Jordan Investment Co. c/o Walter E. Herman). [Additional Reference(s): DWR Levee Log, 2005 (HLM 0.08). USACE Sacramento O&M Manual, Unit 111, May 1959, Revised 29 December 2016, (RM 27.87 - O&M Manual misidentifies this location as RM 28.87), listed as 4-inch pipe. USACE As-Built Drawing No. 06-13-1100, Sheet 15, upstream of 'L' 1663+96, January 1933]. FS Date: 6/9/2020 9:26:37 AM

Water-Side: View of levee slope looking from crown

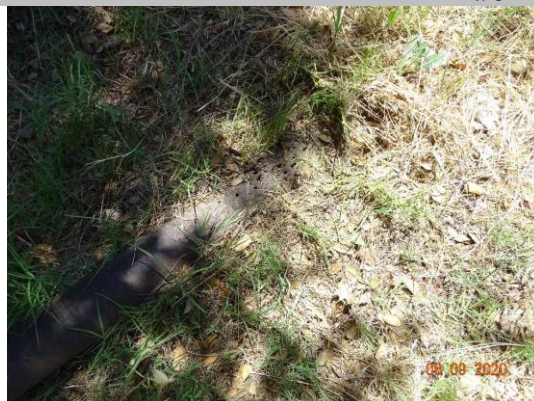
Photo 2 of 3 : UCIP_FA_2023_60725_88052.jpg

Land-Side: View of pipe with through holes on levee slope

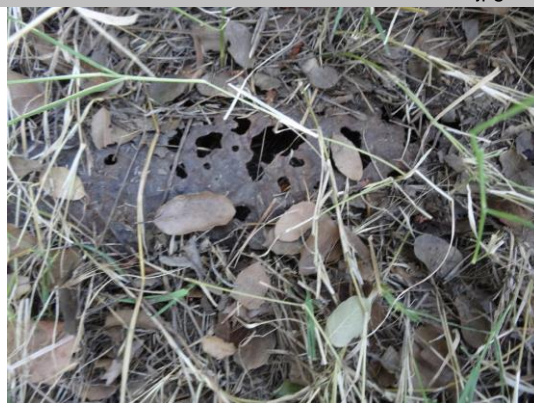
Photo 3 of 3 : UCIP_FA_2023_60725_75200.jpg

LS slope: holes in pipe still present.

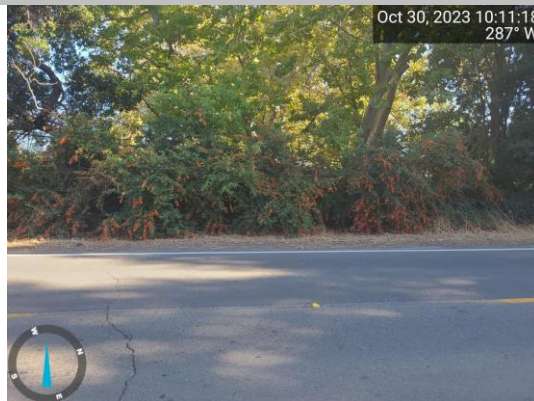
Photo 1 of 1 : FA_2023_RD0369_207_4_20231101_00024.jpg

LM Start	0.10	Rating **	M	Issue No.	4
LM End	0.10	Issue Type +	En	Location *	LS
Category	Earthen Levee			GPS Latitude/Longitude	
				Start	End
Item	Vegetation			38.257819°	38.257819°
				-121.516427°	-121.516427°
DWR ID	DWR_RD0369_01_s_2012_4				
Comment Code					
V6 : Landscaping					
Inspector Comment					
Landscaping on landside shoulder needs to be maintained.

View of landscaping on the landside shoulder (Fall 2023).

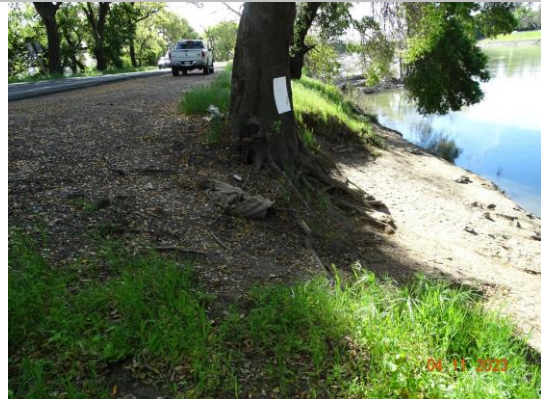
Photo 1 of 1 : FA_2023_RD0369_207_9_20231030_00003.jpg

LM Start	0.11	Rating **	A/W	Issue No.	9
LM End	0.11	Issue Type +	Ma	Location *	WS
Category	Earthen Levee			GPS Latitude/Longitude	
				Start	End
Item	Erosion / Foot Traffic			38.257757°	38.257757°
				-121.516347°	-121.516347°
DWR ID	DWR_RD0369_01_s_2020_9				
Comment Code					
E3 : Repair the levee slope damaged by foot traffic and prevent access where possible.					
Inspector Comment					
Minor path created by fishermen. Levee is wide in this section due to a turnout on the WS.

View of the minor erosion on the WS slope (Spring 2023).

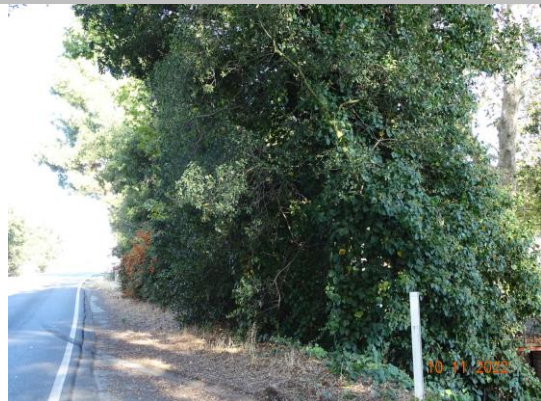
Photo 1 of 1 : FA_2023_RD0369_207_13_20231030_00006.jpg

LM Start	0.11	Rating **	M	Issue No.	13
LM End	0.12	Issue Type +	En	Location *	LS
Category	Earthen Levee			GPS Latitude/Longitude	
				Start	End
Item	Vegetation			38.257772°	38.257682°
				-121.516248°	-121.516201°
DWR ID	DWR_RD0369_01_f _ 2019_13				
Comment Code					
V6 : Landscaping					
Inspector Comment					
Remove ivy.

View of the ivy on the LS slope (Fall 2022).

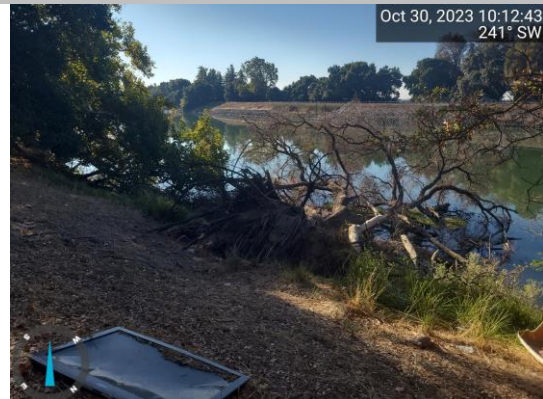
Photo 1 of 1 : FA_2023_RD0369_207_3_20231101_00025.jpg

LM Start	0.13	Rating **	M	Issue No.	3
LM End	0.13	Issue Type +	Ma	Location *	WS
Category	Earthen Levee			GPS Latitude/Longitude	
				Start	End
Item	Trim / Thin Trees			38.257593°	38.257593°
				-121.516089°	-121.516089°
DWR ID	DWR_RD0369_01_f_2023_3				
Comment Code					
T3 : Fallen tree with root ball.					
Inspector Comment					
A fallen tree with a root ball needs to be removed, and root ball backfilled and compacted to original grade.

View of a fallen tree with root ball on the waterside slope (Fall 2023).

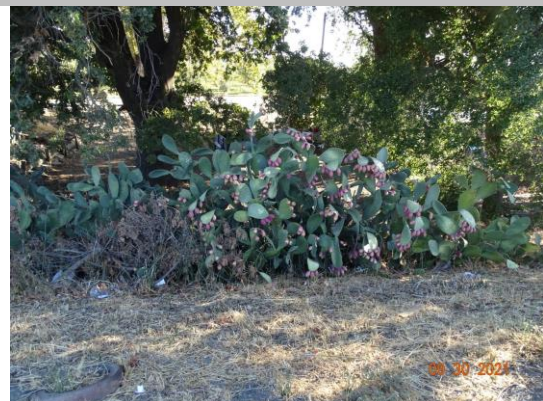
Photo 1 of 1 : FA_2023_RD0369_207_32_20231030_00015.jpg

LM Start	0.17	Rating **	U	Issue No.	32
LM End	0.17	Issue Type +	En	Location *	LS
Category	Earthen Levee			GPS Latitude/Longitude	
				Start	End
Item	Vegetation			38.257197°	38.257197°
				-121.515403°	-121.515403°
DWR ID	DWR_RD0369_01_f _ 2021_32				
Comment Code					
V6 : Landscaping					
Inspector Comment					
Remove cactus on the landside slope.

View of cactus on the landside slope (Fall 2021).

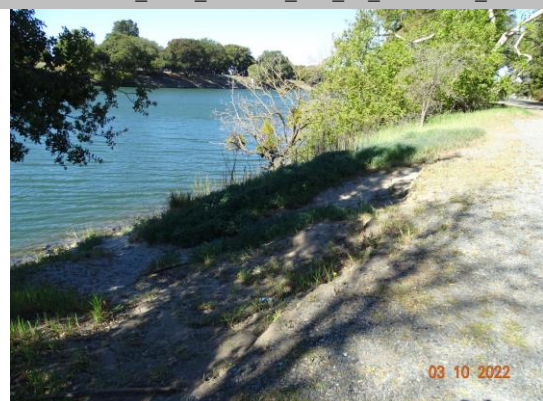
Photo 1 of 1 : FA_2023_RD0369_207_10_20231030_00004.jpg

LM Start	0.18	Rating **	A/W	Issue No.	10
LM End	0.18	Issue Type +	Ma	Location *	WS
Category	Earthen Levee			GPS Latitude/Longitude	
				Start	End
Item	Erosion / Foot Traffic			38.257137°	38.257137°
				-121.515407°	-121.515407°
DWR ID	DWR_RD0369_01_f_2019_10				
Comment Code					
E3 : Repair the levee slope damaged by foot traffic and prevent access where possible.					
Inspector Comment					
Large path created by fishermen. Levee is very wide in this section due to a turnout on the WS.

View of erosion due to foot traffic on the WS slope looking slightly upstream (Spring 2022).

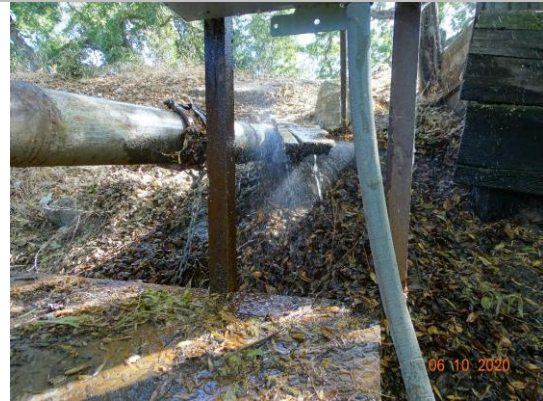
Photo 1 of 3 : UCIP_FA_2023_60752_88065.jpg

DS_ID:18972
FS_ID:60752
EP_NO: 11117
Repair Type: Urgent
EVAL Issue: 1, Pipe Integrity
Crossing Status: Found
UCIP Comments: 06/10/2020 Record updated from Non-Urgent to Urgent. Hole in pipe on waterside slope above pump. Pipe is running - leak through the hole poses a threat to waterside levee slope. 6-inch pipe installed on landside slope right after siphon breaker. Levee slope was disturbed at this location. 6-inch pipe is running down diagonally on landside slope towards PVC pipe connection at the toe. Unable to find a permit for modification. No permit has been identified authorizing pipe through the levee. Need to have CVFPB review ABO and determine current owner. (O.Yakimov - DWR UCIP)
10/15/2012 Siphon breaker on LS slope needs protection. Water is leaking from pump station. Abandoned concrete structure found on WS.

10-inch abandoned pipe found on WS. Should be removed. 6-inch abandoned pipe found on WS. Should be removed.
FIELD_STRUCT_DESC: 10-inch steel irrigation discharge pipe through the levee, 4.5 feet below the crown. Pump and gate valve on the waterside (WS) shoulder. Siphon breaker on the landside (LS) slope. Electric meter, panel at landside toe, 1.5-inch electrical conduit at same location. Abandoned concrete standpipe at landside levee toe. (10-inch pipe [HLM 0.36] authorized under Automatic Board Order (ABO) issued as Permit No. 11117, 1975 - Erma E. Locke et al). [Additional Reference(s): DWR Levee Log, 2005 (HLM 0.36). USACE Sacramento O&M Manual, Unit 111, May 1959, Revised 29 December 2016, (RM 27.63), listed as 10-inch pipe. USACE As-Built Drawing No. 50-04-2983, Sheets 2 and 3, Station 5+83, March 1954. USACE As-Built Drawing No. 06-13-1100, Sheet 15, downstream of 'L' 1671+00, January 1933].

Water-Side: Pipe leak on levee slope above pump

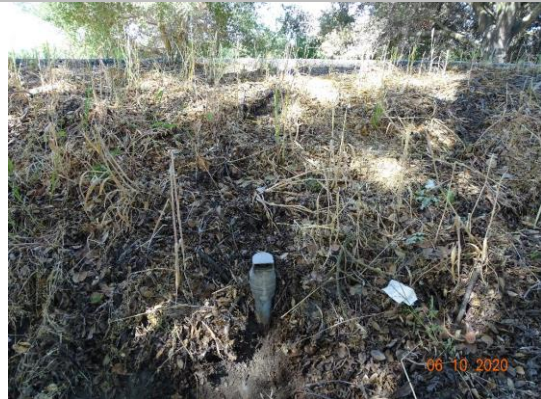
Photo 2 of 3 : UCIP_FA_2023_60752_88060.jpg

Land-Side: Siphon breaker on levee shoulder. Signs of levee slope disturbance below it

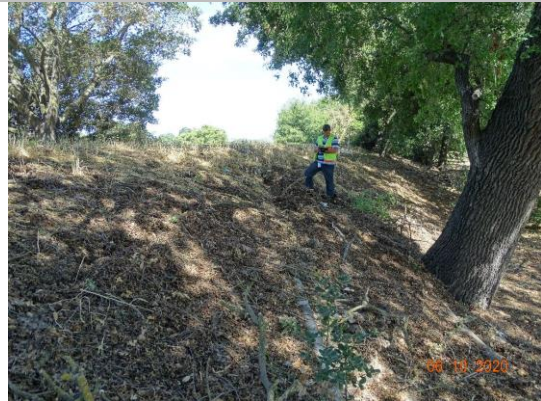
Photo 3 of 3 : UCIP_FA_2023_60752_88061.jpg

Land-Side: Overview of levee slope looking from toe. 6-inch pipe runs diagonally on levee slope

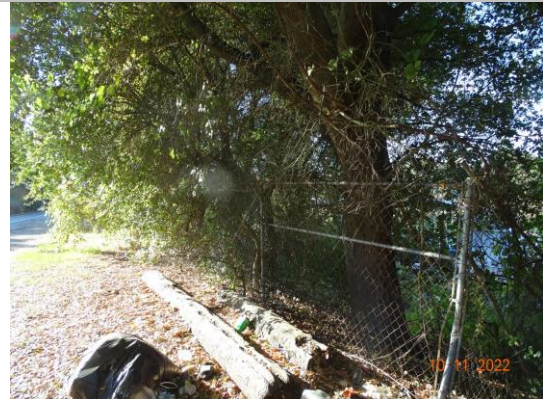
Photo 1 of 1 : FA_2023_RD0369_207_25_20231030_00012.jpg

LM Start	0.56	Rating **	M	Issue No.	25
LM End	0.60	Issue Type +	En	Location *	WS
Category	Earthen Levee			GPS Latitude/Longitude	
				Start	End
Item	Encroachments			38.252692°	38.252247°
				-121.511167°	-121.510922°
DWR ID	DWR_RD0369_01_s_2019_25				
Comment Code					
FE : Fence					
Inspector Comment					
A chain-link fence is located on the waterside slope.

View of the fence on the WS slope (Fall 2022).

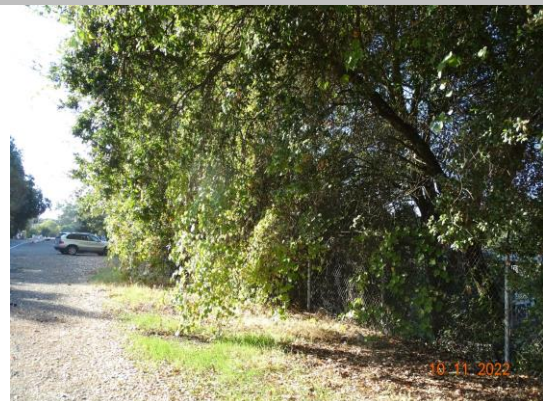
Photo 1 of 1 : FA_2023_RD0369_207_26_20231030_00013.jpg

LM Start	0.57	Rating **	U	Issue No.	26
LM End	0.60	Issue Type +	En	Location *	WS
Category	Earthen Levee			GPS Latitude/Longitude	
				Start	End
Item	Vegetation			38.252662°	38.252247°
				-121.511138°	-121.510922°
DWR ID	DWR_RD0369_01_s_2019_26				
Comment Code					
V6 : Landscaping					
Inspector Comment					
Vegetation on chain-link fence is blocking view down waterside slope.

View of the vegetation and fence on the WS slope (Fall 2022).

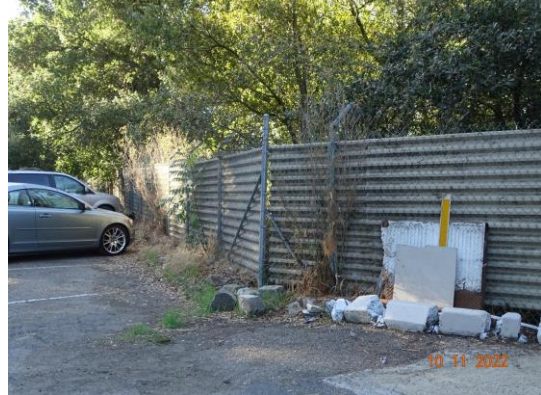
Photo 1 of 1 : FA_2023_RD0369_207_29_20231030_00014.jpg

LM Start	0.62	Rating **	U	Issue No.	29
LM End	0.67	Issue Type +	En	Location *	WS
Category	Earthen Levee			GPS Latitude/Longitude	
				Start	End
Item	Encroachments			38.251982°	38.251267°
				-121.510853°	-121.510480°
DWR ID	DWR_RD0369_01_s_2019_29				
Comment Code					
FE : Fence					
Inspector Comment					
A fence is blocking the view of the waterside slope.

View of the fence on the WS shoulder (Fall 2022).

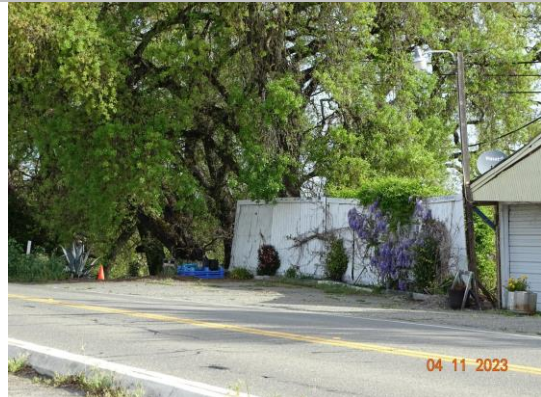
Photo 1 of 1 : FA_2023_RD0369_207_15_20231030_00008.jpg

LM Start	0.66	Rating **	U	Issue No.	15
LM End	0.66	Issue Type +	En	Location *	LS
Category	Earthen Levee			GPS Latitude/Longitude	
				Start	End
Item	Encroachments			38.251403°	38.251403°
				-121.510532°	-121.510532°
DWR ID	DWR_RD0369_01_s_2012_15				
Comment Code					
FE : Fence					
Inspector Comment					
A tall, white, solid fence is blocking the view of the landside levee slope.

View of the fence on the LS shoulder (Spring 2023).

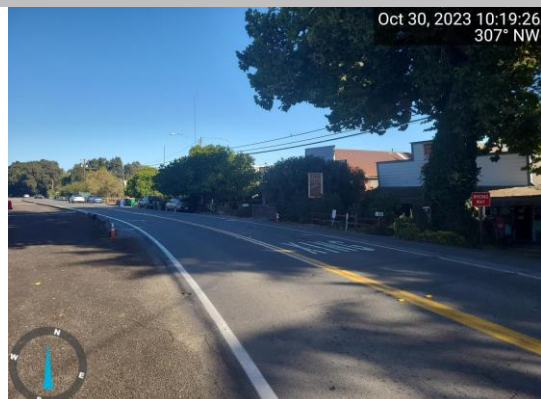
Photo 1 of 1 : FA_2023_RD0369_207_8_20231101_00026.jpg

LM Start	0.70	Rating **	M	Issue No.	8
LM End	0.77	Issue Type +	En	Location *	LS
Category	Earthen Levee			GPS Latitude/Longitude	
				Start	End
Item	Vegetation			38.250904°	38.249930°
				-121.510223°	-121.509880°
DWR ID	DWR_RD0369_01_s_2017_8				
Comment Code					
V6 : Landscaping					
Inspector Comment					
Landscaping needs to be thinned and maintained to allow inspection and access to landside slope and toe.

View looking upstream at landscaping on the landside slope (Fall 2023).
