Flood Control Project Maintenance Levee Inspections

Fall 2024 Levee Maintenance Deficiency Summary Report

Sacramento River Basin

Reclamation District No. 0369 Libby McNeil

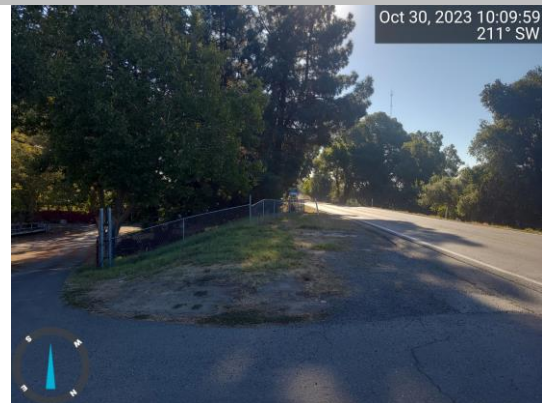
Photo 1 of 1 : FA_2024_RD0369_207_20_20241001_00009.jpg

LM Start	0.07	Rating **	M	Issue No.	20
LM End	0.10	Issue Type +	En	Location *	LS
Category	Earthen Levee			GPS Latitude/Longitude	
				Start	End
Item	Encroachments			38.258223 °	38.257943 °
				-121.516918 °	-121.516490 °
DWR ID	DWR_RD0369_01_f _ 2019_20				
Comment Code					
FE : Fence					
Inspector Comment					
There is a chain link fence on the LS shoulder.

View of a chain link fence on the landside slope (Fall 2023).

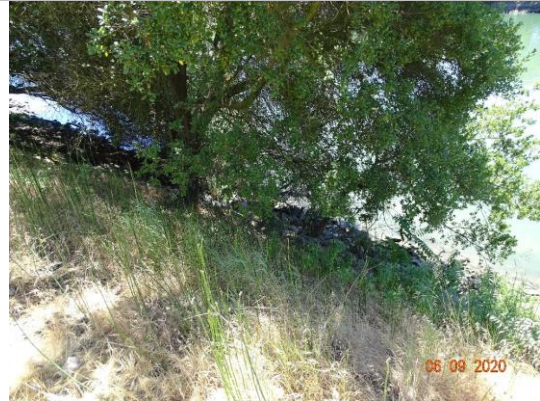
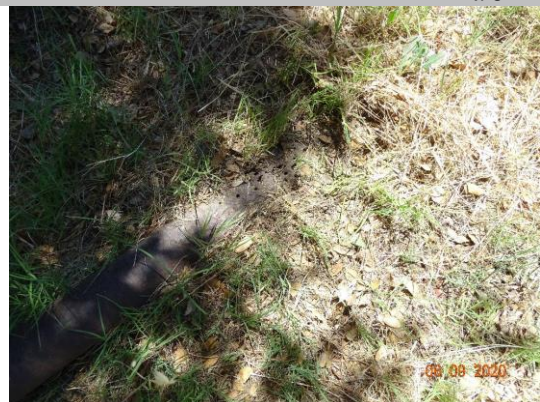
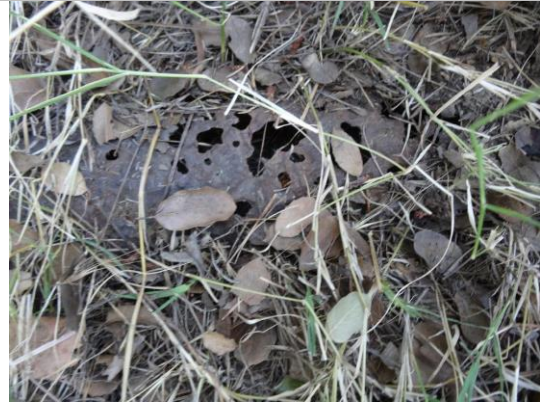
DS_ID:25084
FS_ID:60725
EP_NO: N/A
Repair Type: Urgent
EVAL Issue: 1, Pipe Integrity
Crossing Status: Found
UCIP Comments: 06/09/2020 Record remains Urgent. Through holes in pipe on landside slope. Crossing appears abandoned. No pipe found on waterside. No permit has been identified authorizing pipe. Need to have CVFPB review ABO and determine current owner. (O.Yakimov - DWR UCIP)
07/12/2018 Pipe shows more signs of corrosion. Unable to find pipe on WS. (O.Yakimov-DWR UCIP)
06/01/2016 Same as last inspection.

(K. Fazel - UCIP)
03/04/2015 Severe corrosion and holes visible in pipe on LS shoulder. Pipe appears abandoned and should be done so properly. (W. Wyle - FPIIB)
FIELD_STRUCT_DESC: 4-inch steel pipe of an unknown purpose through the levee, 1 foot below the crown. Pipe visible on the landside (LS) slope just in front of the gate on the LS shoulder. (4-inch pipe [HLM 0.08] authorized under Automatic Board Order (ABO) issued as Permit No. 8555, 1973 - Jordan Investment Co. c/o Walter E. Herman).
[Additional Reference(s): DWR Levee Log, 2005 (HLM 0.08). USACE Sacramento O&M Manual, Unit 111, May 1959, Revised 29 December 2016, (RM 27.87 - O&M Manual misidentifies this location as RM 28.87), listed as 4-inch pipe. USACE As-Built Drawing No. 06-13-1100, Sheet 15, upstream of 'L' 1663+96, January 1933].
FS Date: 6/9/2020 9:26:37 AM

Water-Side: View of levee slope looking from crown

Land-Side: View of pipe with through holes on levee slope

LS slope: holes in pipe still present.

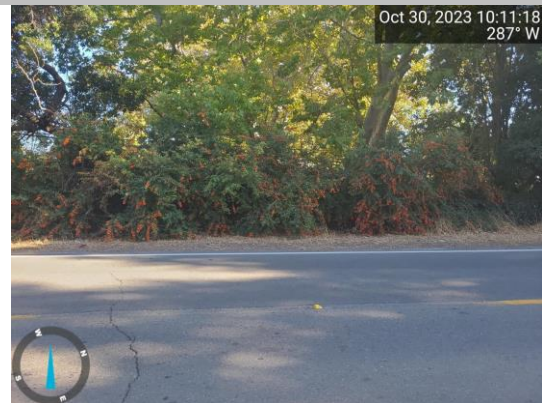
Photo 1 of 1 : FA_2024_RD0369_207_4_20241001_00002.jpg

LM Start	0.10	Rating **	M	Issue No.	4
LM End	0.10	Issue Type +	En	Location *	LS
Category	Earthen Levee			GPS Latitude/Longitude	
				Start	End
Item	Vegetation			38.257819°	38.257819°
				-121.516427°	-121.516427°
DWR ID	DWR_RD0369_01_s_2012_4				
Comment Code					
V6 : Landscaping					
Inspector Comment					
Landscaping on landside shoulder needs to be maintained.

View of landscaping on the landside shoulder (Fall 2023).

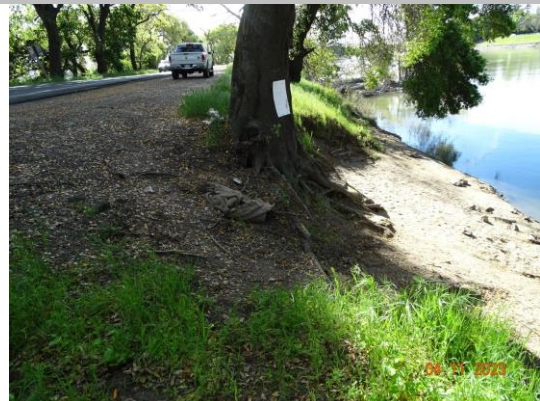
Photo 1 of 1 : FA_2024_RD0369_207_9_20241001_00004.jpg

LM Start	0.11	Rating **	A/W	Issue No.	9
LM End	0.11	Issue Type +	Ma	Location *	WS
Category	Earthen Levee			GPS Latitude/Longitude	
				Start	End
Item	Erosion / Foot Traffic			38.257757°	38.257757°
				-121.516347°	-121.516347°
DWR ID	DWR_RD0369_01_s_2020_9				
Comment Code					
E3 : Repair the levee slope damaged by foot traffic and prevent access where possible.					
Inspector Comment					
Minor path created by fishermen. Levee is wide in this section due to a turnout on the waterside. Monitor for now.

View of the minor erosion on the WS slope (Spring 2023).

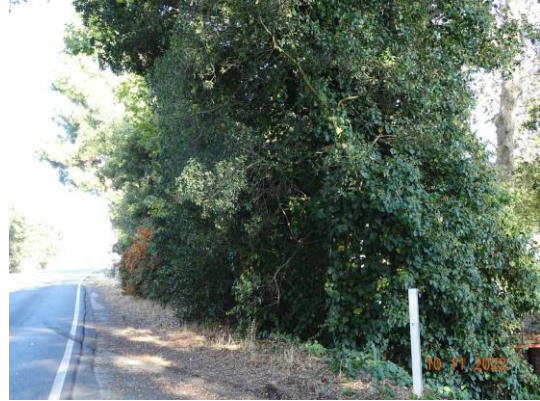
Photo 1 of 1 : FA_2024_RD0369_207_13_20241001_00006.jpg

LM Start	0.11	Rating **	M	Issue No.	13
LM End	0.12	Issue Type +	En	Location *	LS
Category	Earthen Levee			GPS Latitude/Longitude	
				Start	End
Item	Vegetation			38.257772 °	38.257682 °
				-121.516248 °	-121.516201 °
DWR ID	DWR_RD0369_01_f _ 2019_13				
Comment Code					
V6 : Landscaping					
Inspector Comment					
Remove ivy from landside slope.

View of the ivy on the LS slope (Fall 2022).

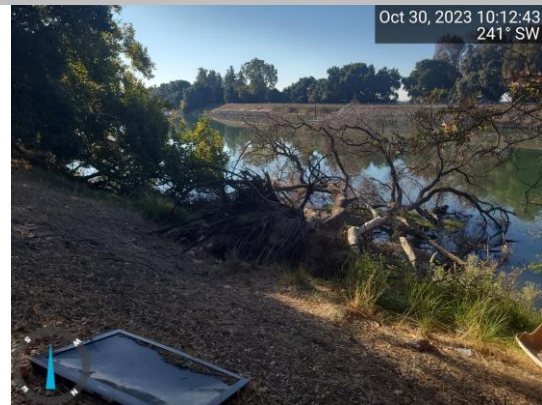
Photo 1 of 1 : FA_2024_RD0369_207_3_20241001_00001.jpg

LM Start	0.13	Rating **	M	Issue No.	3
LM End	0.13	Issue Type +	Ma	Location *	WS
Category	Earthen Levee			GPS Latitude/Longitude	
				Start	End
Item	Trim / Thin Trees			38.257593°	38.257593°
				-121.516089°	-121.516089°
DWR ID	DWR_RD0369_01_f_2023_3				
Comment Code					
T3 : Fallen tree with root ball.					
Inspector Comment					
A fallen tree with a root ball needs to be removed, and root ball backfilled and compacted to original grade.

View of a fallen tree with root ball on the waterside slope (Fall 2023).

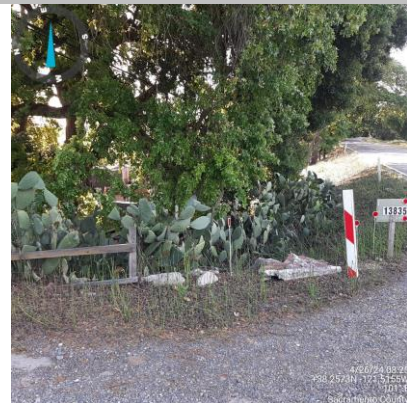
Photo 1 of 1 : FA_2024_RD0369_207_32_20241001_00013.jpg

LM Start	0.17	Rating **	U	Issue No.	32
LM End	0.17	Issue Type +	En	Location *	LS
Category	Earthen Levee			GPS Latitude/Longitude	
				Start	End
Item	Vegetation			38.257197 °	38.257197 °
				-121.515403 °	-121.515403 °
DWR ID	DWR_RD0369_01_f_2021_32				
Comment Code					
V6 : Landscaping					
Inspector Comment					
Remove cactus on the landside slope.

View of cactus on the LS slope (Spring 2024).

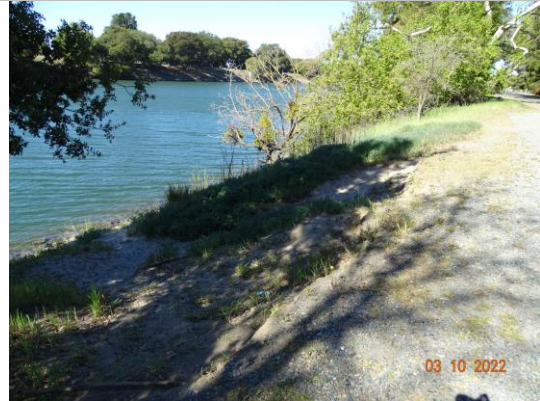
Photo 1 of 1 : FA_2024_RD0369_207_10_20241001_00005.jpg

LM Start	0.18	Rating **	A/W	Issue No.	10
LM End	0.18	Issue Type +	Ma	Location *	WS
Category	Earthen Levee			GPS Latitude/Longitude	
				Start	End
Item	Erosion / Foot Traffic			38.257137 °	38.257137 °
				-121.515407 °	-121.515407 °
DWR ID	DWR_RD0369_01_f_2019_10				
Comment Code					
E3 : Repair the levee slope damaged by foot traffic and prevent access where possible.					
Inspector Comment					
Large path created by fishermen. Levee is very wide in this section due to a turnout on the waterside. Monitor for now.

View of erosion due to foot traffic on the WS slope looking slightly upstream (Spring 2022).

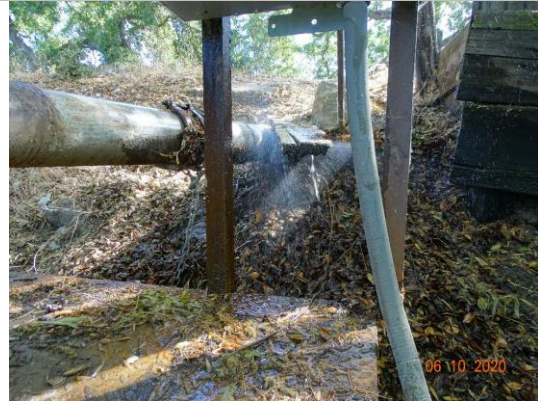
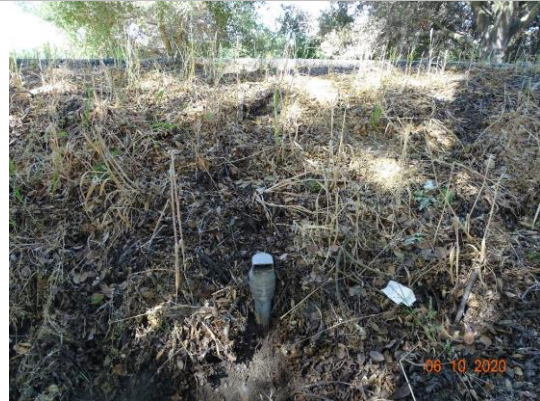
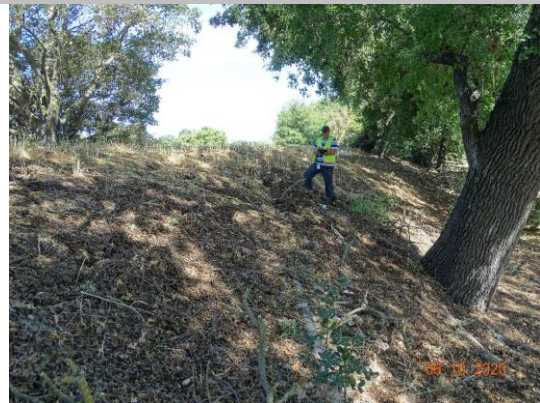
Comment Code					
Inspector Comment					
DS_ID:18972 FS_ID:60752 EP_NO: 11117 Repair Type: Urgent EVAL Issue: 1, Pipe Integrity Crossing Status: Found UCIP Comments: 06/10/2020 Record updated from Non-Urgent to Urgent. Hole in pipe on waterside slope above pump. Pipe is running - leak through the hole poses a threat to waterside levee slope. 6-inch pipe installed on landside slope right after siphon breaker. Levee slope was disturbed at this location. 6-inch pipe is running down diagonally on landside slope towards PVC pipe connection at the toe. Unable to find a permit for modification. No permit has been identified authorizing pipe through the levee. Need to have CVFPB review ABO and determine current owner. (O.Yakimov - DWR UCIP) 10/15/2012 Siphon breaker on LS slope needs protection. Water is leaking from pump station. Abandoned concrete structure found on WS. 10-inch abandoned pipe found on WS. Should be removed. 6-inch abandoned pipe found on WS. Should be removed. FIELD_STRUCT_DESC: 10-inch steel irrigation discharge pipe through the levee, 4.5 feet below the crown. Pump and gate valve on the waterside (WS) shoulder. Siphon breaker on the landside (LS) slope. Electric meter, panel at landside toe, 1.5-inch electrical conduit at same location. Abandoned concrete standpipe at landside levee toe. (10-inch pipe [HLM 0.36] authorized under Automatic Board Order (ABO) issued as Permit No. 11117, 1975 - Erma E. Locke et al). [Additional Reference(s): DWR Levee Log, 2005 (HLM 0.36). USACE Sacramento O&M Manual, Unit 111, May 1959, Revised 29 December 2016, (RM 27.63), listed as 10-inch pipe. USACE As-Built Drawing No. 50-04-2983, Sheets 2 and 3, Station 5+83, March 1954. USACE As-Built Drawing No. 06-13-1100, Sheet 15, downstream of 'L' 1671+00, January 1933]. FS Date: 6/10/2020 10:27:02 AM

Water-Side: Pipe leak on levee slope above pump

Land-Side: Siphon breaker on levee shoulder. Signs of levee slope disturbance below it

Land-Side: Overview of levee slope looking from toe. 6-inch pipe runs diagonally on levee slope

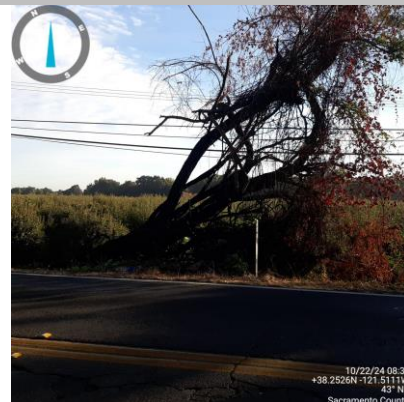
Photo 1 of 1 : FA_2024_RD0369_207_5_20241023_00020.jpg

LM Start	0.51	Rating **	U	Issue No.	5
LM End	0.51	Issue Type +	Ma	Location *	LS
Category	Earthen Levee			GPS Latitude/Longitude	
				Start	End
Item	Trim / Thin Trees			38.253362 °	38.253362 °
				-121.511625 °	-121.511625 °
DWR ID	DWR_RD0369_01_f_2024_5				
Comment Code					
T3 : Fallen tree with root ball.					
Inspector Comment					
A fallen tree with a root ball needs to be removed, and root ball backfilled and compacted to original grade.

View of fallen tree on the landside slope. (Fall 2024)

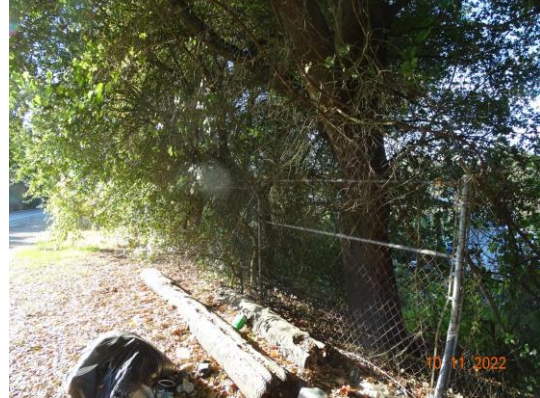
Photo 1 of 1 : FA_2024_RD0369_207_25_20241001_00010.jpg

LM Start	0.56	Rating **	M	Issue No.	25
LM End	0.60	Issue Type +	En	Location *	WS
Category	Earthen Levee			GPS Latitude/Longitude	
				Start	End
Item	Encroachments			38.252692 °	38.252247 °
				-121.511167 °	-121.510922 °
DWR ID	DWR_RD0369_01_s _ 2019_25				
Comment Code					
FE : Fence					
Inspector Comment					
A chain link fence is located on the waterside slope.

View of the fence on the WS slope (Fall 2022).

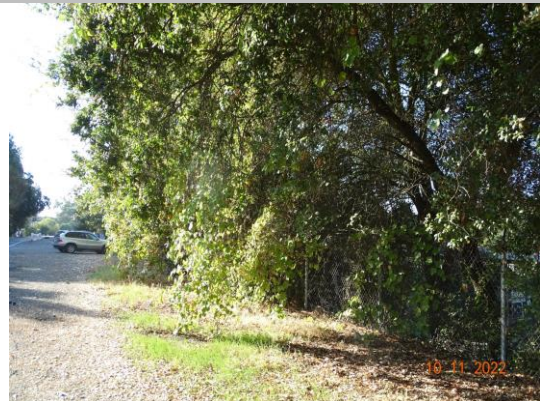
Photo 1 of 1 : FA_2024_RD0369_207_26_20241001_00011.jpg

LM Start	0.57	Rating **	U	Issue No.	26
LM End	0.60	Issue Type +	En	Location *	WS
Category	Earthen Levee			GPS Latitude/Longitude	
				Start	End
Item	Vegetation			38.252662 °	38.252247 °
				-121.511138 °	-121.510922 °
DWR ID	DWR_RD0369_01_s _ 2019_26				
Comment Code					
V6 : Landscaping					
Inspector Comment					
Vegetation on chain link fence is blocking view down waterside slope.

View of the vegetation and fence on the WS slope (Fall 2022).

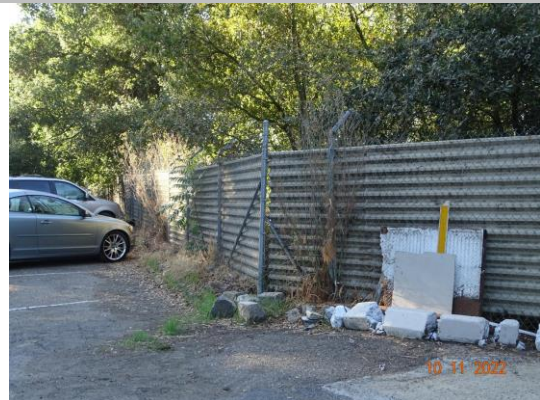
Photo 1 of 1 : FA_2024_RD0369_207_29_20241001_00012.jpg

LM Start	0.62	Rating **	U	Issue No.	29
LM End	0.67	Issue Type +	En	Location *	WS
Category	Earthen Levee			GPS Latitude/Longitude	
				Start	End
Item	Encroachments			38.251982 °	38.251267 °
				-121.510853 °	-121.510480 °
DWR ID	DWR_RD0369_01_s _ 2019_29				
Comment Code					
FE : Fence					
Inspector Comment					
A fence is blocking the view of the waterside slope.

View of the fence on the WS shoulder (Fall 2022).

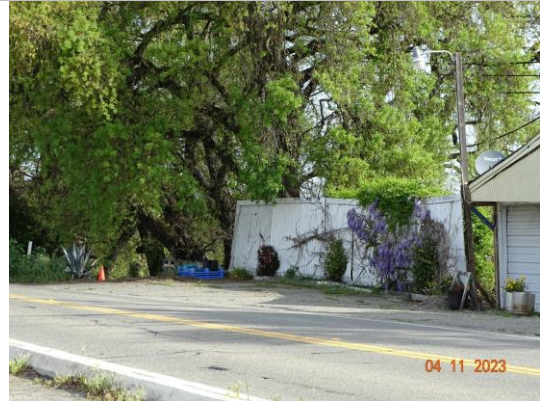
Photo 1 of 1 : FA_2024_RD0369_207_15_20241001_00007.jpg

LM Start	0.66	Rating **	U	Issue No.	15
LM End	0.66	Issue Type +	En	Location *	LS
Category	Earthen Levee			GPS Latitude/Longitude	
				Start	End
Item	Encroachments			38.251403 °	38.251403 °
				-121.510532 °	-121.510532 °
DWR ID	DWR_RD0369_01_s _ 2012_15				
Comment Code					
FE : Fence					
Inspector Comment					
A tall, white, solid fence is blocking the view of the landside levee slope.

View of the fence on the LS shoulder (Spring 2023).

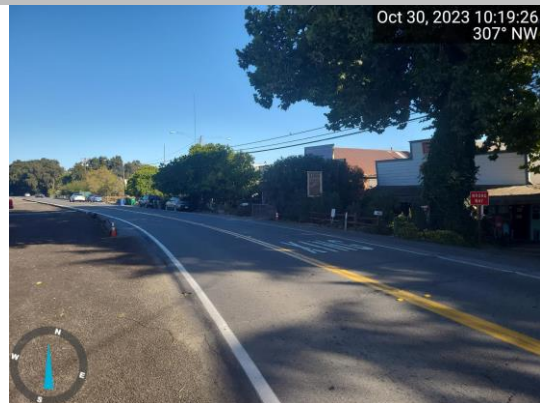
Photo 1 of 1 : FA_2024_RD0369_207_8_20241001_00003.jpg

LM Start	0.70	Rating **	M	Issue No.	8
LM End	0.77	Issue Type +	En	Location *	LS
Category	Earthen Levee			GPS Latitude/Longitude	
				Start	End
Item	Vegetation			38.250904 °	38.249930 °
				-121.510223 °	-121.509880 °
DWR ID	DWR_RD0369_01_s _ 2017_8				
Comment Code					
V6 : Landscaping					
Inspector Comment					
Landscaping needs to be thinned and maintained to allow inspection and access to landside slope and toe.

View looking upstream at landscaping on the landside slope (Fall 2023).
