**Flood Control Project Maintenance
Levee Inspections****LMA District Cover Sheet****Spring 2012 Levee Inspection Results****Reclamation District No. 0369 Libby McNeil**

Spring 2012 Levee Inspection Results

Reclamation District No. 0369 Libby McNeil

Waterway			Bank	Unit Miles
Unit No. 01 Steamboat Slough			Left	0.80
	Spring (March - May)	Summer (June - August)	(September - November) Fall	Winter (December - February)
Unit Maintenance Rating (Fall Only)				
Date of Inspection	3/15/2012 - 3/15/2012			
DWR Inspector	Herman Phillips			
Accompanied By	Clarence Chu Reclamation 369

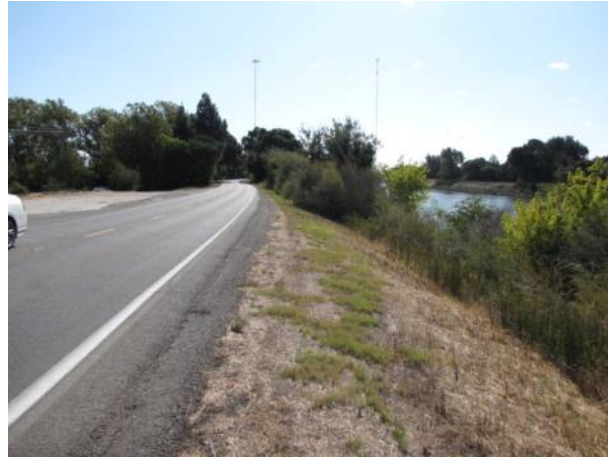
Levee Mile Report Line	4
Start Levee Mile	0.00
End Levee Mile	0.00
Location	Water Side
Category	Earthen Levee
Item	Vegetation

Standing on the waterward shoulder RD 369 L/M 0.00 looking downstream. Photo taken 10-05-2011.

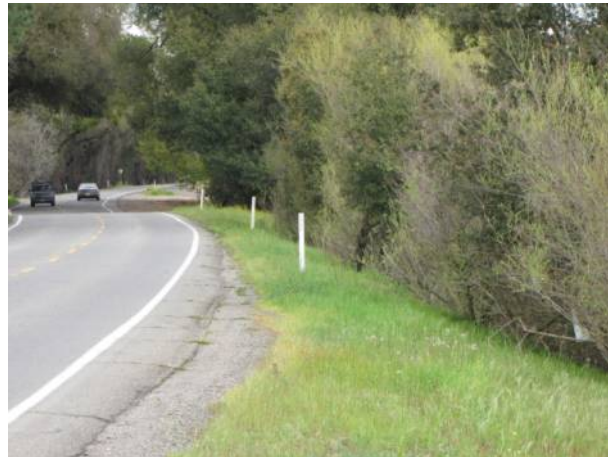
Levee Mile Report Line	4
Start Levee Mile	0.00
End Levee Mile	0.00
Location	Water Side
Category	Earthen Levee
Item	Vegetation

RD 369 Levee mile 0.00 looking downstream from waterside slope. Photo taken 3-15-2012.

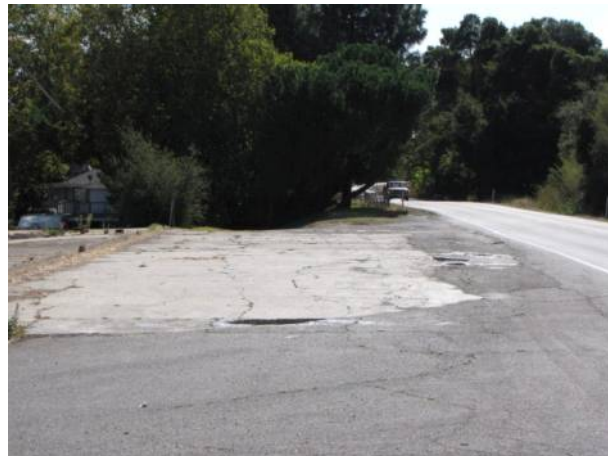
Levee Mile Report Line	5
Start Levee Mile	0.00
End Levee Mile	0.00
Location	Land Side
Category	Earthen Levee
Item	Vegetation

Standing on landward shoulder on RD 369 looking downstream from L/M 0.00. This photo was taken 10-05-2011

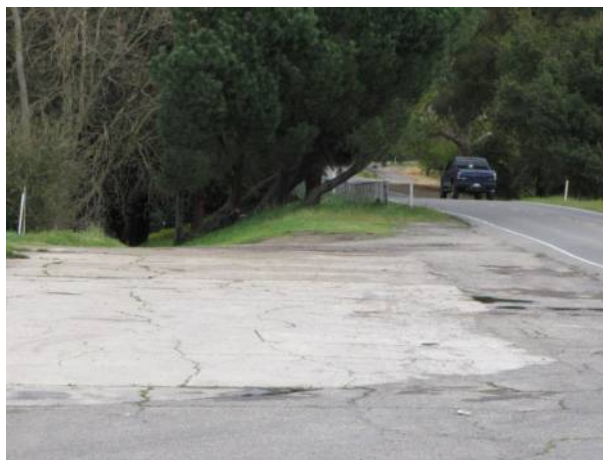
Levee Mile Report Line	5
Start Levee Mile	0.00
End Levee Mile	0.00
Location	Land Side
Category	Earthen Levee
Item	Vegetation

RD 369 Looking downstream from levee mile 0.00 landside. Photo taken 3-15-2012.

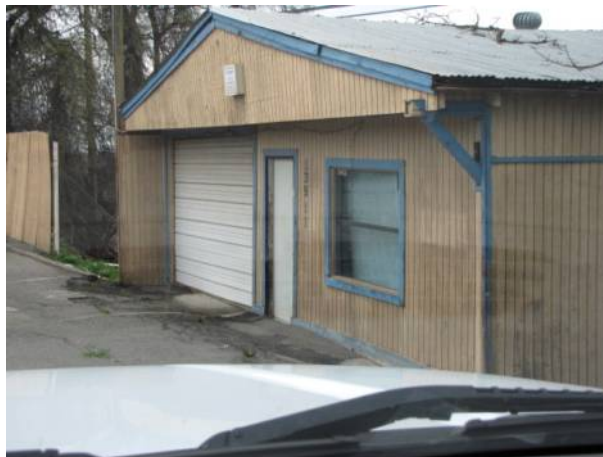
Levee Mile Report Line	15
Start Levee Mile	0.60
End Levee Mile	0.61
Location	Land Side
Category	Earthen Levee
Item	Encroachments

Building and partial wooden fence landside shoulder levee mile 0.60-0.61. Photo taken 3-15-2012.

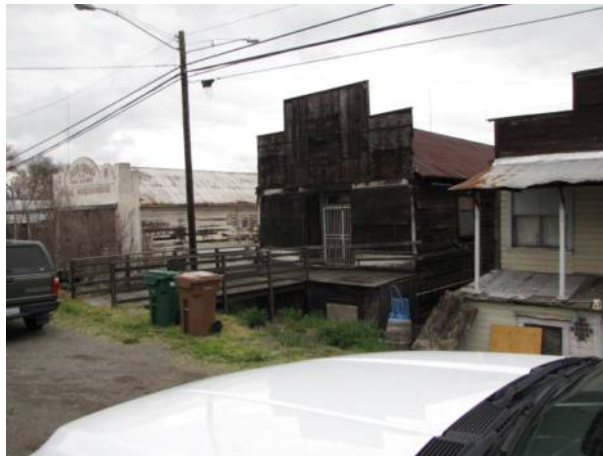
Levee Mile Report Line	17
Start Levee Mile	0.67
End Levee Mile	0.69
Location	Land Side
Category	Earthen Levee
Item	Encroachments

Building landside levee mile 0.68. Photo taken 3-15-2012.

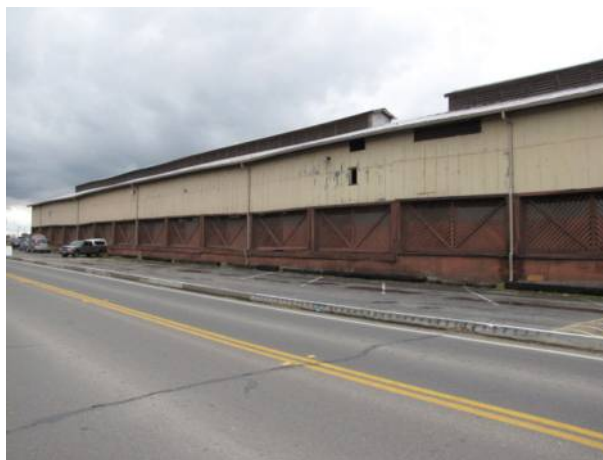
Levee Mile Report Line	18
Start Levee Mile	0.68
End Levee Mile	0.78
Location	Water Side
Category	Earthen Levee
Item	Encroachments

RD 369 Boat Marina Building levee mile 0.68-0.78. Photo taken 3-15-2012
