**Flood Control Project Maintenance  
Levee Inspections**  
**LMA District Cover Sheet**  
**Spring 2013 Levee Inspection Results**

**Reclamation District No. 0369 Libby McNeil**

**Levee Inspection Report By Mile - Spring 2013**

Waterway				Bank	Unit Miles	Inspection Start/End	Inspector	
Unit No. 01 Steamboat Slough				Left	0.80	03/20/2013 03/20/2013	Herman Phillips

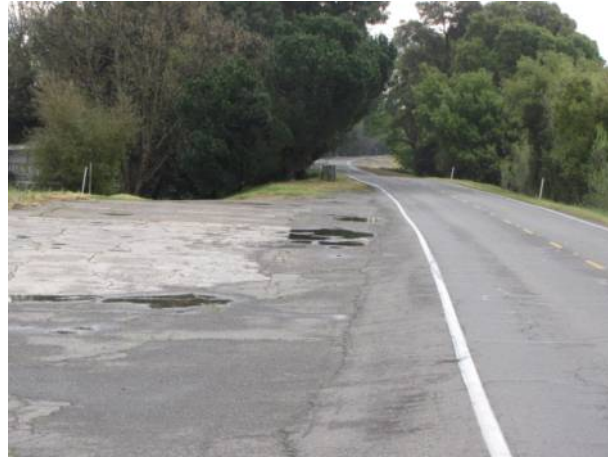
Levee Mile Report Line	4
Start Levee Mile	0.00
End Levee Mile	0.00
Location	Land Side
Category	
Item	Vegetation
RD 369 Looking downstream from levee mile 0.00 landside shoulder. Photo taken 3-20-2013.	
phillips_s_20130408_371.JPG

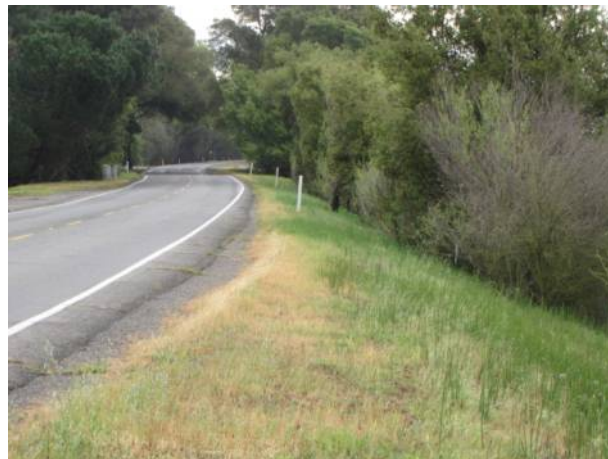
Levee Mile Report Line	5
Start Levee Mile	0.00
End Levee Mile	0.58
Location	Water Side
Category	
Item	Vegetation
RD 369 Looking downstream from levee mile 0.00 waterside slope. Photo taken 3-20-2013.	
phillips_s_20130408_370.JPG
