**Flood Control Project Maintenance
Levee Inspections**
LMA District Cover Sheet
Spring 2018 Levee Inspection Results

Reclamation District No. 0369 Libby McNeil

Levee Inspection Report By Mile - Spring 2018

Waterway	Bank	Unit Miles	Inspection Start/End	Inspector
Unit No. 01 Sacramento River	Left	0.78	03/21/2018 03/21/2018	Keith Millard

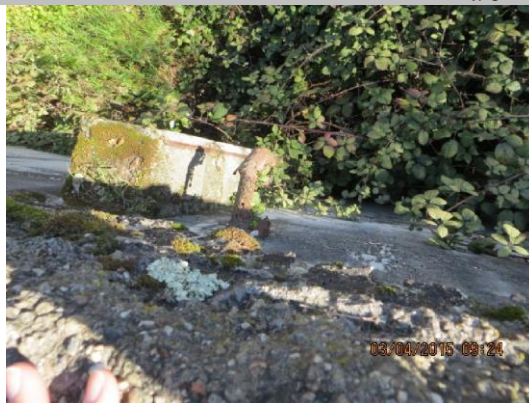
Photo 1 of 3 : UCIP_SP_2018_50105_73165.jpg

Comment Code					
Inspector Comment					
FS_ID:50105 DS_ID:18971 EP_NO: 8555 Repair Type: Non-Urgent Crossing Status: Found UCIP Comments: 03/04/2015 Pipe corroded through on LS at retaining wall. May not go all the way through the levee. Appears abandoned and if so should be done so properly. FIELD_STRUCT_DESC: *ABANDONED* 2 of 2: 4-inch steel pipe of an unknown purpose through the levee, 4 feet below the crown. Pipe visible on the landside (LS) at a retaining wall. (Retention of a 6-inch pipe and a 4-inch pipe through the levee authorized under Automatic Board Order (ABO) issued as Permit No. 8555, 1973 - Jordon Investment Company, care of Walter E. Herman). [Additional Reference(s): DWR Levee Log, 2005. USACE Sacramento O&M Manual 111, May 1959, (RM 27.87), O&M Manual misidentifies this location as RM 28.87]. FS Date: 3/4/2015 4:11:00 PM

Pipe visible on retaining wall at LS toe.

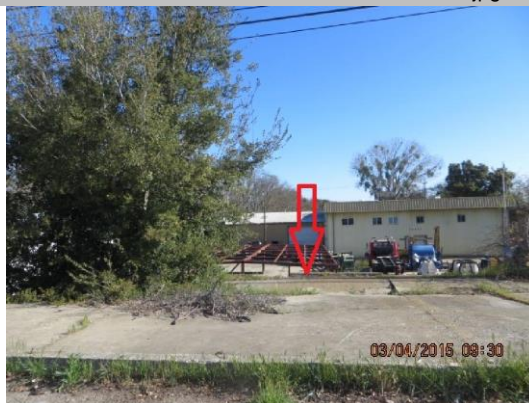
Photo 2 of 3 : UCIP_SP_2018_50105_73164.jpg

Pipe visible on retaining wall at LS toe.

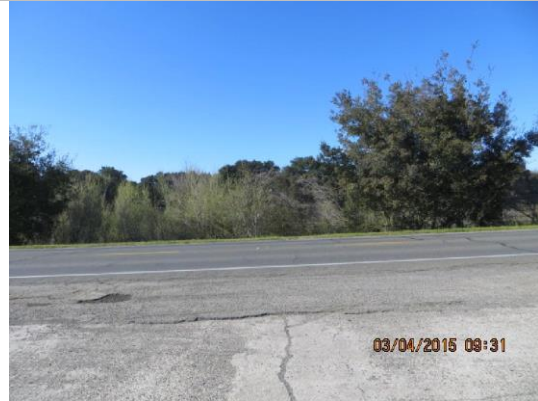
Photo 3 of 3 : UCIP_SP_2018_50105_73163.jpg

View of WS. Pipe not found on WS.

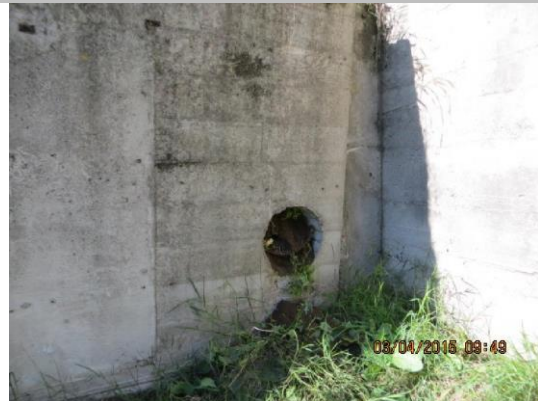
Photo 1 of 3 : UCIP_SP_2018_43811_73162.jpg

LM Start	0.05	Rating **	M	Issue No.	30
LM End	0.05	Issue Type +	En	Location *	
Category	Supplemental			GPS Latitude/Longitude	
				Start	End
Item	DWR UCIP Field Study			38.258347 °	38.258347 °
				-121.517169 °	-121.517169 °
DWR ID					
Comment Code					
Inspector Comment					
FS_ID:43811 DS_ID:18970 EP_NO: N/A Repair Type: Non-Urgent Crossing Status: Found UCIP Comments: 03/04/2015 Pipe appears abandoned and is filled with soil. Appears abandoned and if so should be done so properly. FIELD_STRUCT_DESC: *ABANDONED* 8-inch steel gravity drainage pipe through the levee, 8 feet below the crown. Hole in the concrete retaining wall on the landside (LS) slope, measures 10 inches in diameter. [Additional Reference(s): DWR Levee Log, 2005]. FS Date: 3/4/2015 4:41:00 PM

10-inch hole in concrete retaining wall likely for this pipe. Visible on LS toe. Portion of pipe visible.

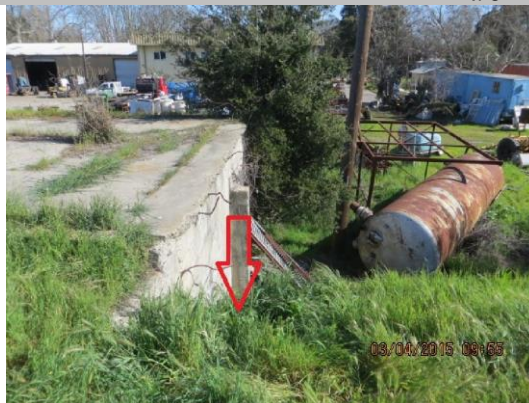
Photo 2 of 3 : UCIP_SP_2018_43811_73161.jpg

10-inch hole in concrete retaining wall likely for this pipe. Visible on LS toe.

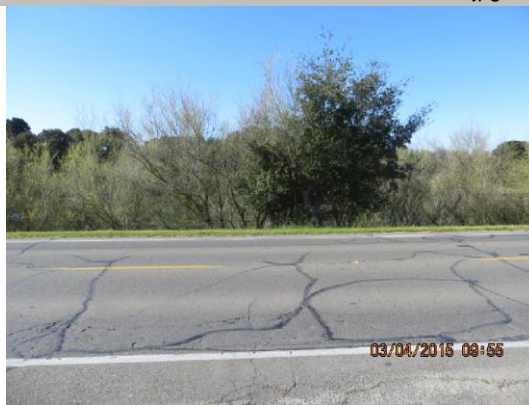
Photo 3 of 3 : UCIP_SP_2018_43811_73160.jpg

View of WS. No pipe found.

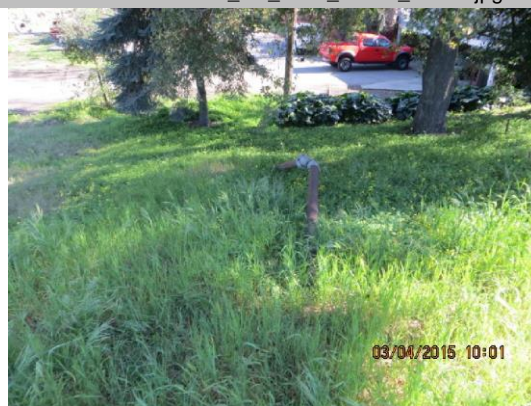
Photo 1 of 3 : UCIP_SP_2018_50158_73331.jpg

Comment Code					
Inspector Comment					
FS_ID:50158 DS_ID:25084 EP_NO: N/A Repair Type: Urgent Crossing Status: Found UCIP Comments: 06/01/2016 Same as last inspection. (K. Fazel - UCIP)03/04/2015 Severe corrosion and holes visible in pipe on LS shoulder. Pipe appears abandoned and should be done so properly. (W. Wyle - FPIIB) FIELD_STRUCT_DESC: *ABANDONED* 4-inch steel pipe of an unknown purpose through the levee, 1 foot below the crown. Pipe visible on the landside (LS) slope just in front of the gate on the LS shoulder. [Additional Reference(s): USACE Sacramento O&M Manual 111, May 1959, (RM 27.87), O&M Manual misidentifies this location as RM 28.87]. FS Date: 6/1/2016

Pipe visible on LS slope.

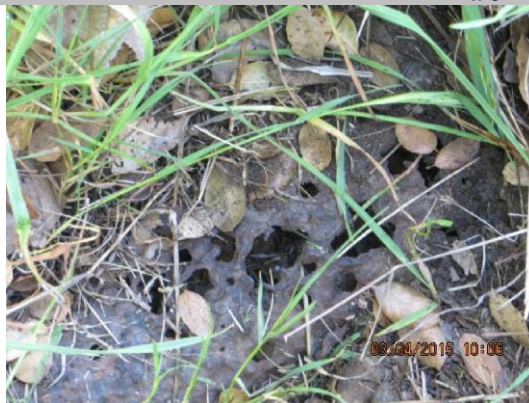
Photo 3 of 3 : UCIP_SP_2018_50158_73333.jpg

LS slope: severe corrosion and holes in pipe at upper end of pipe (near crown).

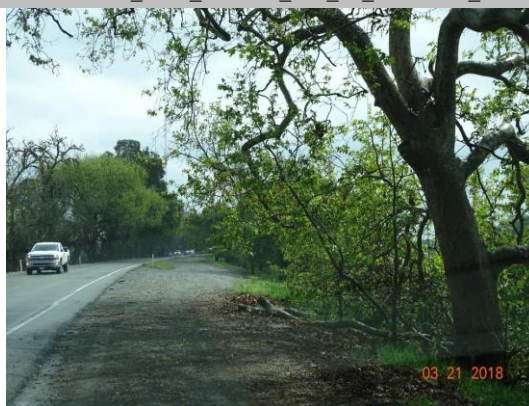
Photo 1 of 1 : SP_2018_RD0369_207_12_20180322_00025.jpg

LM Start	0.15	Rating **	M	Issue No.	12
LM End	0.15	Issue Type +	Ma	Location *	WS
Category	Earthen Levee			GPS Latitude/Longitude	
				Start	End
Item	Encroachments			38.257380 °	38.257380 °
				-121.515787 °	-121.515787 °
DWR ID	DWR_RD0369_01_s_2018_12				
Comment Code					
TR : Tree or limb					
Inspector Comment					
Cut tree branches should be removed from waterside shoulder.

Remove tree branches from waterside shoulder.

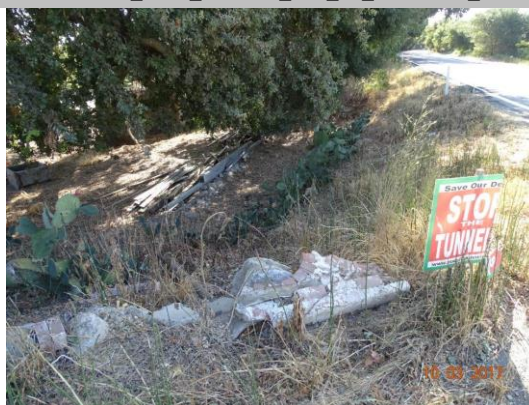
Photo 1 of 2 : SP_2018_RD0369_207_11_20180305_00005.jpg

LM Start	0.16	Rating **	U	Issue No.	11
LM End	0.16	Issue Type +	En	Location *	LS
Category	Earthen Levee			GPS Latitude/Longitude	
				Start	End
Item	Encroachments			38.257346 °	38.257346 °
				-121.515523 °	-121.515523 °
DWR ID	DWR_RD0369_01_f_2017_11				
Comment Code					
DE : Debris					
Inspector Comment					
Remove irrigation pipes, broken concrete and woody debris from land side slope and toe south of driveway to allow visibility and access.

10/03/2017: Irrigation pipes, lumber, woody debris and broken concrete should be removed from land side slope and toe.

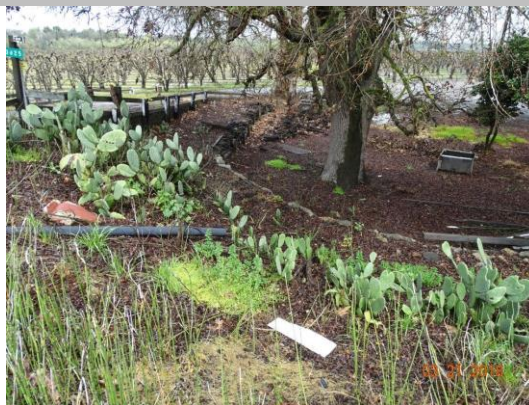
Photo 2 of 2 : SP_2018_RD0369_207_11_20180322_00026.jpg

Wood piles in landside easement.

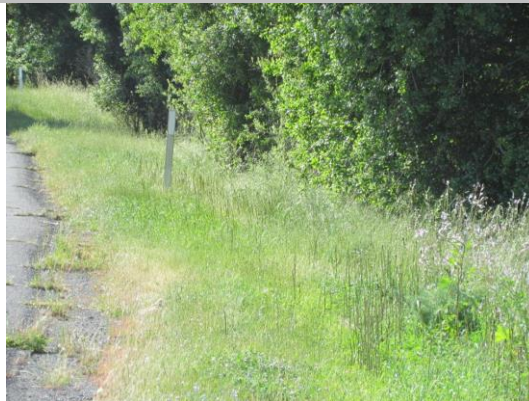
Photo 1 of 1 : SP_2018_RD0369_207_9_20180305_00003.jpg

LM Start	0.25	Rating **	M	Issue No.	9
LM End	0.57	Issue Type +	Ma	Location *	WS
Category	Earthen Levee			GPS Latitude/Longitude	
				Start	End
Item	Vegetation			38.256372 °	38.252597 °
				-121.514504 °	-121.511130 °
DWR ID	DWR_RD0369_01_s_2017_9				
Comment Code					
V2 : Remove the wild growth other than native grasses from the levee slopes.					
Inspector Comment					
Spray the weed growth along the waterside slope to 20' from crown.

Looking downstream from the waterside shoulder.

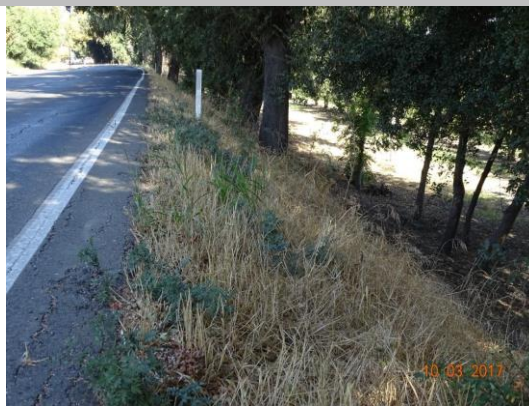
Photo 1 of 1 : SP_2018_RD0369_207_13_20180305_00006.jpg

LM Start	0.26	Rating **	A/W	Issue No.	13
LM End	0.32	Issue Type +	Ma	Location *	LS
Category	Earthen Levee			GPS Latitude/Longitude	
				Start	End
Item	Trim / Thin Trees			38.256222 °	38.255659 °
				-121.514320 °	-121.513706 °
DWR ID	DWR_RD0369_01_f_2016_13				
Comment Code					
T2 : Thin trees to allow visibility of the ground and room to flood fight.					
Inspector Comment					
Thin out the tree growth along the landside slope.

10/03/2017: Vines and low branches and heavy weed growth have been removed. Visibility and access are improved.

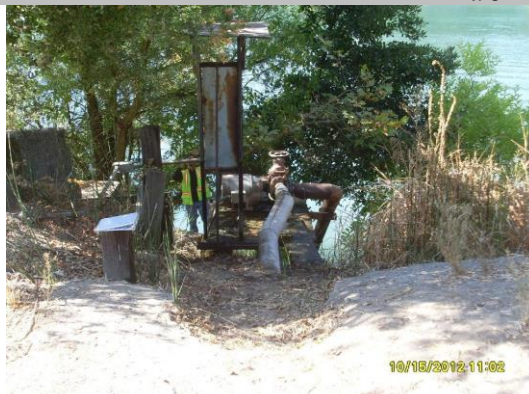
Photo 1 of 3 : UCIP_SP_2018_43814_10460.jpg

FS_ID:43814
DS_ID:18972
EP_NO: 11117
Repair Type: Non-Urgent
Crossing Status: Found
UCIP Comments: 10/15/2012 Siphon breaker on LS slope needs protection. Water is leaking from pump station. Abandoned concrete structure found on WS. 10-inch abandoned pipe found on WS. Should be removed. 6-inch abandoned pipe found on WS. Should be removed.
FIELD_STRUCT_DESC: *ABANDONED* 10-inch steel irrigation discharge pipe through the levee, 4.5 feet below the crown. Pump and gate valve on the waterside (WS) shoulder. Siphon breaker on the landside (LS) slope. 6-inch abandoned pipe also found on the WS. (Retention of a 10-inch pipe through the levee, 4.5 feet below the crown, and a pump in a pump house on the WS slope authorized under Automatic Board Order (ABO) issued as Permit No. 11117, 1975 - Erma E. Locke, et al.). [Additional Reference(s): DWR Levee Log, 2005. USACE Sacramento O&M Manual 111, May 1959, (RM 27.63), referenced as invert elevation 3.8 feet below the crown].

Waterside view: overview of pipe & pump and abandoned concrete structure (left). Shutoff Valve.

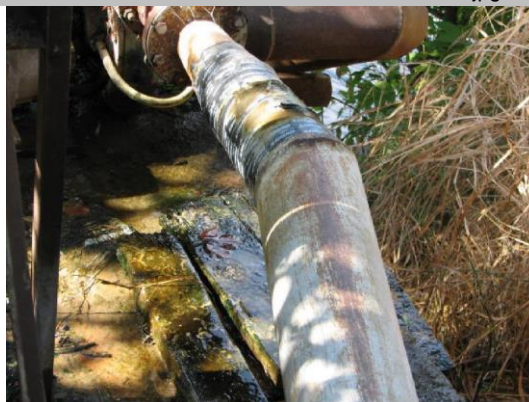
Photo 2 of 3 : UCIP_SP_2018_43814_10456.jpg

Waterside view: water leaking pump station.

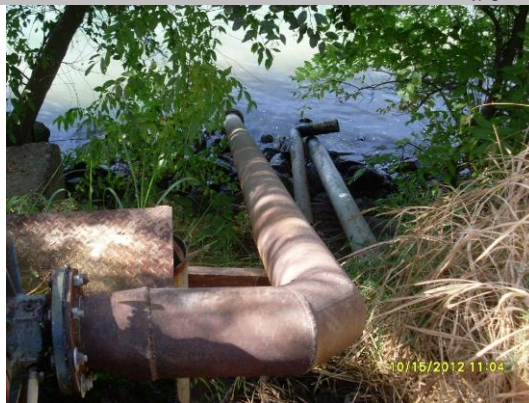
Photo 3 of 3 : UCIP_SP_2018_43814_10459.jpg

Waterside view: overview of active pipe and two abandoned pipes.

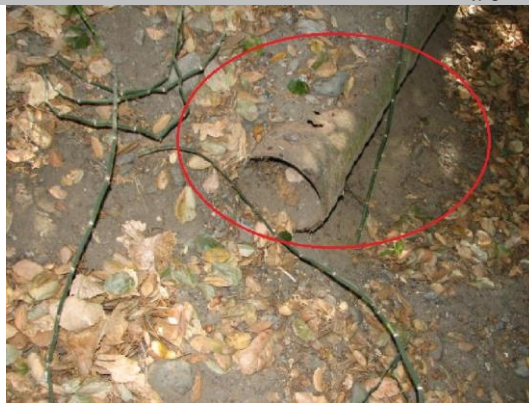
Photo 1 of 2 : UCIP_SP_2018_43815_73301.jpg

LM Start	0.50	Rating **	M	Issue No.	33
LM End	0.50	Issue Type +	En	Location *	
Category	Supplemental			GPS Latitude/Longitude	
				Start	End
Item	DWR UCIP Field Study			38.253468 °	38.253468 °
				-121.511654 °	-121.511654 °
DWR ID					
Comment Code					
Inspector Comment					
FS_ID:43815					
DS_ID:18981					
EP_NO: N/A					
Repair Type: Non-Urgent					
Crossing Status: Indicator Found					
UCIP Comments: Found abandoned pipe laying on WS levee slope.					
Pipe purpose and status should be determined. further investigation required.					
FIELD_STRUCT_DESC: 8-inch steel pipe of an unknown purpose running parallel to the levee crown on the waterside (WS) slope, 4.5 feet below the crown. This pipe was field discovered.					
FS Date: 3/4/2015

Pipe visible on WS slope running parallel to crown.

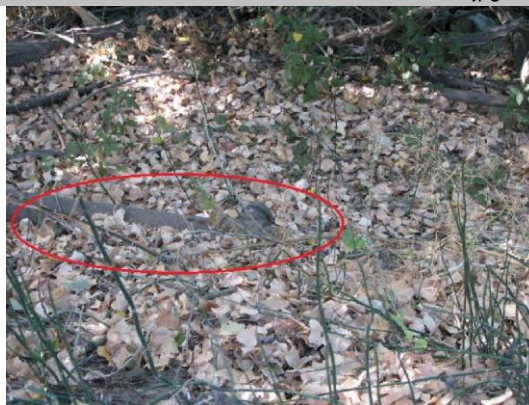
Photo 2 of 2 : UCIP_SP_2018_43815_73300.jpg

Pipe on WS slope running parallel to leveel crown.

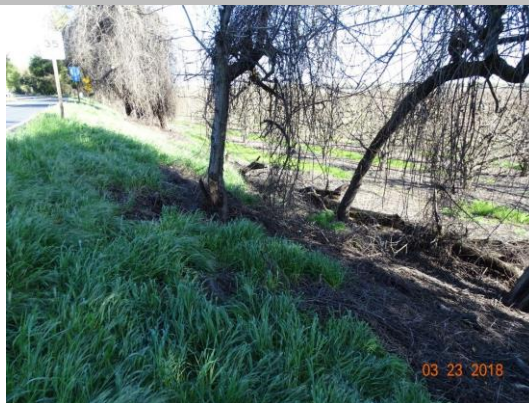
Photo 1 of 1 : SP_2018_RD0369_207_14_20180323_00027.jpg

LM Start	0.58	Rating **	M	Issue No.	14
LM End	0.58	Issue Type +	En	Location *	LS
Category	Earthen Levee			GPS Latitude/Longitude	
				Start	End
Item	Encroachments			38.252494 °	38.252494 °
				-121.510961 °	-121.510961 °
DWR ID	DWR_RD0369_01_s_2018_14				
Comment Code					
TR : Tree or limb					
Inspector Comment					
Fallen tree and branches should be removed from landside toe.

Remove fallen tree and brabches from landside toe.

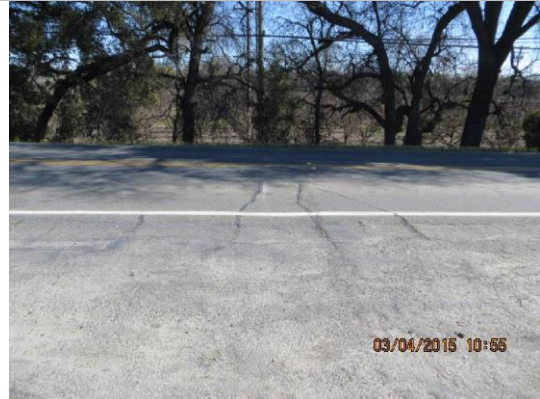
Photo 1 of 3 : UCIP_SP_2018_50159_73166.jpg

FS_ID:50159
DS_ID:18977
EP_NO: 14313
Repair Type: Urgent
Crossing Status: Indicator Found
UCIP Comments: 06/01/2016 Could not locate pipe. Likely buried next to leach box. Could not find signs of leaking or presence of water or erosion. Pipe may still be leaking but buried. (K. Fazel - UCIP)03/04/2015 Septic line appears to be leaking at LS toe. Erosion of soil and wet soil visible at LS toe. No septic smell accompanied other evidence at site. (W. Wylie - FPIIB)
FIELD_STRUCT_DESC: 3 of 3: 2-inch galvanized steel sewer line through the levee, 1 foot below the crown. Metal cutoff wall placed around the pipe near the centerline of the levee. 4-foot by 6-foot concrete box at the landside (LS) toe. Sewer line runs through the property of the district president, Clarence Chu, at ckchu52@comcast.net, (916) 776-1684, and (916) 813-7037. (Plans to install three utility pipes through the levee authorized under Permit No. 14313, 1986 - Frank and Genie Schmiedel. Plans to construct a 59-covered-berth addition to an existing boat dock, extending approximately 60 feet into the Sacramento River, authorized under Permit No. 13783, 1984 - Frank and Genie Schmiedel, mentions the leach line for the septic system).

View at crossing through crown on LS shoulder from WS shoulder.
Evidence of trench visible at cut in pavement.

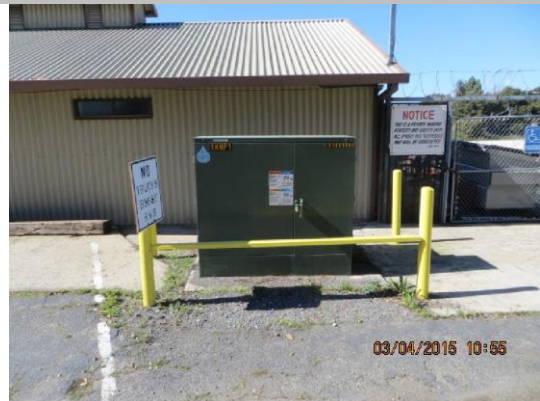
Photo 2 of 3 : UCIP_SP_2018_50159_73167.jpg

Waterside view. Unclear if there is a sewer cleanout or other evidence of pipe location on WS shoulder.

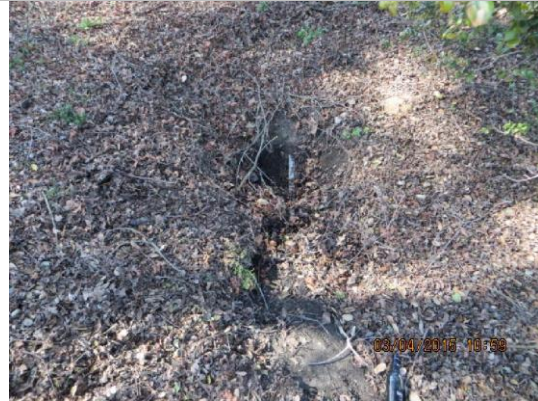
Photo 3 of 3 : UCIP_SP_2018_50159_73168.jpg

Septic line leaking at LS toe. Erosion of soil at toe visible.

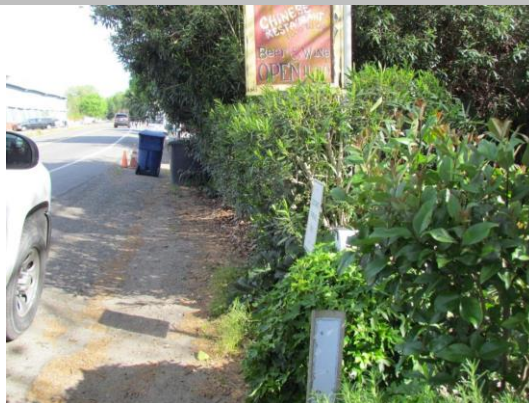
Photo 1 of 2 : SP_2018_RD0369_207_8_20180305_00001.jpg

LM Start	0.74	Rating **	U	Issue No.	8
LM End	0.77	Issue Type +	En	Location *	LS
Category	Earthen Levee			GPS Latitude/Longitude	
				Start	End
Item	Vegetation			38.250340 °	38.249930 °
				-121.510135 °	-121.509880 °
DWR ID	DWR_RD0369_01_s_2017_8				
Comment Code					
V6 : Landscaping					
Inspector Comment					
Landscaping needs to be thinned and maintained to allow inspection and access to landside slope and toe.

Looking upstream from levee mile 0.77 to levee mile 0.75 at the woody tree and vegetation on the landside slope.

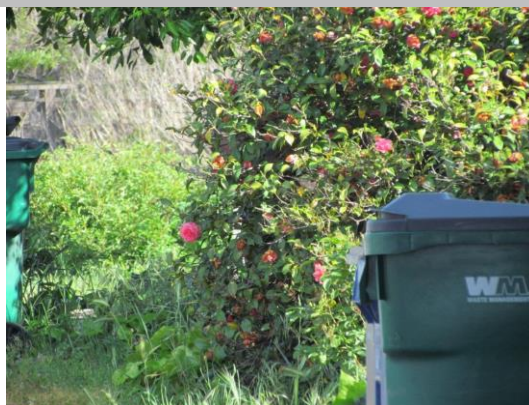
Photo 2 of 2 : SP_2018_RD0369_207_8_20180305_00002.jpg

Looking upstream from levee mile 0.77 to levee mile 0.75 levee slope blocked by vegetation typical view of growth along this section.
