**Flood Control Project Maintenance  
Levee Inspections**  
**LMA District Cover Sheet**  
**Spring 2020 Levee Inspection Results**

**Reclamation District No. 0369 Libby McNeil**

**Levee Inspection Report By Mile - Spring 2020**

Waterway	Bank	Unit Miles	Inspection Start/End	Inspector
Unit No. 01 Sacramento River	Left	0.78	03/25/2020 03/25/2020	David Julian

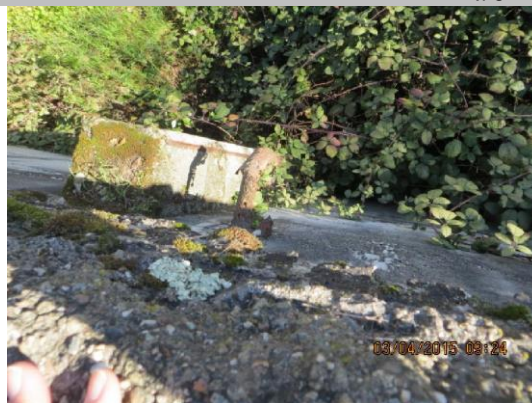
Photo 1 of 3 : UCIP\_SP\_2020\_50105\_73165.jpg

LM Start	0.04	Rating **	M	Issue No.	30
LM End	0.04	Issue Type +	En	Location *	
Category	Supplemental			GPS Latitude/Longitude	
				Start	End
Item	DWR UCIP Field Study			38.258434 °	38.258434 °
				-121.517283 °	-121.517283 °
DWR ID	18971

Comment Code					
Inspector Comment					
DS_ID:18971 FS_ID:50105 EP_NO: 8555 Repair Type: Non-Urgent Crossing Status: Found UCIP Comments: 03/04/2015 Pipe corroded through on LS at retaining wall. May not go all the way through the levee. Appears abandoned and if so should be done so properly. FIELD_STRUCT_DESC: *ABANDONED* 2 of 2: 4-inch steel pipe of an unknown purpose through the levee, 4 feet below the crown. Pipe visible on the landside (LS) at a retaining wall. (Retention of a 6-inch pipe and a 4-inch pipe through the levee authorized under Automatic Board Order (ABO) issued as Permit No. 8555, 1973 - Jordon Investment Company, care of Walter E. Herman). [Additional Reference(s): DWR Levee Log, 2005. USACE Sacramento O&M Manual 111, May 1959, (RM 27.87), O&M Manual misidentifies this location as RM 28.87]. FS Date: 3/4/2015 4:11:00 PM

Pipe visible on retaining wall at LS toe.

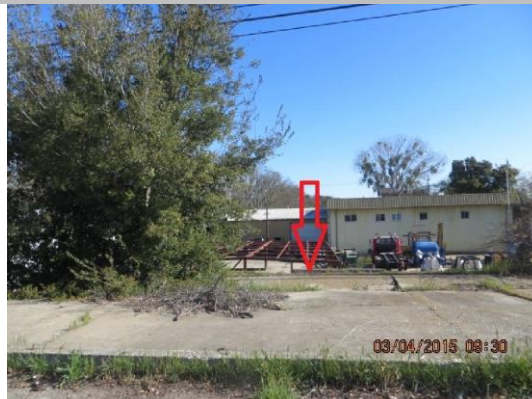
Photo 2 of 3 : UCIP\_SP\_2020\_50105\_73164.jpg

Pipe visible on retaining wall at LS toe.

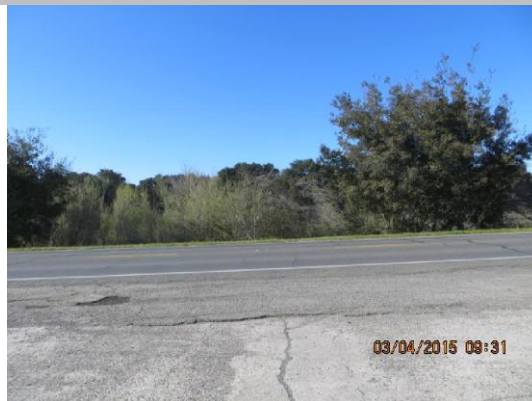
Photo 3 of 3 : UCIP\_SP\_2020\_50105\_73163.jpg

View of WS. Pipe not found on WS.

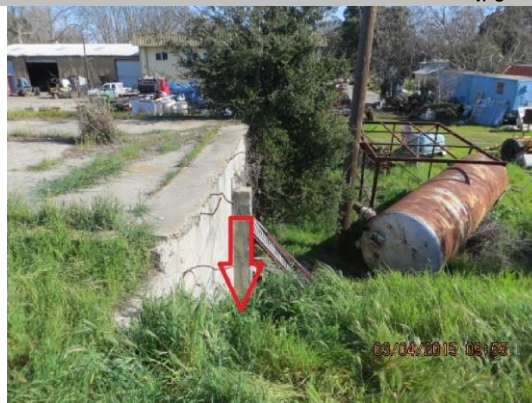
Photo 2 of 3 : UCIP\_SP\_2020\_43811\_73161.jpg

10-inch hole in concrete retaining wall likely for this pipe. Visible on LS toe.

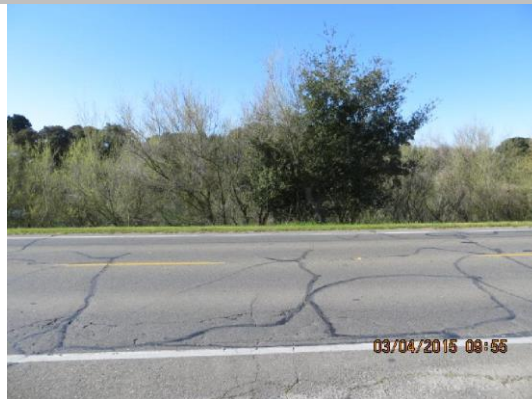
Photo 3 of 3 : UCIP\_SP\_2020\_43811\_73160.jpg

View of WS. No pipe found.

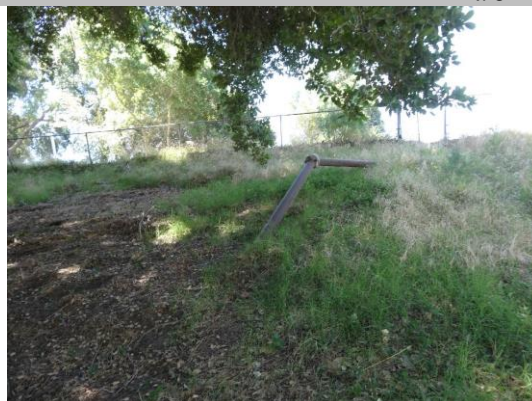
Photo 3 of 3 : UCIP\_SP\_2020\_53396\_75199.jpg

LS slope: view of pipe.

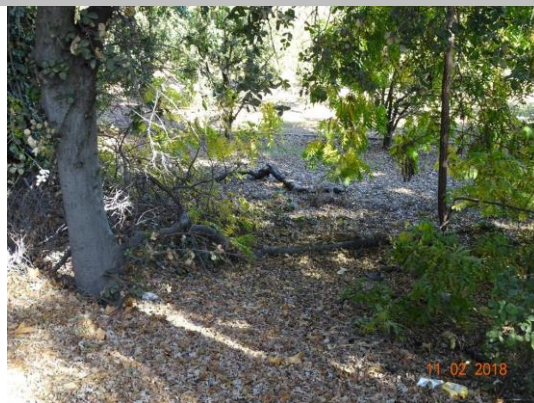
Photo 1 of 1 : SP\_2020\_RD0369\_207\_21\_20200304\_00008.jpg

LM Start	0.13	Rating **	M	Issue No.	21
LM End	0.13	Issue Type +	Ma	Location *	LS
Category	Earthen Levee			GPS Latitude/Longitude	
				Start	End
Item	Encroachments			38.257673 °	38.257673 °
				-121.516052 °	-121.516052 °
DWR ID	DWR_RD0369_01_f _ 2018_21				
Comment Code					
TR : Tree or limb					
Inspector Comment					
Remove tree limb from the landside slope.

View of tree limb on the landside slope (November 2018).

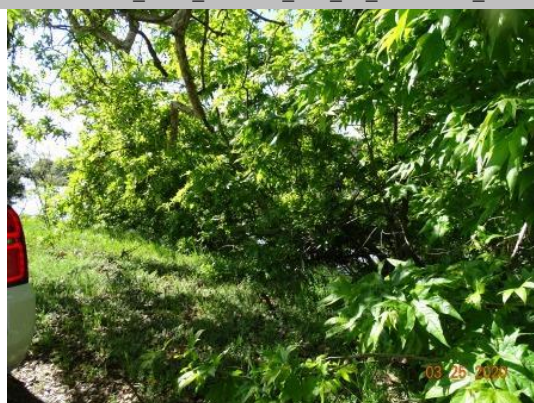
Photo 1 of 1 : SP\_2020\_RD0369\_207\_23\_20200325\_00030.jpg

LM Start	0.15	Rating **	U	Issue No.	23
LM End	0.15	Issue Type +	Ma	Location *	WS
Category	Earthen Levee			GPS Latitude/Longitude	
				Start	End
Item	Trim / Thin Trees			38.257368 °	38.257368 °
				-121.515752 °	-121.515752 °
DWR ID	DWR_RD0369_01_s_2020_23				
Comment Code					
T2 : Thin trees to allow visibility of the ground and room to flood fight.					
Inspector Comment

View of thick tree branches on the waterside slope (Spring 2020).

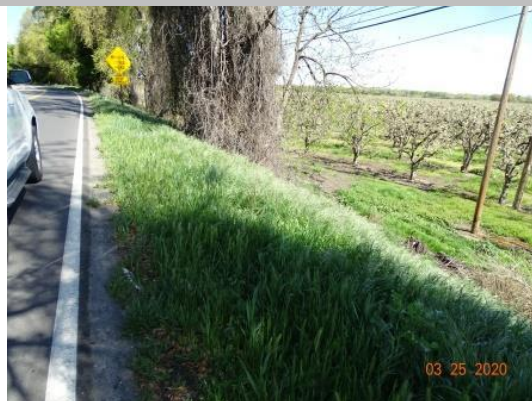
Photo 1 of 1 : SP\_2020\_RD0369\_207\_24\_20200325\_00031.jpg

LM Start	0.27	Rating **	M	Issue No.	24
LM End	0.65	Issue Type +	Ma	Location *	LS
Category	Earthen Levee			GPS Latitude/Longitude	
				Start	End
Item	Vegetation			38.256234 °	38.251485 °
				-121.514200 °	-121.510485 °
DWR ID	DWR_RD0369_01_s_2020_24				
Comment Code					
V1 : Control annual grass and weeds on the levee slopes and easements.					
Inspector Comment

View looking upstream at annual vegetation on the landside slope (Spring 2020).

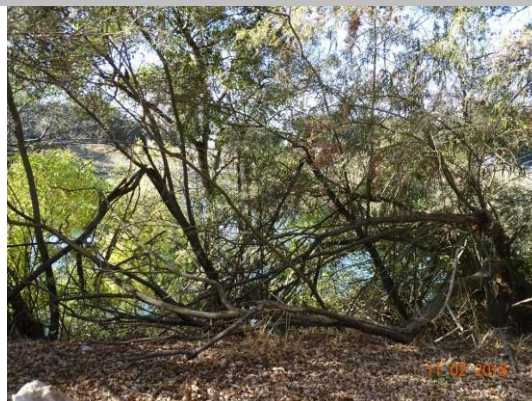
Photo 1 of 1 : SP\_2020\_RD0369\_207\_17\_20200304\_00005.jpg

LM Start	0.27	Rating **	M	Issue No.	17
LM End	0.27	Issue Type +	Ma	Location *	WS
Category	Earthen Levee			GPS Latitude/Longitude	
				Start	End
Item	Trim / Thin Trees			38.256133 °	38.256133 °
				-121.514162 °	-121.514162 °
DWR ID	DWR_RD0369_01_f_2018_17				
Comment Code					
T2 : Thin trees to allow visibility of the ground and room to flood fight.					
Inspector Comment					
Remove some tree branches to allow better visibility and access.

View of relatively thick tree branches on the waterside slope (November 2018).

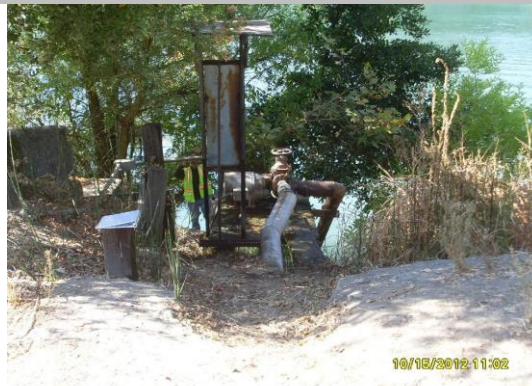
Photo 1 of 3 : UCIP\_SP\_2020\_43814\_10460.jpg

DS\_ID:18972  
FS\_ID:43814  
EP\_NO: 11117  
Repair Type: Non-Urgent  
Crossing Status: Found  
UCIP Comments: 10/15/2012 Siphon breaker on LS slope needs protection. Water is leaking from pump station. Abandoned concrete structure found on WS. 10-inch abandoned pipe found on WS. Should be removed. 6-inch abandoned pipe found on WS. Should be removed.  
FIELD\_STRUCT\_DESC: \*ABANDONED\* 10-inch steel irrigation discharge pipe through the levee, 4.5 feet below the crown. Pump and gate valve on the waterside (WS) shoulder. Siphon breaker on the landside (LS) slope. 6-inch abandoned pipe also found on the WS. (Retention of a 10-inch pipe through the levee, 4.5 feet below the crown, and a pump in a pump house on the WS slope authorized under Automatic Board Order (ABO) issued as Permit No. 11117, 1975 - Erma E. Locke, et al.). [Additional Reference(s): DWR Levee Log, 2005. USACE Sacramento O&M Manual 111, May 1959, (RM 27.63), referenced as invert elevation 3.8 feet below the crown].

Waterside view: overview of pipe & pump and abandoned concrete structure (left). Shutoff Valve.

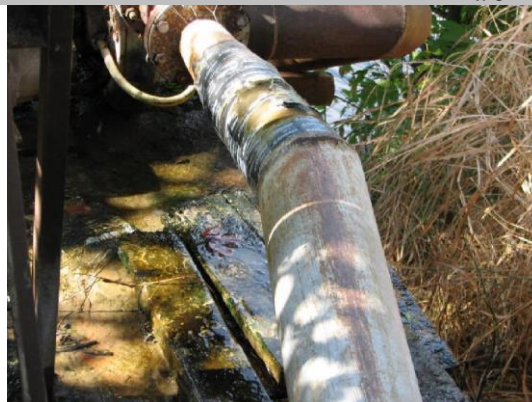
Photo 2 of 3 : UCIP\_SP\_2020\_43814\_10456.jpg

Waterside view: water leaking pump station.

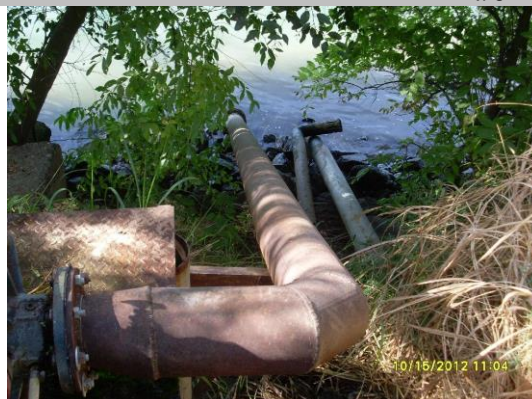
Photo 3 of 3 : UCIP\_SP\_2020\_43814\_10459.jpg

Waterside view: overview of active pipe and two abandoned pipes.

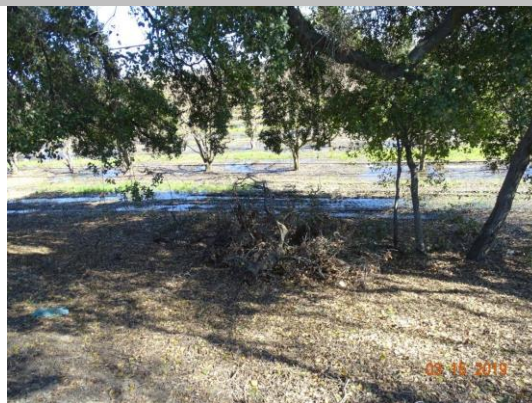
Photo 1 of 1 : SP\_2020\_RD0369\_207\_11\_20200304\_00003.jpg

LM Start	0.35	Rating **	M	Issue No.	11
LM End	0.35	Issue Type +	Ma	Location *	LS
Category	Earthen Levee			GPS Latitude/Longitude	
				Start	End
Item	Encroachments			38.255250 °	38.255250 °
				-121.513207 °	-121.513207 °
DWR ID	DWR_RD0369_01_s_2019_11				
Comment Code					
TR : Tree or limb					
Inspector Comment					
Remove fallen tree limbs from the landside slope.

View of fallen limbs on the landside slope (Spring 2019).

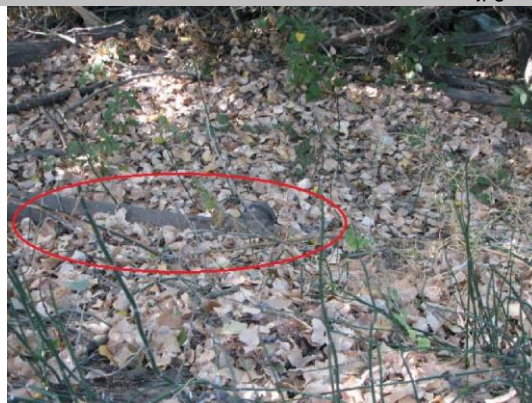
Photo 2 of 2 : UCIP\_SP\_2020\_43815\_73300.jpg

Pipe on WS slope running parallel to levee crown.

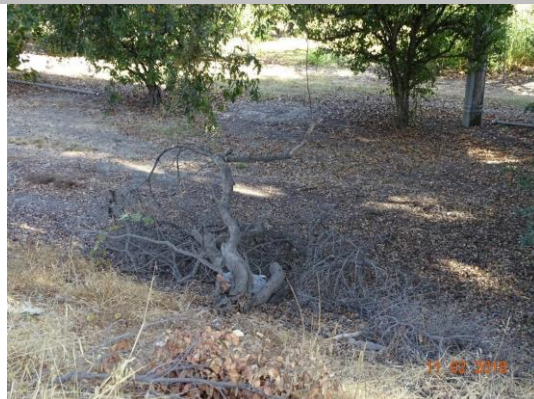
Photo 1 of 1 : SP\_2020\_RD0369\_207\_19\_20200304\_00007.jpg

View of tree limb on the land sideslope (November 2018).

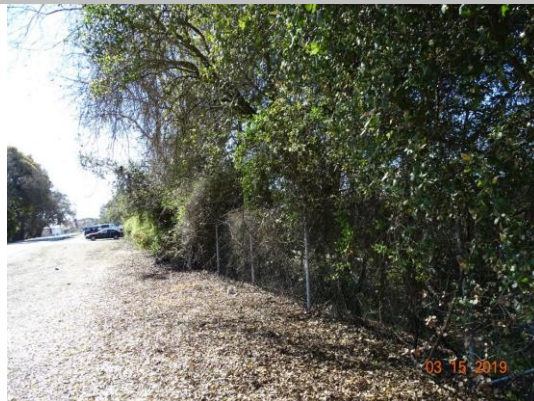
Photo 1 of 1 : SP\_2020\_RD0369\_207\_25\_20200304\_00009.jpg

LM Start	0.57	Rating **	U	Issue No.	25
LM End	0.60	Issue Type +	En	Location *	WS
Category	Earthen Levee			GPS Latitude/Longitude	
				Start	End
Item	Encroachments			38.252662 °	38.252247 °
				-121.511138 °	-121.510922 °
DWR ID	DWR_RD0369_01_s_2019_25				
Comment Code					
FE : Fence					
Inspector Comment					
A chainlink fence is located on the waterside slope.

View looking downstream at chainlink fence on the waterside slope (Spring 2019).

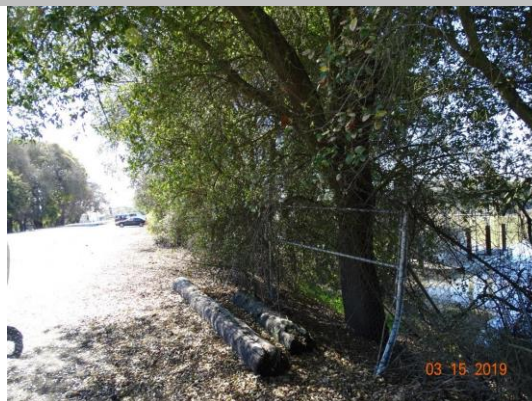
Photo 1 of 1 : SP\_2020\_RD0369\_207\_26\_20200304\_00010.jpg

View looking downstream at the chainlink on the waterside shoulder and slope (Spring 2019).

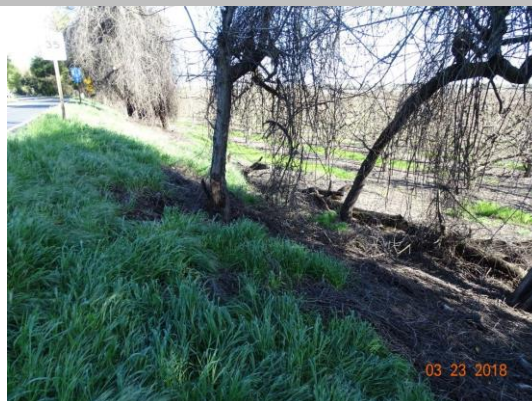
Photo 1 of 1 : SP\_2020\_RD0369\_207\_14\_20200304\_00004.jpg

LM Start	0.58	Rating **	M	Issue No.	14
LM End	0.58	Issue Type +	Ma	Location *	LS
Category	Earthen Levee			GPS Latitude/Longitude	
				Start	End
Item	Encroachments			38.252494 °	38.252494 °
				-121.510961 °	-121.510961 °
DWR ID	DWR_RD0369_01_s_2018_14				
Comment Code					
TR : Tree or limb					
Inspector Comment					
Fallen tree and branches should be removed from landside toe.

Remove fallen tree and branches from landside toe.

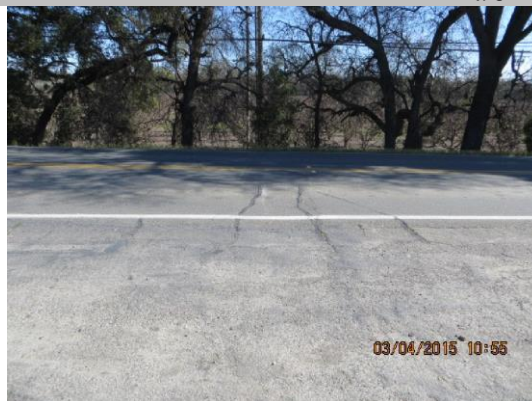
Photo 1 of 3 : UCIP\_SP\_2020\_53524\_73166.jpg

DS\_ID:18977  
FS\_ID:53524  
EP\_NO: 14313  
Repair Type: Urgent  
Crossing Status: Indicator Found  
UCIP Comments: 07/12/2018 Pipe is covered by thick layer of dry debris on LS. Patch repair along pipe alignment is visible on levee crown. (O.Yakimov-DWR UCIP)06/01/2016 Could not locate pipe. Likely buried next to leach box. Could not find signs of leaking or presence of water or erosion. Pipe may still be leaking but buried. (K. Fazel - UCIP)03/04/2015 Septic line appears to be leaking at LS toe. Erosion of soil and wet soil visible at LS toe. No septic smell accompanied other evidence at site. (W. Wylie - FPIIB)  
FIELD\_STRUCT\_DESC: 3 of 3: 2-inch galvanized steel sewer line through the levee, 1 foot below the crown. Metal cutoff wall placed around the pipe near the centerline of the levee. 4-foot by 6-foot concrete box at the landside (LS) toe. Sewer line runs through the property of the district president, Clarence Chu, at ckchu52@comcast.net, (916) 776-1684, and (916) 813-7037. (Plans to install three utility pipes through the levee authorized under Permit No. 14313, 1986 - Frank and Genie Schmiedel. Plans to construct a 59-covered-berth addition to an existing boat dock, extending approximately 60 feet into the Sacramento River, authorized under Permit No. 13783, 1984 - Frank and Genie Schmiedel, mentions the leach line for the septic system).

View at crossing through crown on LS shoulder from WS shoulder.  
Evidence of trench visible at cut in pavement.

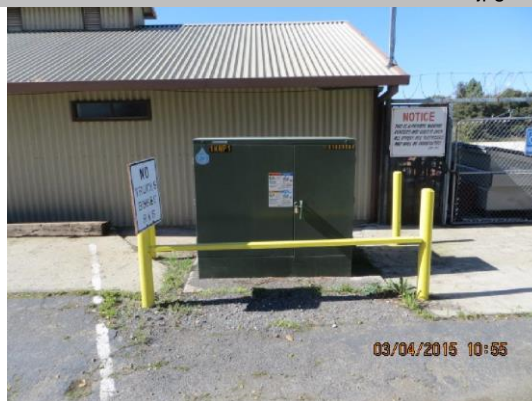
Photo 2 of 3 : UCIP\_SP\_2020\_53524\_73167.jpg

Waterside view. Unclear if there is a sewer cleanout or other evidence of pipe location on WS shoulder.

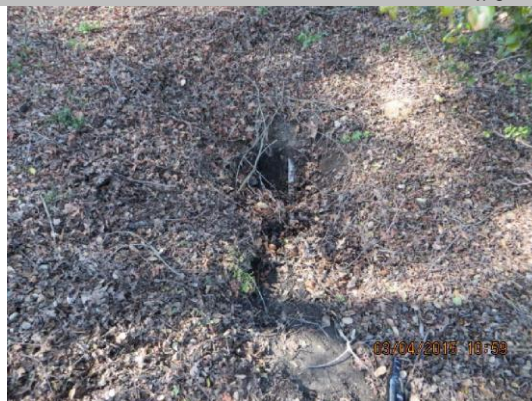
Photo 3 of 3 : UCIP\_SP\_2020\_53524\_73168.jpg

Septic line leaking at LS toe. Erosion of soil at toe visible.

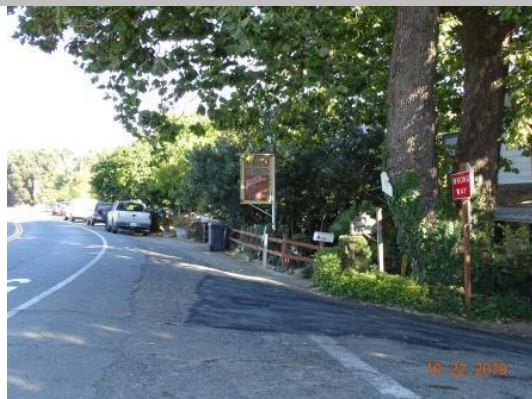
Photo 1 of 1 : SP\_2020\_RD0369\_207\_8\_20200304\_00001.jpg

View looking upstream at landscaping on the landside slope (Fall 2019).
