**Flood Control Project Maintenance
Levee Inspections
LMA District Cover Sheet**

Reclamation District No. 0369 Libby McNeil

Levee Inspection Report By Mile - Spring 2021

Waterway	Bank	Unit Miles	Inspection Start/End	Inspector
Unit No. 01 Sacramento River	Left	0.78	04/08/2021 04/08/2021	David Julian

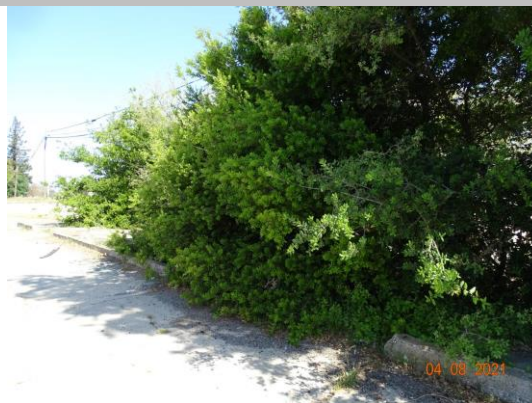
Photo 1 of 1 : SP_2021_RD0369_207_24_20210408_00033.jpg

LM Start	0.03	Rating **	U	Issue No.	24
LM End	0.03	Issue Type +	Ma	Location *	LS
Category	Earthen Levee			GPS Latitude/Longitude	
				Start	End
Item	Trim / Thin Trees			38.258599 °	38.258599 °
				-121.517315 °	-121.517315 °
DWR ID	DWR_RD0369_01_s_2021_24				
Comment Code					
T2 : Thin trees to allow visibility of the ground and room to flood fight.					
Inspector Comment

View of thick tree on the landside slope (Spring 2021).

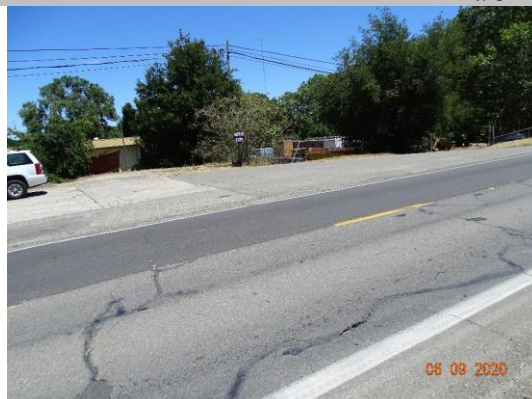
Photo 1 of 3 : UCIP_SP_2021_60724_88049.jpg

FS_ID:60724
DS_ID:18970
EP_NO: N/A
Repair Type: Non-Urgent
Crossing Status: Found
UCIP Comments: 06/09/2020 Record remains Non-Urgent. Crossing appears abandoned. Tree branches have grown through abandoned hole in retaining wall plugging it completely. Unable to find pipe on waterside. Unauthorized encroachment recorded in Levee Log prior to 2011. (O.Yakimov - DWR UCIP)
03/04/2015 Pipe appears abandoned and is filled with soil. Appears abandoned and if so should be done so properly.
FIELD_STRUCT_DESC: 8-inch steel gravity drainage pipe through the levee, 8 feet below the crown. Hole in the concrete retaining wall on the landside (LS) slope, measures 10 inches in diameter. (6-inch pipe [HLM 0.06] authorized under Automatic Board Order (ABO) issued as Permit No. 8555, 1973 - Jordan Investment Co. c/o Walter E. Herman).
[Additional Reference(s): DWR Levee Log, 2005 (HLM 0.05), listed as 8-inch pipe].

Top of Levee: View of levee crown looking towards landside

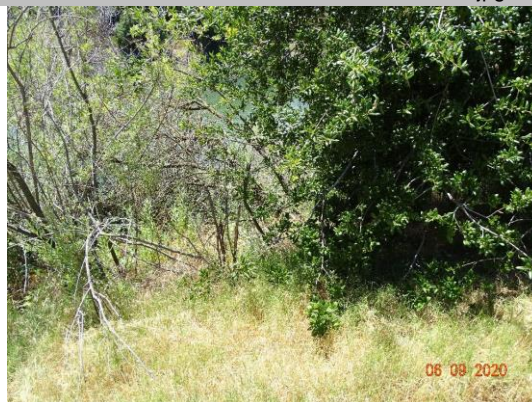
Photo 2 of 3 : UCIP_SP_2021_60724_88050.jpg

Water-Side: View of levee slope looking from crown. No pipe found on waterside

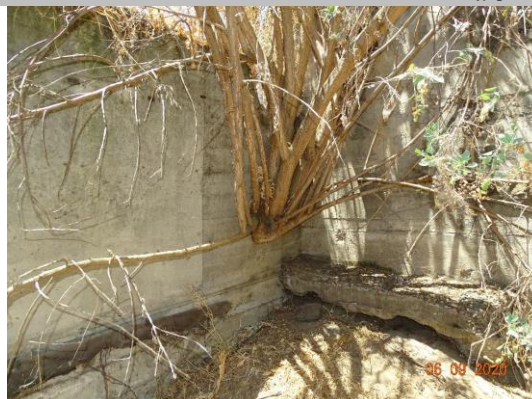
Photo 3 of 3 : UCIP_SP_2021_60724_88048.jpg

Land-Side: View of retaining wall on landside. Tree branches are plugging this hole completely

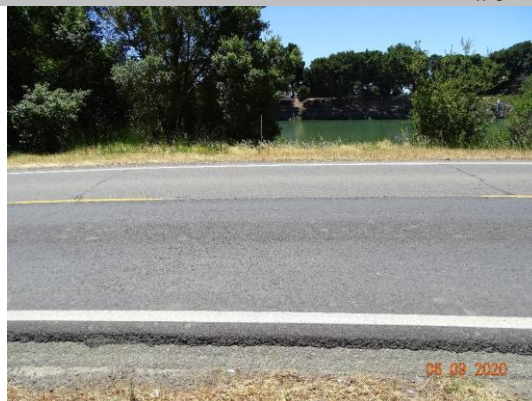
Photo 1 of 3 : UCIP_SP_2021_60725_88053.jpg

FS_ID:60725
DS_ID:25084
EP_NO: N/A
Repair Type: Urgent
Crossing Status: Found
UCIP Comments: 06/09/2020 Record remains Urgent. Through holes in pipe on landside slope. Crossing appears abandoned. No pipe found on waterside. No permit has been identified authorizing pipe. Need to have CVFPB review ABO and determine current owner. (O.Yakimov - DWR UCIP)
07/12/2018 Pipe shows more signs of corrosion. Unable to find pipe on WS. (O.Yakimov-DWR UCIP)06/01/2016 Same as last inspection.

(K. Fazel - UCIP)03/04/2015 Severe corrosion and holes visible in pipe on LS shoulder. Pipe appears abandoned and should be done so properly. (W. Wyle - FPIIB)
FIELD_STRUCT_DESC: 4-inch steel pipe of an unknown purpose through the levee, 1 foot below the crown. Pipe visible on the landside (LS) slope just in front of the gate on the LS shoulder. (4-inch pipe [HLM 0.08] authorized under Automatic Board Order (ABO) issued as Permit No. 8555, 1973 - Jordan Investment Co. c/o Walter E. Herman). [Additional Reference(s): DWR Levee Log, 2005 (HLM 0.08). USACE Sacramento O&M Manual, Unit 111, May 1959, Revised 29 December 2016, (RM 27.87 - O&M Manual misidentifies this location as RM 28.87), listed as 4-inch pipe. USACE As-Built Drawing No. 06-13-1100, Sheet 15, upstream of 'L' 1663+96, January 1933].
FS Date: 6/9/2020 9:26:37 AM

Top of Levee: View of levee crown looking towards waterside

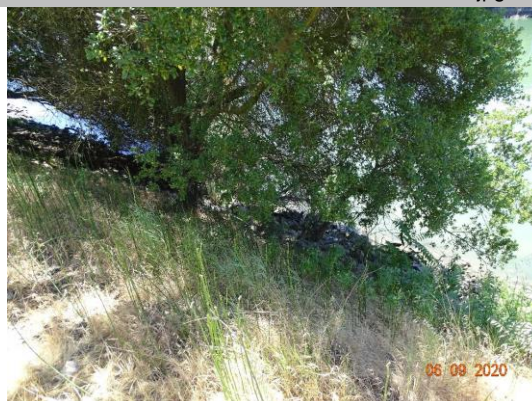
Photo 2 of 3 : UCIP_SP_2021_60725_88054.jpg

Water-Side: View of levee slope looking from crown

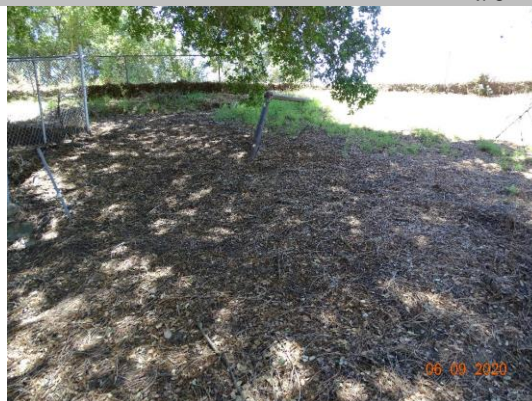
Photo 3 of 3 : UCIP_SP_2021_60725_88051.jpg

Land-Side: View of levee slope looking from toe

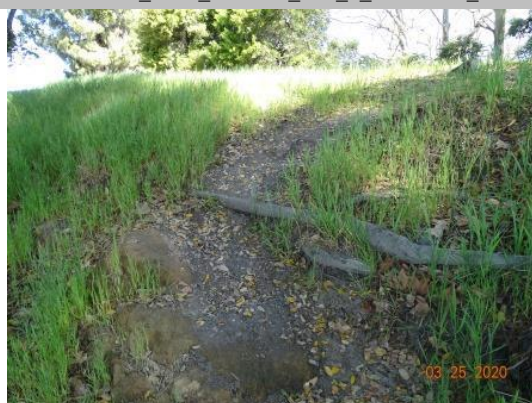
Photo 1 of 1 : SP_2021_RD0369_207_9_20210301_00003.jpg

LM Start	0.11	Rating **	M	Issue No.	9
LM End	0.11	Issue Type +	Ma	Location *	WS
Category	Earthen Levee			GPS Latitude/Longitude	
				Start	End
Item	Slope Stability			38.257757 °	38.257757 °
				-121.516347 °	-121.516347 °
DWR ID	DWR_RD0369_01_s_2020_9				
Comment Code					
S2 : Repair the levee slope damaged by foot traffic and prevent access where possible.					
Inspector Comment

View of footpath down the waterside slope (Spring 2020).

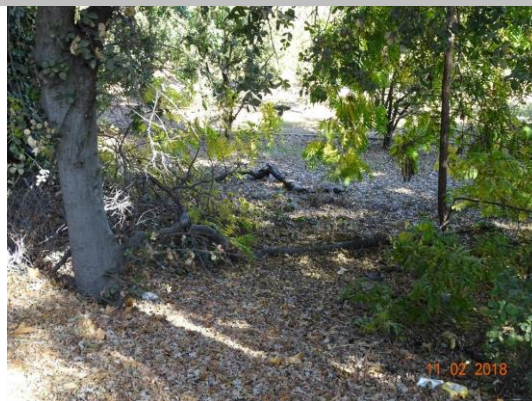
Photo 1 of 1 : SP_2021_RD0369_207_21_20210301_00010.jpg

LM Start	0.13	Rating **	M	Issue No.	21
LM End	0.13	Issue Type +	Ma	Location *	LS
Category	Earthen Levee			GPS Latitude/Longitude	
				Start	End
Item	Encroachments			38.257673 °	38.257673 °
				-121.516052 °	-121.516052 °
DWR ID	DWR_RD0369_01_f _ 2018_21				
Comment Code					
TR : Tree or limb					
Inspector Comment					
Remove tree limb from the landside slope.

View of tree limb on the landside slope (November 2018).

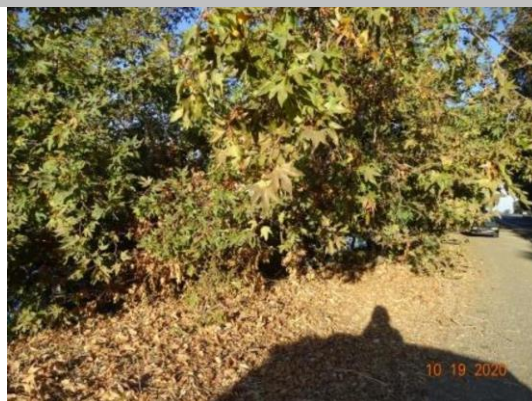
Photo 1 of 1 : SP_2021_RD0369_207_23_20210301_00011.jpg

LM Start	0.15	Rating **	U	Issue No.	23
LM End	0.15	Issue Type +	Ma	Location *	WS
Category	Earthen Levee			GPS Latitude/Longitude	
				Start	End
Item	Trim / Thin Trees			38.257368 °	38.257368 °
				-121.515752 °	-121.515752 °
DWR ID	DWR_RD0369_01_s_2020_23				
Comment Code					
T2 : Thin trees to allow visibility of the ground and room to flood fight.					
Inspector Comment

View of thick tree branches on the waterside slope (Fall 2020).

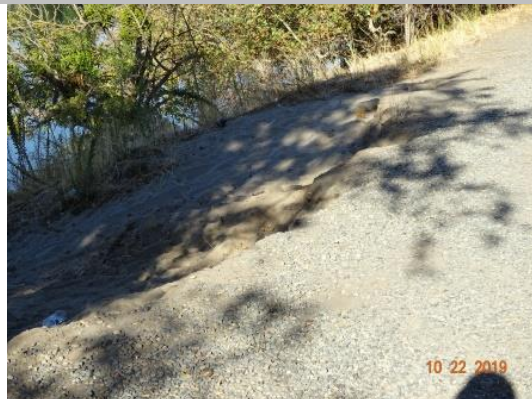
Photo 1 of 1 : SP_2021_RD0369_207_10_20210301_00004.jpg

LM Start	0.18	Rating **	M	Issue No.	10
LM End	0.18	Issue Type +	Ma	Location *	WS
Category	Earthen Levee			GPS Latitude/Longitude	
				Start	End
Item	Slope Stability			38.257137 °	38.257137 °
				-121.515407 °	-121.515407 °
DWR ID	DWR_RD0369_01_f_2019_10				
Comment Code					
S2 : Repair the levee slope damaged by foot traffic and prevent access where possible.					
Inspector Comment					
Large path created by fishermen. Levee is extra wide in this section.

View looking slightly upstream erosion due to foot traffic on the waterside slope (Fall 2019).

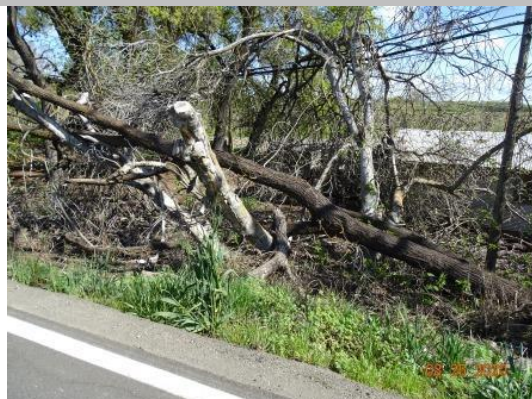
Photo 1 of 1 : SP_2021_RD0369_207_12_20210301_00006.jpg

LM Start	0.20	Rating **	U	Issue No.	12
LM End	0.20	Issue Type +	Ma	Location *	LS
Category	Earthen Levee			GPS Latitude/Longitude	
				Start	End
Item	Encroachments			38.256953 °	38.256953 °
				-121.515067 °	-121.515067 °
DWR ID	DWR_RD0369_01_f_2019_12				
Comment Code					
TR : Tree or limb					
Inspector Comment

View of down tree on the landside slope (Spring 2020).

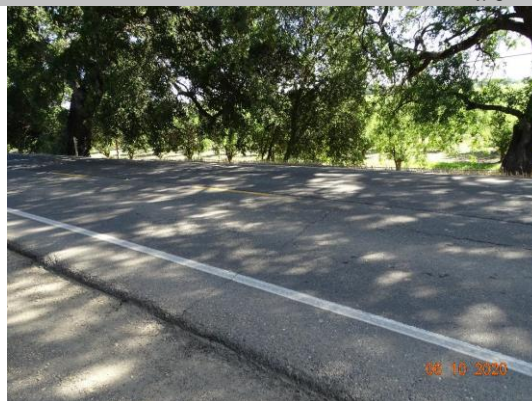
Photo 1 of 3 : UCIP_SP_2021_60752_88063.jpg

FS_ID:60752
DS_ID:18972
EP_NO: 11117
Repair Type: Urgent
Crossing Status: Found
UCIP Comments: 06/10/2020 Record updated from Non-Urgent to Urgent. Hole in pipe on waterside slope above pump. Pipe is running - leak through the hole poses a threat to waterside levee slope. 6-inch pipe installed on landside slope right after siphon breaker. Levee slope was disturbed at this location. 6-inch pipe is running down diagonally on landside slope towards PVC pipe connection at the toe. Unable to find a permit for modification. No permit has been identified authorizing pipe through the levee. Need to have CVFPB review ABO and determine current owner. (O.Yakimov - DWR UCIP)
10/15/2012 Siphon breaker on LS slope needs protection. Water is leaking from pump station. Abandoned concrete structure found on WS. 10-inch abandoned pipe found on WS. Should be removed. 6-inch abandoned pipe found on WS. Should be removed.

FIELD_STRUCT_DESC: 10-inch steel irrigation discharge pipe through the levee, 4.5 feet below the crown. Pump and gate valve on the waterside (WS) shoulder. Siphon breaker on the landside (LS) slope. Electric meter, panel at landside toe, 1.5-inch electrical conduit at same location. Abandoned concrete standpipe at landside levee toe. (10-inch pipe [HLM 0.36] authorized under Automatic Board Order (ABO) issued as Permit No. 11117, 1975 - Erma E. Locke et al). [Additional Reference(s): DWR Levee Log, 2005 (HLM 0.36). USACE Sacramento O&M Manual, Unit 111, May 1959, Revised 29 December 2016, (RM 27.63), listed as 10-inch pipe. USACE As-Built Drawing No. 50-04-2983, Sheets 2 and 3, Station 5+83, March 1954. USACE As-Built Drawing No. 06-13-1100, Sheet 15, downstream of 'L' 1671+00, January 1933].
FS Date: 6/10/2020 10:27:02 AM

Top of Levee: View of levee crown looking towards landside

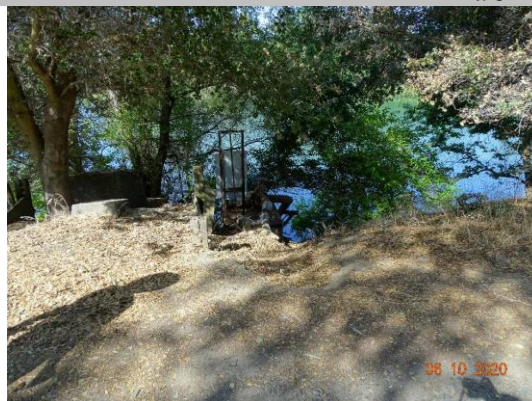
Photo 2 of 3 : UCIP_SP_2021_60752_88064.jpg

Water-Side: View of levee slope looking from crown

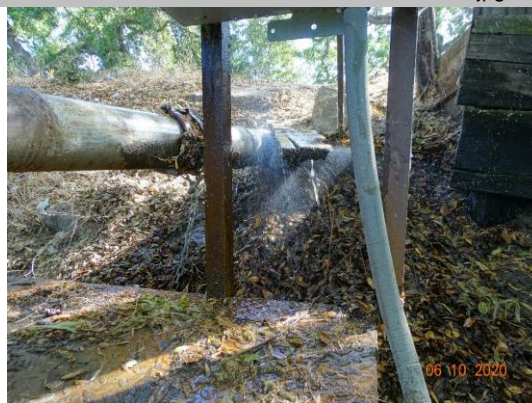
Photo 3 of 3 : UCIP_SP_2021_60752_88065.jpg

Water-Side: Pipe leak on levee slope above pump

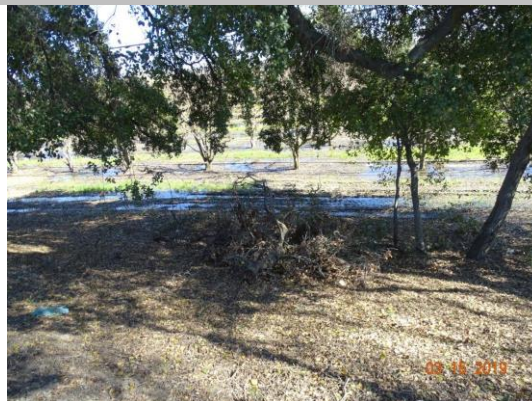
Photo 1 of 1 : SP_2021_RD0369_207_11_20210301_00005.jpg

LM Start	0.35	Rating **	M	Issue No.	11
LM End	0.35	Issue Type +	Ma	Location *	LS
Category	Earthen Levee			GPS Latitude/Longitude	
				Start	End
Item	Encroachments			38.255250 °	38.255250 °
				-121.513207 °	-121.513207 °
DWR ID	DWR_RD0369_01_s_2019_11				
Comment Code					
TR : Tree or limb					
Inspector Comment					
Remove fallen tree limbs from the landside slope.

View of fallen limbs on the landside slope (Spring 2019).

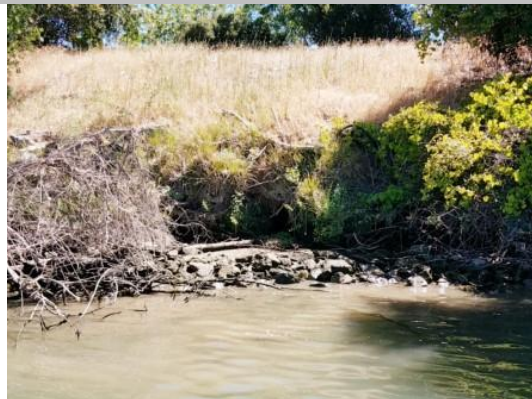
Photo 1 of 1 : SP_2021_RD0369_207_2_20210301_00001.jpg

LM Start	0.40	Rating **	U	Issue No.	2
LM End	0.40	Issue Type +	Ma	Location *	WS
Category	Earthen Levee			GPS Latitude/Longitude	
				Start	End
Item	Animal Control			38.254530 °	38.254530 °
				-121.512930 °	-121.512930 °
DWR ID	DWR_RD0369_01_s_2020_2				
Comment Code					
A3 : No rodents visible, but rodent burrows visible; need to backfill and compact or grout burrows.					
Inspector Comment					
Large animal burrow into the wateride toe that is sometimes submerged.

View from the channel at animal hole burrowed into the waterside toe (Summer 2020).

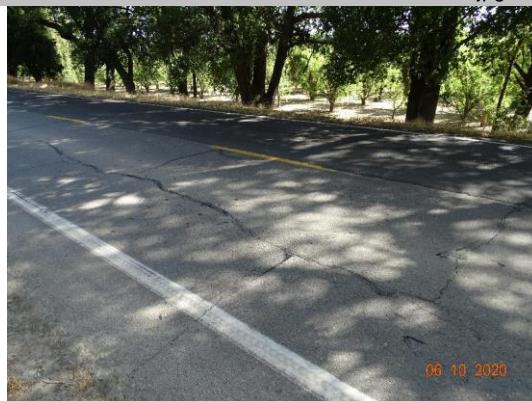
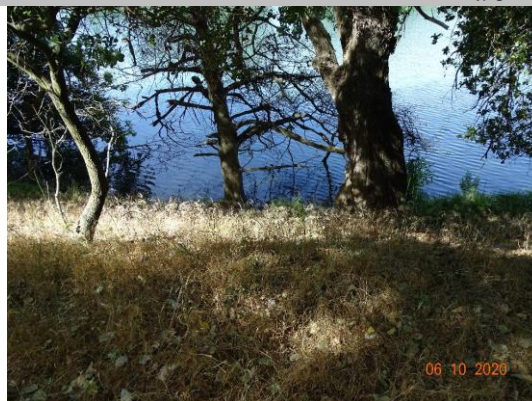
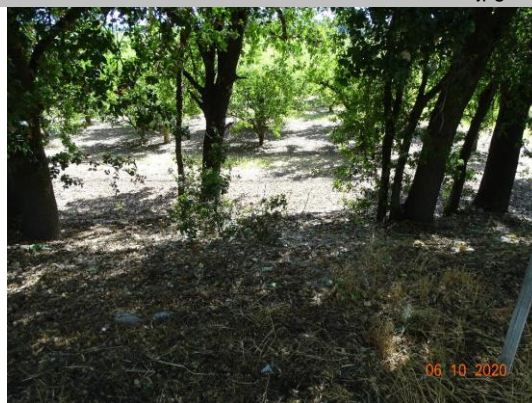
Comment Code					
Inspector Comment					
FS_ID:60764					
DS_ID:18980					
EP_NO: N/A					
Repair Type: Non-Urgent					
Crossing Status: Not Found					
UCIP Comments: 06/10/2020 Record updated from No Action Needed to Non-Urgent. Crossing not found. 6-inch pipe debris found on waterside slope downstream of this crossing. No permit has been identified authorizing pipe. (O.Yakimov - DWR UCIP)					
FIELD_STRUCT_DESC: 6-inch irrigation discharge pipe of an unknown material through the levee, at an unknown depth. Pump and gate valve on the waterside (WS). Additional Reference(s): USACE Sacramento O&M Manual, Unit 111, May 1959, Revised 29 December 2016, (RM 27.51), listed as 6-inch pipe. USACE As-Built Drawing No. 06-13-1100, Sheet 15, upstream of 'L' 1686+35, January 1933].					
FS Date: 6/10/2020 10:57:57 AM

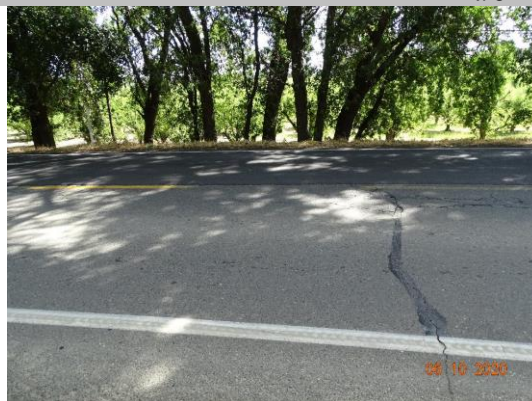
Photo 1 of 3 : UCIP_SP_2021_60775_88087.jpg

FS_ID:60775
DS_ID:18981
EP_NO: N/A
Repair Type: Non-Urgent
Crossing Status: Not Found
UCIP Comments: 06/10/2020 Record remains Non-Urgent. Crossing not found. Field measured 6-inch pipe debris on waterside slope parallel to levee crown might be coming from not found pipe DSID 18980 just upstream of this site. No evidence of pipe found on landside. No permit has been found authorizing this pipe through the levee at this location. (O.Yakimov - DWR UCIP)
03/04/2015 Found abandoned pipe laying on WS levee slope. Pipe purpose and status should be determined. further investigation required. (W.Wylie - DWR UCIP)
FIELD_STRUCT_DESC: 8-inch steel pipe of an unknown purpose running parallel to the levee crown on the waterside (WS) slope, 4.5 feet below the crown. This pipe was field discovered.
FS Date: 6/10/2020 11:11:31 AM

Top of Levee: View of levee crown looking towards landside

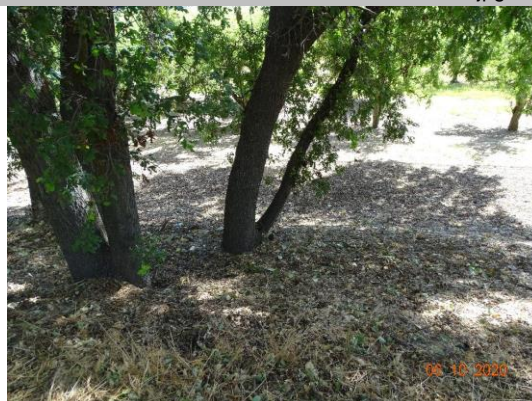
Photo 2 of 3 : UCIP_SP_2021_60775_88088.jpg

Land-Side: View of levee slope looking from crown

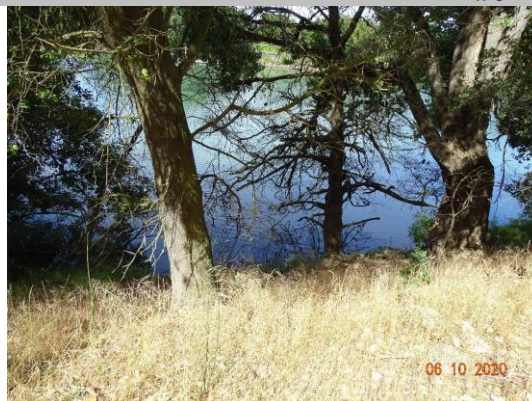
Photo 3 of 3 : UCIP_SP_2021_60775_88086.jpg

Water-Side: View of levee slope looking from crown

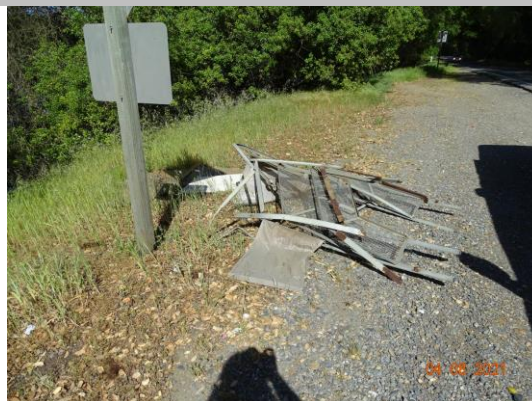
Photo 1 of 1 : SP_2021_RD0369_207_18_20210408_00034.jpg

LM Start	0.51	Rating **	M	Issue No.	18
LM End	0.51	Issue Type +	Ma	Location *	WS
Category	Earthen Levee			GPS Latitude/Longitude	
				Start	End
Item	Encroachments			38.253359 °	38.253359 °
				-121.511628 °	-121.511628 °
DWR ID	DWR_RD0369_01_s_2021_18				
Comment Code					
GA : Garbage					
Inspector Comment					
Remove discarded furniture from waterside slope.

View of discarded metal furniture on the waterside hinge (Spring 2021).

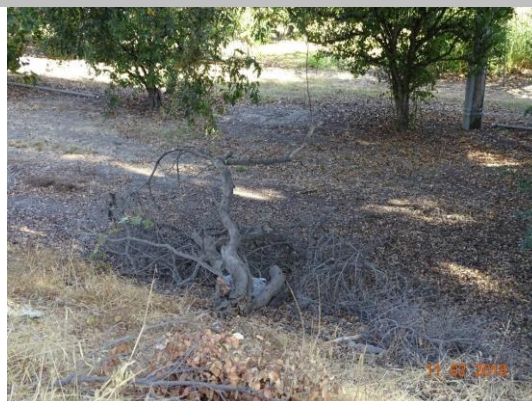
Photo 1 of 1 : SP_2021_RD0369_207_19_20210301_00009.jpg

LM Start	0.52	Rating **	M	Issue No.	19
LM End	0.52	Issue Type +	Ma	Location *	LS
Category	Earthen Levee			GPS Latitude/Longitude	
				Start	End
Item	Encroachments			38.253273 °	38.253273 °
				-121.511505 °	-121.511505 °
DWR ID	DWR_RD0369_01_f_2018_19				
Comment Code					
TR : Tree or limb					
Inspector Comment					
Remove tree limb from the landside slope.

View of tree limb on the landside slope (November 2018).

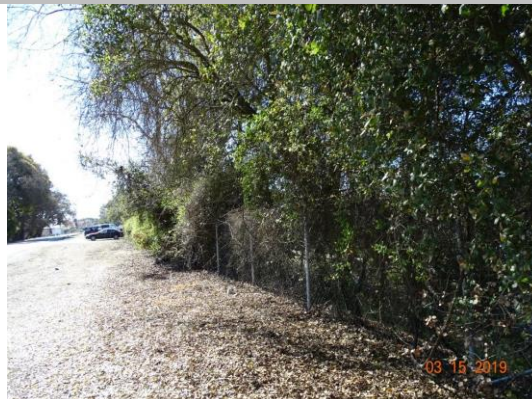
Photo 1 of 1 : SP_2021_RD0369_207_25_20210301_00012.jpg

View looking downstream at chainlink fence on the waterside slope (Spring 2019).

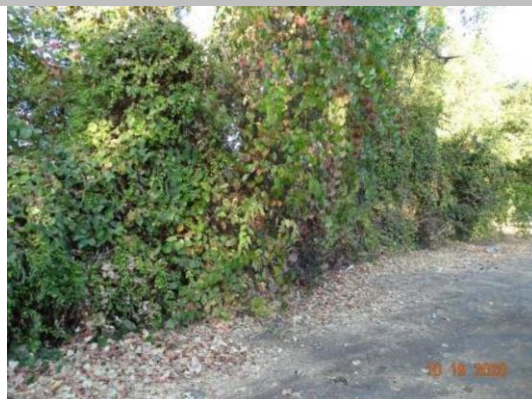
Photo 1 of 1 : SP_2021_RD0369_207_26_20210301_00013.jpg

LM Start	0.57	Rating **	U	Issue No.	26
LM End	0.60	Issue Type +	En	Location *	WS
Category	Earthen Levee			GPS Latitude/Longitude	
				Start	End
Item	Vegetation			38.252662 °	38.252247 °
				-121.511138 °	-121.510922 °
DWR ID	DWR_RD0369_01_s_2019_26				
Comment Code					
V6 : Landscaping					
Inspector Comment					
Vegetation on chainlink fence is blocking view down waterside slope.

View of thick vegetation on the waterside shoulder and slope (Fall 2020).

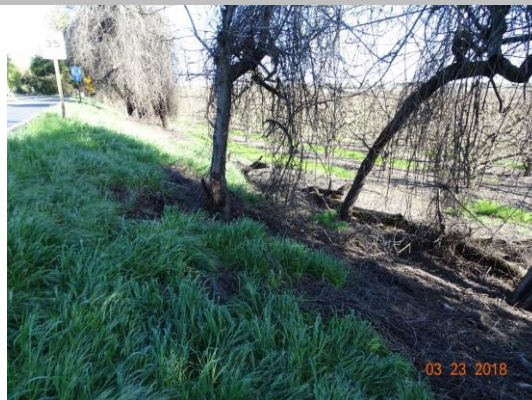
Photo 1 of 1 : SP_2021_RD0369_207_14_20210301_00007.jpg

LM Start	0.58	Rating **	M	Issue No.	14
LM End	0.58	Issue Type +	Ma	Location *	LS
Category	Earthen Levee			GPS Latitude/Longitude	
				Start	End
Item	Encroachments			38.252494 °	38.252494 °
				-121.510961 °	-121.510961 °
DWR ID	DWR_RD0369_01_s_2018_14				
Comment Code					
TR : Tree or limb					
Inspector Comment					
Fallen tree and branches should be removed from landside toe.

Remove fallen tree and branches from landside toe.

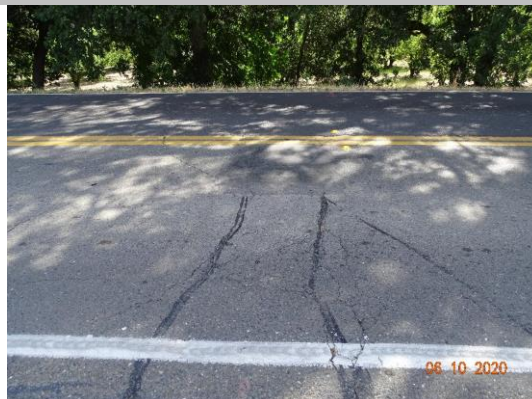
Photo 1 of 3 : UCIP_SP_2021_60848_88154.jpg

FS_ID:60848
DS_ID:18977
EP_NO: 14313
Repair Type: Non-Urgent
Crossing Status: Indicator Found
UCIP Comments: 06/10/2020 Record updated from Urgent to Non-Urgent. Unable to evaluate landside levee slope condition due to thick layer of leaves on levee slope. No septic smell or wet spot on landside detected. Unable to access waterside since it's gated. (O.Yakimov - DWR UCIP)
07/12/2018 Pipe is covered by thick layer of dry debris on LS. Patch repair along pipe alignment is visible on levee crown. (O.Yakimov-DWR UCIP)06/01/2016 Could not locate pipe. Likely buried next to leach box. Could not find signs of leaking or presence of water or erosion. Pipe may still be leaking but buried. (K. Fazel - UCIP)03/04/2015 Septic line appears to be leaking at LS toe. Erosion of soil and wet soil visible at LS toe. No septic smell accompanied other evidence at site. (W. Wylie - FPIIB)
FIELD_STRUCT_DESC: 2-inch galvanized steel sewer line through the levee, 1 foot below the crown. Metal cutoff wall placed around the pipe near the centerline of the levee. Sewer line runs through the property of the district president, Clarence Chu, at ckchu52@comcast.net, (916) 776-1684, and (916) 813-7037. (2-inch sewer line authorized under Permit No. 14313, 1986 - Frank and Jeanie Schmiedel). (Construction of a 59-covered-berth addition to an existing boat dock, extending approximately 60 feet into the Sacramento River, authorized under Permit No. 13783, 1984 - Frank and Genie Schmiedel, mentions the leach line for the septic system).

Top of Levee: View of levee crown looking towards landside

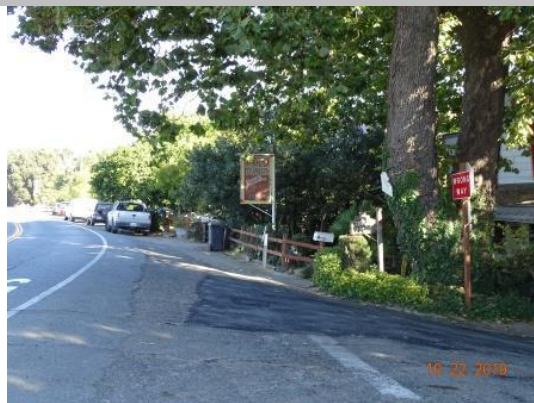
Photo 1 of 1 : SP_2021_RD0369_207_8_20210301_00002.jpg

LM Start	0.74	Rating **	M	Issue No.	8
LM End	0.77	Issue Type +	En	Location *	LS
Category	Earthen Levee			GPS Latitude/Longitude	
				Start	End
Item	Vegetation			38.250340 °	38.249930 °
				-121.510135 °	-121.509880 °
DWR ID	DWR_RD0369_01_s_2017_8				
Comment Code					
V6 : Landscaping					
Inspector Comment					
Landscaping needs to be thinned and maintained to allow inspection and access to landside slope and toe.

View looking upstream at landscaping on the landside slope (Fall 2019).
