Flood Control Project Maintenance
Levee Inspections
LMA District Cover Sheet

Reclamation District No. 0369 Libby McNeil

Levee Inspection Report By Mile - Spring 2024

Waterway	Bank	Unit Miles	Inspection Start/End	Inspector
Unit No. 01 Sacramento River	Left	0.78	04/18/2024 04/18/2024	Gregg McMillon

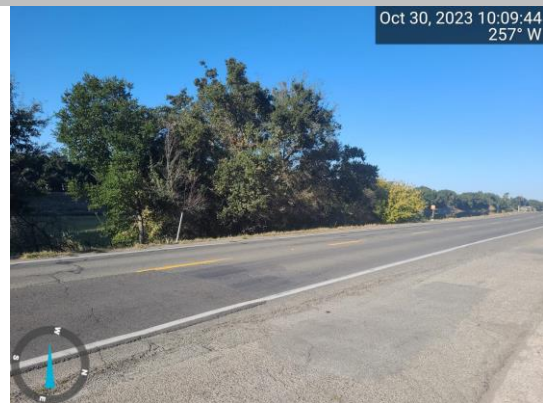
Photo 1 of 1 : SP_2024_RD0369_207_17_20240301_00008.jpg

LM Start	0.04	Rating **	M	Issue No.	17
LM End	0.04	Issue Type +	Ma	Location *	WS
Category	Earthen Levee			GPS Latitude/Longitude	
				Start	End
Item	Trim / Thin Trees			38.258386°	38.258386°
				-121.517269°	-121.517269°
DWR ID	DWR_RD0369_01_f_2021_17				
Comment Code					
T1 : Trim and thin trees to at least five feet above ground level to allow visibility of the ground and room to flood fight.					
Inspector Comment					
Trees on the waterside slope need to be trimmed to 5 feet above the waterside slope for visibility.

View of trees with low hanging branches on the waterside slope (Fall 2023).

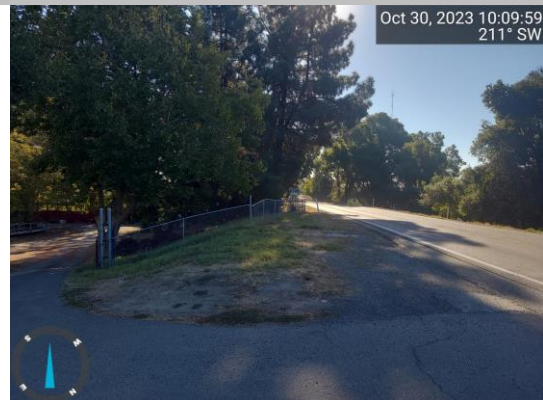
Photo 1 of 1 : SP_2024_RD0369_207_20_20240301_00009.jpg

LM Start	0.07	Rating **	M	Issue No.	20
LM End	0.10	Issue Type +	En	Location *	LS
Category	Earthen Levee			GPS Latitude/Longitude	
				Start	End
Item	Encroachments			38.258223°	38.257943°
				-121.516918°	-121.516490°
DWR ID	DWR_RD0369_01_f_2019_20				
Comment Code					
FE : Fence					
Inspector Comment					
There is a chain-link fence on the LS shoulder.

View of a chainlink fence on the landside slope (Fall 2023).

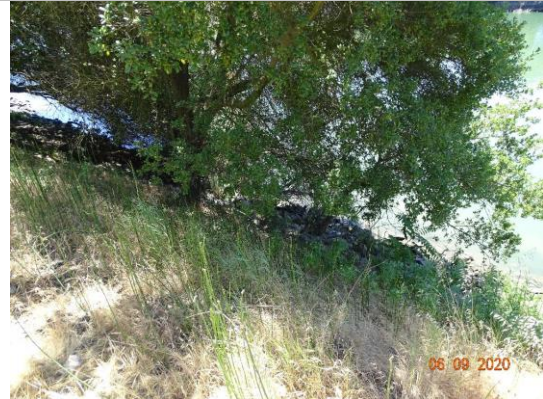
Photo 1 of 3 : UCIP_SP_2024_60725_88054.jpg

Comment Code						
Inspector Comment						
DS_ID:25084 FS_ID:60725 EP_NO: N/A Repair Type: Urgent EVAL Issue: 1, Pipe Integrity Crossing Status: Found UCIP Comments: 06/09/2020 Record remains Urgent. Through holes in pipe on landside slope. Crossing appears abandoned. No pipe found on waterside. No permit has been identified authorizing pipe. Need to have CVFPB review ABO and determine current owner. (O.Yakimov - DWR UCIP) 07/12/2018 Pipe shows more signs of corrosion. Unable to find pipe on WS. (O.Yakimov-DWR UCIP)06/01/2016 Same as last inspection. (K. Fazel - UCIP)03/04/2015 Severe corrosion and holes visible in pipe on LS shoulder. Pipe appears abandoned and should be done so properly. (W. Wyle - FPIIB) FIELD_STRUCT_DESC: 4-inch steel pipe of an unknown purpose through the levee, 1 foot below the crown. Pipe visible on the landside (LS) slope just in front of the gate on the LS shoulder. (4-inch pipe [HLM 0.08] authorized under Automatic Board Order (ABO) issued as Permit No. 8555, 1973 - Jordan Investment Co. c/o Walter E. Herman). [Additional Reference(s): DWR Levee Log, 2005 (HLM 0.08). USACE Sacramento O&M Manual, Unit 111, May 1959, Revised 29 December 2016, (RM 27.87 - O&M Manual misidentifies this location as RM 28.87), listed as 4-inch pipe. USACE As-Built Drawing No. 06-13-1100, Sheet 15, upstream of 'L' 1663+96, January 1933]. FS Date: 6/9/2020 9:26:37 AM

Water-Side: View of levee slope looking from crown

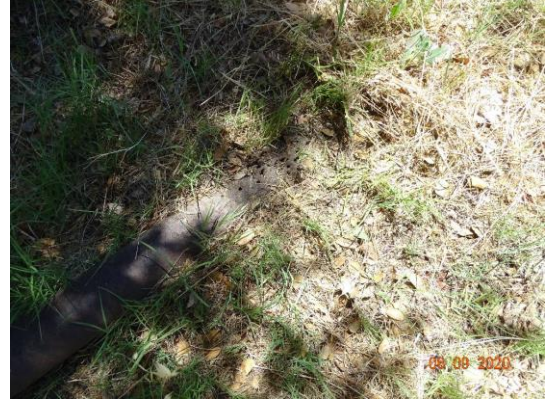
Photo 2 of 3 : UCIP_SP_2024_60725_88052.jpg

Land-Side: View of pipe with through holes on levee slope

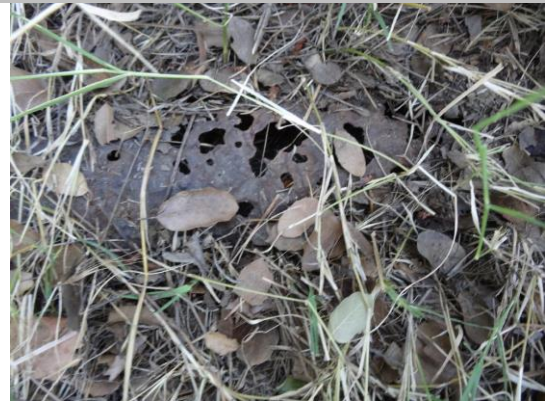
Photo 3 of 3 : UCIP_SP_2024_60725_75200.jpg

LS slope: holes in pipe still present.

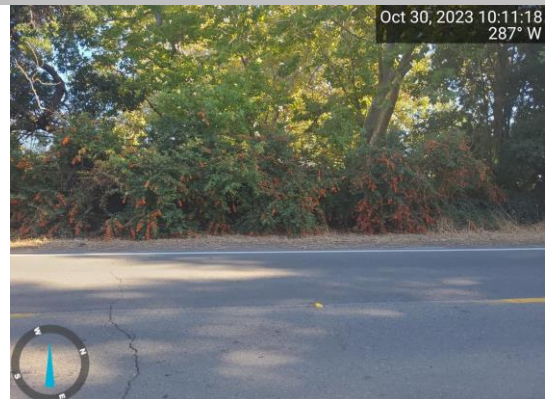
Photo 1 of 1 : SP_2024_RD0369_207_4_20240301_00002.jpg

LM Start	0.10	Rating **	M	Issue No.	4
LM End	0.10	Issue Type +	En	Location *	LS
Category	Earthen Levee			GPS Latitude/Longitude	
				Start	End
Item	Vegetation			38.257819°	38.257819°
				-121.516427°	-121.516427°
DWR ID	DWR_RD0369_01_s_2012_4				
Comment Code					
V6 : Landscaping					
Inspector Comment					
Landscaping on landside shoulder needs to be maintained.

View of landscaping on the landside shoulder (Fall 2023).

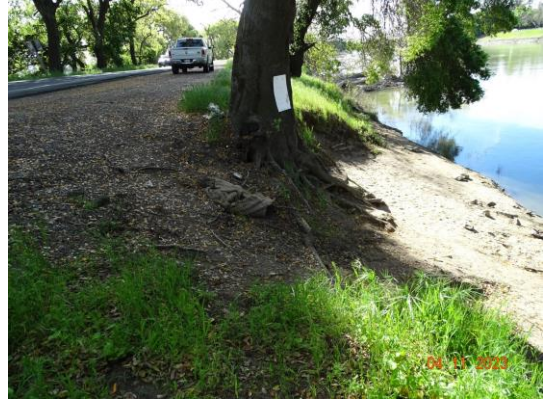
Photo 1 of 1 : SP_2024_RD0369_207_9_20240301_00004.jpg

LM Start	0.11	Rating **	A/W	Issue No.	9
LM End	0.11	Issue Type +	Ma	Location *	WS
Category	Earthen Levee			GPS Latitude/Longitude	
				Start	End
Item	Erosion / Foot Traffic			38.257757°	38.257757°
				-121.516347°	-121.516347°
DWR ID	DWR_RD0369_01_s_2020_9				
Comment Code					
E3 : Repair the levee slope damaged by foot traffic and prevent access where possible.					
Inspector Comment					
Minor path created by fishermen. Levee is wide in this section due to a turnout on the WS.

View of the minor erosion on the WS slope (Spring 2023).

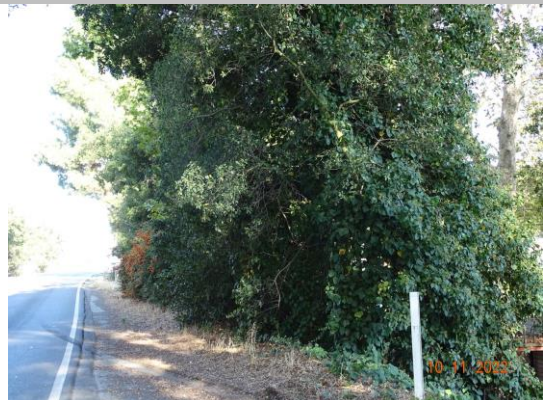
Photo 1 of 1 : SP_2024_RD0369_207_13_20240301_00006.jpg

LM Start	0.11	Rating **	M	Issue No.	13
LM End	0.12	Issue Type +	En	Location *	LS
Category	Earthen Levee			GPS Latitude/Longitude	
				Start	End
Item	Vegetation			38.257772°	38.257682°
				-121.516248°	-121.516201°
DWR ID	DWR_RD0369_01_f _ 2019_13				
Comment Code					
V6 : Landscaping					
Inspector Comment					
Remove ivy.

View of the ivy on the LS slope (Fall 2022).

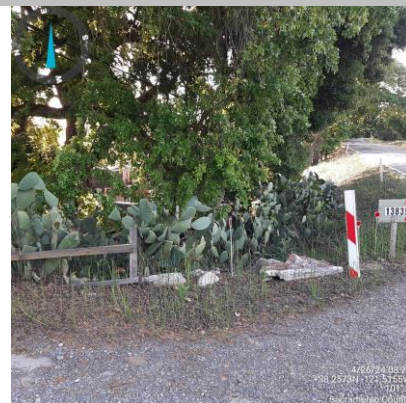
Photo 1 of 1 : SP_2024_RD0369_207_32_20240426_00021.jpg

LM Start	0.17	Rating **	U	Issue No.	32
LM End	0.17	Issue Type +	En	Location *	LS
Category	Earthen Levee			GPS Latitude/Longitude	
				Start	End
Item	Vegetation			38.257197°	38.257197°
				-121.515403°	-121.515403°
DWR ID	DWR_RD0369_01_f _ 2021_32				
Comment Code					
V6 : Landscaping					
Inspector Comment					
Remove cactus on the landside slope.

View of cactus on the LS slope (Spring 2024).

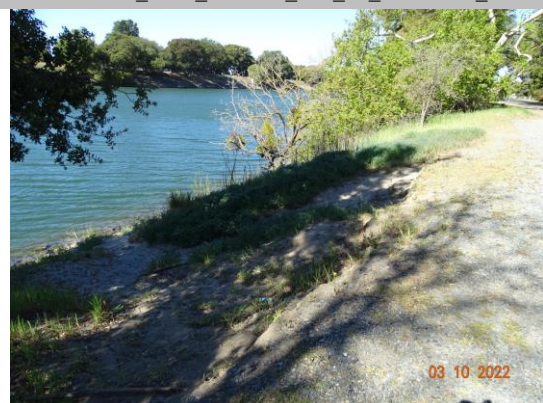
Photo 1 of 1 : SP_2024_RD0369_207_10_20240301_00005.jpg

LM Start	0.18	Rating **	A/W	Issue No.	10
LM End	0.18	Issue Type +	Ma	Location *	WS
Category	Earthen Levee			GPS Latitude/Longitude	
				Start	End
Item	Erosion / Foot Traffic			38.257137°	38.257137°
				-121.515407°	-121.515407°
DWR ID	DWR_RD0369_01_f_2019_10				
Comment Code					
E3 : Repair the levee slope damaged by foot traffic and prevent access where possible.					
Inspector Comment					
Large path created by fishermen. Levee is very wide in this section due to a turnout on the WS.

View of erosion due to foot traffic on the WS slope looking slightly upstream (Spring 2022).

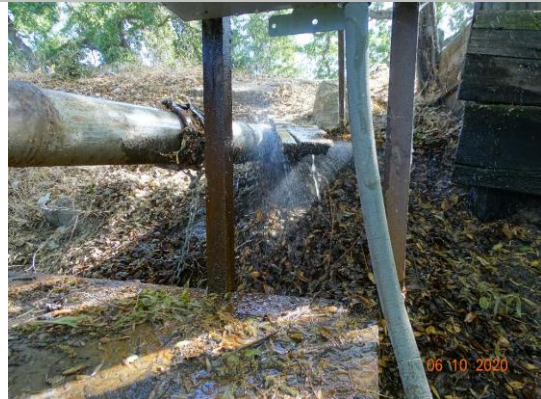
Photo 1 of 3 : UCIP_SP_2024_60752_88065.jpg

Comment Code						
Inspector Comment						
DS_ID:18972 FS_ID:60752 EP_NO: 11117 Repair Type: Urgent EVAL Issue: 1, Pipe Integrity Crossing Status: Found UCIP Comments: 06/10/2020 Record updated from Non-Urgent to Urgent. Hole in pipe on waterside slope above pump. Pipe is running - leak through the hole poses a threat to waterside levee slope. 6-inch pipe installed on landside slope right after siphon breaker. Levee slope was disturbed at this location. 6-inch pipe is running down diagonally on landside slope towards PVC pipe connection at the toe. Unable to find a permit for modification. No permit has been identified authorizing pipe through the levee. Need to have CVFPB review ABO and determine current owner. (O.Yakimov - DWR UCIP) 10/15/2012 Siphon breaker on LS slope needs protection. Water is leaking from pump station. Abandoned concrete structure found on WS. 10-inch abandoned pipe found on WS. Should be removed. 6-inch abandoned pipe found on WS. Should be removed. FIELD_STRUCT_DESC: 10-inch steel irrigation discharge pipe through the levee, 4.5 feet below the crown. Pump and gate valve on the waterside (WS) shoulder. Siphon breaker on the landside (LS) slope. Electric meter, panel at landside toe, 1.5-inch electrical conduit at same location. Abandoned concrete standpipe at landside levee toe. (10-inch pipe [HLM 0.36] authorized under Automatic Board Order (ABO) issued as Permit No. 11117, 1975 - Erma E. Locke et al). [Additional Reference(s): DWR Levee Log, 2005 (HLM 0.36). USACE Sacramento O&M Manual, Unit 111, May 1959, Revised 29 December 2016, (RM 27.63), listed as 10-inch pipe. USACE As-Built Drawing No. 50-04-2983, Sheets 2 and 3, Station 5+83, March 1954. USACE As-Built Drawing No. 06-13-1100, Sheet 15, downstream of 'L' 1671+00, January 1933]. FS Date: 6/10/2020 10:27:02 AM

Water-Side: Pipe leak on levee slope above pump

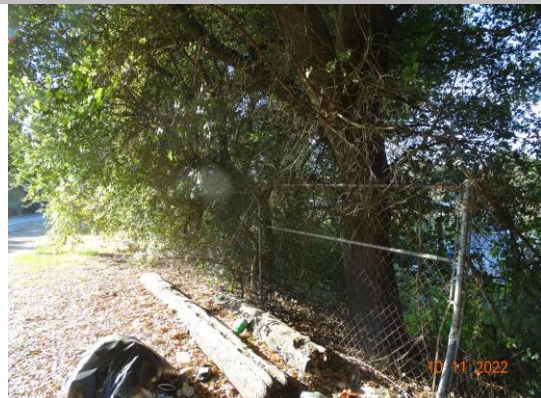
Photo 1 of 1 : SP_2024_RD0369_207_25_20240301_00011.jpg

LM Start	0.56	Rating **	M	Issue No.	25
LM End	0.60	Issue Type +	En	Location *	WS
Category	Earthen Levee			GPS Latitude/Longitude	
				Start	End
Item	Encroachments			38.252692°	38.252247°
				-121.511167°	-121.510922°
DWR ID	DWR_RD0369_01_s_2019_25				
Comment Code					
FE : Fence					
Inspector Comment					
A chain-link fence is located on the waterside slope.

View of the fence on the WS slope (Fall 2022).

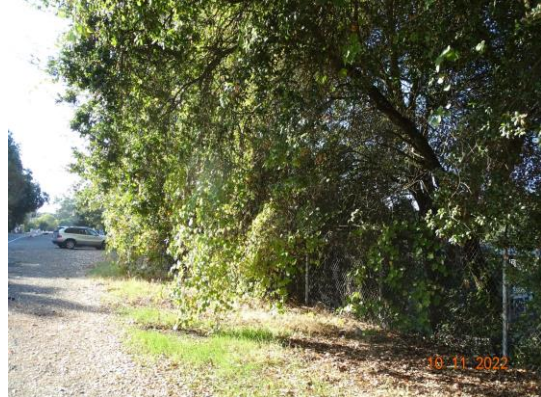
Photo 1 of 1 : SP_2024_RD0369_207_26_20240301_00012.jpg

LM Start	0.57	Rating **	U	Issue No.	26
LM End	0.60	Issue Type +	En	Location *	WS
Category	Earthen Levee			GPS Latitude/Longitude	
				Start	End
Item	Vegetation			38.252662°	38.252247°
				-121.511138°	-121.510922°
DWR ID	DWR_RD0369_01_s_2019_26				
Comment Code					
V6 : Landscaping					
Inspector Comment					
Vegetation on chain-link fence is blocking view down waterside slope.

View of the vegetation and fence on the WS slope (Fall 2022).

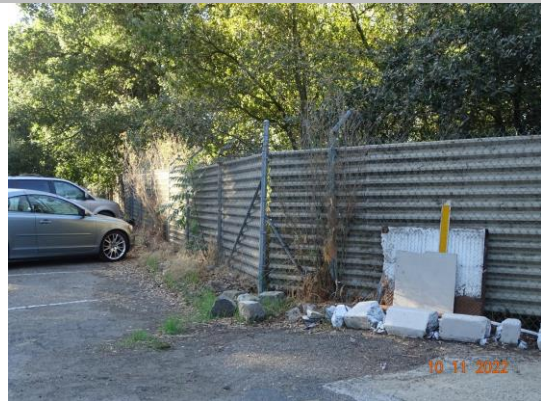
Photo 1 of 1 : SP_2024_RD0369_207_29_20240301_00013.jpg

LM Start	0.62	Rating **	U	Issue No.	29
LM End	0.67	Issue Type +	En	Location *	WS
Category	Earthen Levee			GPS Latitude/Longitude	
				Start	End
Item	Encroachments			38.251982°	38.251267°
				-121.510853°	-121.510480°
DWR ID	DWR_RD0369_01_s_2019_29				
Comment Code					
FE : Fence					
Inspector Comment					
A fence is blocking the view of the waterside slope.

View of the fence on the WS shoulder (Fall 2022).

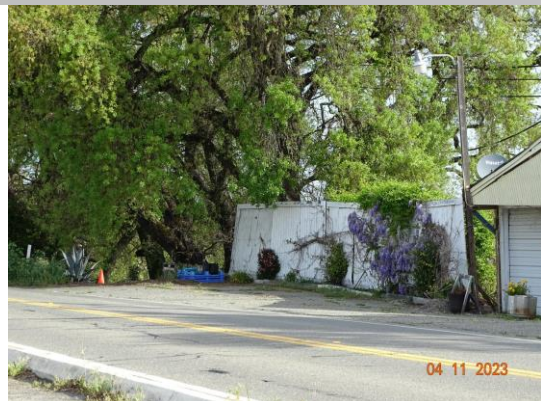
Photo 1 of 1 : SP_2024_RD0369_207_15_20240301_00007.jpg

LM Start	0.66	Rating **	U	Issue No.	15
LM End	0.66	Issue Type +	En	Location *	LS
Category	Earthen Levee			GPS Latitude/Longitude	
				Start	End
Item	Encroachments			38.251403°	38.251403°
				-121.510532°	-121.510532°
DWR ID	DWR_RD0369_01_s_2012_15				
Comment Code					
FE : Fence					
Inspector Comment					
A tall, white, solid fence is blocking the view of the landside levee slope.

View of the fence on the LS shoulder (Spring 2023).

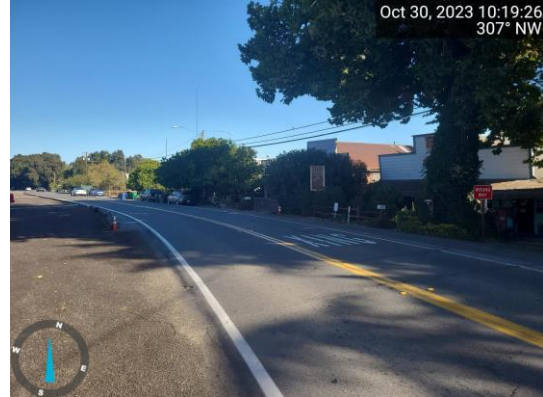
Photo 1 of 1 : SP_2024_RD0369_207_8_20240301_00003.jpg

LM Start	0.70	Rating **	M	Issue No.	8
LM End	0.77	Issue Type +	En	Location *	LS
Category	Earthen Levee			GPS Latitude/Longitude	
				Start	End
Item	Vegetation			38.250904°	38.249930°
				-121.510223°	-121.509880°
DWR ID	DWR_RD0369_01_s_2017_8				
Comment Code					
V6 : Landscaping					
Inspector Comment					
Landscaping needs to be thinned and maintained to allow inspection and access to landside slope and toe.

View looking upstream at landscaping on the landside slope (Fall 2023).
