**Flood Control Project Maintenance  
Levee Inspections**

**Maintenance Issue Types Only, Levee Inspection Report By Mile - Fall 2015**

**Reclamation District No. 0369 Libby McNeil**

Waterway	Bank	Unit Miles	Inspection Start/End	Inspector
Unit No. 01 Sacramento River	Left	0.78	09/25/2015 09/25/2015	Herman Phillips

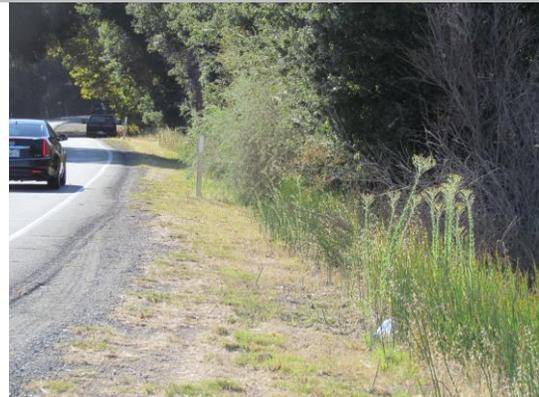
Photo 1 of 1 : FA\_2015\_RD0369\_207\_6\_20150928\_00002.jpg

LM Start	<b>0.02</b>	Rating **	M	Issue No.	<b>6</b>
LM End	<b>0.10</b>	Issue Type +	Ma	Location *	WS
Category	Earthen Levee		GPS Latitude/Longitude		
			Start	End	
Item	Vegetation		38.258645 °	38.257842 °	
			-121.517580 °	-121.516463 °	
DWR ID	DWR_RD0369_01_f_2015_6				
Action/Comments					
Control annual grass and weeds on the levee slopes and easements. Inspector Comments: Downstream from where this photo was taken we met the goat contractor with goats working this waterside slope and shoulder. From here to levee mile 0.78 waterside is good.

RD 369 Looking downstream at the waterside levee section.
