**Flood Control Project Maintenance
Levee Inspections
LMA District Cover Sheet
Spring 2010 Levee Inspection Results**

Reclamation District No. 0369 Libby McNeil

Levee Inspection Report By Mile - Spring 2010

Waterway	Bank	Unit Miles	Inspection Start/End	Inspector
Unit No. 01 Steamboat Slough	Left	0.80	03/26/2010 03/26/2010	Herman Phillips

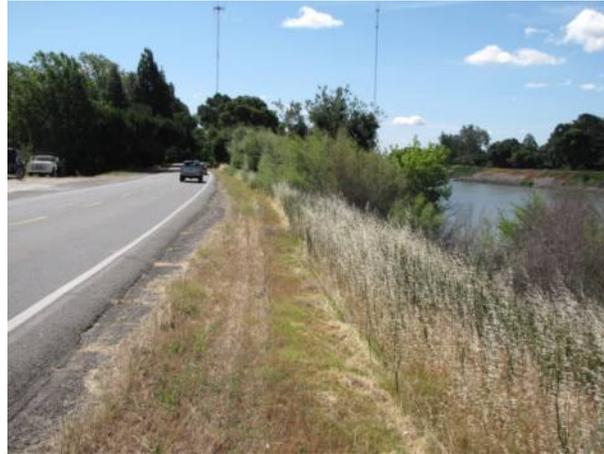
phillips_s_20100623_097.jpg

Levee Mile Report Line	1
Start Levee Mile	0.00
End Levee Mile	0.00
Location	Land Side
Category	Earthen Levee
Item	Vegetation

This photo was taken on the waterward shoulder looking down stream from levee mile 0.00. Wild growth is present on the slope District needs to control this growth. The County has mowed two passed on the shoulders.

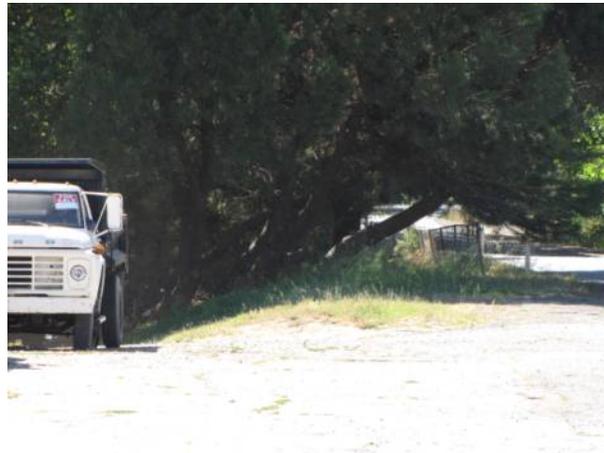
phillips_s_20100623_098.jpg

Levee Mile Report Line	1
Start Levee Mile	0.00
End Levee Mile	0.00
Location	Land Side
Category	Earthen Levee
Item	Vegetation

This photo was taken on the land side at levee mile 0.00 looking downstream.
