**Flood Control Project Maintenance  
Levee Inspections**

**Fall 2010 Levee Maintenance Deficiency Summary Report**

**Reclamation District No. 0404 Boggs**

**Levee Inspection Report By Mile - Fall 2010**

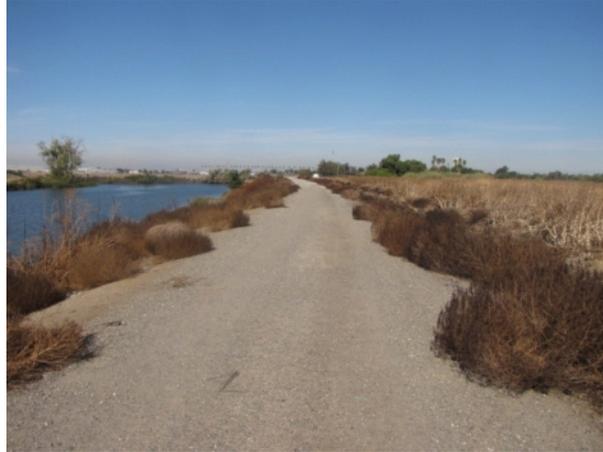
Levee Mile Report Line	1
Start Levee Mile	0.03
End Levee Mile	0.48
Location	Land Side
Category	Earthen Levee
Item	Vegetation
Looking north at modest vegetation on landside and waterside slopes.	
richard_f_20101029_349.jpg

LMR No.	Levee Mile		Category	Item	* Location	** Rating	Action/Comment	GPS Latitude/Longitude		Issue No. Photo
	Start	End						Start	End	
1	0.03	0.48	Earthen Levee	Vegetation	LS	M	Remove the wild growth other than native grasses from the levee slopes.	37.941695 ° -121.344917 °	37.939652 ° -121.338373 °	5 Y
2	0.03	0.20	Earthen Levee	Vegetation	WS	M	Remove the wild growth other than native grasses from the levee slopes.	37.941697 ° -121.344917 °	37.939853 ° -121.343210 °	8 Y
3	0.21	0.25	Supplemental	DWR Erosion Survey	WS	U	Inspector Comments: 9/07/2010: No significant change observed on site. There is emergent vegetation at the water line. Several pocket erosions lined along the lower slope that stretches from RM 40.86 to RM 41.14. [2010 SiteID: RD0404U01RM40.86]	37.939480 ° -121.342730 °	37.939480 ° -121.342730 °	1 Y
4	0.24	0.27	Earthen Levee	Erosion / Bank Caving	WS	M	Note and monitor erosion site.	37.939430 ° -121.342620 °	37.939430 ° -121.342620 °	6 Y

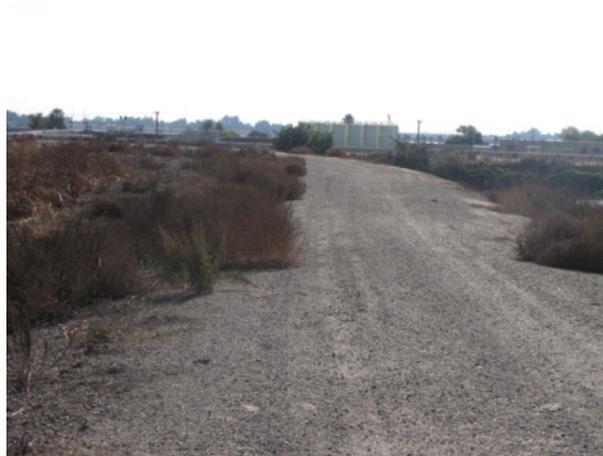
Levee Mile Report Line	2
Start Levee Mile	0.03
End Levee Mile	0.20
Location	Water Side
Category	Earthen Levee
Item	Vegetation
Looking south modest vegetation on waterside slope.	
richard_f_20101029_350.jpg

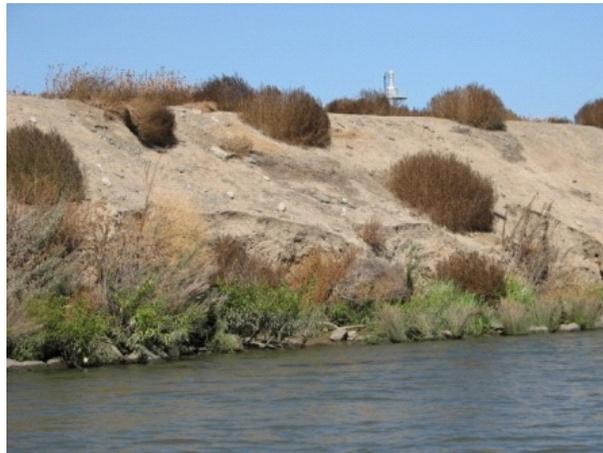
Levee Mile Report Line	3
Start Levee Mile	0.21
End Levee Mile	0.25
Location	Water Side
Category	Supplemental
Item	DWR Erosion Survey
Upstream view of Site 1 at RM 41.14.	
SJR2010_RM40.86U1LM.23RBa.jpg

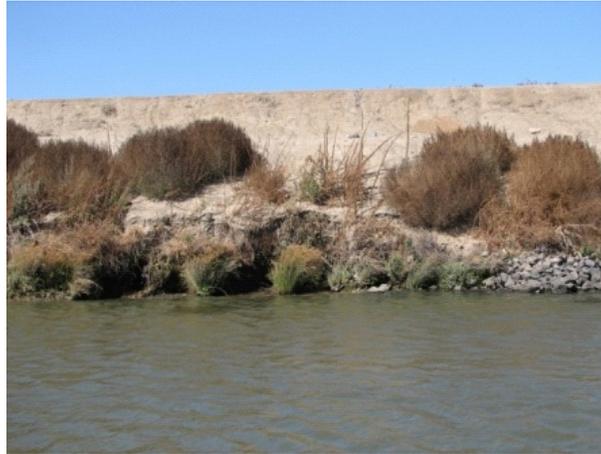
Levee Mile Report Line	3
Start Levee Mile	0.21
End Levee Mile	0.25
Location	Water Side
Category	Supplemental
Item	DWR Erosion Survey

Front view of Site 1 at RM 40.98.

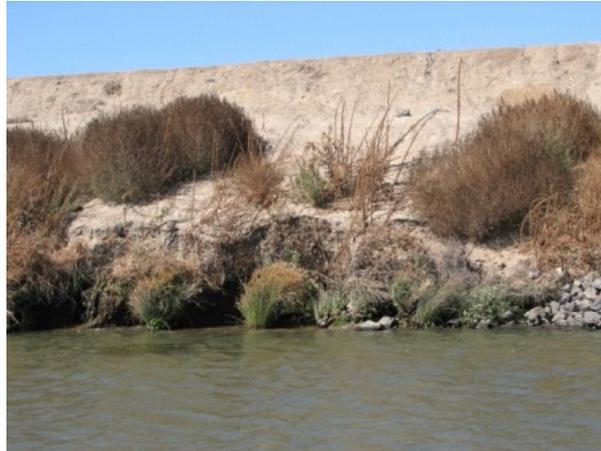
Levee Mile Report Line	3
Start Levee Mile	0.21
End Levee Mile	0.25
Location	Water Side
Category	Supplemental
Item	DWR Erosion Survey

Front view of site 2 at RM 40.93.

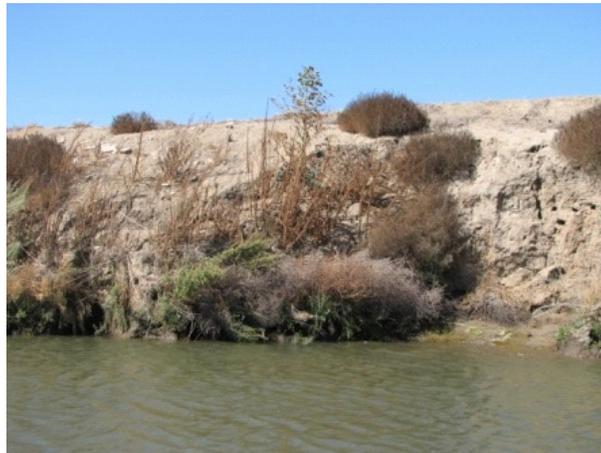
Levee Mile Report Line	3
Start Levee Mile	0.21
End Levee Mile	0.25
Location	Water Side
Category	Supplemental
Item	DWR Erosion Survey

Front view of site at RM40.86.

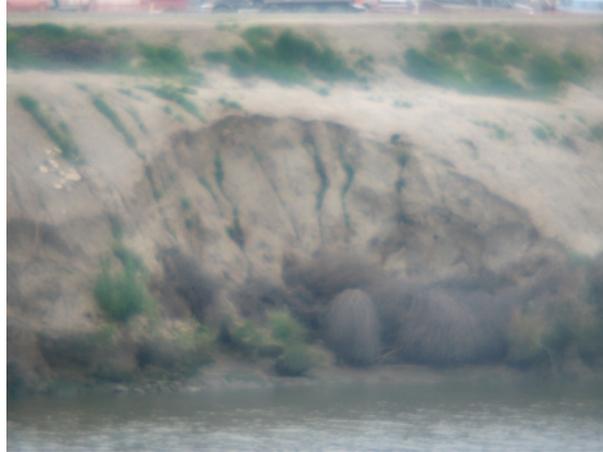
Levee Mile Report Line	4
Start Levee Mile	0.24
End Levee Mile	0.27
Location	Water Side
Category	Earthen Levee
Item	Erosion / Bank Caving
Erosion from LM 0.24 to 0.27	
richard_f_20100921_076.jpg

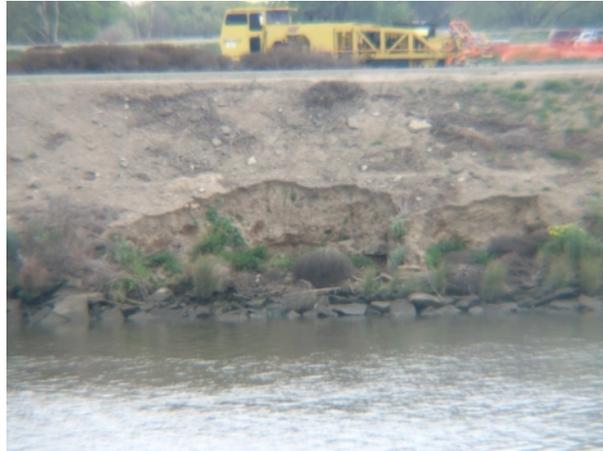
Levee Mile Report Line	4
Start Levee Mile	0.24
End Levee Mile	0.27
Location	Water Side
Category	Earthen Levee
Item	Erosion / Bank Caving
Erosion at LM 0.27	
richard_f_20100921_077.jpg

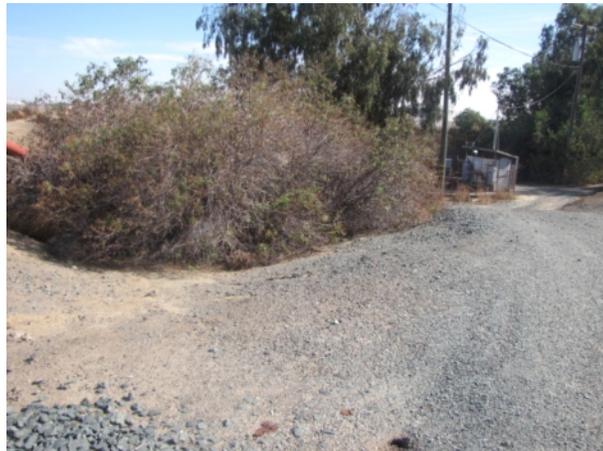
Levee Mile Report Line	5
Start Levee Mile	0.75
End Levee Mile	0.75
Location	Land Side
Category	Earthen Levee
Item	Vegetation
Looking southeast at elderberry on landside slope.	
richard_f_20101029_351.jpg

5	0.75	0.75	Earthen Levee	Vegetation	LS	M	Elderberries are blocking visibility and flood fight capability.	37.937758 ° -121.334149 °	37.937758 ° -121.334149 °	7 Y
6	0.96	0.96	Earthen Levee	Vegetation	LS	M	Elderberries are blocking visibility and flood fight capability.	37.935990 ° -121.331600 °	37.935990 ° -121.331600 °	2
7	1.56	1.56	Earthen Levee	Repair Gates	CR	U	Inspector Comments: Not able to access levee due to no key to lock. Not able inspected for LM 0.80 to 1.55	37.929048 ° -121.327253 °	37.929048 ° -121.327253 °	10
8	1.57	1.67	Earthen Levee	Animal Control	LS	M	No rodents visible, but rodent burrows visible; need to backfill and compact or grout borrows.	37.928723 ° -121.327207 °	37.927945 ° -121.325933 °	9
9	1.63	1.63	Earthen Levee	Slope Stability	WS	M	Repair slope instability.	37.928208 ° -121.326608 °	37.928208 ° -121.326608 °	12 Y
10	1.64	1.65	Earthen Levee	Slope Stability	LS	M	Repair the levee slope damaged by vehicle traffic and prevent access where possible.	37.928118 ° -121.326338 °	37.927970 ° -121.326007 °	11 Y

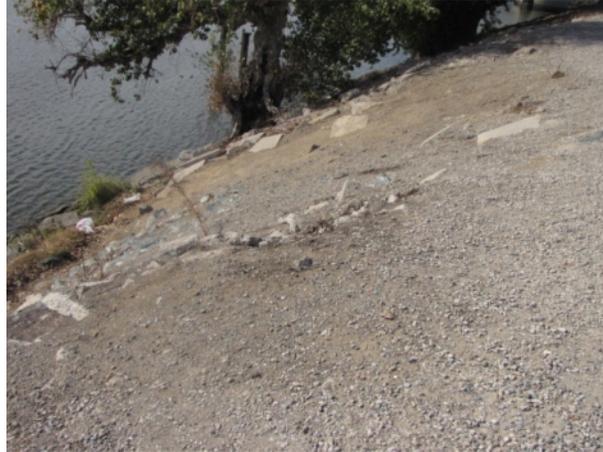
Levee Mile Report Line	9
Start Levee Mile	1.63
End Levee Mile	1.63
Location	Water Side
Category	Earthen Levee
Item	Slope Stability
Looking southwest at minor slope sliding on waterside slope.	
richard_f_20101029_355.jpg

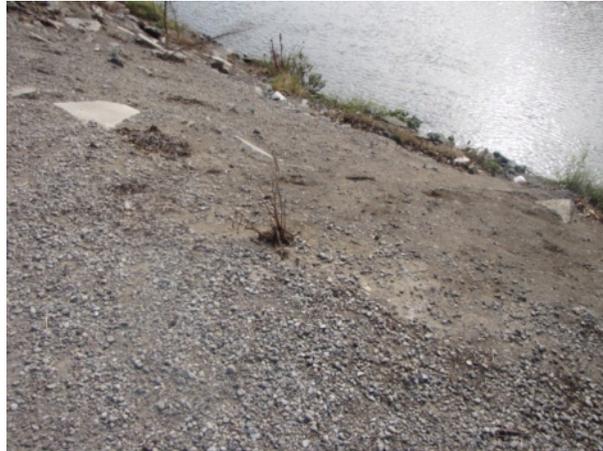
Levee Mile Report Line	9
Start Levee Mile	1.63
End Levee Mile	1.63
Location	Water Side
Category	Earthen Levee
Item	Slope Stability
Looking southeast at minor slope sliding on waterside slope.	
richard_f_20101029_356.jpg

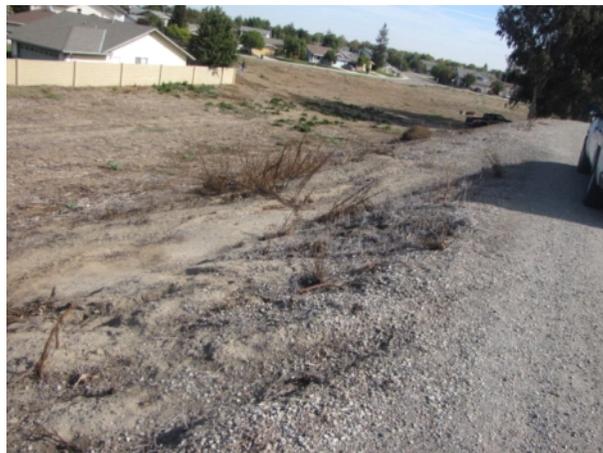
Levee Mile Report Line	10
Start Levee Mile	1.64
End Levee Mile	1.65
Location	Land Side
Category	Earthen Levee
Item	Slope Stability
Looking northeast at minor slope damage on landside slope cause by vehicle traffic.	
richard_f_20101029_352.jpg

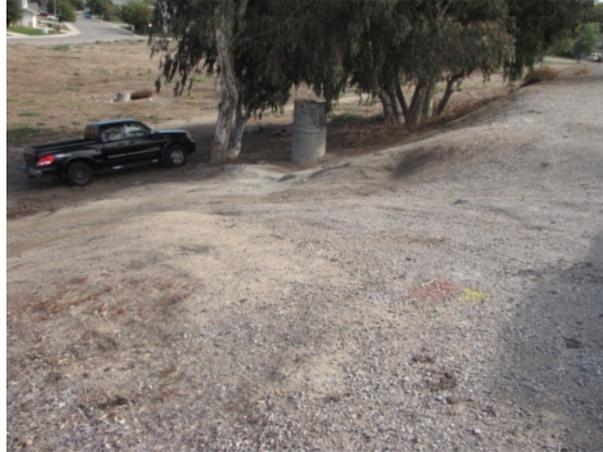
Levee Mile Report Line	10
Start Levee Mile	1.64
End Levee Mile	1.65
Location	Land Side
Category	Earthen Levee
Item	Slope Stability
Looking northeast at slope damage on landside slope cause by vehicle traffic.	
richard_f_20101029_353.jpg

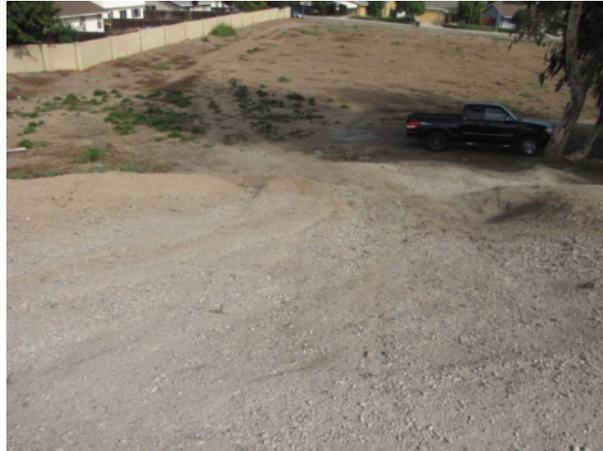
Levee Mile Report Line	10
Start Levee Mile	1.64
End Levee Mile	1.65
Location	Land Side
Category	Earthen Levee
Item	Slope Stability
Looking east at slope damage on landside slope.	
richard_f_20101029_354.jpg

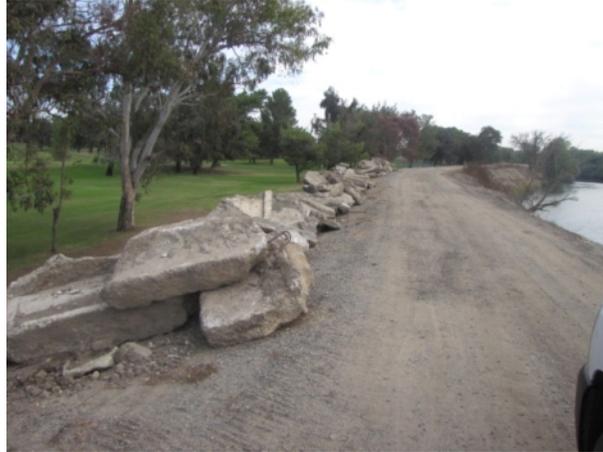
LMR No.	Levee Mile		Category	Item	* Location	** Rating	Action/Comment	GPS Latitude/Longitude		Issue No. Photo
	Start	End						Start	End	
1	0.01	0.05	Earthen Levee	Encroachments	LS	M	Material Inspector Comments: Concrete rubble left on landside shoulder from waterside erosion repair.	37.920222 ° -121.318138 °	37.919888 ° -121.317558 °	2 Y
2	0.19	0.35	Earthen Levee	Animal Control	LS	M	No rodents visible, but rodent burrows visible; need to backfill and compact or grout borrows.	37.919543 ° -121.311432 °	37.918935 ° -121.313335 °	3
3	0.48	0.48	Earthen Levee	Animal Control	LS	M	No rodents visible, but rodent burrows visible; need to backfill and compact or grout borrows.	37.919525 ° -121.311193 °	37.919525 ° -121.311193 °	8
4	0.82	0.91	Earthen Levee	Vegetation	LS	M	Remove the wild growth other than native grasses from the levee slopes.	37.918320 ° -121.305740 °	37.917162 ° -121.305285 °	4
5	1.13	1.18	Earthen Levee	Animal Control	LS	M	Exterminate rodents and backfill and compact or grout burrows.	37.916347 ° -121.301887 °	37.916497 ° -121.301095 °	11

Levee Mile Report Line	1
Start Levee Mile	0.01
End Levee Mile	0.05
Location	Land Side
Category	Earthen Levee
Item	Encroachments
Looking south at concrete rubble with rebar on landside slope.	
richard_f_20101029_357.jpg

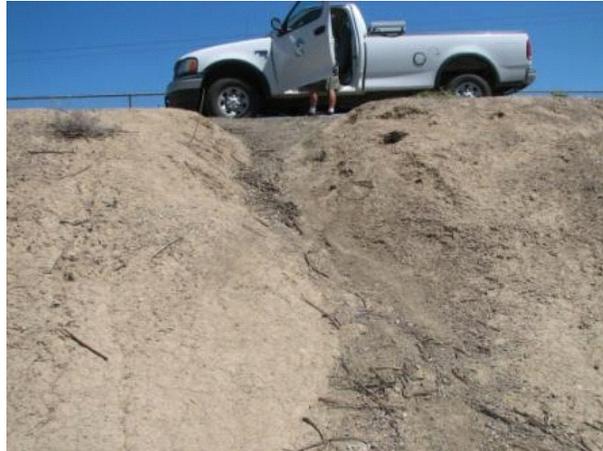
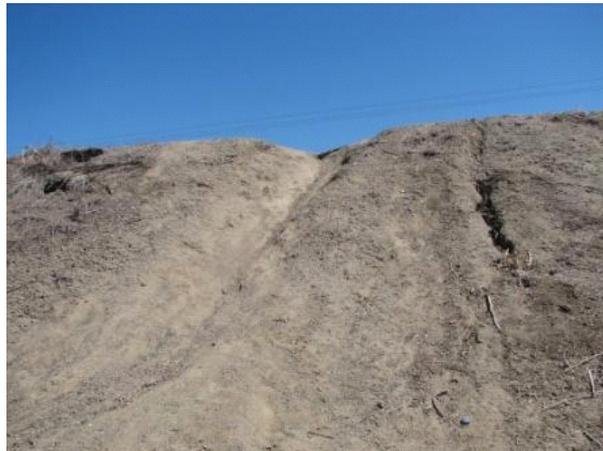
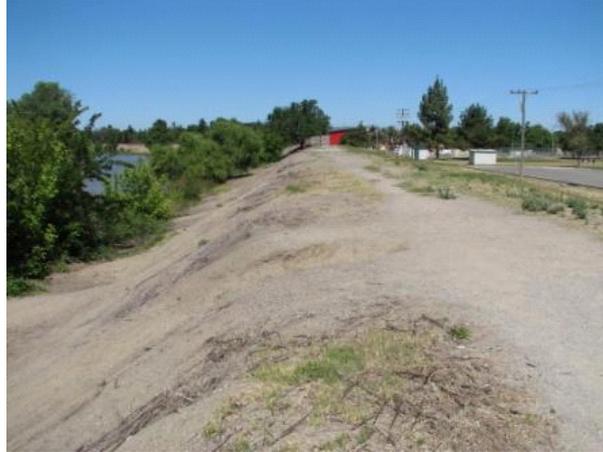
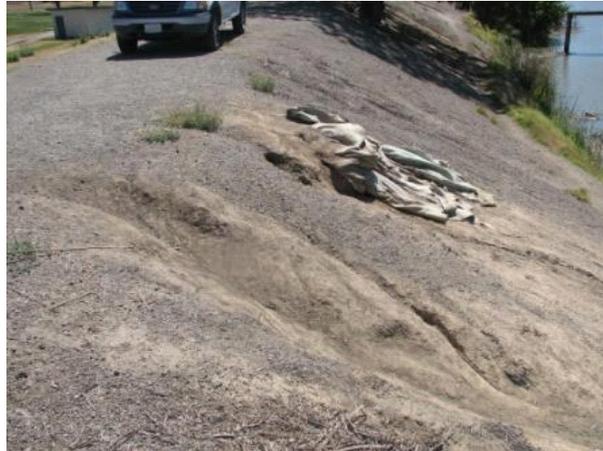
6	1.32	1.58	Supplemental	DWR Erosion Survey	WS	U	Inspector Comments: 11/30/2010: Site was not inspected this year due to time constraints. There has been no reports from the district that the site was corrected. Continue to monitor during flood events. 08/05/2010: Recommended for annual assessment and monitoring during flood events, per CLRO. [2010 SiteID: RD0404U02RM1.56]	37.918440 ° -121.297040 °	37.918440 ° -121.297040 °	1 Y
7	1.47	1.52	Earthen Levee	Encroachments	LS	PO	Fences	37.918440 ° -121.296707 °	37.918517 ° -121.295763 °	6 Y

Levee Mile Report Line	6
Start Levee Mile	1.32
End Levee Mile	1.58
Location	Water Side
Category	Supplemental
Item	DWR Erosion Survey
Photo taken in 2007.	
SJR2010_RM1.56U2LM1.45RBa.jpg

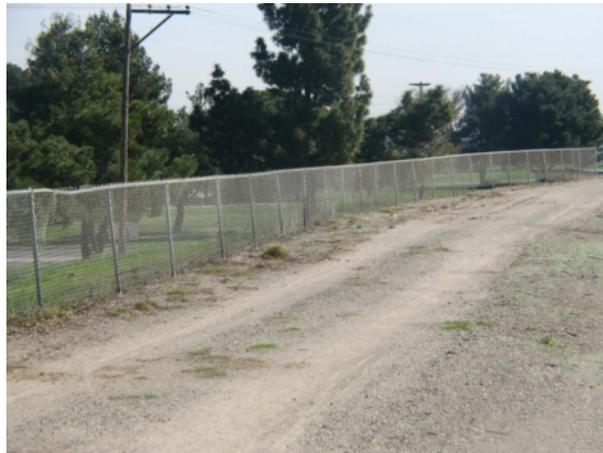
Levee Mile Report Line	7
Start Levee Mile	1.47
End Levee Mile	1.52
Location	Land Side
Category	Earthen Levee
Item	Encroachments
Fence at landside shoulder from LM 1.47 to 1.52	
richard_f_20100921_082.jpg
