**Flood Control Project Maintenance
Levee Inspections**
LMA District Cover Sheet
Spring 2008 Levee Inspection Results

Reclamation District No. 0404

Levee Inspection Report By Mile - Spring 2008

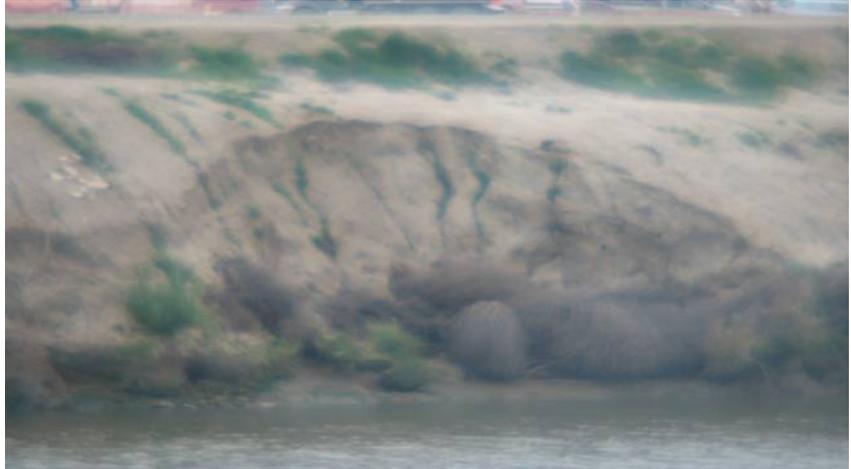
Levee Mile Report Line	3
Start Levee Mile	0.24
End Levee Mile	0.27
Location	
Category	Earthen Levee
Item	Erosion / Bank Caving
Erosion from LM 0.24 to 0.27

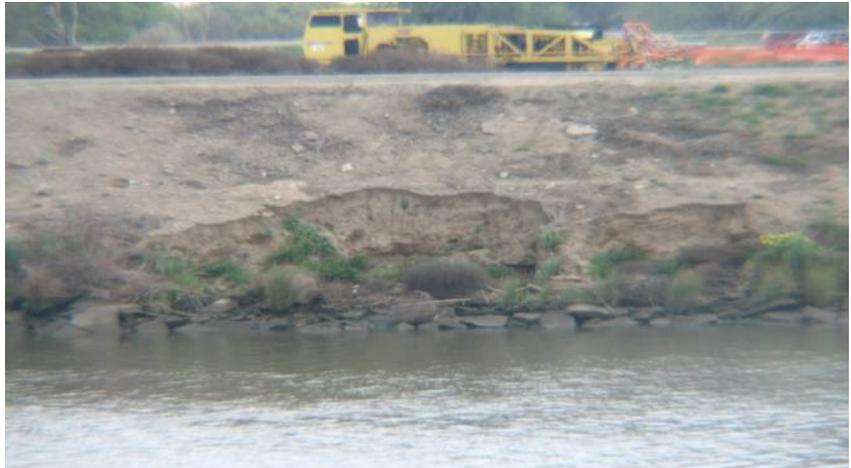
Levee Mile Report Line	3
Start Levee Mile	0.24
End Levee Mile	0.27
Location	
Category	Earthen Levee
Item	Erosion / Bank Caving
Erosion at LM 0.27

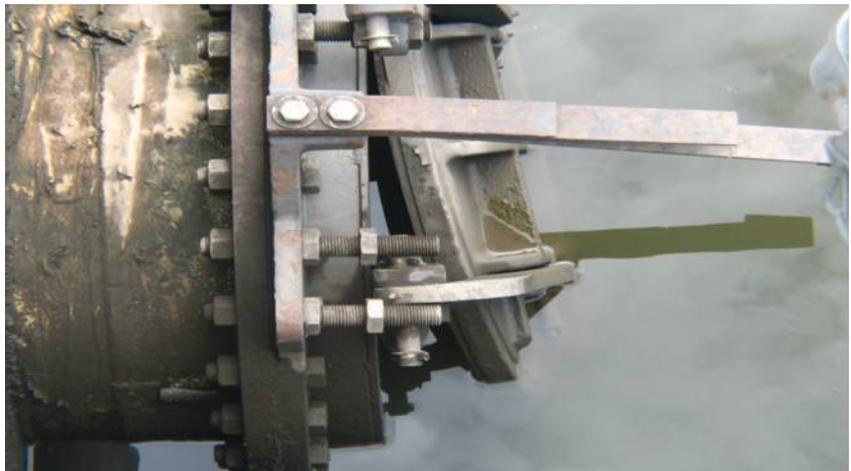
6	1.80	1.80	Interior Drainage & Piping Systems	Flap Gates	WS	M	Inspector Comments: This pipe is maintain by the City of Stockton Public Works Dept.	37.926298 ° -121.324622 °	37.926298 ° -121.324622 °	Y	5

Levee Mile Report Line	6
Start Levee Mile	1.80
End Levee Mile	1.80
Location	
Category	Interior Drainage & Piping Systems
Item	Flap Gates
Flap gate at City of Stockton Pump Station LM 1.80 right hinge broken

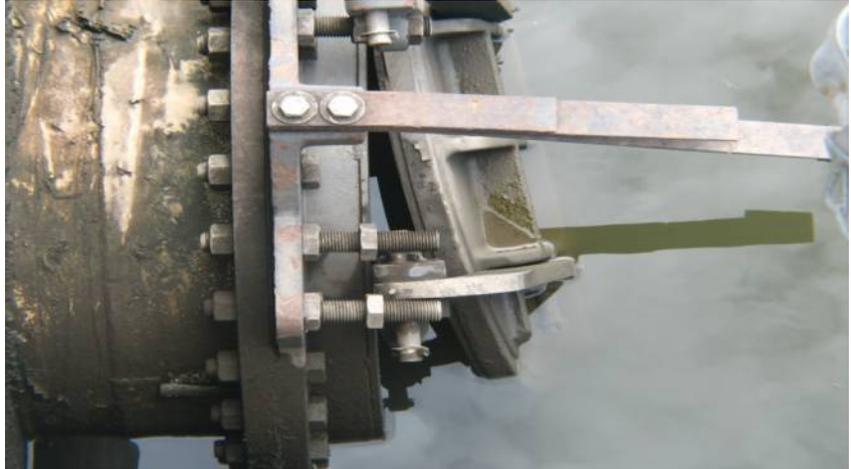
Levee Mile Report Line	6
Start Levee Mile	1.80
End Levee Mile	1.80
Location	
Category	Interior Drainage & Piping Systems
Item	Flap Gates
Flap gate at City of Stockton Pump Station LM 1.80 right hinge broken

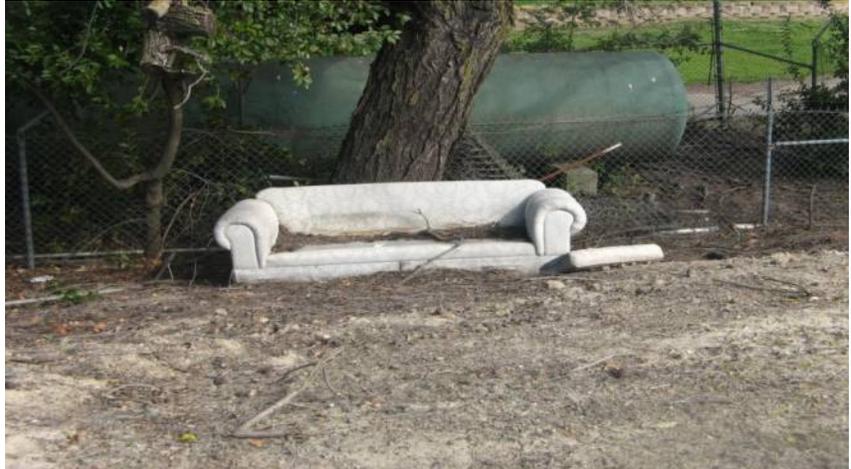
Levee Mile Report Line	4
Start Levee Mile	1.13
End Levee Mile	1.13
Location	
Category	Earthen Levee
Item	Encroachments
Sofa to landside toe LM 1.13

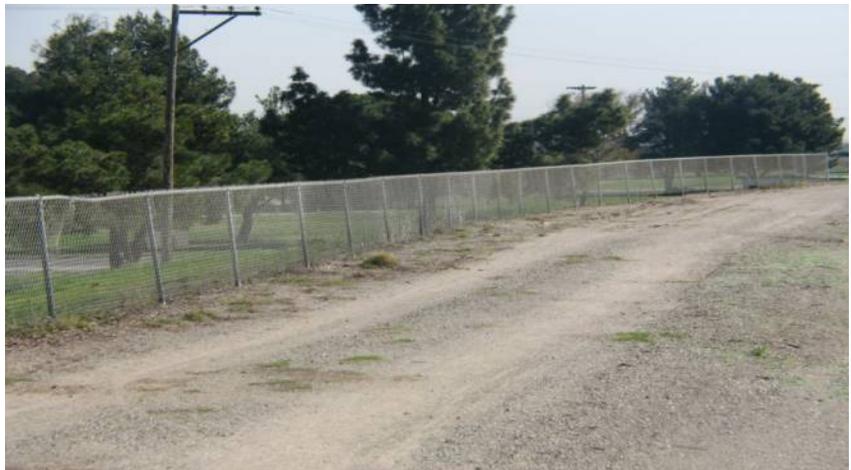
5	1.35	1.75	Earthen Levee	Crown Surface / Depressions / Rutting	CR	M	Add appropriate gravel or road base. Grade and compact.	37.918147 ° -121.298747 °	37.917263 ° -121.291778 °		5
6	1.47	1.52	Earthen Levee	Encroachments	LS	PO	Fences	37.918440 ° -121.296707 °	37.918517 ° -121.295763 °	Y	6

Levee Mile Report Line	6
Start Levee Mile	1.47
End Levee Mile	1.52
Location	
Category	Earthen Levee
Item	Encroachments
Fence at landside shoulder from LM 1.47 to 1.52
