**Flood Control Project Maintenance  
Levee Inspections**  
**LMA District Cover Sheet**  
**Spring 2015 Levee Inspection Results**

**Reclamation District No. 0404 Boggs**

**Spring 2015 Levee Inspection Results**

Waterway		Bank	Unit Miles
Unit No. 01 San Joaquin River		Right	2.35

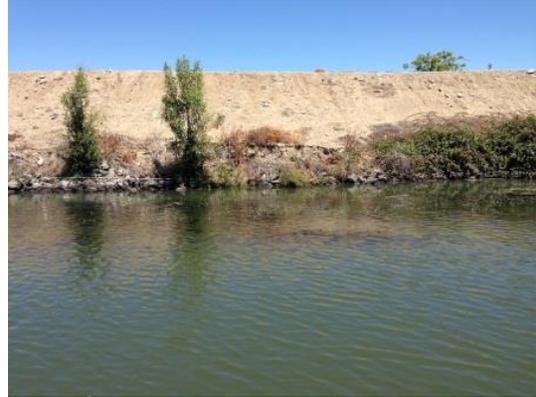
Photo 1 of 1 : SP\_2015\_RD0404\_305\_18\_20150309\_00012.jpg

LM Start	<b>0.34</b>	Rating **	U	Issue No.	<b>18</b>
LM End	<b>0.34</b>	Issue Type +	Ma	Location *	WS
Category	Supplemental			GPS Latitude/Longitude	
				Start	End
Item	DWR Erosion Survey			37.939228 °	37.939228 °
				-121.340786 °	-121.340786 °
DWR ID	DWR_RD0404_01_s_2015_18				
Action/Comments					
Inspector Comments: 06/19/2014: No significant change observed. 08/13/2013: The pocket erosion is located at immediately upstream of a small oak tree. [2014 Site ID:RD0404U01RM40.98]

Front view of the erosion.

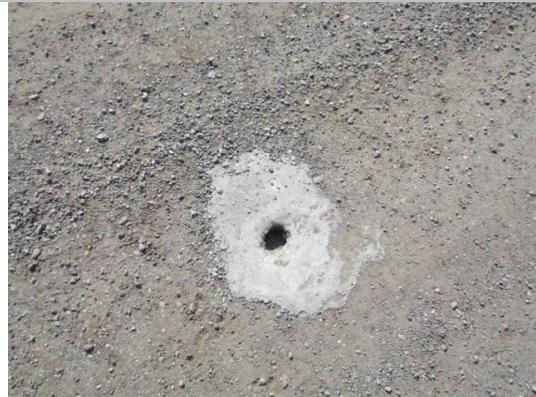
Photo 1 of 4 : SP\_2015\_RD0404\_305\_5\_20150309\_00003.jpg

LM Start	<b>0.43</b>	Rating **	A/W	Issue No.	<b>5</b>
LM End	<b>0.43</b>	Issue Type +	Ma	Location *	CR
Category	Earthen Levee			GPS Latitude/Longitude	
				Start	End
Item	Animal Control			37.939635 °	37.939635 °
				-121.339063 °	-121.339063 °
DWR ID	DWR_RD0404_01_s_2013_5				
Action/Comments					
No rodents visible, but rodent burrows visible; need to backfill and compact or grout burrows. Inspector Comments: One large rodent hole located on levee crown and several rodent holes also located in this area. District grouted hole, but hole was not fully grouted.

Looking at partialled grouted rodent hole on levee crown (Fall 2014).

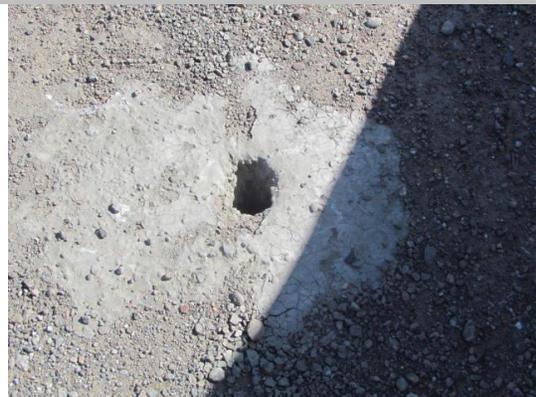
Photo 2 of 4 : SP\_2015\_RD0404\_305\_5\_20150309\_00004.jpg

Looking at partially grouted rodent hole on levee crown

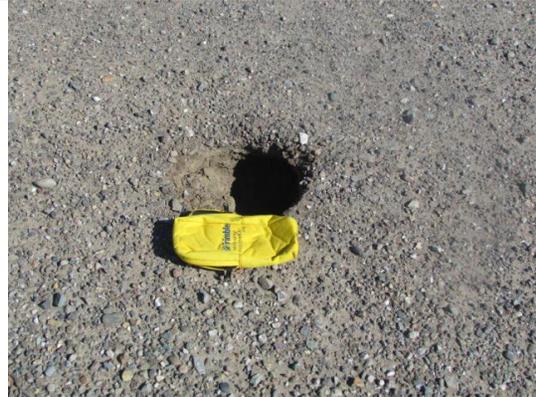
Photo 3 of 4 : SP\_2015\_RD0404\_305\_5\_20150309\_00005.jpg

Looking at rodent hole on levee crown.

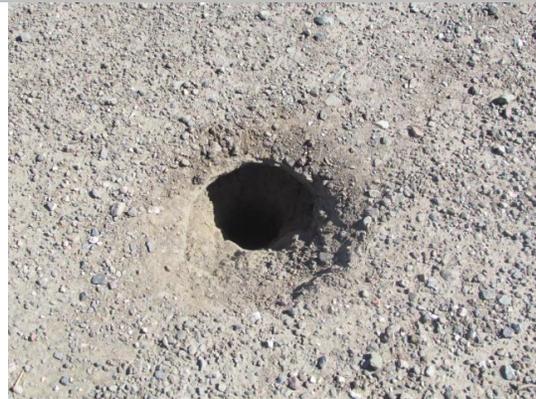
Photo 4 of 4 : SP\_2015\_RD0404\_305\_5\_20150309\_00006.jpg

Looking at one of several rodent holes on levee crown.

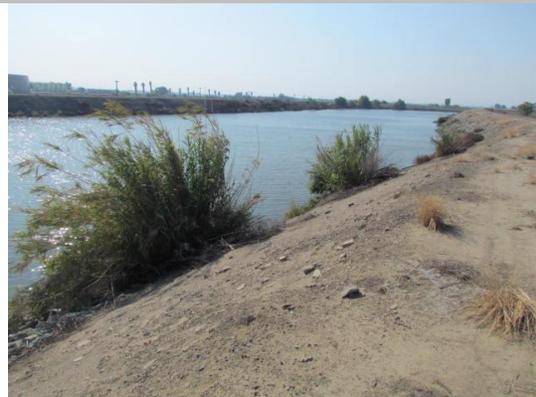
Photo 1 of 3 : SP\_2015\_RD0404\_305\_104\_20150309\_00018.jpg

LM Start	<b>0.45</b>	Rating **	M	Issue No.	<b>104</b>
LM End	<b>0.45</b>	Issue Type +	Ma	Location *	WS
Category	Earthen Levee			GPS Latitude/Longitude	
				Start	End
Item	Vegetation			37.939627 °	37.939627 °
				-121.338808 °	-121.338808 °
DWR ID	DWR_RD0404_01_s_2012_104				
Action/Comments					
Remove the wild growth other than native grasses from the levee slopes. Inspector Comments: Remove bamboo on waterside toe. Bamboo is not within twenty feet zone, but should be removed to stop from spreading along waterward slope. Bamboo has increased in size.

Looking northwest at bamboo on waterside toe.

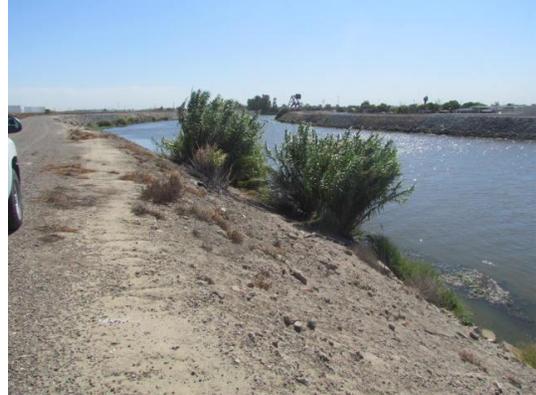
Photo 2 of 3 : SP\_2015\_RD0404\_305\_104\_20150309\_00019.jpg

Looking west at bamboo on waterward slope. 2013

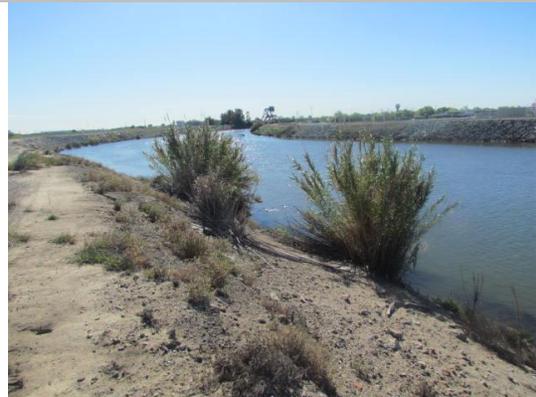
Photo 3 of 3 : SP\_2015\_RD0404\_305\_104\_20150309\_00020.jpg

Looking southwest at bamboo on waterward slope and toe.

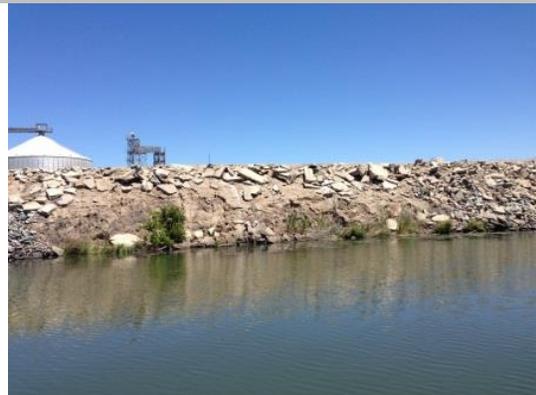
Photo 1 of 1 : SP\_2015\_RD0404\_305\_19\_20150309\_00013.jpg

LM Start	<b>0.48</b>	Rating **	U	Issue No.	<b>19</b>
LM End	<b>0.48</b>	Issue Type +	Ma	Location *	WS
Category	Supplemental		GPS Latitude/Longitude		
			Start	End	
Item	DWR Erosion Survey		37.939190 °	37.939190 °	
			-121.338280 °	-121.338280 °	
DWR ID	DWR_RD0404_01_s_2015_19				
Action/Comments					
Inspector Comments: 6/19/2014: No significant change observed. 08/13/2013: No significant change at this site. 8/7/2012: The erosion is next to a repaired site and approximately 400 feet downstream of a river bend. There are broken concretes at the upper levee slope, but not visible at the levee toe or lower slope. Likely the protection concrete blocks have been washed away. [2014 Site

Front view of the site.

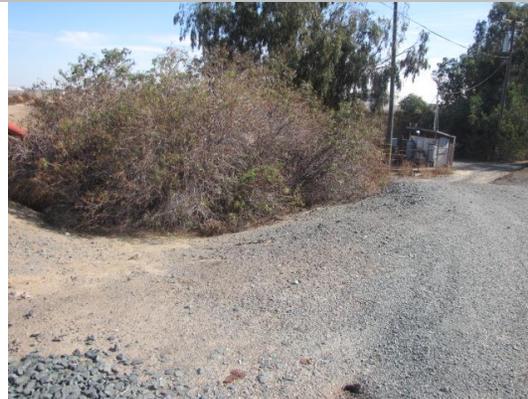
Photo 1 of 1 : SP\_2015\_RD0404\_305\_7\_20150309\_00008.jpg

Looking southeast at elderberry on landside slope.

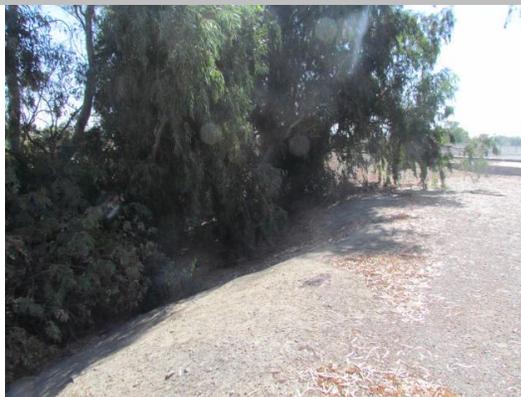
Photo 1 of 1 : SP\_2015\_RD0404\_305\_8\_20150309\_00009.jpg

Looking southeast at dense trees on landward slope and toe.

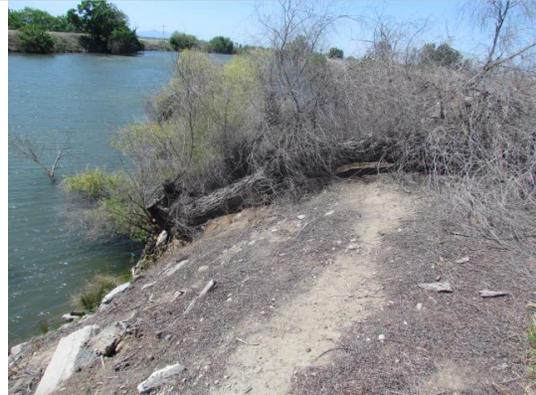
Photo 1 of 2 : SP\_2015\_RD0404\_305\_3\_20150416\_00027.jpg

Looking northwest at downed tree on waterward slope and shoulder.

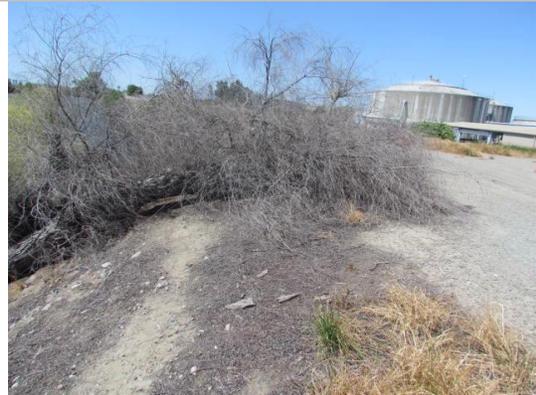
Photo 2 of 2 : SP\_2015\_RD0404\_305\_3\_20150416\_00028.jpg

Looking north at downed tree on waterward slope and shoulder.

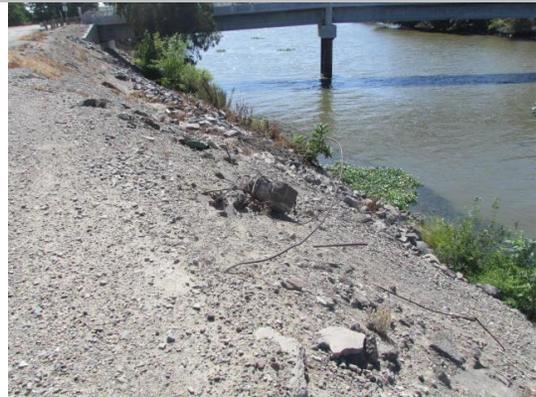
Photo 1 of 1 : SP\_2015\_RD0404\_305\_4\_20150309\_00002.jpg

Looking southwest at concrete rubble with rebar on waterward slope.

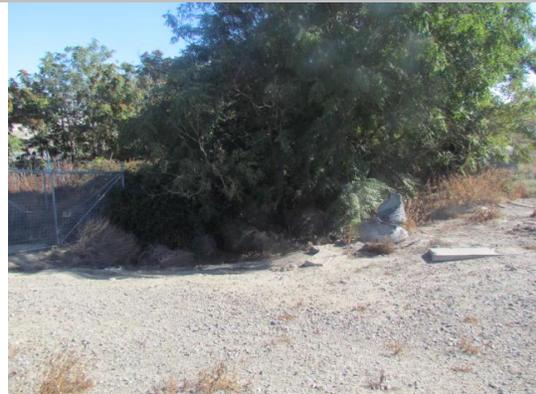
Photo 1 of 1 : SP\_2015\_RD0404\_305\_101\_20150309\_00017.jpg

LM Start	<b>1.19</b>	Rating **	M	Issue No.	<b>101</b>
LM End	<b>1.19</b>	Issue Type +	Ma	Location *	LS
Category	Earthen Levee			GPS Latitude/Longitude	
				Start	End
Item	Vegetation			37.934058 °	37.934058 °
				-121.328188 °	-121.328188 °
DWR ID	DWR_RD0404_01_s_2012_101				
Action/Comments					
Remove the wild growth other than native grasses from the levee slopes.

Looking southeast at overhanging trees on landside slope.

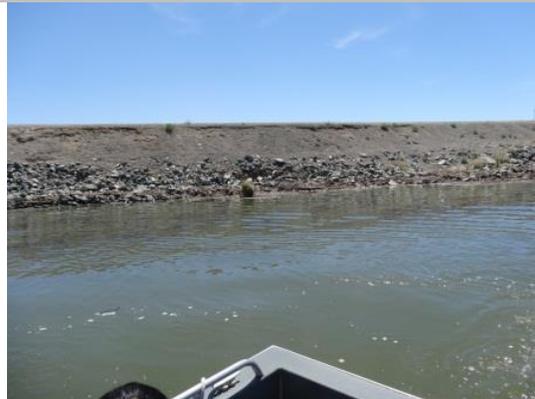
Photo 1 of 2 : SP\_2015\_RD0404\_305\_32\_20150309\_00016.jpg

LM Start	<b>1.45</b>	Rating **	M	Issue No.	<b>32</b>
LM End	<b>1.45</b>	Issue Type +	Ma	Location *	WS
Category	Supplemental			GPS Latitude/Longitude	
				Start	End
Item	DWR Erosion Survey			37.930450 °	37.930450 °
				-121.327450 °	-121.327450 °
DWR ID	DWR_RD0404_01_s_2015_32				
Action/Comments					
Inspector Comments: 06/19/2014: A series of scarp erosions have been found on the lower levee slope and at the levee toe. [2014 Site ID:RD0404U01RM42.02]

Close view of the erosion. Note the protection on the lower levee slope.

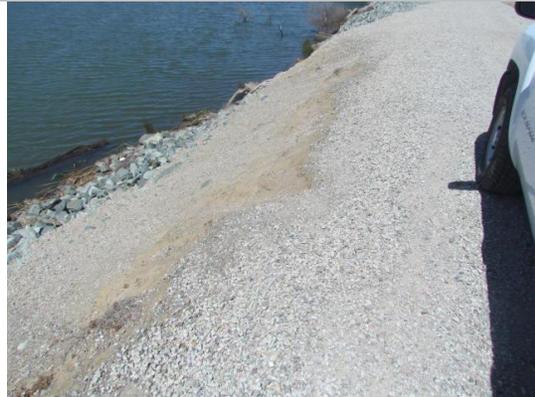
Photo 2 of 2 : SP\_2015\_RD0404\_305\_32\_20150416\_00029.jpg

Looking northwest at erosion on waterward slope.

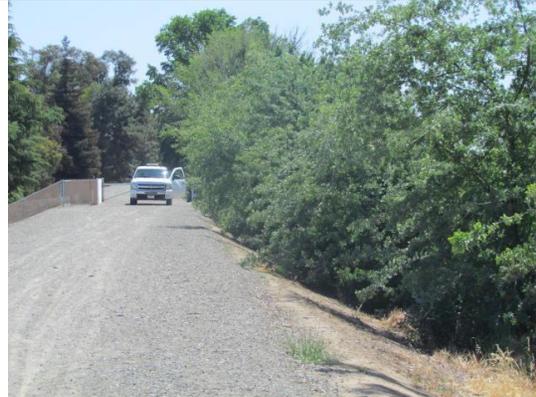
Photo 1 of 1 : SP\_2015\_RD0404\_305\_29\_20150416\_00030.jpg

Looking east at untrimmed trees on waterward slope.

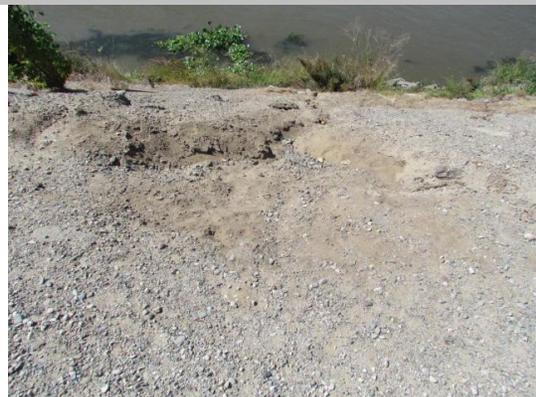
Photo 1 of 2 : SP\_2015\_RD0404\_305\_16\_20150309\_00010.jpg

LM Start	<b>2.01</b>	Rating **	M	Issue No.	<b>16</b>
LM End	<b>2.01</b>	Issue Type +	Ma	Location *	WS
Category	Earthen Levee		GPS Latitude/Longitude		
			Start	End	
Item	Slope Stability		°	°	
			°	°	
DWR ID	DWR_RD0404_01_f_2013_16				
Action/Comments					
Repair the levee slope damaged by foot traffic and prevent access where possible. Inspector Comments: Slope damage due to foot traffic.

Looking west at slope damage due to foot traffic.

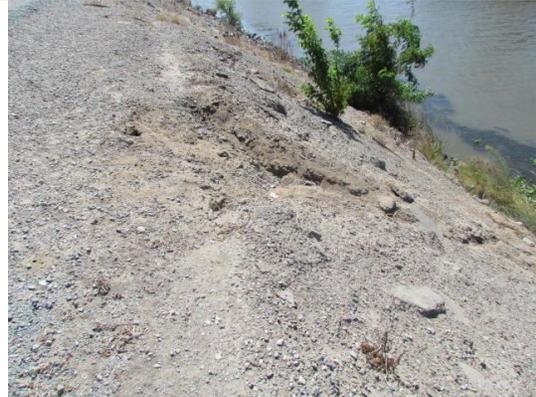
Photo 2 of 2 : SP\_2015\_RD0404\_305\_16\_20150309\_00011.jpg

LM Start	<b>2.01</b>	Rating **	M	Issue No.	<b>16 (cont)</b>
LM End	<b>2.01</b>	Issue Type +	Ma	Location *	WS
Category	Earthen Levee			GPS Latitude/Longitude	
				Start	End
Item	Slope Stability			°	°
DWR ID	DWR_RD0404_01_f_2013_16				
Action/Comments					
Repair the levee slope damaged by foot traffic and prevent access where possible. Inspector Comments: Slope damage due to foot traffic.

Looking southwest at slope damage due to foot traffic.

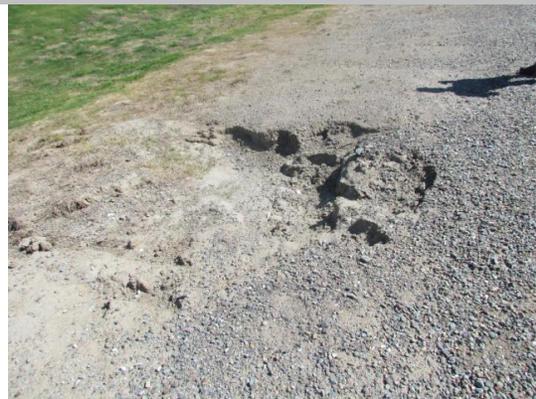
Photo 1 of 2 : SP\_2015\_RD0404\_305\_28\_20150416\_00031.jpg

LM Start	<b>2.21</b>	Rating **	M	Issue No.	<b>28</b>
LM End	<b>2.21</b>	Issue Type +	Ma	Location *	LS
Category	Earthen Levee			GPS Latitude/Longitude	
				Start	End
Item	Erosion / Bank Caving			37.921458 °	37.921458 °
				-121.320502 °	-121.320502 °
DWR ID	DWR_RD0404_01_s_2015_28				
Action/Comments					
Schedule repair of erosion site prior to the next inspection. Inspector Comments: Landward slope erosion.

Looking east at erosion on landward slope.

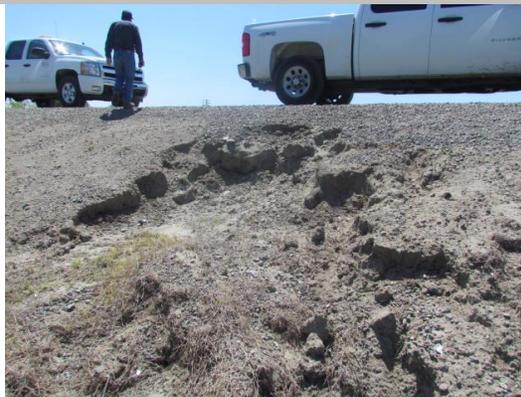
Photo 2 of 2 : SP\_2015\_RD0404\_305\_28\_20150416\_00032.jpg

LM Start	<b>2.21</b>	Rating **	M	Issue No.	<b>28 (cont)</b>
LM End	<b>2.21</b>	Issue Type +	Ma	Location *	LS
Category	Earthen Levee		GPS Latitude/Longitude		
			Start	End	
Item	Erosion / Bank Caving		37.921458 °	37.921458 °	
			-121.320502 °	-121.320502 °	
DWR ID	DWR_RD0404_01_s_2015_28				
Action/Comments					
Schedule repair of erosion site prior to the next inspection. Inspector Comments: Landward slope erosion.

Looking west at erosion on landward slope.

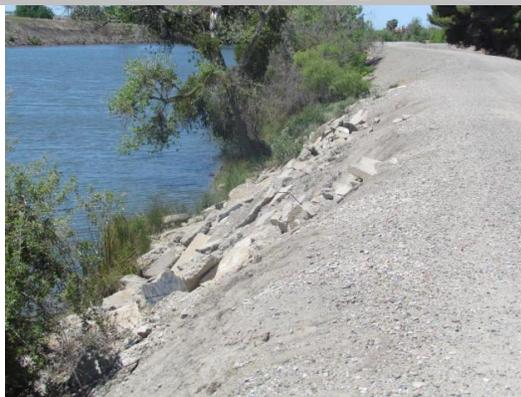
Photo 1 of 2 : SP\_2015\_RD0404\_305\_23\_20150416\_00033.jpg

LM Start	<b>2.33</b>	Rating **	M	Issue No.	<b>23</b>
LM End	<b>2.35</b>	Issue Type +	Ma	Location *	WS
Category	Earthen Levee		GPS Latitude/Longitude		
			Start	End	
Item	Riprap Revetments		37.920488 °	37.920338 °	
			-121.318630 °	-121.318435 °	
DWR ID	DWR_RD0404_01_s_2013_23				
Action/Comments					
Inspector Comments: Remove rebar from existing concrete rip rap on waterward slope.

Looking west at concrete rip rap with repair. (Spring 2015)

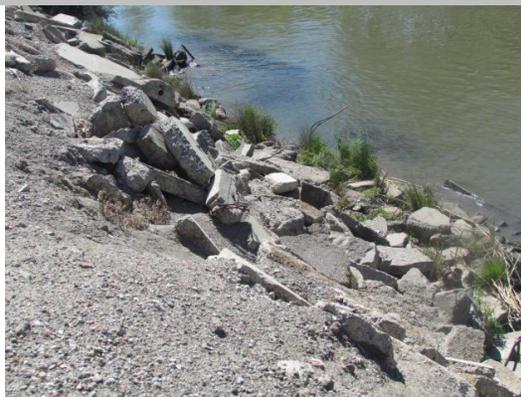
Photo 2 of 2 : SP\_2015\_RD0404\_305\_23\_20150309\_00015.jpg

Looking southwest at concrete rip rap with rebar.

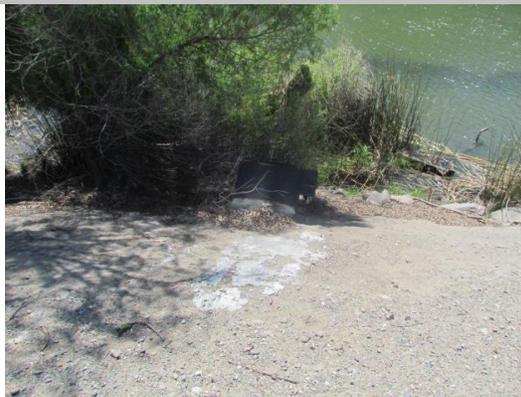
Photo 1 of 1 : SP\_2015\_RD0404\_306\_16\_20150416\_00014.jpg

Looking west at garbage (sofa) on waterward slope.

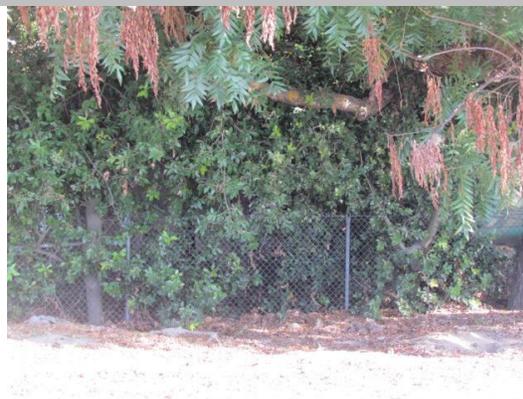
Photo 1 of 4 : SP\_2015\_RD0404\_306\_67\_20150309\_00006.jpg

Looking northeast at dense vegetation inside fenced area near pump station on landside toe.

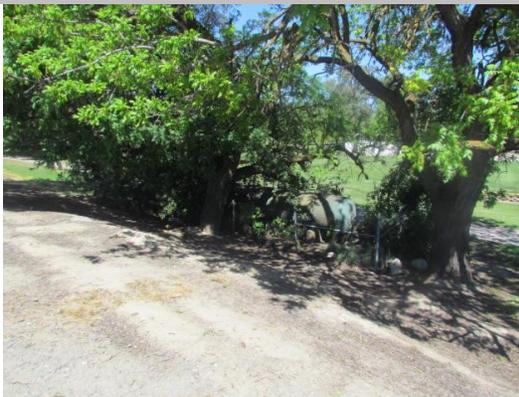
Photo 2 of 4 : SP\_2015\_RD0404\_306\_67\_20150309\_00007.jpg

Looking north at dense vegetation on landward toe around propane tank.

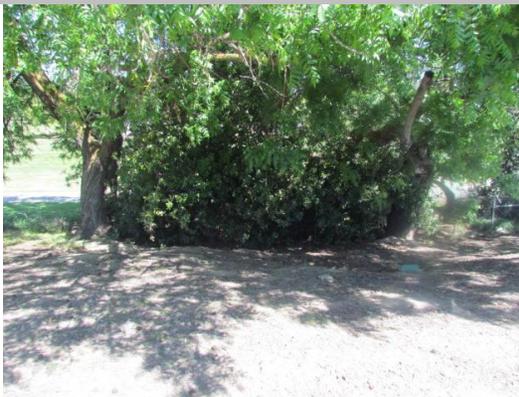
Photo 3 of 4 : SP\_2015\_RD0404\_306\_67\_20150309\_00008.jpg

Looking northeast at dense vegetation on landward toe. (Spring 2013)

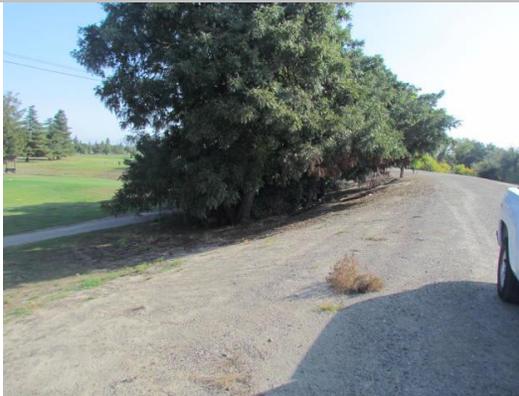
Photo 4 of 4 : SP\_2015\_RD0404\_306\_67\_20150309\_00009.jpg

Looking east at dense vegetation near pump station on landside toe.

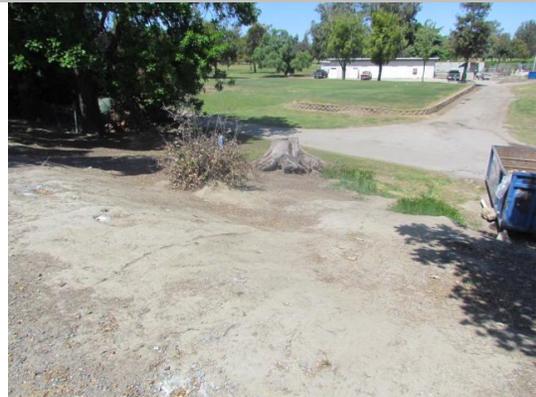
Photo 1 of 1 : SP\_2015\_RD0404\_306\_15\_20150416\_00015.jpg

Looking east at dead stump on landward toe.

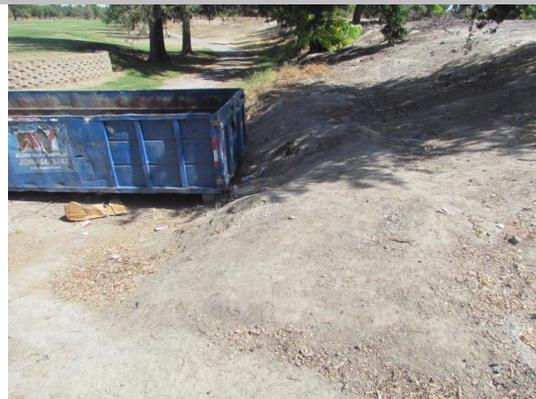
Photo 1 of 1 : SP\_2015\_RD0404\_306\_13\_20150309\_00005.jpg

LM Start	<b>1.15</b>	Rating **	M	Issue No.	<b>13</b>
LM End	<b>1.15</b>	Issue Type +	Ma	Location *	LS
Category	Earthen Levee			GPS Latitude/Longitude	
				Start	End
Item	Erosion / Bank Caving				
DWR ID	DWR_RD0404_02_f_2013_13				
Action/Comments					
Schedule repair of erosion site prior to the next inspection. Inspector Comments: Landside erosion from equipment placement.

Looking southeast at dumpster and landside erosion on landward toe.

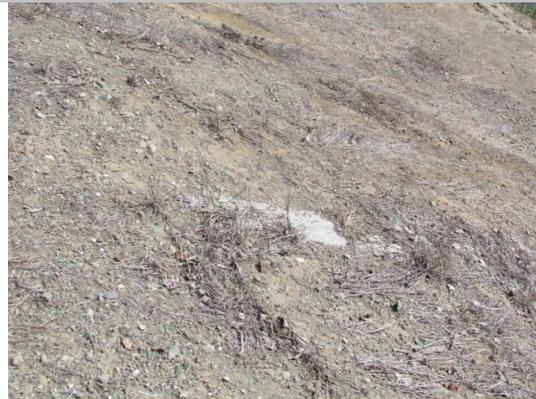
Photo 1 of 1 : SP\_2015\_RD0404\_306\_10\_20150309\_00004.jpg

Looking southeast at typical grouted rodent holes on landward slope.

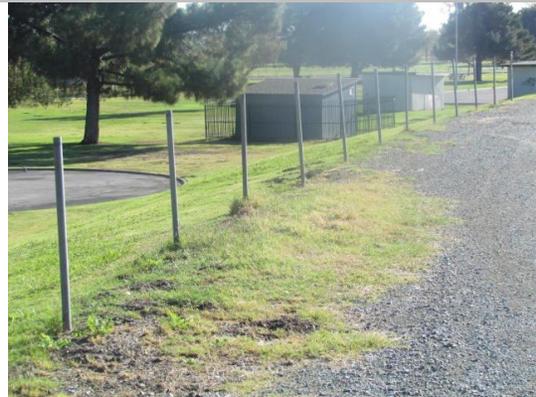
Photo 1 of 2 : SP\_2015\_RD0404\_306\_6\_20150309\_00002.jpg

LM Start	<b>1.47</b>	Rating **	M	Issue No.	<b>6</b>
LM End	<b>1.52</b>	Issue Type +	En	Location *	LS
Category	Earthen Levee			GPS Latitude/Longitude	
				Start	End
Item	Encroachments			37.918440 °	37.918517 °
				-121.296707 °	-121.295763 °
DWR ID	DWR_RD0404_02_s_2012_6				
Action/Comments					
Fence Inspector Comments: District or Landowner has removed fencing, but still need to remove fence poles.

Looking northeast at fence poles on landside shoulder.

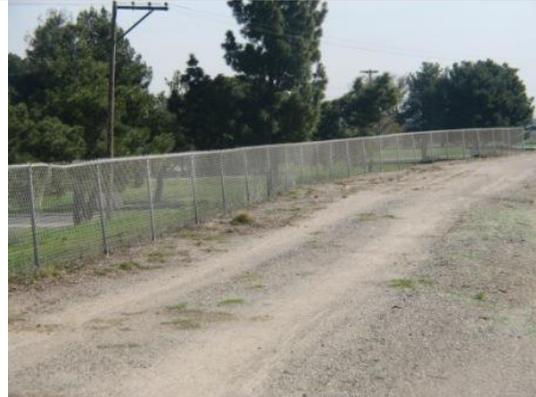
Photo 2 of 2 : SP\_2015\_RD0404\_306\_6\_20150309\_00003.jpg

Fence at landside shoulder from LM 1.47 to 1.52
