**Flood Control Project Maintenance  
Levee Inspections**

**Maintenance Issue Types Only, Levee Inspection Report By Mile - Fall 2014**

**Reclamation District No. 0404 Boggs**

Waterway		Bank	Unit Miles	Inspection Start/End	Inspector
Unit No. 01 San Joaquin River		Right	2.35	10/14/2014 10/14/2014	Richard Willoughby

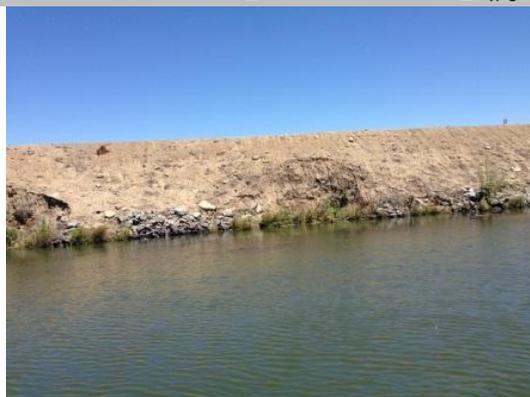
Photo 1 of 1 : SJR2014\_RD0404U01RM40.86\_1.jpg

Item	DWR Erosion Survey			37.939480 °	37.939480 °
				-121.342730 °	-121.342730 °
DWR ID					
Action/Comments					
<p>Inspector Comments: 6/19/2014: No significant change observed.                      08/13/2013: The boat survey found the erosion has progressed significantly in size and in number of pocket erosions.                      08/07/2012: The site has been visited by boat survey. The erosion has developed in size, and more pocket erosions were found.                      8/23/2011: Pockets erosions observed by last survey seem to have progressed during the last flood season. Continuous monitoring of this site suggested                      9/07/2010: No significant change observed on site. There is emergent vegetation at the water line. Several pocket erosions lined along the lower slope that stretches from RM 40.86 to RM 41.14.                      9/30/2009: No major change observed; the site was combined with other existing sites are RM's 40.93, 40.98, and 41.14 as one site; several pocket erosion just above non-uniform toe rip rap; previously rated "U"; bare spots along the upper slope.                      2008: Possibly caused by wave wash erosion; several pocket erosion along the lower slope; site is inside of a bend.                      2006: Visited site 09/12/06. [2014 Site ID:RD0404U01RM40.86]</p>

Front view of the site.

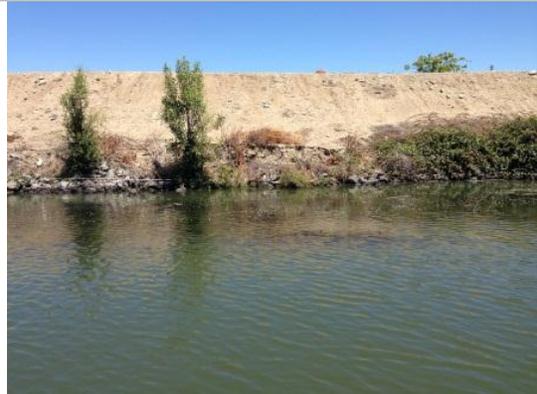
Photo 1 of 1 : SJR2014\_RD0404U01RM40.98\_1.jpg

LM Start	<b>0.34</b>	Rating **	U	Issue No.	<b>18</b>
LM End	<b>0.34</b>	Issue Type +	Ma	Location *	WS
Category	Supplemental		GPS Latitude/Longitude		
			Start	End	
Item	DWR Erosion Survey		37.939228 °	37.939228 °	
			-121.340786 °	-121.340786 °	
DWR ID					
Action/Comments					
Inspector Comments: 06/19/2014: No significant change observed. 08/13/2013: The pocket erosion is located at immediately upstream of a small oak tree. [2014 Site ID:RD0404U01RM40.98]

Front view of the erosion.

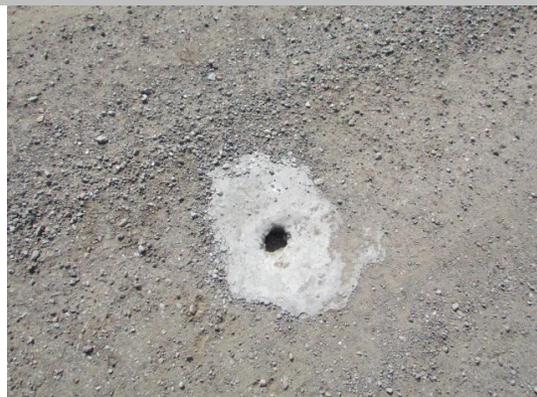
Photo 1 of 4 : FA\_2014\_RD0404\_305\_5\_20141016\_00034.jpg

LM Start	<b>0.44</b>	Rating **	M	Issue No.	<b>5</b>
LM End	<b>0.44</b>	Issue Type +	Ma	Location *	CR
Category	Earthen Levee		GPS Latitude/Longitude		
			Start	End	
Item	Animal Control		37.939635 °	37.939635 °	
			-121.339063 °	-121.339063 °	
DWR ID	DWR_RD0404_01_s_2013_5				
Action/Comments					
No rodents visible, but rodent burrows visible; need to backfill and compact or grout burrows. Inspector Comments: One large rodent hole located on levee crown and several rodent holes also located in this area. District grouted hole, but hole was not fully grouted.

Looking at partialled grouted rodent hole on levee crown (Fall 2014).

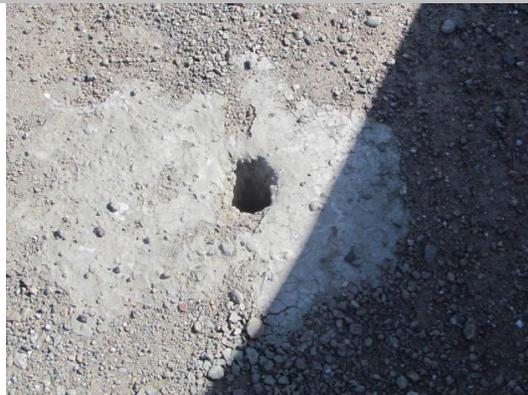
Photo 2 of 4 : FA\_2014\_RD0404\_305\_5\_20141010\_00005.jpg

Looking at partially grouted rodent hole on levee crown

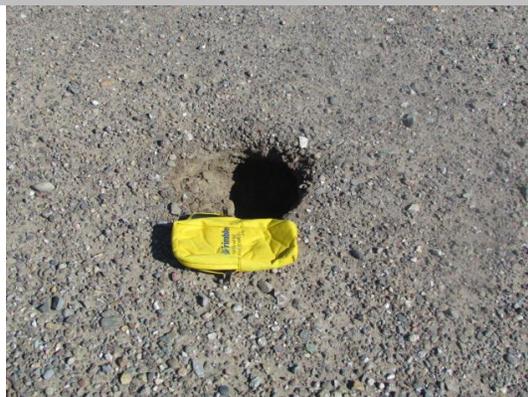
Photo 3 of 4 : FA\_2014\_RD0404\_305\_5\_20141010\_00003.jpg

Looking at rodent hole on levee crown.

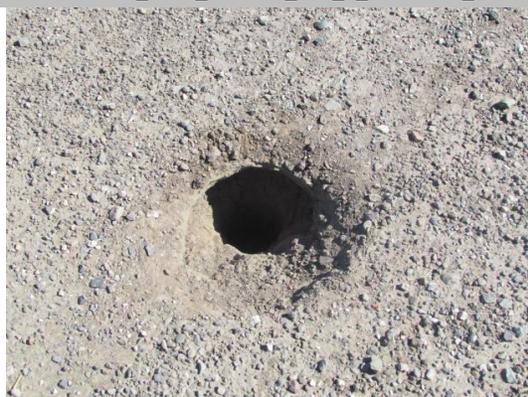
Photo 4 of 4 : FA\_2014\_RD0404\_305\_5\_20141010\_00004.jpg

Looking at one of several rodent holes on levee crown.

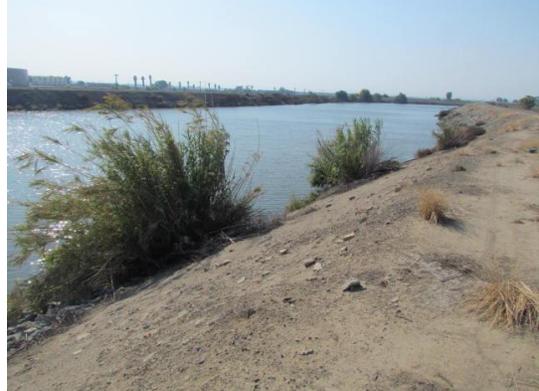
Photo 1 of 3 : FA\_2014\_RD0404\_305\_104\_20141010\_00022.jpg

LM Start	<b>0.45</b>	Rating **	M	Issue No.	<b>104</b>
LM End	<b>0.45</b>	Issue Type +	Ma	Location *	WS
Category	Earthen Levee		GPS Latitude/Longitude		
			Start	End	
Item	Vegetation		37.939627 °	37.939627 °	
			-121.338808 °	-121.338808 °	
DWR ID	DWR_RD0404_01_s_2012_104				
Action/Comments					
Remove the wild growth other than native grasses from the levee slopes. Inspector Comments: Remove bamboo on waterside toe. Bamboo is not within twenty feet zone, but should be removed to stop from spreading along waterward slope. Bamboo has increased in size.

Looking northwest at bamboo on waterside toe.

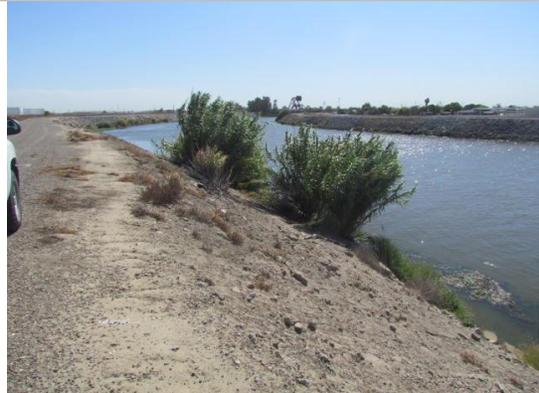
Photo 2 of 3 : FA\_2014\_RD0404\_305\_104\_20141010\_00023.jpg

Looking west at bamboo on waterward slope. 2013

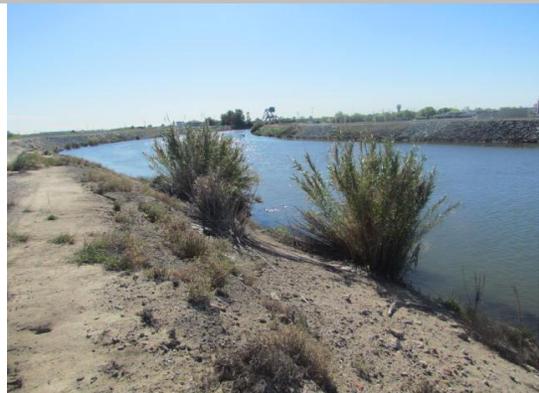
Photo 3 of 3 : FA\_2014\_RD0404\_305\_104\_20141010\_00024.jpg

Looking southwest at bamboo on waterward slope and toe.

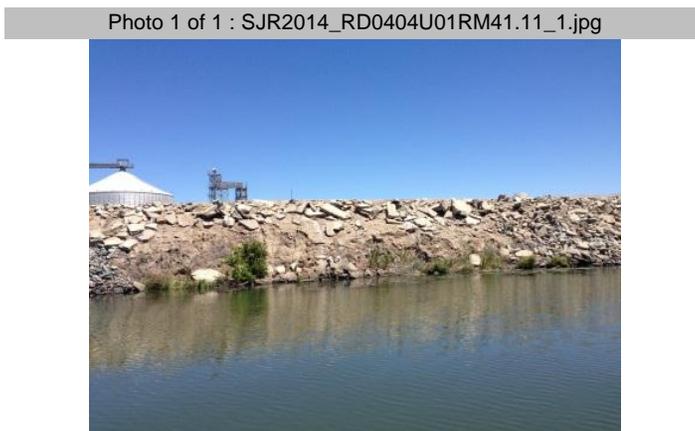
LM Start	<b>0.48</b>	Rating **	U	Issue No.	<b>19</b>
LM End	<b>0.48</b>	Issue Type +	Ma	Location *	WS
Category	Supplemental		GPS Latitude/Longitude		
			Start	End	
Item	DWR Erosion Survey		37.939190 °	37.939190 °	
			-121.338280 °	-121.338280 °	
DWR ID					
Action/Comments					
Inspector Comments: 6/19/2014: No significant change observed. 08/13/2013: No significant change at this site. 8/7/2012: The erosion is next to a repaired site and approximately 400 feet downstream of a river bend. There are broken concretes at the upper levee slope, but not visible at the levee toe or lower slope. Likely the protection concrete blocks have been washed away. [2014 Site

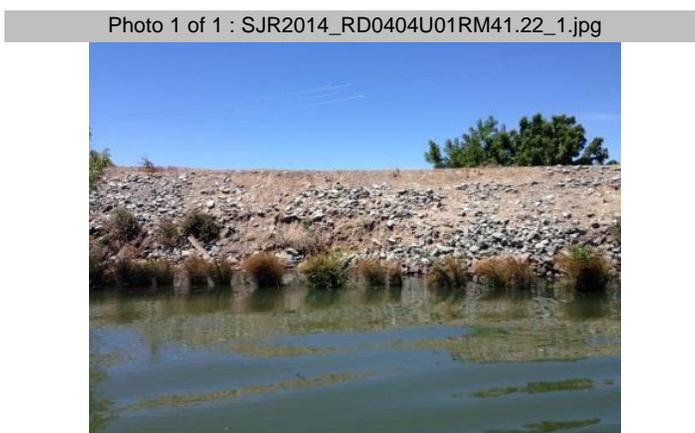
LM Start	<b>0.60</b>	Rating **	U	Issue No.	<b>20</b>
LM End	<b>0.62</b>	Issue Type +	Ma	Location *	WS
Category	Supplemental		GPS Latitude/Longitude		
			Start	End	
Item	DWR Erosion Survey		37.939133 °	37.939133 °	
			-121.336100 °	-121.336100 °	
DWR ID					
Action/Comments					
Inspector Comments: 6/19/2014: No significant change observed. 08/13/2013: No significant change at this site. 08/07/2012: The site was first discovered by levee inspector in the spring inspection. Levee slope was protected with broken concrete blocks, but those blocks have been washed away during high flows. [2014 Site ID:RD0404U01RM41.22]

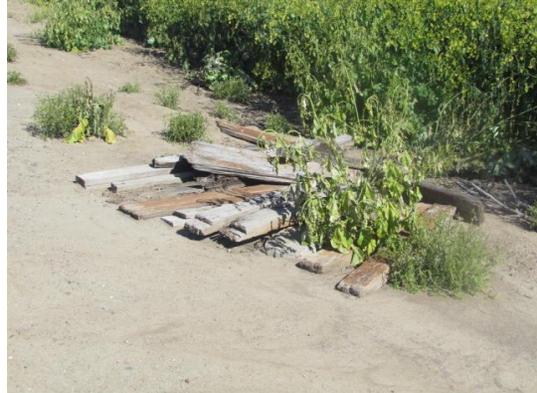
Photo 1 of 1 : FA\_2014\_RD0404\_305\_6\_20141010\_00006.jpg

LM Start	<b>0.67</b>	Rating **	M	Issue No.	<b>6</b>
LM End	<b>0.67</b>	Issue Type +	Ma	Location *	LS
Category	Earthen Levee		GPS Latitude/Longitude		
			Start	End	
Item	Encroachments		37.938583 °	37.938583 °	
			-121.335258 °	-121.335258 °	
DWR ID	DWR_RD0404_01_s_2013_6				
Action/Comments					
Garbage Inspector Comments: Wooden board dumped on landside slope.

Looking northeast at wooden boards on landward slope.

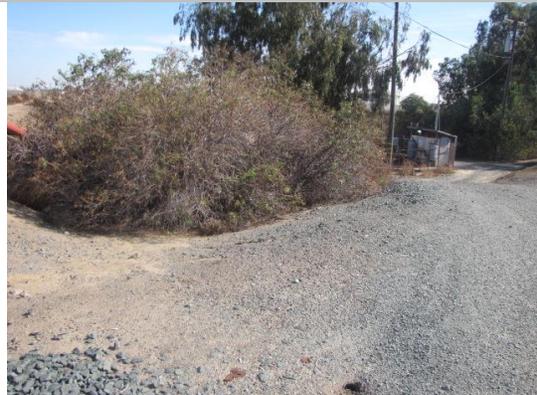
Photo 1 of 1 : FA\_2014\_RD0404\_305\_7\_20141010\_00007.jpg

LM Start	<b>0.75</b>	Rating **	M	Issue No.	<b>7</b>
LM End	<b>0.75</b>	Issue Type +	Ma	Location *	LS
Category	Earthen Levee		GPS Latitude/Longitude		
			Start	End	
Item	Vegetation		37.937758 °	37.937758 °	
			-121.334149 °	-121.334149 °	
DWR ID	DWR_RD0404_01_s_2012_7				
Action/Comments					
Elderberries are blocking visibility and flood fight capability.

Looking southeast at elderberry on landside slope.

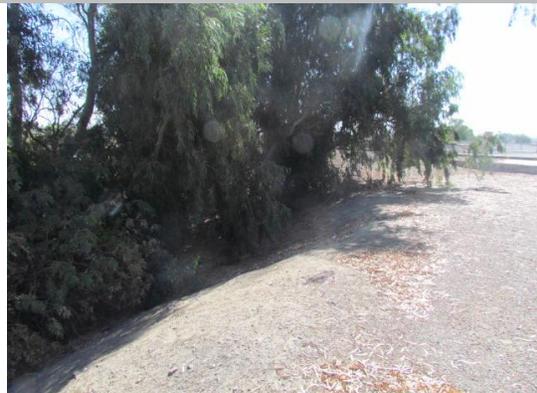
Photo 1 of 1 : FA\_2014\_RD0404\_305\_8\_20141010\_00008.jpg

LM Start	<b>0.78</b>	Rating **	M	Issue No.	<b>8</b>
LM End	<b>0.78</b>	Issue Type +	Ma	Location *	LS
Category	Earthen Levee		GPS Latitude/Longitude		
			Start	End	
Item	Trim / Thin Trees		37.937395 °	37.937395 °	
			-121.333883 °	-121.333883 °	
DWR ID	DWR_RD0404_01_s_2013_8				
Action/Comments					
Trim trees to at least five feet above ground level. Inspector Comments: Trees blocking view of slope.

Looking southeast at dense trees on landward slope and toe.

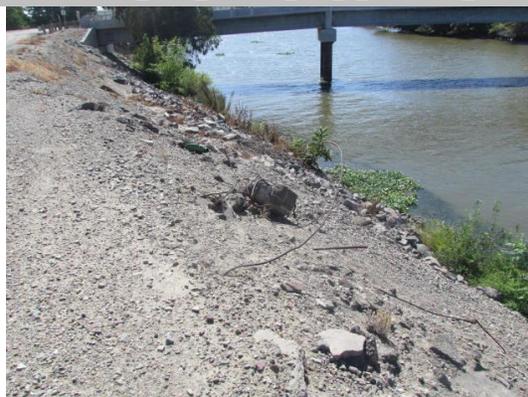
Photo 1 of 1 : FA\_2014\_RD0404\_305\_4\_20141010\_00002.jpg

LM Start	<b>1.10</b>	Rating **	M	Issue No.	<b>4</b>
LM End	<b>1.10</b>	Issue Type +	Ma	Location *	WS
Category	Earthen Levee		GPS Latitude/Longitude		
			Start	End	
Item	Riprap Revetments		37.935158 °	37.935158 °	
			-121.329365 °	-121.329365 °	
DWR ID	DWR_RD0404_01_f_2013_4				
Action/Comments					
Inspector Comments: Concrete rubble with rebar should be removed.

Looking southwest at concrete rubble with rebar on waterward slope.

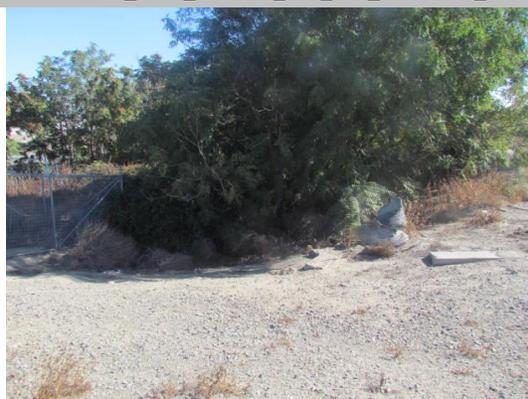
Photo 1 of 1 : FA\_2014\_RD0404\_305\_101\_20141010\_00021.jpg

LM Start	<b>1.20</b>	Rating **	M	Issue No.	<b>101</b>
LM End	<b>1.20</b>	Issue Type +	Ma	Location *	LS
Category	Earthen Levee		GPS Latitude/Longitude		
			Start	End	
Item	Vegetation		37.934058 °	37.934058 °	
			-121.328188 °	-121.328188 °	
DWR ID	DWR_RD0404_01_s_2012_101				
Action/Comments					
Remove the wild growth other than native grasses from the levee slopes.

Looking southeast at overhanging trees on landside slope.

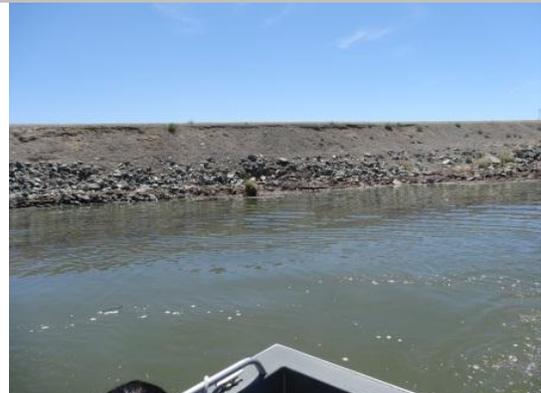
Photo 1 of 1 : SJR2014\_RD0404U01RM42.02\_1.jpg

LM Start	<b>1.45</b>	Rating **	M	Issue No.	<b>32</b>
LM End	<b>1.47</b>	Issue Type +	Ma	Location *	WS
Category	Supplemental		GPS Latitude/Longitude		
			Start	End	
Item	DWR Erosion Survey		37.930450 °	37.930450 °	
			-121.327450 °	-121.327450 °	
DWR ID					
Action/Comments					
Inspector Comments: 06/19/2014: A series of scarp erosions have been found on the lower levee slope and at the levee toe. [2014 Site ID:RD0404U01RM42.02]

Close view of the erosion. Note the protection on the lower levee slope.

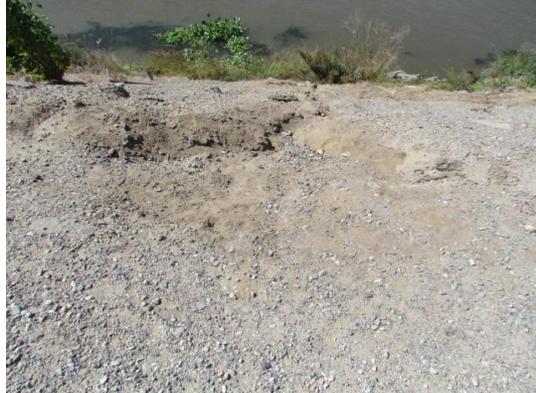
Photo 1 of 2 : FA\_2014\_RD0404\_305\_16\_20141010\_00011.jpg

LM Start	<b>2.01</b>	Rating **	M	Issue No.	<b>16</b>
LM End	<b>2.01</b>	Issue Type +	Ma	Location *	WS
Category	Earthen Levee			GPS Latitude/Longitude	
				Start	End
Item	Slope Stability			°	°
				°	°
DWR ID	DWR_RD0404_01_f_2013_16				
Action/Comments					
Repair the levee slope damaged by foot traffic and prevent access where possible. Inspector Comments: Slope damage due to foot traffic.

Looking west at slope damage due to foot traffic.

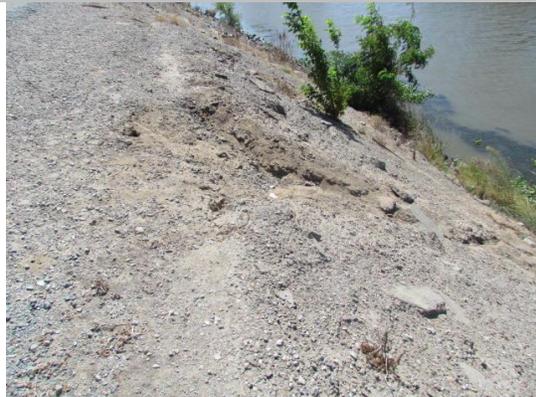
Photo 2 of 2 : FA\_2014\_RD0404\_305\_16\_20141010\_00012.jpg

Looking southwest at slope damage due to foot traffic.

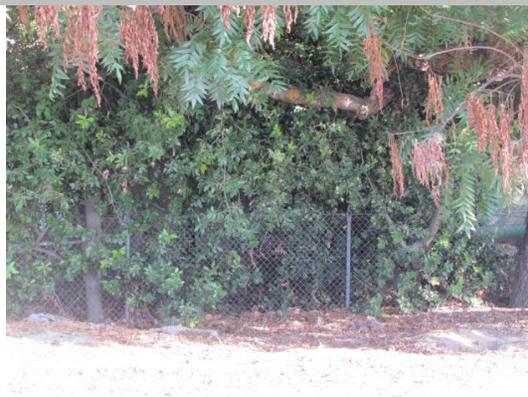
Photo 1 of 4 : FA\_2014\_RD0404\_306\_67\_20141010\_00015.jpg

LM Start	<b>1.13</b>	Rating **	M	Issue No.	<b>67</b>
LM End	<b>1.13</b>	Issue Type +	Ma	Location *	LS
Category	Earthen Levee		GPS Latitude/Longitude		
			Start	End	
Item	Trim / Thin Trees		37.916337 °	37.916337 °	
			-121.301888 °	-121.301888 °	
DWR ID	DWR_RD0404_02_s_2012_67				
Action/Comments					
Trim and thin trees to allow visibility of the ground and room to flood fight. Inspector Comments: Dense vegetation around propane tank inside fenced area.

Looking northeast at dense vegetation inside fenced area near pump station on landside toe.

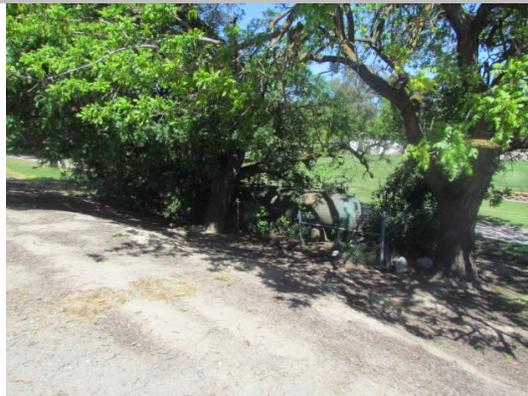
Photo 2 of 4 : FA\_2014\_RD0404\_306\_67\_20141010\_00016.jpg

Looking north at dense vegetation on landward toe around propane tank.

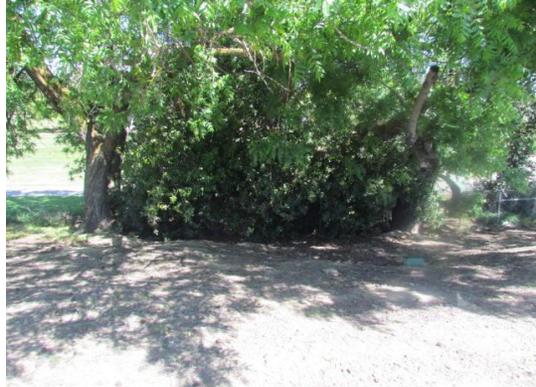
Photo 3 of 4 : FA\_2014\_RD0404\_306\_67\_20141010\_00017.jpg

Looking northeast at dense vegetation on landward toe. (Spring 2013)

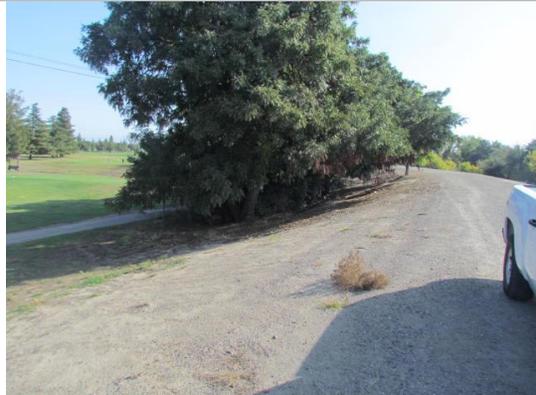
Photo 4 of 4 : FA\_2014\_RD0404\_306\_67\_20141010\_00018.jpg

Looking east at dense vegetation near pump station on landside toe.

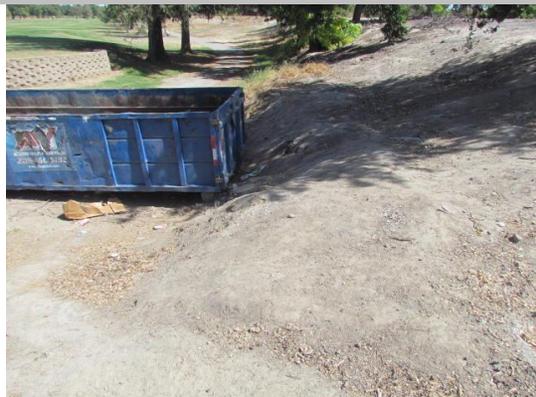
Photo 1 of 1 : FA\_2014\_RD0404\_306\_13\_20141010\_00007.jpg

LM Start	<b>1.15</b>	Rating **	M	Issue No.	<b>13</b>
LM End	<b>1.15</b>	Issue Type +	Ma	Location *	LS
Category	Earthen Levee		GPS Latitude/Longitude		
			Start	End	
Item	Erosion / Bank Caving		°	°	
			°	°	
DWR ID	DWR_RD0404_02_f_2013_13				
Action/Comments					
Schedule repair of erosion site prior to the next inspection. Inspector Comments: Landside erosion from equipment placement.

Looking southeast at dumpster and landside erosion on landward toe.

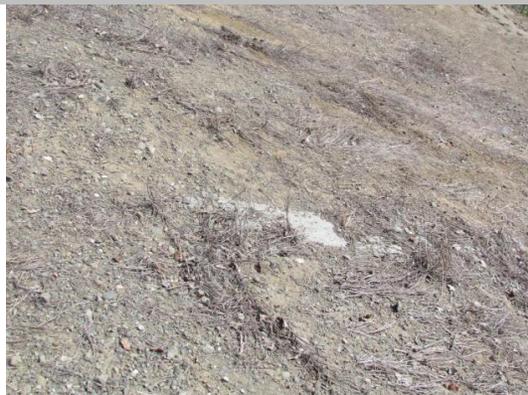
Photo 1 of 1 : FA\_2014\_RD0404\_306\_10\_20141016\_00034.jpg

LM Start	<b>1.35</b>	Rating **	A/W	Issue No.	<b>10</b>
LM End	<b>1.35</b>	Issue Type +	Ma	Location *	LS
Category	Earthen Levee		GPS Latitude/Longitude		
			Start	End	
Item	Animal Control		37.918214 °	37.918214 °	
			-121.298656 °	-121.298656 °	
DWR ID	DWR_RD0404_02_f_2012_10				
Action/Comments					
Exterminate rodents and backfill and compact or grout burrows. Inspector Comments: Grouting rodent holes

Looking southeast at typical grouted rodent holes on landward slope.
