**Flood Control Project Maintenance
Levee Inspections**

Maintenance Issue Types Only, Levee Inspection Report By Mile - Spring 2015

Reclamation District No. 0404 Boggs

Waterway	Bank	Unit Miles	Inspection Start/End	Inspector
Unit No. 01 San Joaquin River	Right	2.35	04/14/2015 04/14/2015	Richard Willoughby

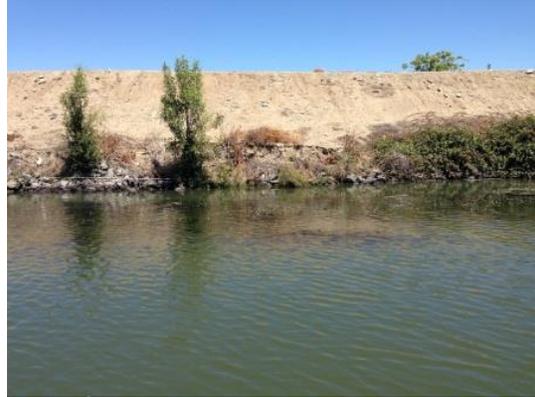
Photo 1 of 1 : SP_2015_RD0404_305_18_20150309_00012.jpg

LM Start	0.34	Rating **	U	Issue No.	18
LM End	0.34	Issue Type +	Ma	Location *	WS
Category	Supplemental			GPS Latitude/Longitude	
				Start	End
Item	DWR Erosion Survey			37.939228 °	37.939228 °
				-121.340786 °	-121.340786 °
DWR ID	DWR_RD0404_01_s_2015_18				
Action/Comments					
Inspector Comments: 06/19/2014: No significant change observed. 08/13/2013: The pocket erosion is located at immediately upstream of a small oak tree. [2014 Site ID:RD0404U01RM40.98]

Front view of the erosion.

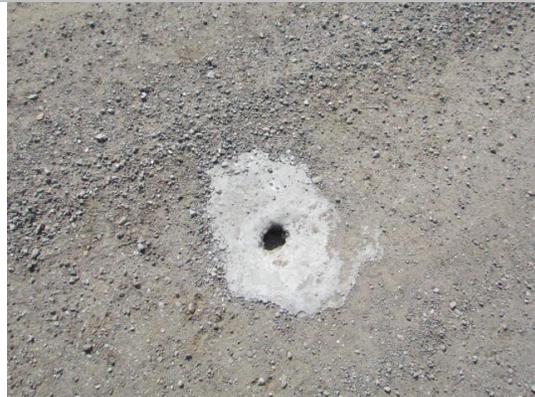
Photo 1 of 4 : SP_2015_RD0404_305_5_20150309_00003.jpg

LM Start	0.43	Rating **	A/W	Issue No.	5
LM End	0.43	Issue Type +	Ma	Location *	CR
Category	Earthen Levee			GPS Latitude/Longitude	
				Start	End
Item	Animal Control			37.939635 °	37.939635 °
				-121.339063 °	-121.339063 °
DWR ID	DWR_RD0404_01_s_2013_5				
Action/Comments					
No rodents visible, but rodent burrows visible; need to backfill and compact or grout burrows. Inspector Comments: One large rodent hole located on levee crown and several rodent holes also located in this area. District grouted hole, but hole was not fully grouted.

Looking at partialled grouted rodent hole on levee crown (Fall 2014).

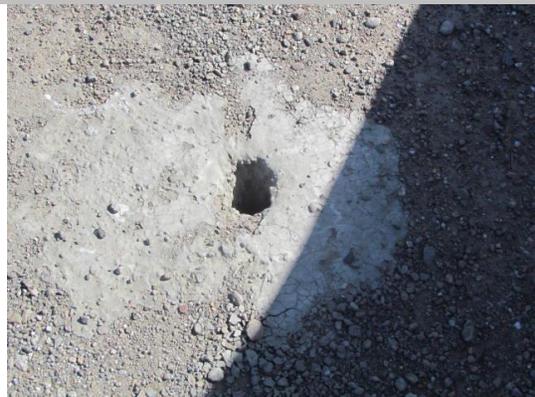
Photo 2 of 4 : SP_2015_RD0404_305_5_20150309_00004.jpg

Looking at partially grouted rodent hole on levee crown

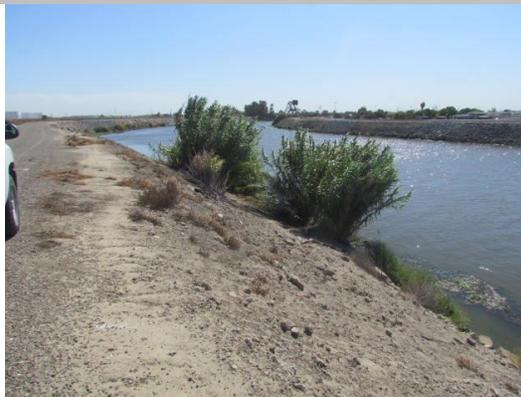
Photo 2 of 3 : SP_2015_RD0404_305_104_20150309_00019.jpg

LM Start	0.45	Rating **	M	Issue No.	104 (cont)
LM End	0.45	Issue Type +	Ma	Location *	WS
Category	Earthen Levee		GPS Latitude/Longitude		
			Start	End	
Item	Vegetation		37.939627 °	37.939627 °	
			-121.338808 °	-121.338808 °	
DWR ID	DWR_RD0404_01_s_2012_104				
Action/Comments					
Remove the wild growth other than native grasses from the levee slopes. Inspector Comments: Remove bamboo on waterside toe. Bamboo is not within twenty feet zone, but should be removed to stop from spreading along waterward slope. Bamboo has increased in size.

Looking west at bamboo on waterward slope. 2013

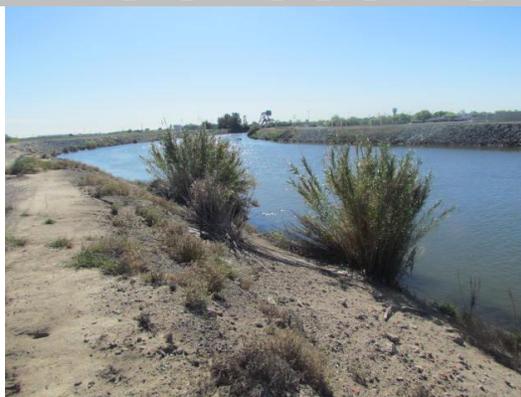
Photo 3 of 3 : SP_2015_RD0404_305_104_20150309_00020.jpg

Looking southwest at bamboo on waterward slope and toe.

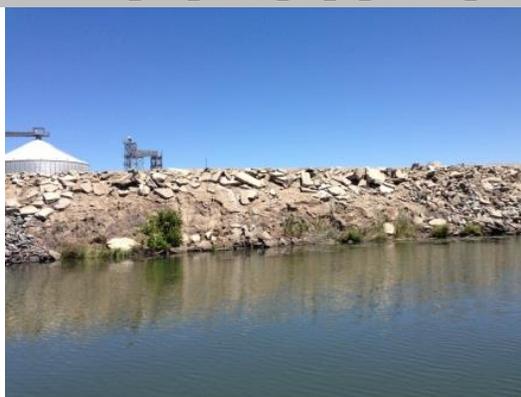
Photo 1 of 1 : SP_2015_RD0404_305_19_20150309_00013.jpg

LM Start	0.48	Rating **	U	Issue No.	19
LM End	0.48	Issue Type +	Ma	Location *	WS
Category	Supplemental		GPS Latitude/Longitude		
			Start	End	
Item	DWR Erosion Survey		37.939190 °	37.939190 °	
			-121.338280 °	-121.338280 °	
DWR ID	DWR_RD0404_01_s_2015_19				
Action/Comments					
Inspector Comments: 6/19/2014: No significant change observed. 08/13/2013: No significant change at this site. 8/7/2012: The erosion is next to a repaired site and approximately 400 feet downstream of a river bend. There are broken concretes at the upper levee slope, but not visible at the levee toe or lower slope. Likely the protection concrete blocks have been washed away. [2014 Site

Front view of the site.

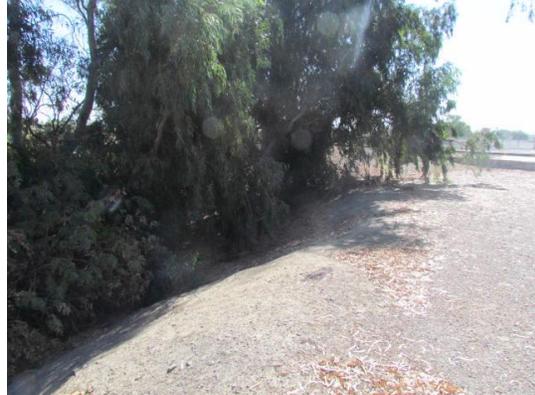
Photo 1 of 1 : SP_2015_RD0404_305_8_20150309_00009.jpg

LM Start	0.78	Rating **	M	Issue No.	8
LM End	0.78	Issue Type +	Ma	Location *	LS
Category	Earthen Levee		GPS Latitude/Longitude		
			Start	End	
Item	Trim / Thin Trees		37.937395 °	37.937395 °	
			-121.333883 °	-121.333883 °	
DWR ID	DWR_RD0404_01_s_2013_8				
Action/Comments					
Trim trees to at least five feet above ground level. Inspector Comments: Trees are blocking view of the slope.

Looking southeast at dense trees on landward slope and toe.

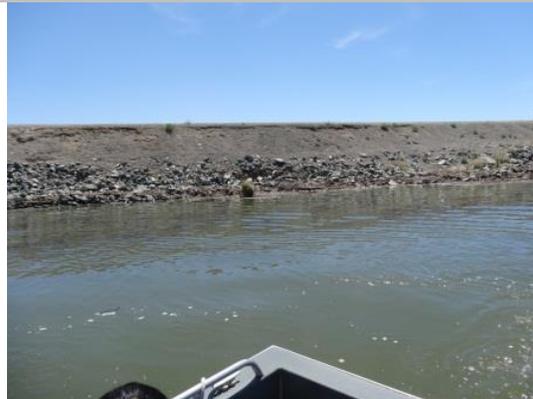
Photo 1 of 2 : SP_2015_RD0404_305_32_20150309_00016.jpg

LM Start	1.45	Rating **	M	Issue No.	32
LM End	1.45	Issue Type +	Ma	Location *	WS
Category	Supplemental			GPS Latitude/Longitude	
				Start	End
Item	DWR Erosion Survey			37.930450 °	37.930450 °
				-121.327450 °	-121.327450 °
DWR ID	DWR_RD0404_01_s_2015_32				
Action/Comments					
Inspector Comments: 06/19/2014: A series of scarp erosions have been found on the lower levee slope and at the levee toe. [2014 Site ID:RD0404U01RM42.02]

Close view of the erosion. Note the protection on the lower levee slope.

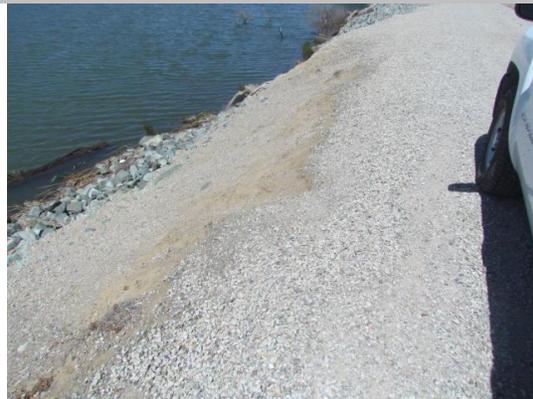
Photo 2 of 2 : SP_2015_RD0404_305_32_20150416_00029.jpg

Looking northwest at erosion on waterward slope.

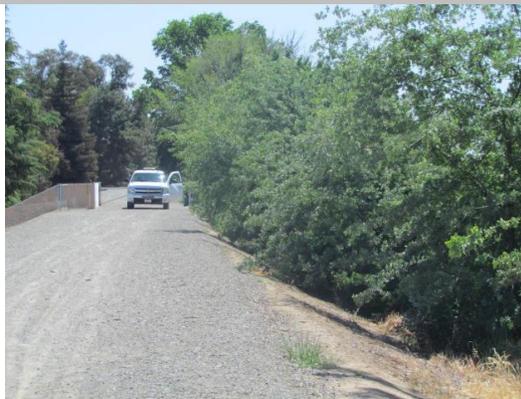
Photo 1 of 1 : SP_2015_RD0404_305_29_20150416_00030.jpg

LM Start	1.70	Rating **	M	Issue No.	29
LM End	1.77	Issue Type +	Ma	Location *	WS
Category	Earthen Levee		GPS Latitude/Longitude		
			Start	End	
Item	Trim / Thin Trees		37.927517 °	37.926632 °	
			-121.325515 °	-121.324868 °	
DWR ID	DWR_RD0404_01_s_2015_29				
Action/Comments					
Trim trees to at least five feet above ground level.

Looking east at untrimmed trees on waterward slope.

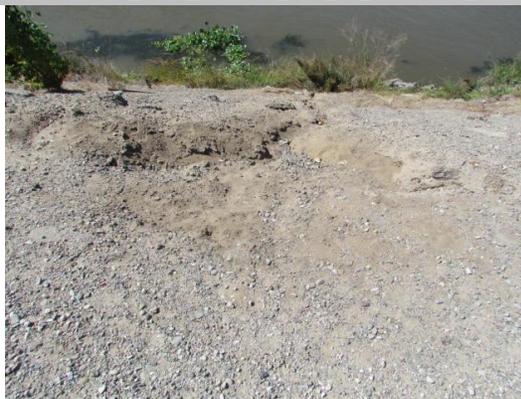
Photo 1 of 2 : SP_2015_RD0404_305_16_20150309_00010.jpg

LM Start	2.01	Rating **	M	Issue No.	16
LM End	2.01	Issue Type +	Ma	Location *	WS
Category	Earthen Levee		GPS Latitude/Longitude		
			Start	End	
Item	Slope Stability			°	°
				°	°
DWR ID	DWR_RD0404_01_f_2013_16				
Action/Comments					
Repair the levee slope damaged by foot traffic and prevent access where possible. Inspector Comments: Slope damage due to foot traffic.

Looking west at slope damage due to foot traffic.

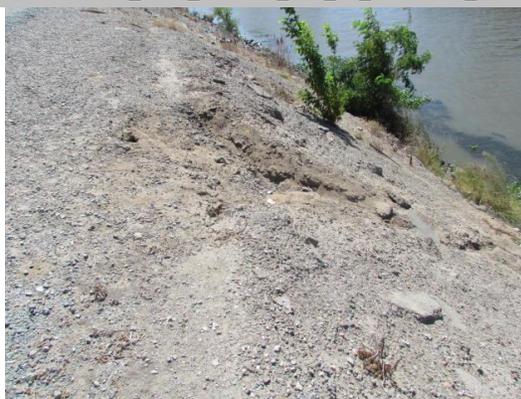
Photo 2 of 2 : SP_2015_RD0404_305_16_20150309_00011.jpg

Looking southwest at slope damage due to foot traffic.

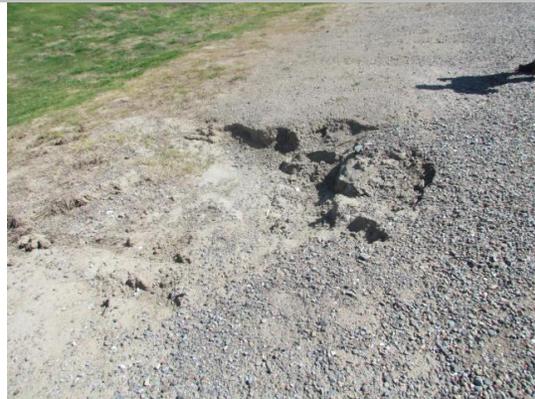
Photo 1 of 2 : SP_2015_RD0404_305_28_20150416_00031.jpg

LM Start	2.21	Rating **	M	Issue No.	28
LM End	2.21	Issue Type +	Ma	Location *	LS
Category	Earthen Levee		GPS Latitude/Longitude		
			Start	End	
Item	Erosion / Bank Caving		37.921458 °	37.921458 °	°
			-121.320502 °	-121.320502 °	°
DWR ID	DWR_RD0404_01_s_2015_28				
Action/Comments					
Schedule repair of erosion site prior to the next inspection. Inspector Comments: Landward slope erosion.

Looking east at erosion on landward slope.

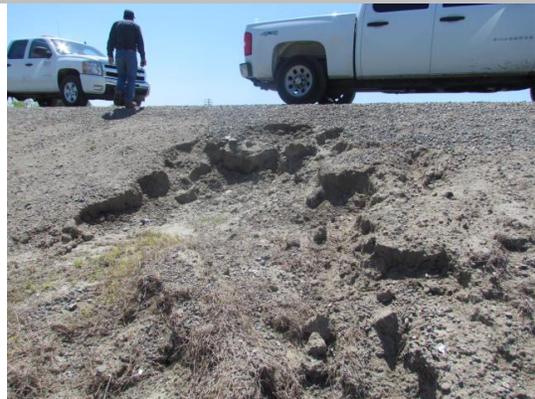
Photo 2 of 2 : SP_2015_RD0404_305_28_20150416_00032.jpg

Looking west at erosion on landward slope.

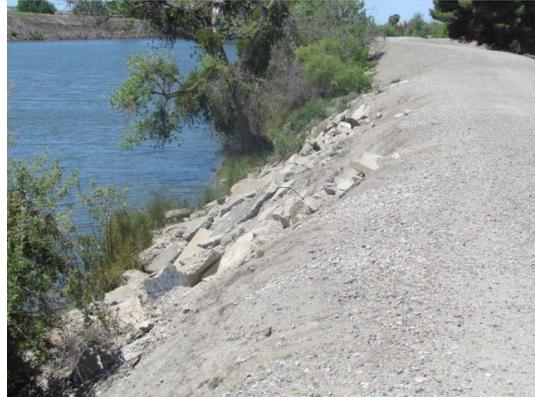
Photo 1 of 2 : SP_2015_RD0404_305_23_20150416_00033.jpg

LM Start	2.33	Rating **	M	Issue No.	23
LM End	2.35	Issue Type +	Ma	Location *	WS
Category	Earthen Levee			GPS Latitude/Longitude	
				Start	End
Item	Riprap Revetments			37.920488 °	37.920338 °
				-121.318630 °	-121.318435 °
DWR ID	DWR_RD0404_01_s_2013_23				
Action/Comments					
Inspector Comments: Remove rebar from existing concrete rip rap on waterward slope.

Looking west at concrete rip rap with repair. (Spring 2015)

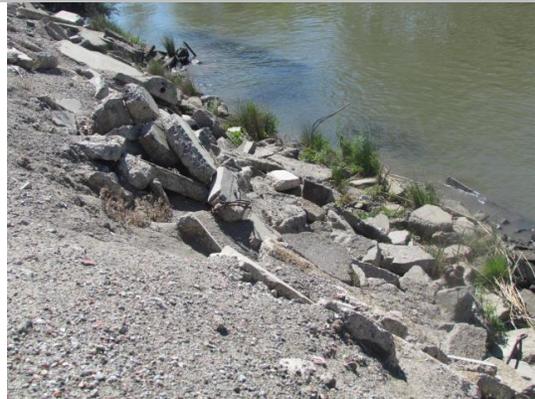
Photo 2 of 2 : SP_2015_RD0404_305_23_20150309_00015.jpg

Looking southwest at concrete rip rap with rebar.

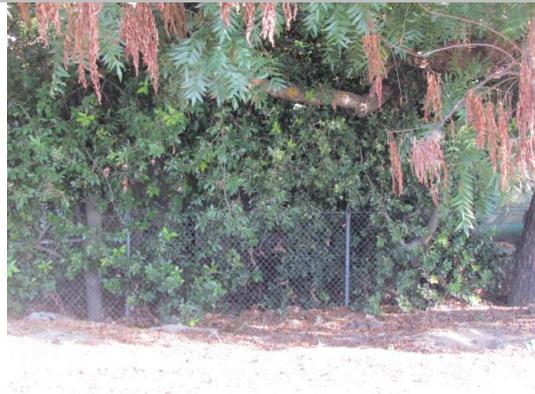
Photo 1 of 4 : SP_2015_RD0404_306_67_20150309_00006.jpg

LM Start	1.13	Rating **	M	Issue No.	67
LM End	1.13	Issue Type +	Ma	Location *	LS
Category	Earthen Levee		GPS Latitude/Longitude		
			Start	End	
Item	Trim / Thin Trees		37.916337 °	37.916337 °	
			-121.301888 °	-121.301888 °	
DWR ID	DWR_RD0404_02_s_2012_67				
Action/Comments					
Trim and thin trees to allow visibility of the ground and room to flood fight. Inspector Comments: Dense vegetation around propane tank inside fenced area.

Looking northeast at dense vegetation inside fenced area near pump station on landside toe.

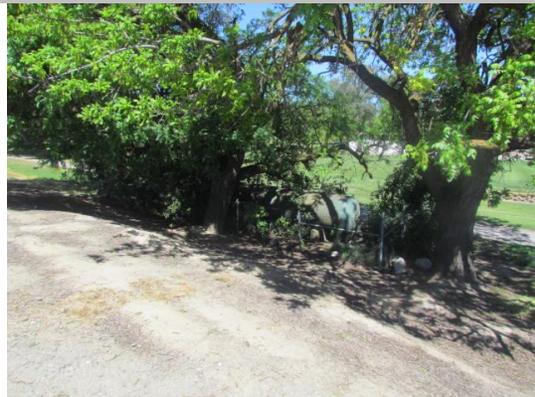
Photo 2 of 4 : SP_2015_RD0404_306_67_20150309_00007.jpg

Looking north at dense vegetation on landward toe around propane tank.

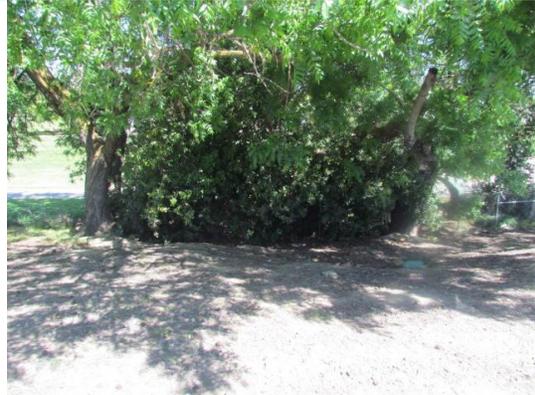
Photo 3 of 4 : SP_2015_RD0404_306_67_20150309_00008.jpg

LM Start	1.13	Rating **	M	Issue No.	67 (cont)
LM End	1.13	Issue Type +	Ma	Location *	LS
Category	Earthen Levee			GPS Latitude/Longitude	
				Start	End
Item	Trim / Thin Trees			37.916337 °	37.916337 °
				-121.301888 °	-121.301888 °
DWR ID	DWR_RD0404_02_s_2012_67				
Action/Comments					
Trim and thin trees to allow visibility of the ground and room to flood fight. Inspector Comments: Dense vegetation around propane tank inside fenced area.

Looking northeast at dense vegetation on landward toe. (Spring 2013)

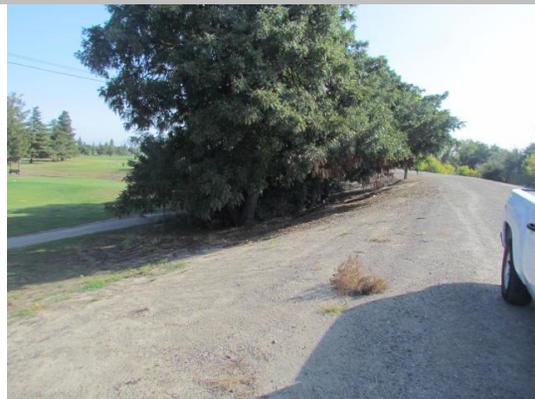
Photo 4 of 4 : SP_2015_RD0404_306_67_20150309_00009.jpg

Looking east at dense vegetation near pump station on landside toe.

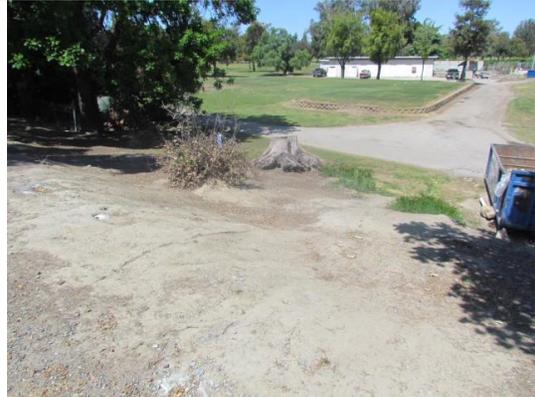
Photo 1 of 1 : SP_2015_RD0404_306_15_20150416_00015.jpg

LM Start	1.14	Rating **	U	Issue No.	15
LM End	1.14	Issue Type +	Ma	Location *	LS
Category	Earthen Levee		GPS Latitude/Longitude		
			Start	End	
Item	Trim / Thin Trees		37.916388 °	37.916388 °	
			-121.301683 °	-121.301683 °	
DWR ID	DWR_RD0404_02_s_2015_15				
Action/Comments					
Tree stumps. Inspector Comments: Remove dead stump.

Looking east at dead stump on landward toe.

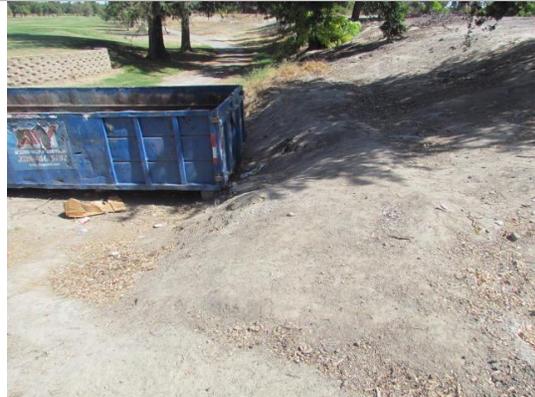
Photo 1 of 1 : SP_2015_RD0404_306_13_20150309_00005.jpg

LM Start	1.15	Rating **	M	Issue No.	13
LM End	1.15	Issue Type +	Ma	Location *	LS
Category	Earthen Levee		GPS Latitude/Longitude		
			Start	End	
Item	Erosion / Bank Caving				
DWR ID	DWR_RD0404_02_f_2013_13				
Action/Comments					
Schedule repair of erosion site prior to the next inspection. Inspector Comments: Landside erosion from equipment placement.

Looking southeast at dumpster and landside erosion on landward toe.

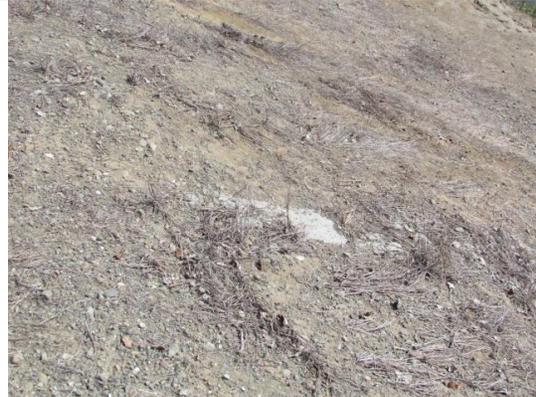
Photo 1 of 1 : SP_2015_RD0404_306_10_20150309_00004.jpg

LM Start	1.36	Rating **	A/W	Issue No.	10
LM End	1.36	Issue Type +	Ma	Location *	LS
Category	Earthen Levee		GPS Latitude/Longitude		
			Start	End	
Item	Animal Control		37.918214 °	37.918214 °	
			-121.298656 °	-121.298656 °	
DWR ID	DWR_RD0404_02_f_2012_10				
Action/Comments					
Exterminate rodents and backfill and compact or grout burrows. Inspector Comments: Grouting rodent holes

Looking southeast at typical grouted rodent holes on landward slope.
