**Flood Control Project Maintenance
Levee Inspections**

Fall 2011 Levee Maintenance Deficiency Summary Report

**Flood Control Project Maintenance
Levee Inspections
LMA District Cover Sheet
Fall 2011 Levee Inspection Results**

Reclamation District No. 0501 Ryer Island

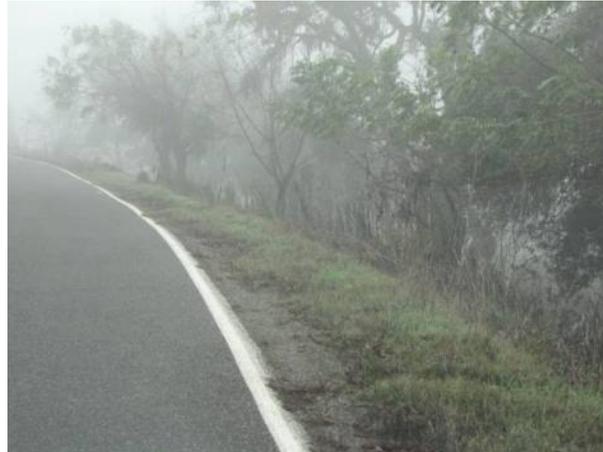
Levee Mile Report Line	7
Start Levee Mile	0.13
End Levee Mile	0.24
Location	Land Side
Category	Earthen Levee
Item	Trim / Thin Trees
Levee mile 0.13: District need to remove the fig trees from levee section on the land side, not trim them up like shown in this photo. All these shown here are less than 2-inches in diameter.	
phillips_f_20110929_108.jpg

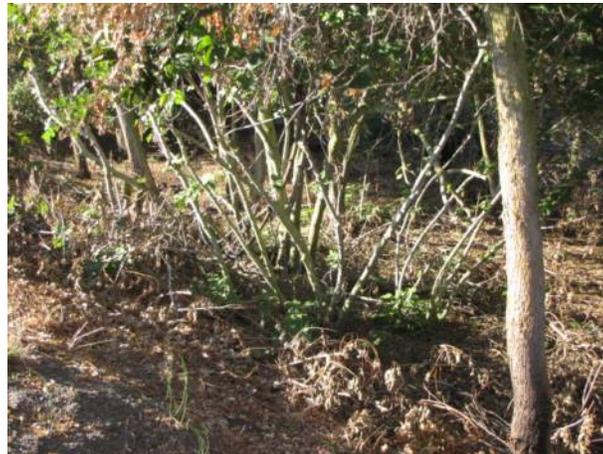
Levee Mile Report Line	9
Start Levee Mile	0.26
End Levee Mile	0.28
Location	Land Side
Category	Earthen Levee
Item	Trim / Thin Trees
This is a view of unsatisfactory fig growth on the levee section land side looking downstream from levee mile 0.26 to 0.28. This photo was taken 11-03-2010. No change since last inspection.	
phillips_f_20110929_109.jpg

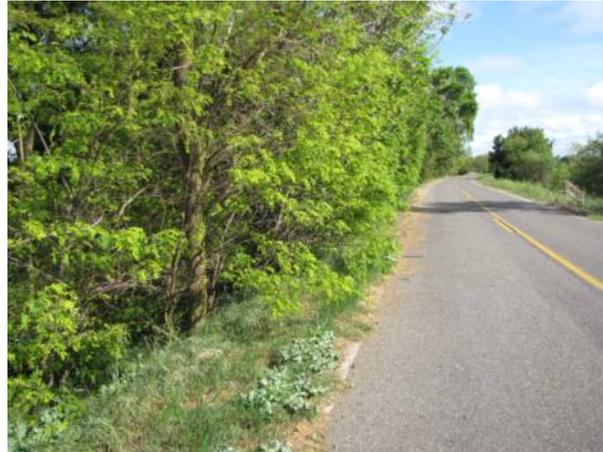
Levee Mile Report Line	20
Start Levee Mile	0.75
End Levee Mile	0.94
Location	Land Side
Category	Earthen Levee
Item	Vegetation
The berries here completely block the view of the levee section. Standing at levee mile 0.75 looking downstream to levee mile 0.94. Photo taken 11-03-2010	
phillips_f_20110929_111.jpg

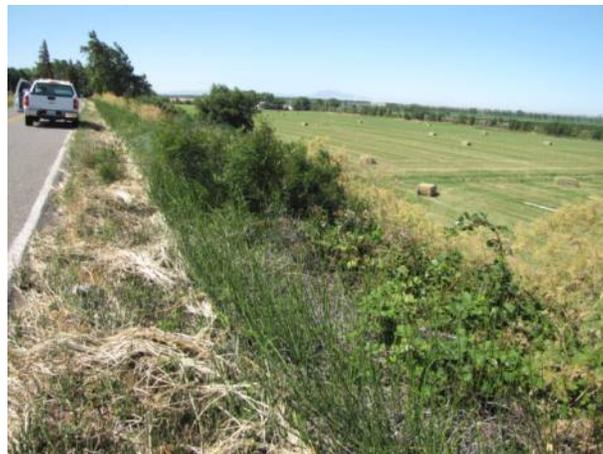
Levee Mile Report Line	20
Start Levee Mile	0.75
End Levee Mile	0.94
Location	Land Side
Category	Earthen Levee
Item	Vegetation
New photo for levee mile 0.75-0.94 RD 501 Unit 1. Photo taken 11-29-2011.	
phillips_f_20111206_098.jpg

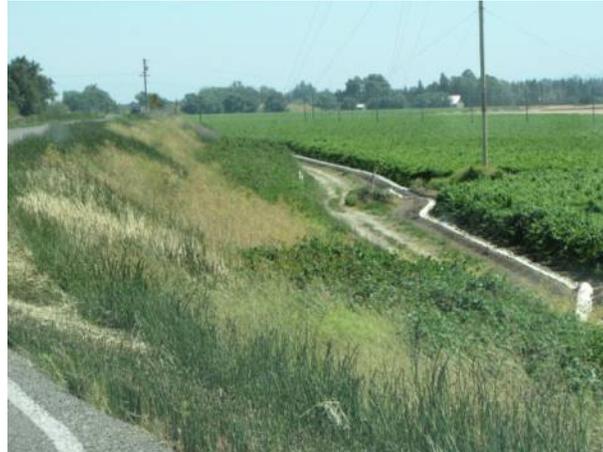
Levee Mile Report Line	24
Start Levee Mile	1.55
End Levee Mile	1.74
Location	Land Side
Category	Earthen Levee
Item	Vegetation
New photo of unsatisfactory growth at levee mile 1.55 looking downstream to levee mile 1.74 landside Unit 1. Photo taken 4-19-11.	
phillips_f_20110929_115.jpg

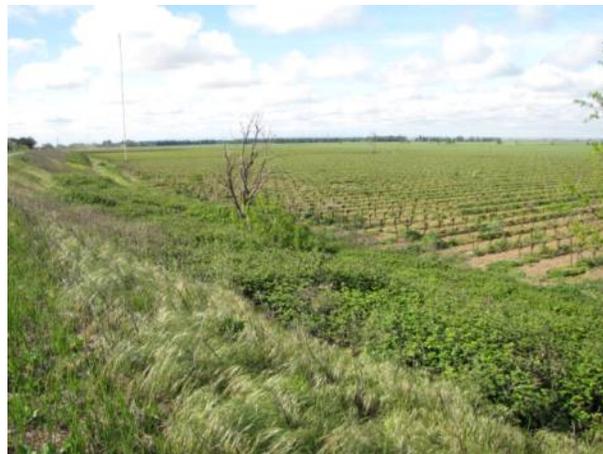
Levee Mile Report Line	24
Start Levee Mile	1.55
End Levee Mile	1.74
Location	Land Side
Category	Earthen Levee
Item	Vegetation
Another view of the unsatisfactory growth on landside slope. Photo taken 4-19-11.	
phillips_f_20110929_116.jpg

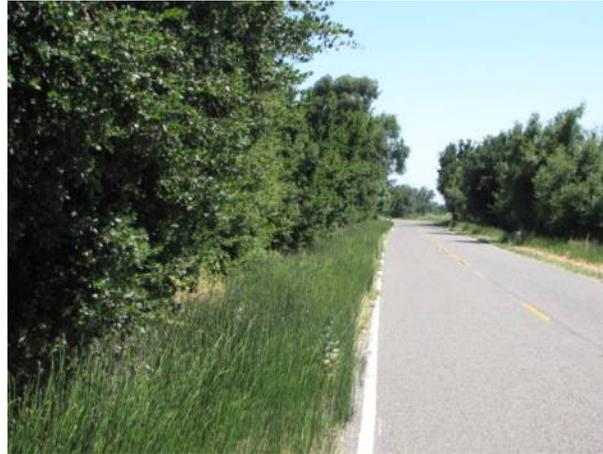
Levee Mile Report Line	38
Start Levee Mile	3.34
End Levee Mile	3.36
Location	Land Side
Category	Earthen Levee
Item	Trim / Thin Trees
Standing on levee mile 3.34 looking downstream towards levee mile 3.36 landward of Unit 1 RD 501 at the unsatisfactory wild growth on the levee slope. Photo taken 4-19-11	
phillips_f_20110929_122.jpg

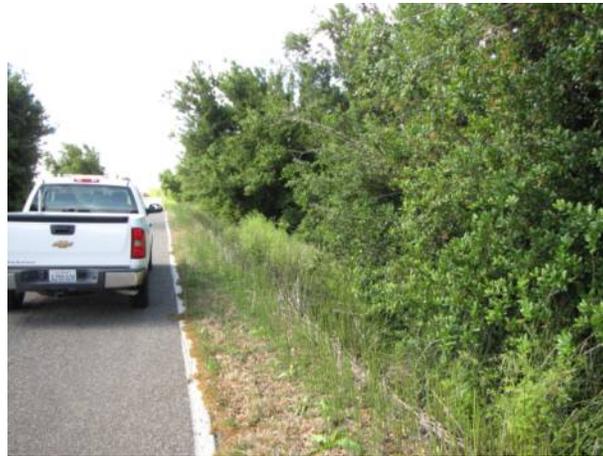
Levee Mile Report Line	38
Start Levee Mile	3.34
End Levee Mile	3.36
Location	Land Side
Category	Earthen Levee
Item	Trim / Thin Trees
Another photo of the unsatisfactory growth on levee slope from levee mile 3.34 to 3.36. Photo taken 4-19-11.	
phillips_f_20110929_123.jpg

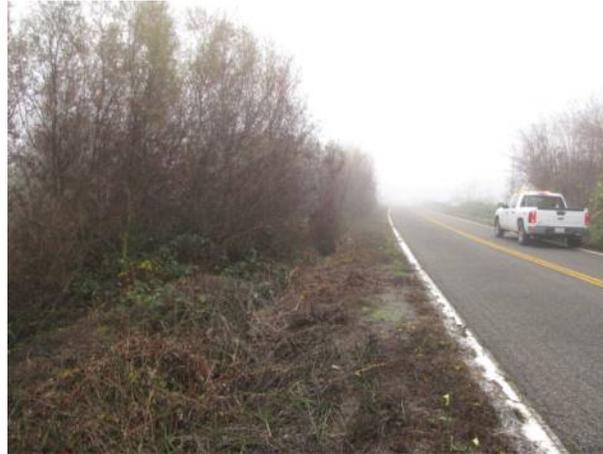
Levee Mile Report Line	47
Start Levee Mile	3.80
End Levee Mile	4.14
Location	Land Side
Category	Earthen Levee
Item	Vegetation
This section here shows that the berry vines are taller than the cab of the truck, you can't see the slope or toe because of the wild growth.	
phillips_f_20110929_117.jpg

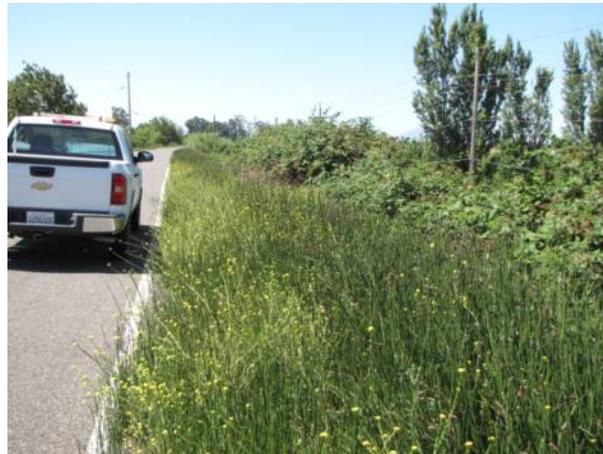
Levee Mile Report Line	47
Start Levee Mile	3.80
End Levee Mile	4.14
Location	Land Side
Category	Earthen Levee
Item	Vegetation
New photo of unsatisfactory growth landward levee mile 3.80-4.14. Photo taken 4-19-11.	
phillips_f_20110929_118.jpg

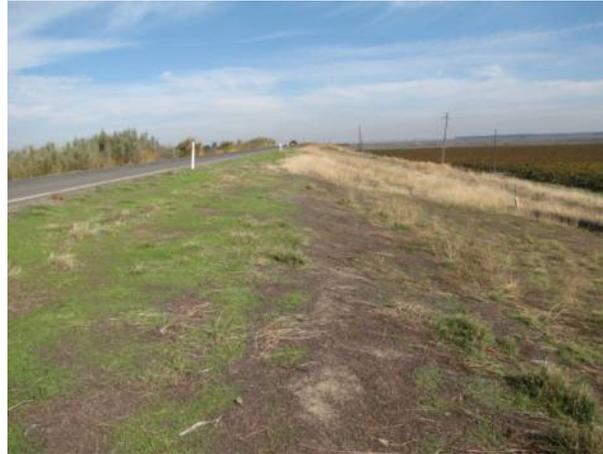
Levee Mile Report Line	3
Start Levee Mile	0.44
End Levee Mile	0.44
Location	Land Side
Category	Earthen Levee
Item	Vegetation
Water side from levee mile 0.44 looking downstream Unit 2 RD 501. Taken 11-03-2010	
phillips_f_20110929_127.jpg

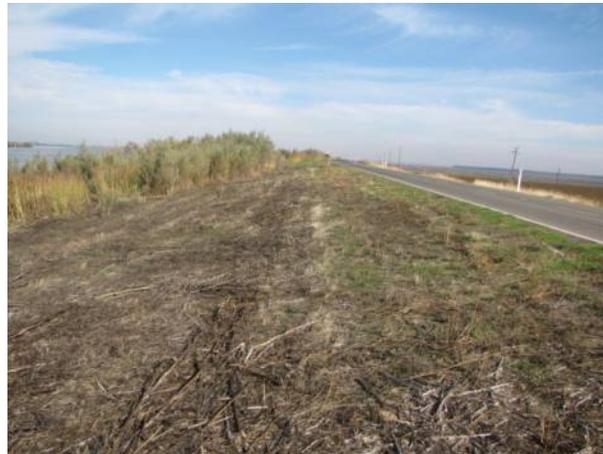
Levee Mile Report Line	3
Start Levee Mile	0.44
End Levee Mile	0.44
Location	Land Side
Category	Earthen Levee
Item	Vegetation
RD 501 Unit 2 looking downstream landside. Photo taken 11-29-2011.	
phillips_f_20111205_081.jpg

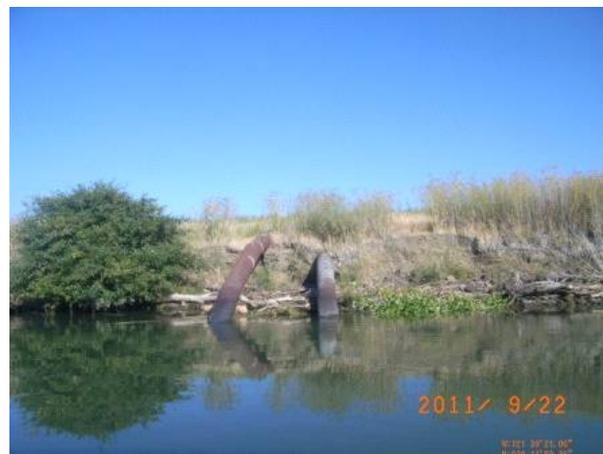
Levee Mile Report Line	6
Start Levee Mile	1.03
End Levee Mile	1.03
Location	Water Side
Category	Earthen Levee
Item	Erosion / Bank Caving
Down at the base of the tree and the stake in view is bank erosion. This site was discovered 2-11 by a resident of the Hester property on the landside of the levee. The District has placed material in the eroded area however more is needed. Photo was taken 4-19-11.	
phillips_f_20110929_125.jpg

6	1.03	1.03	Earthen Levee	Erosion / Bank Caving	WS W	Schedule repair of erosion site prior to the next inspection.		38.198153 ° -121.655614 °	38.198153 ° -121.655614 °	10 Y
7	1.07	1.11	Earthen Levee	Vegetation	WS M	Remove the wild growth other than native grasses from the levee slopes.		38.198602 ° -121.655605 °	38.199148 ° -121.655490 °	8
8	1.98	3.02	Earthen Levee	Vegetation	WS M	Remove the wild growth other than native grasses from the levee slopes.		38.226175 ° -121.604013 °	38.212626 ° -121.609959 °	3
9	1.98	3.02	Earthen Levee	Vegetation	LS M	Remove the wild growth other than native grasses from the levee slopes.		38.207621 ° -121.656219 °	38.220184 ° -121.670834 °	5
10	2.92	2.93	Earthen Levee	Animal Control	LS M	Exterminate rodents and backfill and compact or grout burrows.		38.218890 ° -121.669934 °	38.218997 ° -121.669988 °	4
11	3.43	3.43	Earthen Levee	Trim / Thin Trees	LS M	Trim trees to at least five feet above ground level.		38.225823 ° -121.672837 °	38.225823 ° -121.672837 °	16

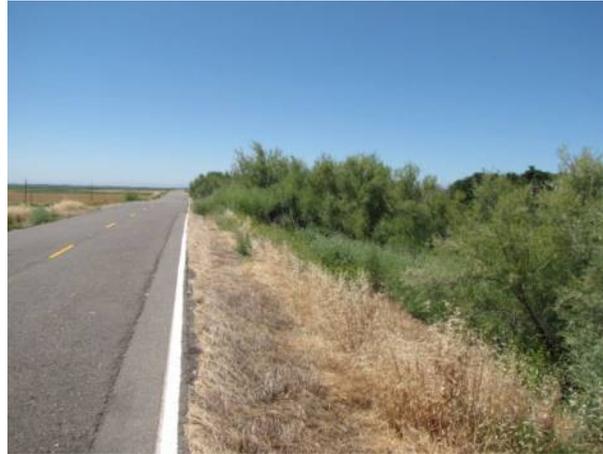
Levee Mile Report Line	6
Start Levee Mile	2.65
End Levee Mile	2.77
Location	Water Side
Category	Earthen Levee
Item	Trim / Thin Trees
Looking upstream from levee mile 2.77.	
phillips_f_20110929_135.jpg

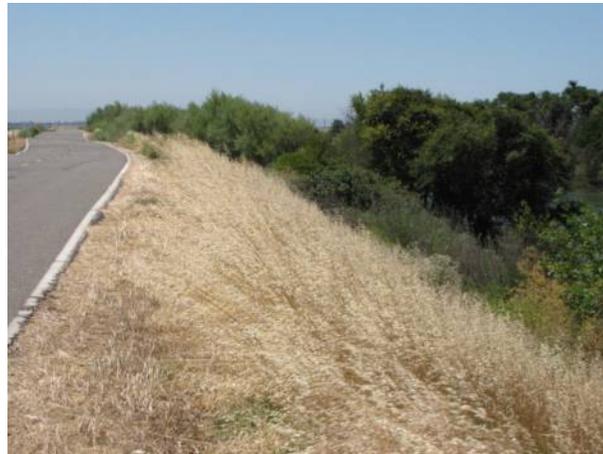
Levee Mile Report Line	7
Start Levee Mile	2.66
End Levee Mile	2.78
Location	Water Side
Category	Earthen Levee
Item	Vegetation
RD 501 Unit 3 levee mile 2.66-2.78 waterside looking downstream. Photo taken 11-29-2011.	
phillips_f_20111205_080.jpg

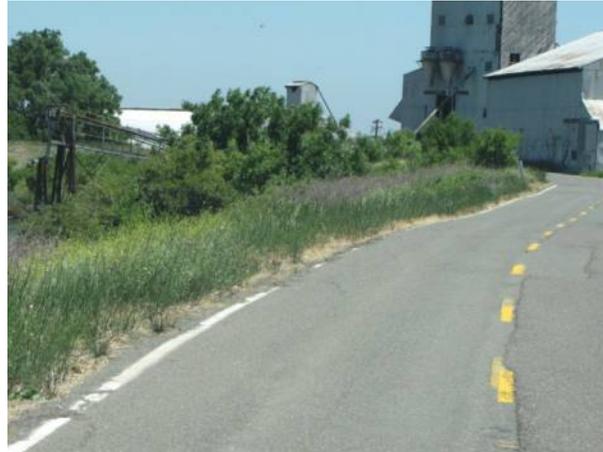
Levee Mile Report Line	8
Start Levee Mile	3.52
End Levee Mile	3.55
Location	Water Side
Category	Earthen Levee
Item	Trim / Thin Trees
Levee mile 3.52 standing on waterside looking upstream wild growth. Photo taken 11-03-2010	
phillips_f_20110929_137.jpg

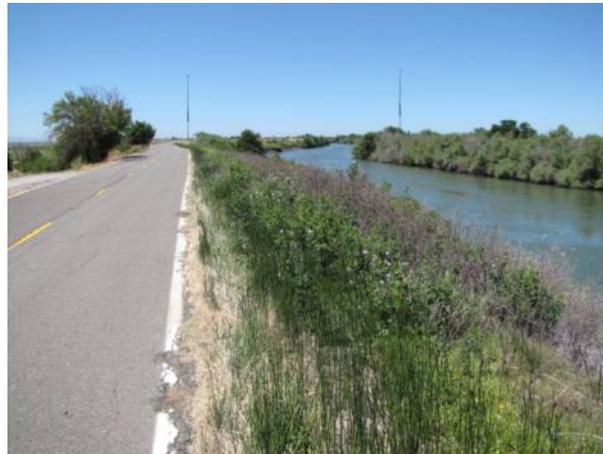
Levee Mile Report Line	8
Start Levee Mile	3.52
End Levee Mile	3.55
Location	Water Side
Category	Earthen Levee
Item	Trim / Thin Trees
Levee mile 3.55 land side tree growth on slope, you can't see the slope for wild growth. These trees has not been trimmed. Photo taken 11-03-2010	
phillips_f_20110929_138.jpg

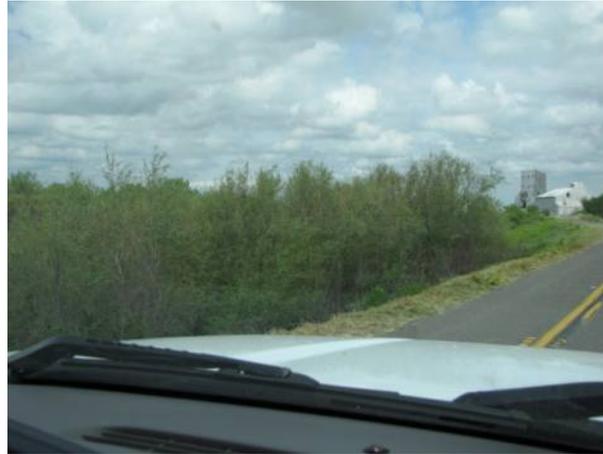
Levee Mile Report Line	10
Start Levee Mile	3.69
End Levee Mile	3.70
Location	Land Side
Category	Earthen Levee
Item	Trim / Thin Trees
Levee mile 3.69 tree growth has blocked view of levee on the land side.	
phillips_f_20110929_140.jpg

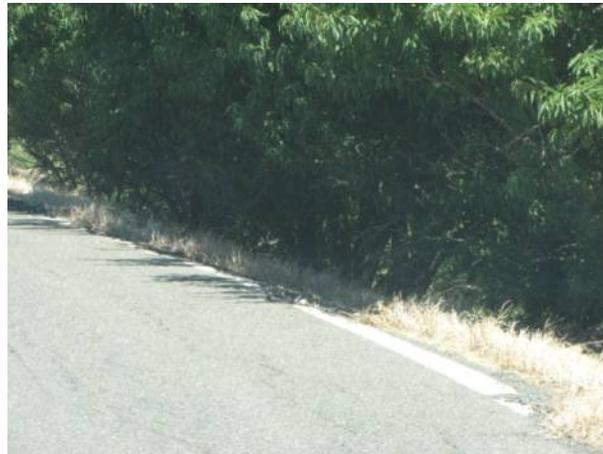
Levee Mile Report Line	10
Start Levee Mile	3.69
End Levee Mile	3.70
Location	Land Side
Category	Earthen Levee
Item	Trim / Thin Trees
Looking downstream from 3.70 tall growth continues down stream from this point. Taken 11-03-2010	
phillips_f_20110929_141.jpg

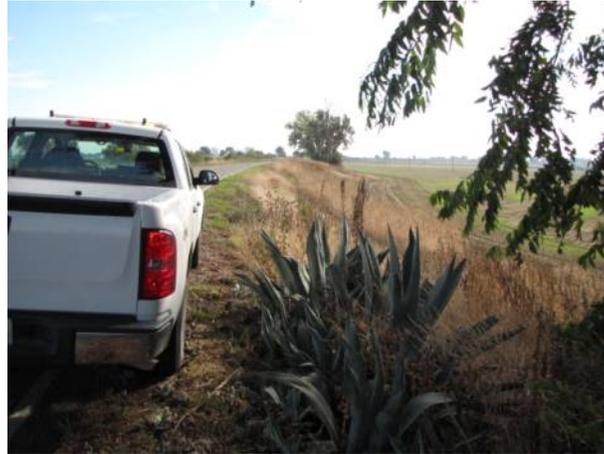
Levee Mile Report Line	2
Start Levee Mile	0.00
End Levee Mile	0.00
Location	Land Side
Category	Earthen Levee
Item	Vegetation
Looking downstream from levee mile 0.00 landward slope. Photo taken 11-29-2011.	
phillips_f_20111205_084.jpg

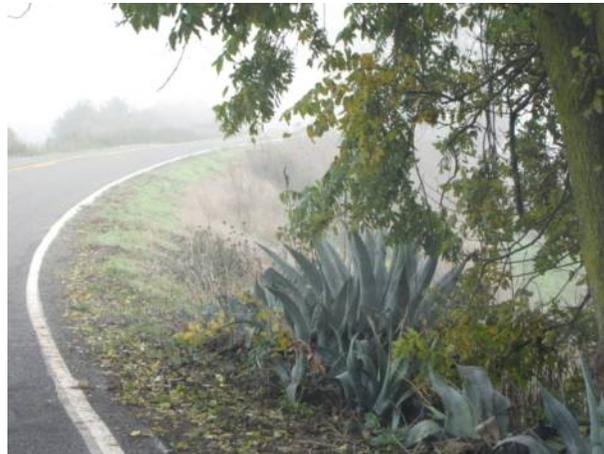
Levee Mile Report Line	4
Start Levee Mile	0.50
End Levee Mile	1.15
Location	Land Side
Category	Earthen Levee
Item	Vegetation
Looking downstream land side wild growth taking over the slope continuing onward downstream to levee mile 1.15.	
phillips_f_20110929_145.jpg

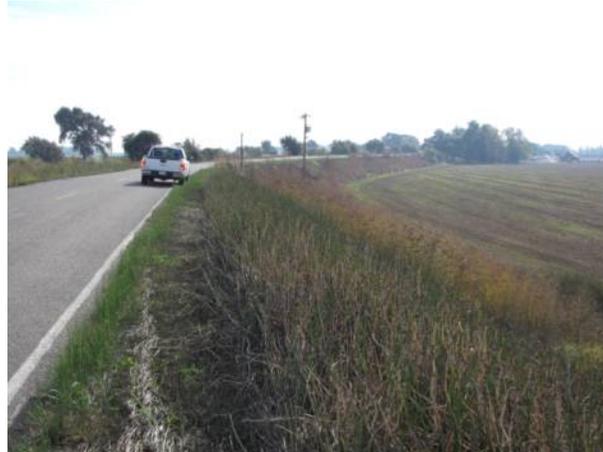
Levee Mile Report Line	12
Start Levee Mile	1.84
End Levee Mile	1.87
Location	Land Side
Category	Earthen Levee
Item	Trim / Thin Trees
<p>Levee mile 1.84 looking downstream landside oak tree growth cover slope from hinge point to toe as seen in this photo.</p>	
<p>phillips_f_20110929_148.jpg</p>
