**Flood Control Project Maintenance
Levee Inspections**

Fall 2009 Levee Maintenance Deficiency Summary Report

Reclamation District No. 0501 Ryer Island

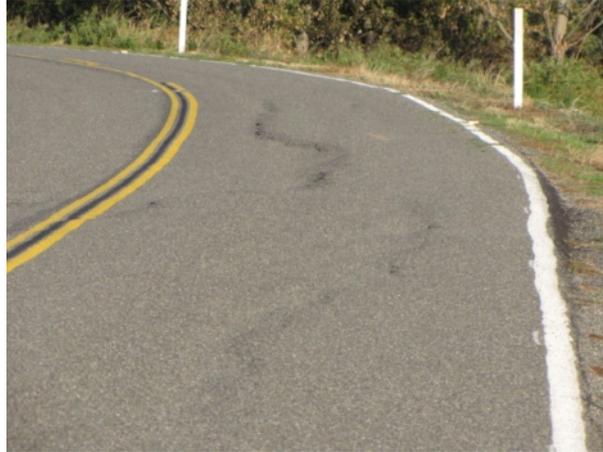
5	1.75	1.75	Earthen Levee	Cracking	CR	M	Monitor and have inspected by geotechnical engineer.	38.247295 ° -121.658033 °	38.247295 ° -121.658033 °	44
6	1.81	1.81	Earthen Levee	Trim / Thin Trees	WS	M	Trim trees to at least five feet above ground level.	38.247820 ° -121.657192 °	38.247833 ° -121.657137 °	11
7	2.23	2.27	Earthen Levee	Trim / Thin Trees	WS	U	Thin trees to allow visibility of the ground and room to flood fight.	38.253727 ° -121.655487 °	38.254223 ° -121.655133 °	14
8	2.43	2.43	Earthen Levee	Vegetation	WS	M	Control annual grass and weeds on the levee slopes and easements.	38.254485 ° -121.652110 °	38.254410 ° -121.652237 °	45
9	2.65	2.77	Earthen Levee	Trim / Thin Trees	WS	U	Thin trees to allow visibility of the ground and room to flood fight.	38.257278 ° -121.651417 °	38.259067 ° -121.651462 °	16
10	3.52	3.55	Earthen Levee	Trim / Thin Trees	WS	U	Thin trees to allow visibility of the ground and room to flood fight.	38.265523 ° -121.642537 °	38.265778 ° -121.642243 °	21

Levee Mile Report Line	4
Start Levee Mile	1.74
End Levee Mile	1.75
Location	Crown
Category	Earthen Levee
Item	Cracking
Cracks in crown roadway, the crown appears to be sinking in the middle	
phillips_20091208_20.jpg

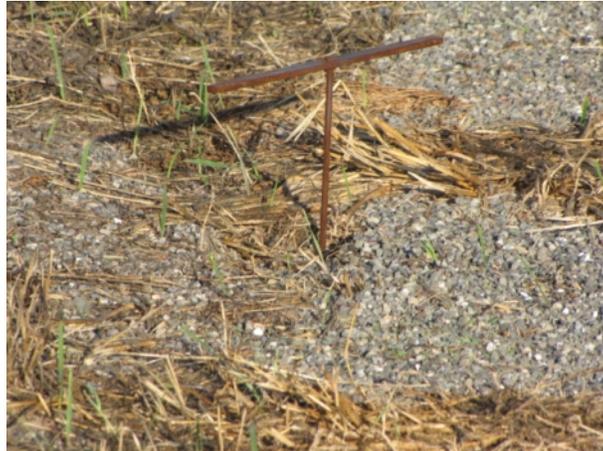
Levee Mile Report Line	4
Start Levee Mile	1.74
End Levee Mile	1.75
Location	Crown
Category	Earthen Levee
Item	Cracking
This probe is stuck in the crack along the shoulder land ward, its in the crown 3-4 foot no resistance.	
phillips_20091208_21.jpg

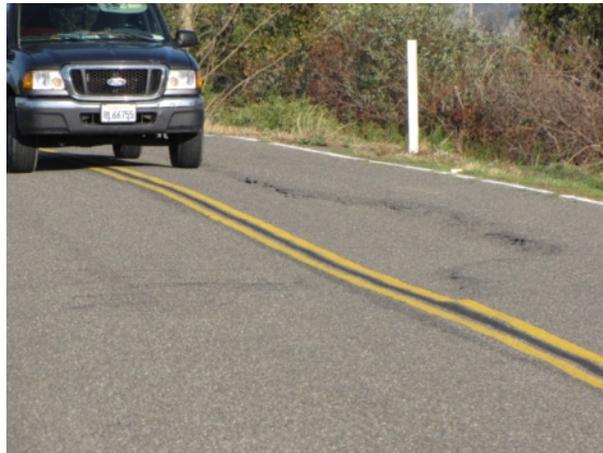
Levee Mile Report Line	4
Start Levee Mile	1.74
End Levee Mile	1.75
Location	Crown
Category	Earthen Levee
Item	Cracking
Depression here has a difference in elevation 1-2-inches if nor more.	
phillips_20091208_22.jpg

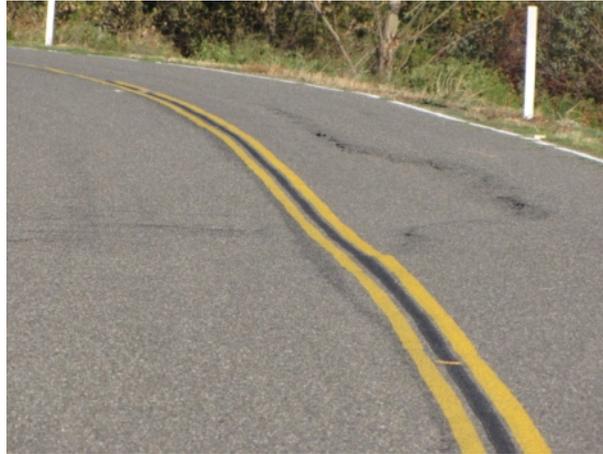
Levee Mile Report Line	4
Start Levee Mile	1.74
End Levee Mile	1.75
Location	Crown
Category	Earthen Levee
Item	Cracking
Shown here with out the vehicle in view.	
phillips_20091208_23.jpg

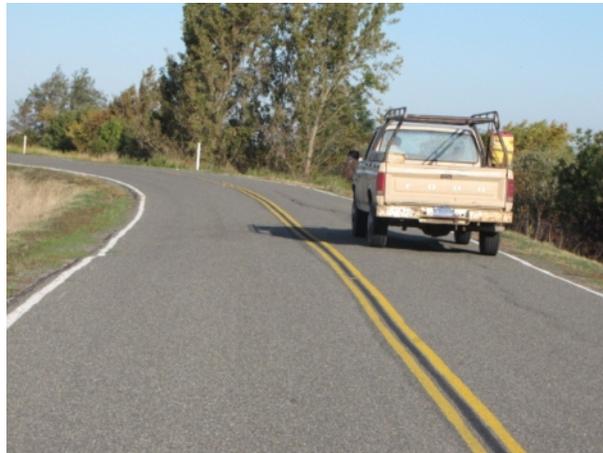
Levee Mile Report Line	4
Start Levee Mile	1.74
End Levee Mile	1.75
Location	Crown
Category	Earthen Levee
Item	Cracking
Another view within same area. The County has placed caution signs within damaged area to slow the traffic down.	
phillips_20091208_24.jpg
