**Flood Control Project Maintenance  
Levee Inspections**

**Fall 2013 Levee Maintenance Deficiency Summary Report**

**Reclamation District No. 0501 Ryer Island**

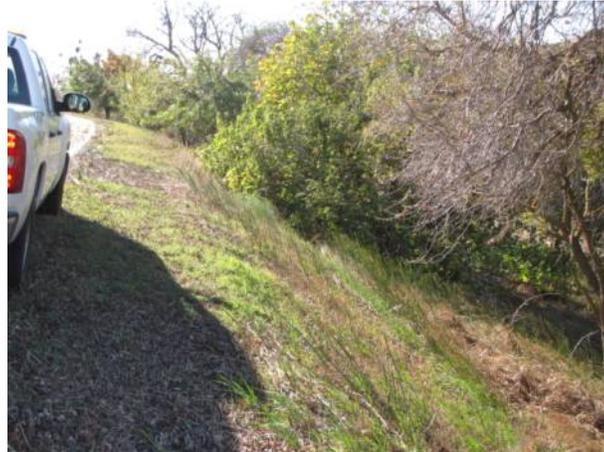
Levee Mile Report Line	5
Start Levee Mile	0.02
End Levee Mile	0.03
Location	Water Side
Category	Earthen Levee
Item	Vegetation
RD 501 Looking downstream from levee mile 0.02. Photo taken 11-22-2013.	
phillips_f_20131203_750.JPG

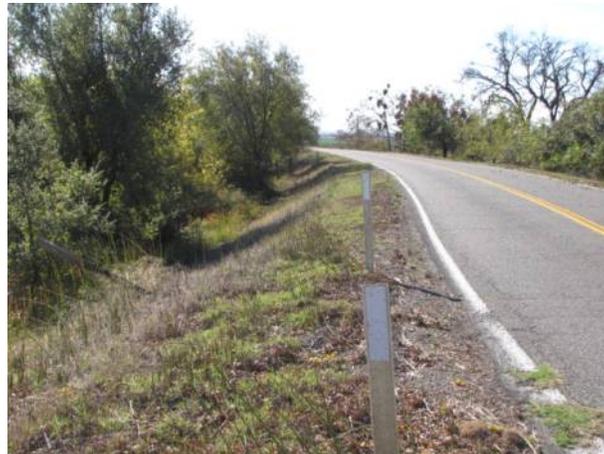
Levee Mile Report Line	6
Start Levee Mile	0.02
End Levee Mile	0.03
Location	Land Side
Category	Earthen Levee
Item	Vegetation
Unsatisfactory woody vegetation blocking visibility of levee section. Photo taken 11-22-2013.	
phillips_f_20131203_751.JPG

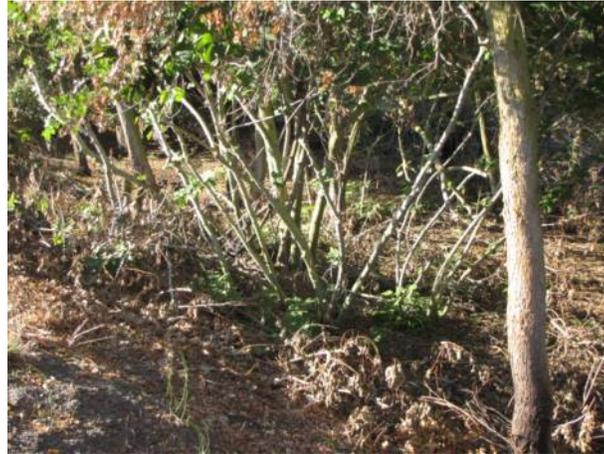
Levee Mile Report Line	15
Start Levee Mile	0.17
End Levee Mile	0.17
Location	Land Side
Category	Supplemental
Item	DWR UCIP Field Study

DWR ID: DWR_RD0501_01_f_2013_45										
15	0.17	0.17	Supplemental	DWR UCIP Field Study	LS	U En	Inspector Comments: FS_ID:18486 EP_NO: 4581 Repair Type: Urgent Crossing Status: Found UCIP Comments: Damage present from leaky pipe. Signs of repair work on crown, however, no permit found to document recent of damage to levee or repair work. Pipe is no longer operational. New PVC pipe has been sleeved through the existing 6-inch pipe. Unable to determine if crossing pipe has been abandoned or if crossing pipe will be used in the future. FIELD_STRUCT_DESC: 6-inch steel pipe through the levee, 2.5 feet below the crown. 2-inch steel electrical conduit through levee. Cutoff wall around pipe at center of levee. Pump and gate valve in pump structure on waterward slope. Service pole on landward slope. Pipe exposed on both slopes. (Permit No. 4581-1964) FS Date: 6/4/2013	38.252140 ° -121.602902 °	38.252140 ° -121.602902 °	46 Y

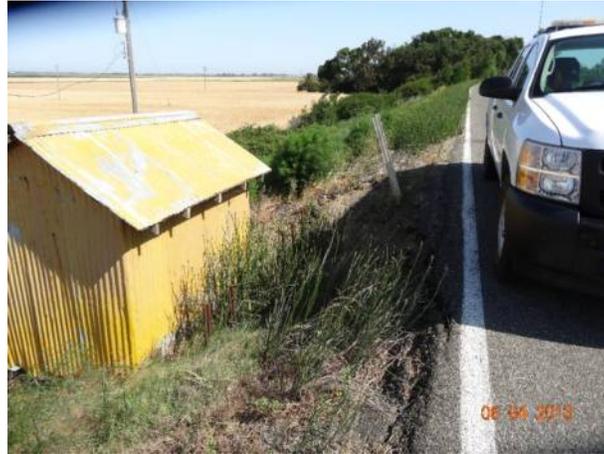
Levee Mile Report Line	42
Start Levee Mile	0.43
End Levee Mile	0.43
Location	Land Side
Category	Supplemental
Item	DWR UCIP Field Study
Overview of waterside at crossing. Marker on shoulder.	
UCIP_10185.jpg

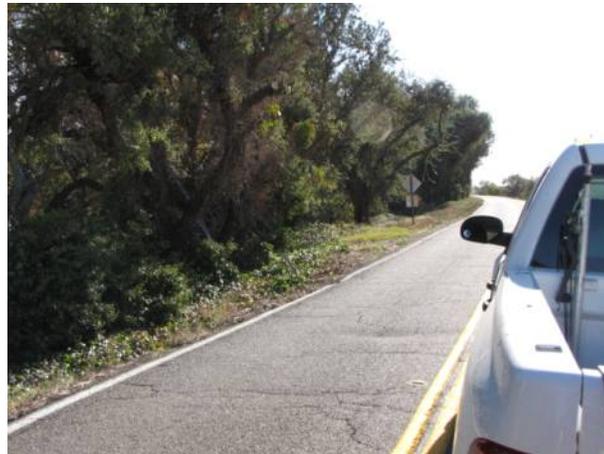
Levee Mile Report Line	56
Start Levee Mile	1.02
End Levee Mile	1.02
Location	Land Side
Category	Earthen Levee
Item	Vegetation
Looking downstream from levee mile 1.02 landside toe and slope at wild berries. Photo taken 11-22-2013.	
phillips_f_20131203_758.JPG

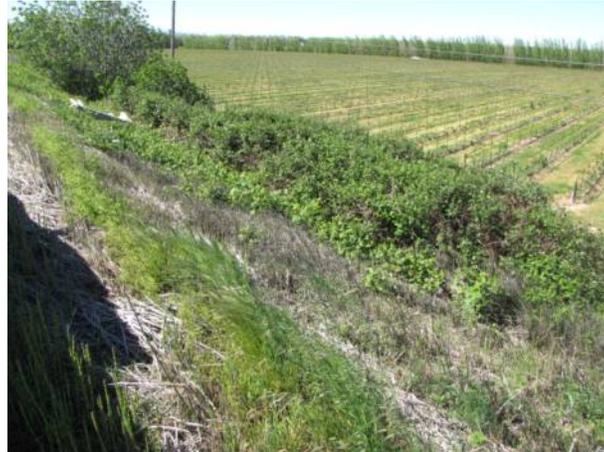
Levee Mile Report Line	62
Start Levee Mile	1.96
End Levee Mile	1.97
Location	Land Side
Category	Earthen Levee
Item	Vegetation
Wild growth on wateside slope. Photo taken 11-22-2013.	
phillips_f_20131203_759.JPG

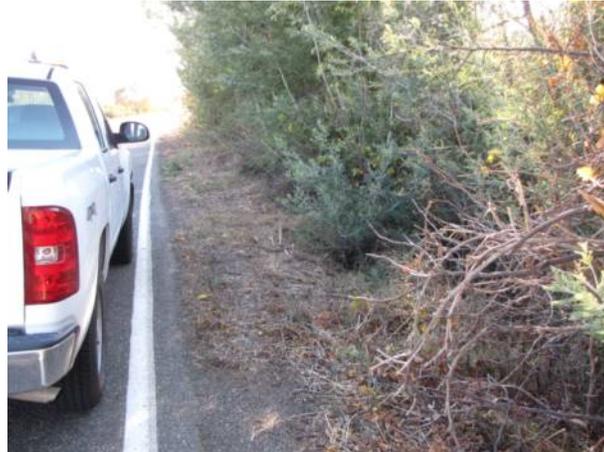
Levee Mile Report Line	116
Start Levee Mile	3.79
End Levee Mile	3.94
Location	Water Side
Category	Earthen Levee
Item	Vegetation
<p>RD 501, unsatisfactory wooded growth on landward slope and toe of levee section. Photo taken 11-26-2012.</p>	
<p>phillips_f_20130925_876.jpg</p>

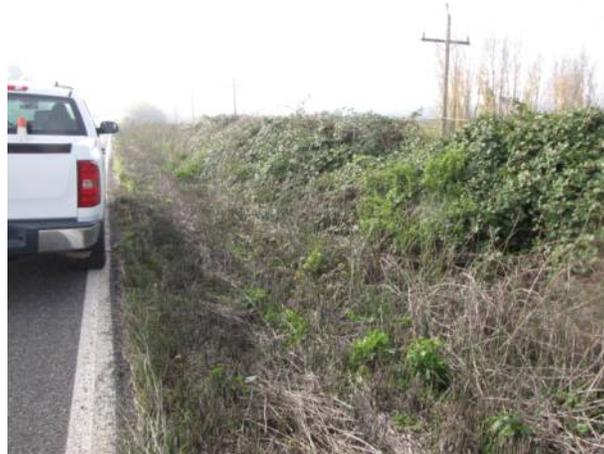
Levee Mile Report Line	118
Start Levee Mile	3.96
End Levee Mile	4.03
Location	Land Side
Category	Earthen Levee
Item	Vegetation
<p>Woody growth landside slope blocking visibility. Photo taken 11-22-2013.</p>	
<p>phillips_f_20131203_761.JPG</p>

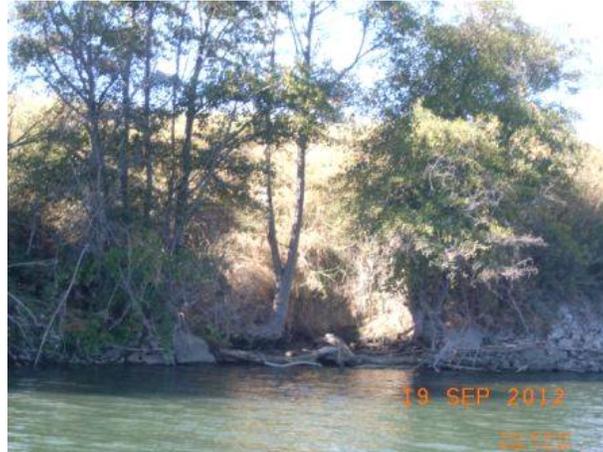
Levee Mile Report Line	135
Start Levee Mile	5.91
End Levee Mile	5.92
Location	Land Side
Category	Earthen Levee
Item	Vegetation
Woody growth blocking levee slope and toe. Photo taken 11-22-2013.	
phillips_f_20131203_762.JPG

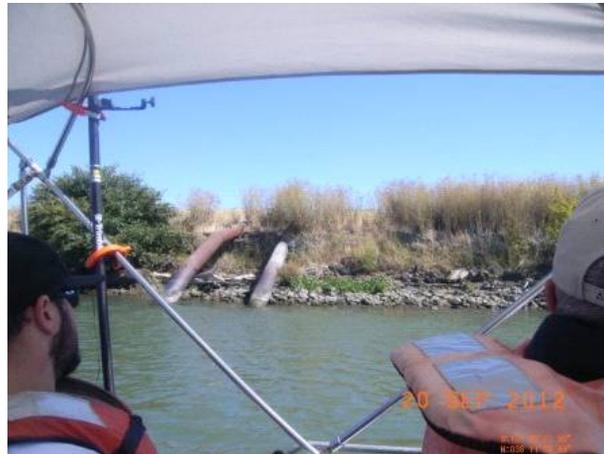
Levee Mile Report Line	26
Start Levee Mile	1.15
End Levee Mile	1.15
Location	Water Side
Category	Supplemental
Item	DWR UCIP Field Study
Waterward side--2-24 inch pipe inlets.	
UCIP_10725.jpg

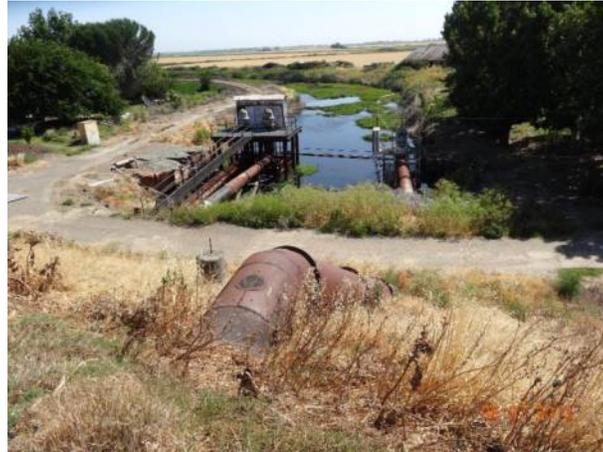
Levee Mile Report Line	56
Start Levee Mile	2.45
End Levee Mile	2.45
Location	Water Side
Category	Supplemental
Item	DWR UCIP Field Study
<p>View of exposed section of pipe along landward slope. Distribution box and possible closure device located near landward toe.</p>	
<p>UCIP_10201.jpg</p>

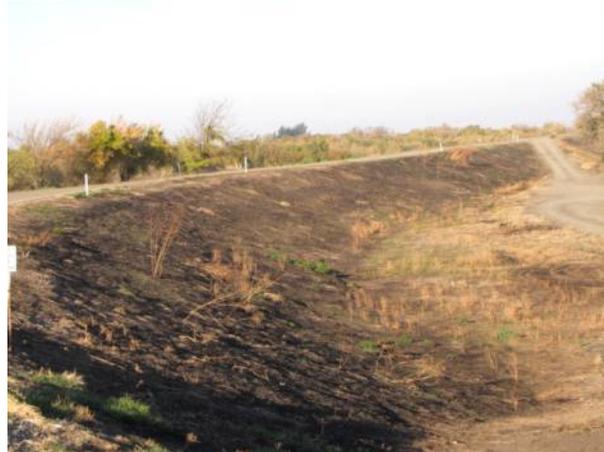
Levee Mile Report Line	4
Start Levee Mile	0.50
End Levee Mile	0.61
Location	Water Side
Category	Earthen Levee
Item	Vegetation
Looking downstream from levee mile 0.50 waterside woody growth blocks visibility of levee slope and toe. Photo taken 11-25-2013.	
phillips_f_20131203_767.JPG

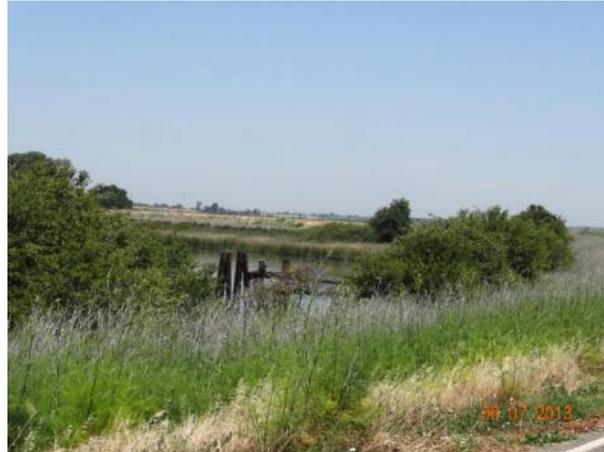
Levee Mile Report Line	22
Start Levee Mile	1.93
End Levee Mile	1.93
Location	Water Side
Category	Supplemental
Item	DWR UCIP Field Study
Overview of landward side. Pipe is visible however dense vegetation limits proper inspection.	
UCIP_10246.jpg

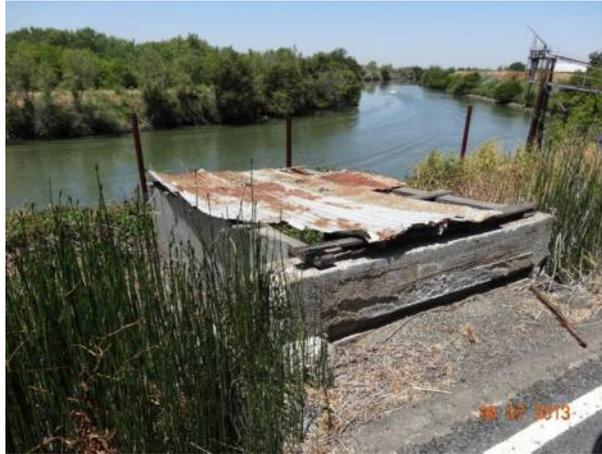
Levee Mile Report Line	55
Start Levee Mile	3.73
End Levee Mile	3.73
Location	Land Side
Category	Supplemental
Item	DWR UCIP Field Study
Unable to find evidence of concrete tunnel. Found pipe going through levee.	
UCIP_10288.jpg

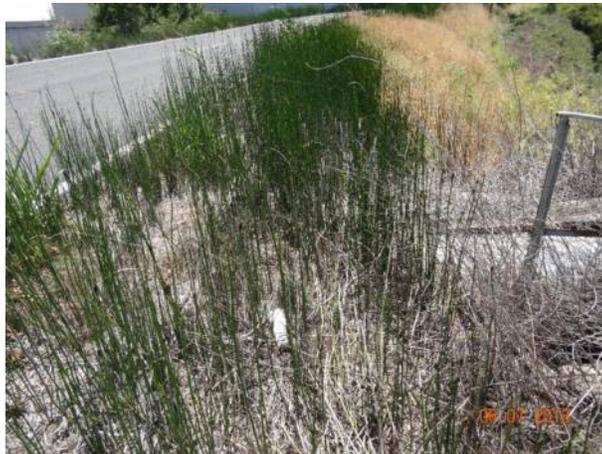
Levee Mile Report Line	63
Start Levee Mile	3.77
End Levee Mile	3.77
Location	Land Side
Category	Supplemental
Item	DWR UCIP Field Study
Pipe section is buried near levee toe.	
UCIP_10901.jpg

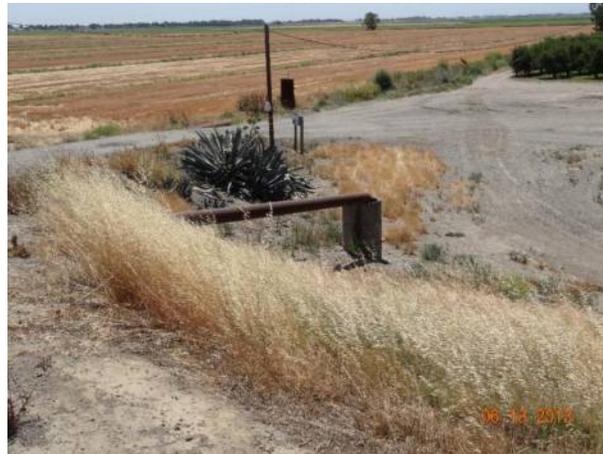
Levee Mile Report Line	91
Start Levee Mile	6.50
End Levee Mile	6.50
Location	Land Side
Category	Supplemental
Item	DWR UCIP Field Study
View of pipe located on landward side. Dry vegetation along levee slope.	
UCIP_10331.jpg
