**Flood Control Project Maintenance  
Levee Inspections**

**Fall 2014 Levee Maintenance Deficiency Summary Report**

**Sacramento River Basin**

**Reclamation District No. 0501 Ryer Island**

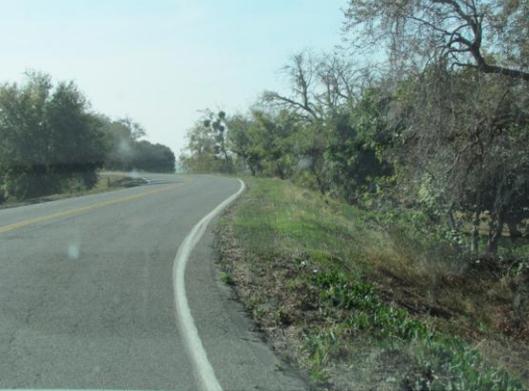
Photo 1 of 1 : FA\_2014\_RD0501\_169\_118\_20141126\_00096.jpg

LM Start	<b>0.01</b>	Rating **	A	Issue No.	<b>118</b>
LM End	<b>2.33</b>	Issue Type +	Ma	Location *	LS
Category	Earthen Levee		GPS Latitude/Longitude		
			Start	End	
Item	Vegetation		38.254089 °	38.221505 °	
			-121.601730 °	##### °	
DWR ID	DWR_RD0501_01_f_2014_118				
Action/Comments					
Control annual grass and weeds on the levee slopes and easements. Inspector Comments: The RD is doing a good job trimming the trees on the landward slope.

Looking downstream from 0.01 to 2.33.

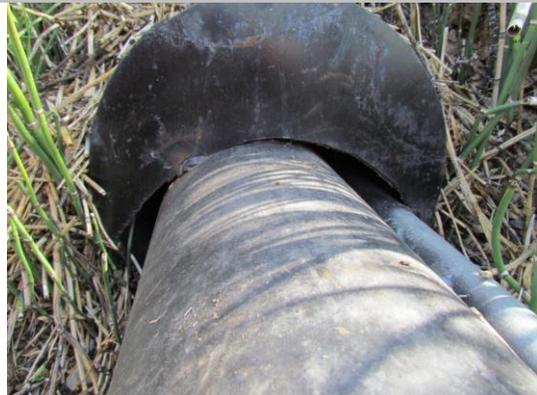
Photo 1 of 1 : FA\_2014\_RD0501\_169\_73\_20141126\_00097.jpg

LM Start	<b>1.84</b>	Rating **	<b>U</b>	Issue No.	<b>73</b>
LM End	<b>1.84</b>	Issue Type +	<b>En</b>	Location *	<b>LS</b>
Category	Earthen Levee		GPS Latitude/Longitude		
			Start	End	
Item	Encroachments		38.228399 °	38.228399 °	
			-121.604134 °	-121.604134 °	
DWR ID	DWR_RD0501_01_s_2014_73				
Action/Comments					
Pipe Inspector Comments: Pipe has been replaced but the job is not complete. 4-02-2014. This project as of 11-6-2014 has not been completed. The grouting has not been done.

Looking at the unfinished pipe work at levee mile 1.84.

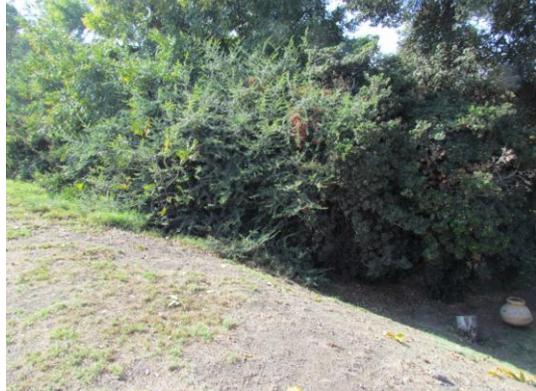
Photo 1 of 1 : FA\_2014\_RD0501\_169\_116\_20141126\_00098.jpg

LM Start	<b>2.32</b>	Rating **	U	Issue No.	<b>116</b>
LM End	<b>2.32</b>	Issue Type +	Ma	Location *	LS
Category	Earthen Levee		GPS Latitude/Longitude		
			Start	End	
Item	Trim / Thin Trees		38.221620 °	38.221620 °	
			-121.603390 °	-121.603393 °	
DWR ID	DWR_RD0501_01_f_2014_116				
Action/Comments					
Trim trees to at least five feet above ground level. Inspector Comments: Trim the trees to allow slope to be seen.

Looking downstream at the woody tree growth on the landward levee slope.

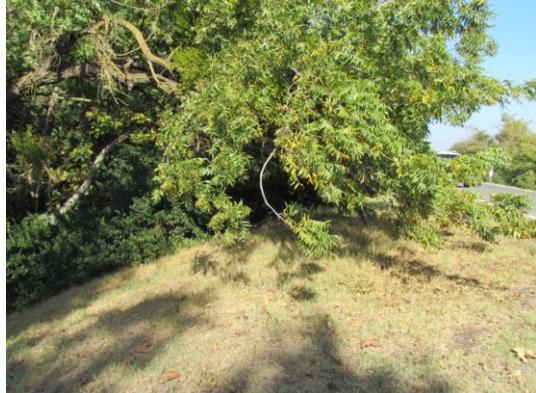
Photo 1 of 1 : FA\_2014\_RD0501\_169\_133\_20141126\_00099.jpg

LM Start	<b>2.32</b>	Rating **	U	Issue No.	<b>133</b>
LM End	<b>2.32</b>	Issue Type +	Ma	Location *	LS
Category	Earthen Levee		GPS Latitude/Longitude		
			Start	End	
Item	Vegetation		38.221606 °	38.221529 °	
			-121.603429 °	-121.603436 °	
DWR ID	DWR_RD0501_01_f_2013_133				
Action/Comments					
Remove the wild growth other than native grasses from the levee slopes. Inspector Comments: Remove the vegetation off the levee slope landward.

Looking upstream at woody tree growth and vegetation has completely blocked the view of the slope.

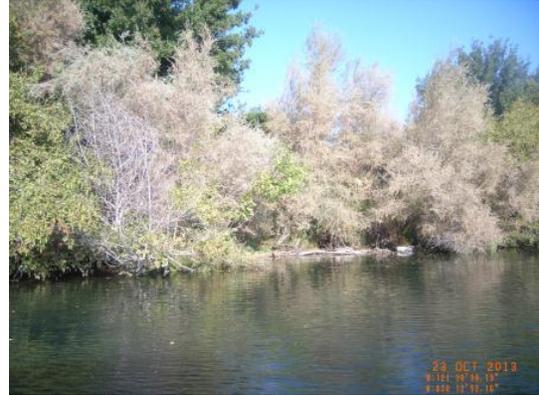
Photo 1 of 1 : FA\_2014\_RD0501\_169\_11\_20141008\_00004.jpg

LM Start	<b>2.85</b>	Rating **	M	Issue No.	<b>11</b>
LM End	<b>2.93</b>	Issue Type +	Ma	Location *	WS
Category	Supplemental			GPS Latitude/Longitude	
				Start	End
Item	USACE Erosion Survey			38.214838 °	38.214075 °
				-121.608129 °	-121.608750 °
DWR ID	DWR_RD0501_01_f_2014_11				
Action/Comments					
Inspector Comments: 2009 - Rock is starting to unravel, probably from a tree pop-out, hard toe. 2013: No observed changes. [2013 Site ID: STM_18-9_R]

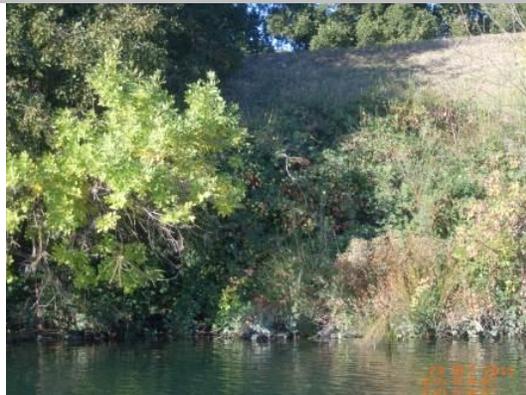
Photo 1 of 1 : FA\_2014\_RD0501\_169\_5\_20141008\_00002.jpg

LM Start	<b>3.03</b>	Rating **	M	Issue No.	<b>5</b>
LM End	<b>3.18</b>	Issue Type +	Ma	Location *	WS
Category	Supplemental			GPS Latitude/Longitude	
				Start	End
Item	USACE Erosion Survey			38.212573 °	38.211596 °
				-121.609760 °	-121.609928 °
DWR ID	DWR_RD0501_01_f_2014_5				
Action/Comments					
Inspector Comments: 2000 - Slow erosion of lower and mid-slope with rock bench at the low water line. 2013: No observed changes. [2013 Site ID: STM_18-8_R]

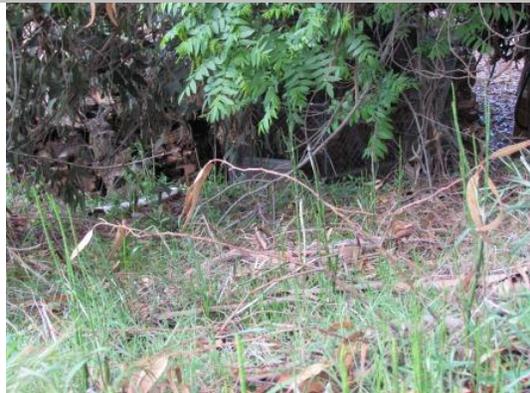
Photo 1 of 1 : FA\_2014\_RD0501\_169\_63\_20141008\_00007.jpg

LM Start	<b>3.25</b>	Rating **	U	Issue No.	<b>63</b>
LM End	<b>3.26</b>	Issue Type +	En	Location *	LS
Category	Earthen Levee		GPS Latitude/Longitude		
			Start	End	
Item	Encroachments		38.209811 °	38.209713 °	
			-121.610813 °	-121.610882 °	
DWR ID	DWR_RD0501_01_f_2012_63				
Action/Comments					
Material Inspector Comments: There is stock pile of equipment and materials on the levee section that needs to be removed off the levee. No new photo taken of this issue 2014.

Equipment and other material on slope and toe of levee section.

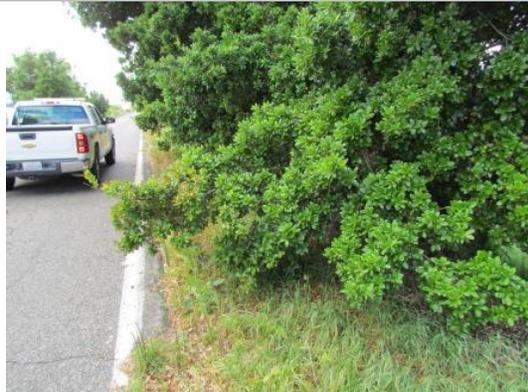
Photo 1 of 1 : FA\_2014\_RD0501\_169\_43\_20141008\_00006.jpg

LM Start	<b>3.34</b>	Rating **	U	Issue No.	<b>43</b>
LM End	<b>3.36</b>	Issue Type +	Ma	Location *	LS
Category	Earthen Levee		GPS Latitude/Longitude		
			Start	End	
Item	Trim / Thin Trees		38.208468 °	38.208292 °	
			-121.611348 °	-121.611437 °	
DWR ID	DWR_RD0501_01_s_2012_43				
Action/Comments					
Trim trees to at least five feet above ground level. Inspector Comments: Trim trees 5-feet above ground, can't see levee slope.

Woody tree growth on levee slope and shoulder of the landside. No new photo taken.

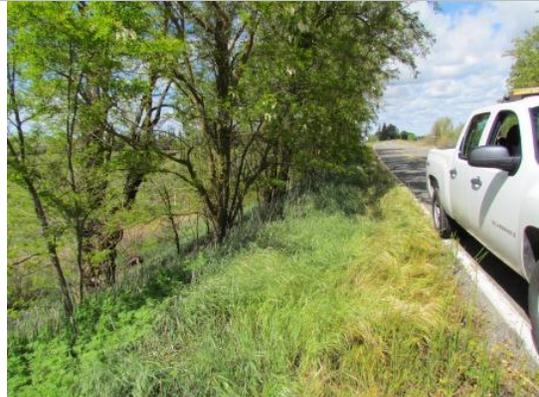
Photo 1 of 1 : FA\_2014\_RD0501\_169\_140\_20141008\_00013.jpg

LM Start	<b>3.49</b>	Rating **	U	Issue No.	<b>140</b>
LM End	<b>3.60</b>	Issue Type +	Ma	Location *	N/A
Category	Earthen Levee		GPS Latitude/Longitude		
			Start	End	
Item	Vegetation		38.206494 °	38.205020 °	
			-121.612244 °	-121.612824 °	
DWR ID	DWR_RD0501_01_f_2013_140				
Action/Comments					
Trees / Woody Vegetation Inspector Comments: RD 501 was working in this area during inspection and plans to thin out these trees.

Looking back upstream from landside slope wild growth of black locust trees on the slope and toe. No new photo of this issue.

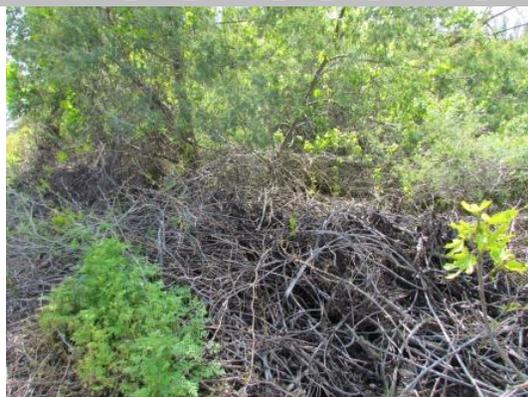
Photo 1 of 1 : FA\_2014\_RD0501\_169\_142\_20141008\_00014.jpg

LM Start	<b>3.77</b>	Rating **	U	Issue No.	<b>142</b>
LM End	<b>3.77</b>	Issue Type +	Ma	Location *	LS
Category	Earthen Levee		GPS Latitude/Longitude		
			Start	End	
Item	Vegetation		38.202627 °	38.202625 °	
			-121.613587 °	-121.613590 °	
DWR ID	DWR_RD0501_01_f_2013_142				
Action/Comments					
Trees / Woody Vegetation Inspector Comments: RD 501 is in process of removing issue.

Unsatisfactory woody growth on the landward slope and shoulder blocking view of levee section. RD 501 is in process of removing this issue. No new photo taken.

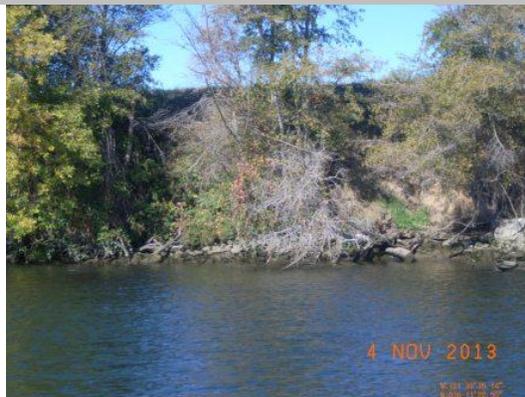
Photo 1 of 1 : FA\_2014\_RD0501\_169\_3\_20141008\_00001.jpg

LM Start	<b>5.75</b>	Rating **	M	Issue No.	<b>3</b>
LM End	<b>5.75</b>	Issue Type +	Ma	Location *	WS
Category	Supplemental		GPS Latitude/Longitude		
			Start	End	
Item	USACE Erosion Survey		38.189311 °	38.190001 °	
			-121.643917 °	-121.643160 °	
DWR ID	DWR_RD0501_01_f_2014_3				
Action/Comments					
Inspector Comments: 2008 - Overstepped levee section with multiple small pockets of erosion 10 - 20 ft wide. 2013: Site has fresh erosion and taller vertical sections. [2013 Site ID: STM_15-7_R]

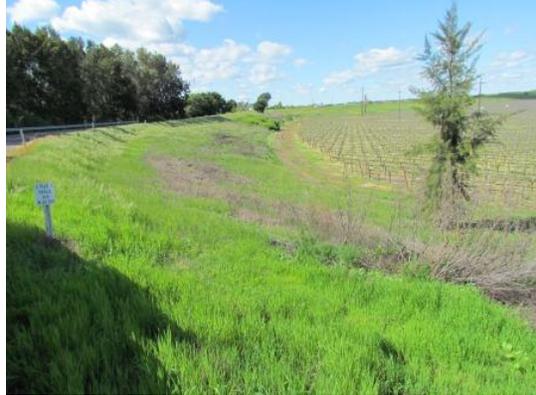
Photo 1 of 1 : FA\_2014\_RD0501\_170\_21\_20141008\_00002.jpg

LM Start	<b>0.00</b>	Rating **	M	Issue No.	<b>21</b>
LM End	<b>0.00</b>	Issue Type +	Ma	Location *	LS
Category	Earthen Levee		GPS Latitude/Longitude		
			Start	End	
Item	Vegetation		38.188260 °	38.188260 °	
			-121.648701 °	-121.648700 °	
DWR ID	DWR_RD0501_02_s_2012_21				
Action/Comments					
Remove the wild growth other than native grasses from the levee slopes.

Looking downstream from levee mile 0.00 along the landside slope.

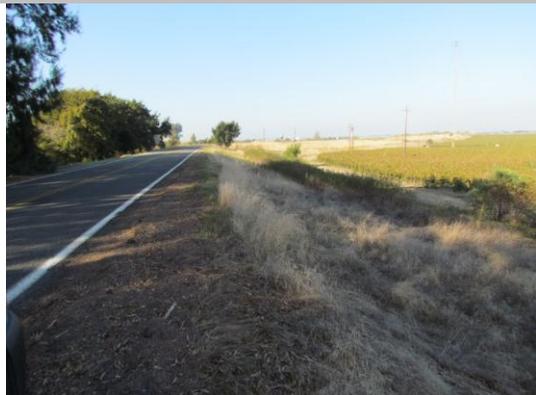
Photo 1 of 1 : FA\_2014\_RD0501\_170\_46\_20141126\_00034.jpg

LM Start	<b>0.20</b>	Rating **	M	Issue No.	<b>46</b>
LM End	<b>3.57</b>	Issue Type +	Ma	Location *	LS
Category	Earthen Levee		GPS Latitude/Longitude		
			Start	End	
Item	Vegetation		38.186738 °	38.227815 °	
			-121.658798 °	-121.673129 °	
DWR ID	DWR_RD0501_02_f_2014_46				
Action/Comments					
Control annual grass and weeds on the levee slopes and easements.

Looking downstream from levee mile 0.20 landside slope at tall weeds present on levee slope.

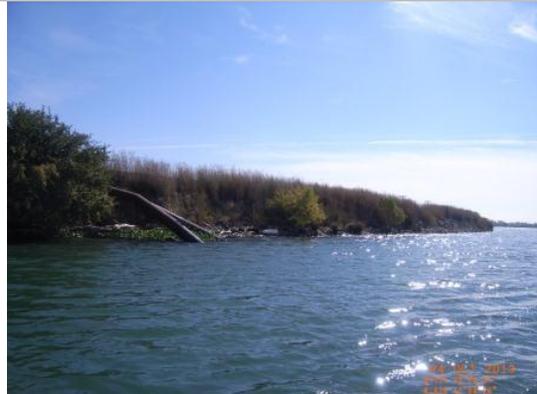
Photo 1 of 1 : FA\_2014\_RD0501\_170\_5\_20141008\_00001.jpg

LM Start	<b>1.13</b>	Rating **	M	Issue No.	<b>5</b>
LM End	<b>1.13</b>	Issue Type +	Ma	Location *	WS
Category	Supplemental		GPS Latitude/Longitude		
			Start	End	
Item	USACE Erosion Survey		38.199128 °	38.200146 °	
			-121.655881 °	-121.655638 °	
DWR ID	DWR_RD0501_02_f_2014_5				
Action/Comments					
Inspector Comments: 2005 - Large vertical sections due to wave wash. New stone dumped on the bank with exposed geotextile. Cohesive toe has thin weak stratigraphic unit that is washing out. 2006 - Partially repaired, but 100 ft in the middle of the reach has exposed filter fabric and stone riprap is gone. 2010 - Site extended downstream to include new erosion pocket. 2013: No observed changes. [2013 Site ID: CHS_15-9_L]

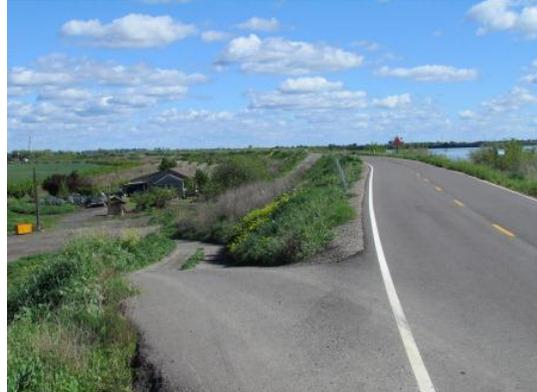
Photo 1 of 1 : FA\_2014\_RD0501\_170\_76\_20141008\_00003.jpg

LM Start	<b>1.67</b>	Rating **	U	Issue No.	<b>76</b>
LM End	<b>2.43</b>	Issue Type +	Ma	Location *	N/A
Category	Earthen Levee		GPS Latitude/Longitude		
			Start	End	
Item	Vegetation		38.209213 °	38.213214 °	
			-121.656992 °	-121.664813 °	
DWR ID	DWR_RD0501_02_f_2013_76				
Action/Comments					
Remove the wild growth other than native grasses from the levee slopes. Inspector Comments: No new photo, no change.

Tall weeds on landside slope and toe of levee section looking back upstream from levee mile 2.43 to 1.67. No new picture; no change.

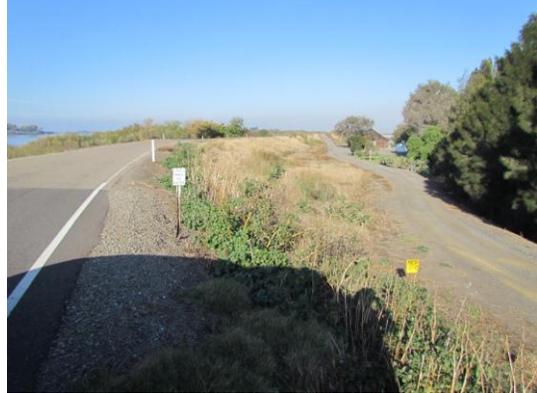
Photo 1 of 1 : FA\_2014\_RD0501\_171\_1\_20141126\_00070.jpg

LM Start	<b>0.00</b>	Rating **	<b>U</b>	Issue No.	<b>1</b>
LM End	<b>0.93</b>	Issue Type +	<b>Ma</b>	Location *	<b>LS</b>
Category	Earthen Levee		GPS Latitude/Longitude		
			Start	End	
Item	Vegetation		38.227815 °	38.238702 °	
			-121.673129 °	-121.664900 °	
DWR ID	DWR_RD0501_03_s_2012_1				
Action/Comments					
Remove the wild growth other than native grasses from the levee slopes. Inspector Comments: Remove the unwanted tall weeds from the landside slope.

Looking downstream from levee mile 0.00 Unit 3 RD 501 Unsatisfactory tall weeds on landside slope.

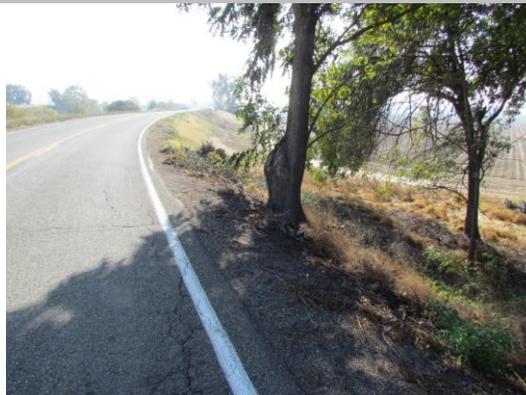
Photo 1 of 1 : FA\_2014\_RD0501\_172\_5\_20141126\_00046.jpg

LM Start	<b>0.00</b>	Rating **	A	Issue No.	<b>5</b>
LM End	<b>2.32</b>	Issue Type +	Ma	Location *	LS
Category	Earthen Levee		GPS Latitude/Longitude		
			Start	End	
Item	Vegetation		38.285591 °	38.254319 °	
			-121.606317 °	-121.601491 °	
DWR ID	DWR_RD0501_04_s_2012_5				
Action/Comments					
Remove the wild growth other than native grasses from the levee slopes. Inspector Comments: RD 501 Has done a great job of removing the wild grasses from the landward slope.

Unit 4 looking downstream from levee mile 0.00.

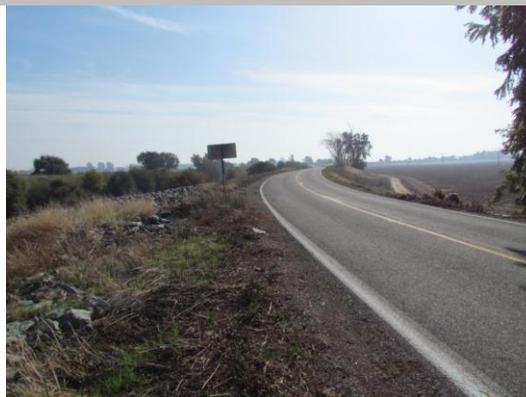
Photo 1 of 1 : FA\_2014\_RD0501\_172\_53\_20141126\_00047.jpg

LM Start	<b>0.01</b>	Rating **	A	Issue No.	<b>53</b>
LM End	<b>2.32</b>	Issue Type +	Ma	Location *	WS
Category	Earthen Levee		GPS Latitude/Longitude		
			Start	End	
Item	Vegetation		38.285440 °	38.254038 °	
			-121.606132 °	-121.601870 °	
DWR ID	DWR_RD0501_04_f_2014_53				
Action/Comments					
Control annual grass and weeds on the levee slopes and easements. Inspector Comments: RD 501 has done a good job of controlling wild grasses on the waterside slope.

Looking downstream from levee mile 0.00 waterside slope.

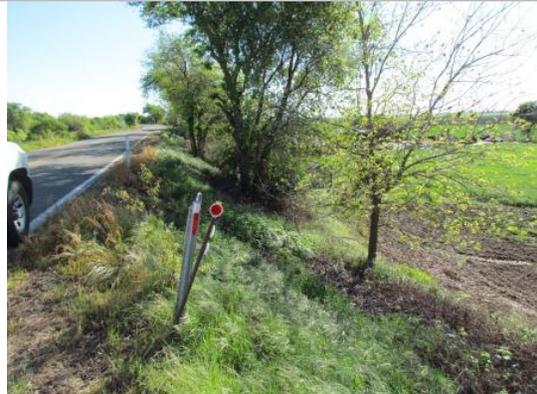
Photo 1 of 1 : FA\_2014\_RD0501\_172\_65\_20141008\_00003.jpg

Wild growth on the landside slope and toe.

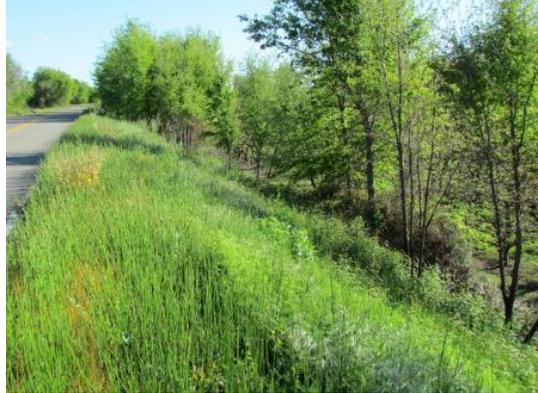
Photo 1 of 1 : FA\_2014\_RD0501\_172\_14\_20141008\_00002.jpg

Wild growth on landward slope and toe.
