**Flood Control Project Maintenance
Levee Inspections**
LMA District Cover Sheet
Spring 2015 Levee Inspection Results

Reclamation District No. 0501 Ryer Island

Spring 2015 Levee Inspection Results

Waterway		Bank	Unit Miles
Unit No. 01 Steamboat Slough		Right	6.71

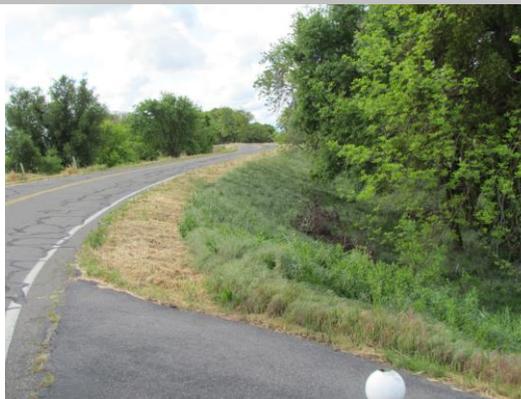
Photo 1 of 1 : SP_2015_RD0501_169_123_20150420_00099.jpg

LM Start	0.26	Rating **	M	Issue No.	123
LM End	1.11	Issue Type +	Ma	Location *	LS
Category	Earthen Levee		GPS Latitude/Longitude		
			Start	End	
Item	Vegetation		38.250999 °	38.238869 °	
			-121.603126 °	-121.604356 °	
DWR ID	DWR_RD0501_01_f_2013_123				
Action/Comments					
Remove the wild growth other than native grasses from the levee slopes.

Looking downstream from landside slope.

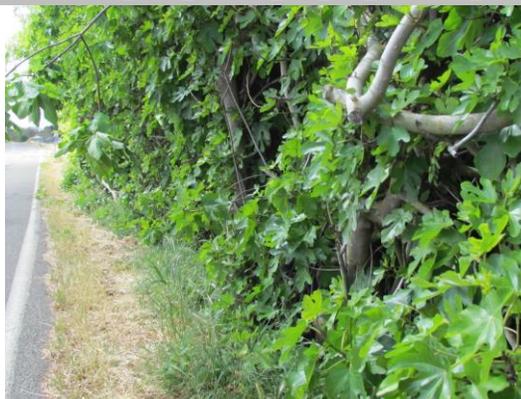
Photo 1 of 1 : SP_2015_RD0501_169_413_20150413_00092.jpg

LM Start	0.27	Rating **	U	Issue No.	413
LM End	0.33	Issue Type +	Ma	Location *	LS
Category	Earthen Levee		GPS Latitude/Longitude		
			Start	End	
Item	Trim / Thin Trees		38.250940 °	38.250047 °	
			-121.603070 °	-121.603137 °	
DWR ID	DWR_RD0501_01_s_2015_413				
Action/Comments					
Trim and thin trees to allow visibility of the ground and room to flood fight. Inspector Comments: The district needs to remove the fig trees from the landside levee shoulder and slope.

Unacceptable woody tree growth on landside levee shoulder and slope.

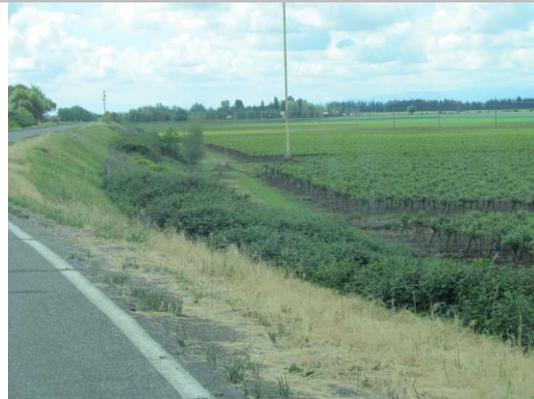
Photo 1 of 1 : SP_2015_RD0501_169_417_20150413_00094.jpg

LM Start	1.55	Rating **	U	Issue No.	417
LM End	1.87	Issue Type +	Ma	Location *	LS
Category	Earthen Levee			GPS Latitude/Longitude	
				Start	End
Item	Vegetation			38.232562 °	38.228025 °
				-121.603473 °	-121.604148 °
DWR ID	DWR_RD0501_01_s_2015_417				
Action/Comments					
Remove the wild growth other than native grasses from the levee slopes. Inspector Comments: District 501 is aware of the wild growth of berries and are scheduling to have them removed.

Unacceptable growth of wild berries on the land side slope and toe.

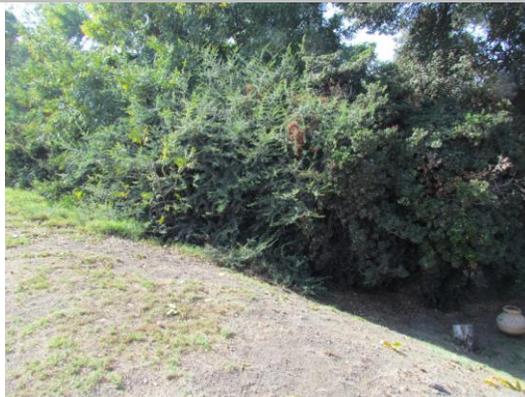
Photo 1 of 1 : SP_2015_RD0501_169_116_20150312_00007.jpg

LM Start	2.31	Rating **	U	Issue No.	116
LM End	2.31	Issue Type +	Ma	Location *	LS
Category	Earthen Levee			GPS Latitude/Longitude	
				Start	End
Item	Trim / Thin Trees			38.221620 °	38.221620 °
				-121.603390 °	-121.603393 °
DWR ID	DWR_RD0501_01_f_2014_116				
Action/Comments					
Trim trees to at least five feet above ground level. Inspector Comments: Trim the trees to allow slope to be seen.

Looking downstream at the woody tree growth on the landward levee slope.

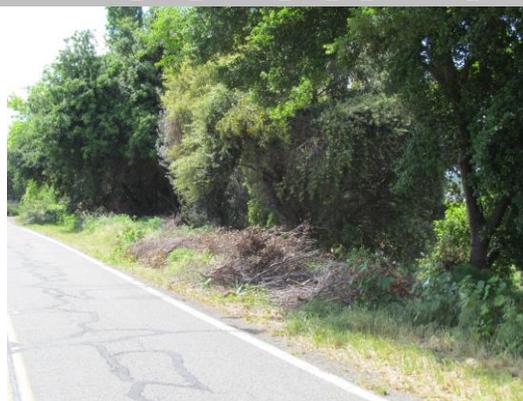
Photo 1 of 1 : SP_2015_RD0501_169_31_20150413_00096.jpg

LM Start	2.38	Rating **	M	Issue No.	31
LM End	3.74	Issue Type +	Ma	Location *	LS
Category	Earthen Levee			GPS Latitude/Longitude	
				Start	End
Item	Vegetation			38.220732 °	38.202810 °
				-121.603734 °	-121.613523 °
DWR ID	DWR_RD0501_01_s_2012_31				
Action/Comments					
Remove the wild growth other than native grasses from the levee slopes. Inspector Comments: Remove the wild growth so the levee slope can be seen and inspected.

Wild growth on levee section.

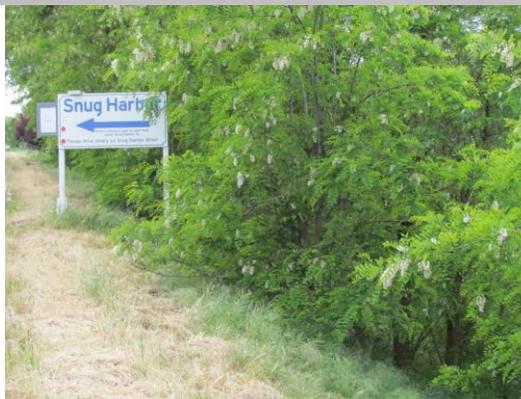
Photo 1 of 1 : SP_2015_RD0501_169_36_20150413_00097.jpg

LM Start	2.84	Rating **	M	Issue No.	36
LM End	3.30	Issue Type +	Ma	Location *	LS
Category	Earthen Levee			GPS Latitude/Longitude	
				Start	End
Item	Vegetation			38.215112 °	38.208925 °
				-121.608273 °	-121.611162 °
DWR ID	DWR_RD0501_01_s_ 2012_36				
Action/Comments					
Remove the wild growth other than native grasses from the levee slopes. Inspector Comments: Remove and or thin so the slope can be inspected. Unable to see the ground under wild tree growth.

Wild growth of black locus trees on levee slope, thin out so levee slope can be seen.

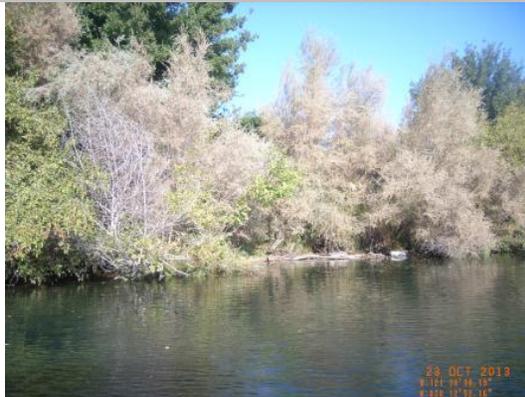
Photo 1 of 1 : SP_2015_RD0501_169_11_20150312_00003.jpg

LM Start	2.85	Rating **	M	Issue No.	11
LM End	2.91	Issue Type +	Ma	Location *	WS
Category	Supplemental			GPS Latitude/Longitude	
				Start	End
Item	USACE Erosion Survey			38.214838 °	38.214075 °
				-121.608129 °	-121.608750 °
DWR ID	DWR_RD0501_01_f_2014_11				
Action/Comments					
Inspector Comments: 2009 - Rock is starting to unravel, probably from a tree pop-out, hard toe. 2013: No observed changes. [2013 Site ID: STM_18-9_R]

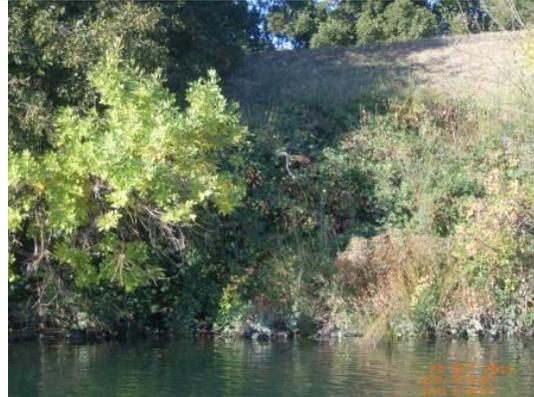
Photo 1 of 1 : SP_2015_RD0501_169_5_20150312_00002.jpg

LM Start	3.04	Rating **	M	Issue No.	5
LM End	3.10	Issue Type +	Ma	Location *	WS
Category	Supplemental			GPS Latitude/Longitude	
				Start	End
Item	USACE Erosion Survey			38.212573 °	38.211596 °
				-121.609760 °	-121.609928 °
DWR ID	DWR_RD0501_01_f_2014_5				
Action/Comments					
Inspector Comments: 2000 - Slow erosion of lower and mid-slope with rock bench at the low water line. 2013: No observed changes. [2013 Site ID: STM_18-8_R]

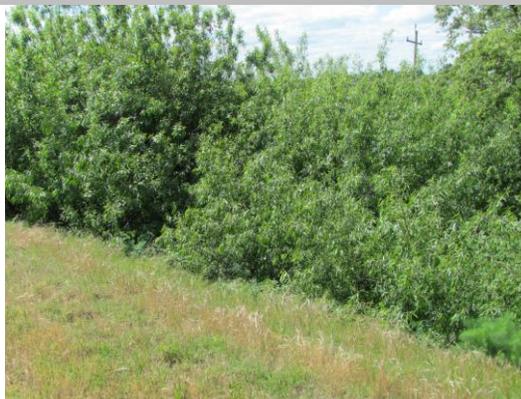
Photo 1 of 1 : SP_2015_RD0501_169_47_20150413_00095.jpg

LM Start	3.59	Rating **	M	Issue No.	47
LM End	3.64	Issue Type +	Ma	Location *	LS
Category	Earthen Levee			GPS Latitude/Longitude	
				Start	End
Item	Trim / Thin Trees			38.204983 °	38.204227 °
				-121.612868 °	-121.613045 °
DWR ID	DWR_RD0501_01_s_2012_47				
Action/Comments					
Trim and thin trees to allow visibility of the ground and room to flood fight. Inspector Comments: Not able to see levee slope.

Wild tree growth on landside slope and shoulder should be trimmed and thinned.

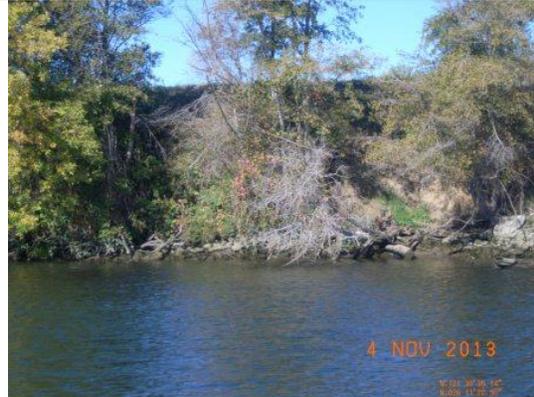
Photo 1 of 1 : SP_2015_RD0501_169_3_20150312_00001.jpg

LM Start	5.77	Rating **	M	Issue No.	3
LM End	5.84	Issue Type +	Ma	Location *	WS
Category	Supplemental			GPS Latitude/Longitude	
				Start	End
Item	USACE Erosion Survey			38.190001 °	38.189311 °
				-121.643160 °	-121.643917 °
DWR ID	DWR_RD0501_01_f_2014_3				
Action/Comments					
Inspector Comments: 2008 - Overstepped levee section with multiple small pockets of erosion 10 - 20 ft wide. 2013: Site has fresh erosion and taller vertical sections. [2013 Site ID: STM_15-7_R]

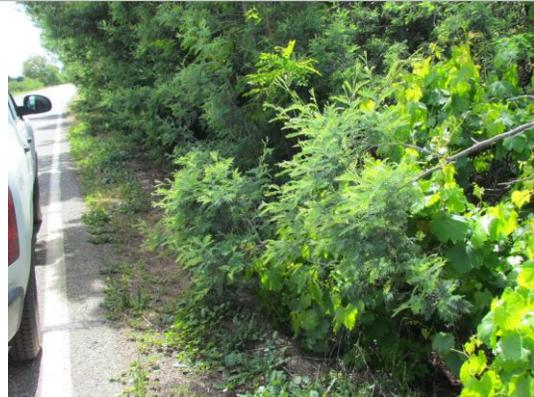
Photo 1 of 1 : SP_2015_RD0501_169_20_20150420_00101.jpg

LM Start	5.88	Rating **	M	Issue No.	20
LM End	6.17	Issue Type +	Ma	Location *	LS
Category	Earthen Levee			GPS Latitude/Longitude	
				Start	End
Item	Vegetation			38.188929 °	38.185941 °
				-121.644645 °	-121.648359 °
DWR ID	DWR_RD0501_01_s_2012_20				
Action/Comments					
Remove the wild growth other than native grasses from the levee slopes. Inspector Comments: Remove the wild growth from the levee section. Can't see the slope.

Looking downstream from landside slope unacceptable wild growth on the landward shoulder and slope.

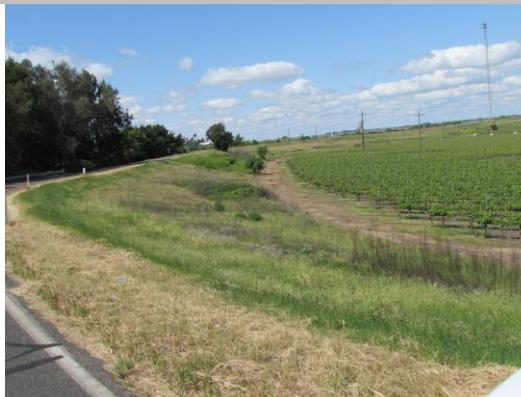
Photo 1 of 1 : SP_2015_RD0501_170_21_20150420_00035.jpg

LM Start	0.00	Rating **	M	Issue No.	21
LM End	0.00	Issue Type +	Ma	Location *	LS
Category	Earthen Levee		GPS Latitude/Longitude		
			Start	End	
Item	Vegetation		38.188260 °	38.188260 °	
			-121.648701 °	-121.648700 °	
DWR ID	DWR_RD0501_02_s_2012_21				
Action/Comments					
Remove the wild growth other than native grasses from the levee slopes.

Looking downstream along the landside levee slope.

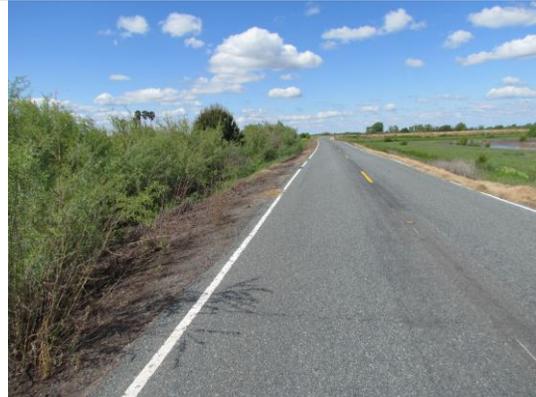
Photo 1 of 1 : SP_2015_RD0501_170_11_20150420_00037.jpg

LM Start	0.54	Rating **	M	Issue No.	11
LM End	0.54	Issue Type +	Ma	Location *	WS
Category	Earthen Levee		GPS Latitude/Longitude		
			Start	End	
Item	Trim / Thin Trees		38.191117 °	38.191170 °	
			-121.656468 °	-121.656437 °	
DWR ID	DWR_RD0501_02_s_2012_11				
Action/Comments					
Trim and thin trees to allow visibility of the ground and room to flood fight. Inspector Comments: Remove the young willow trees from the levee slope.

Wild growth on the waterside levee slope.

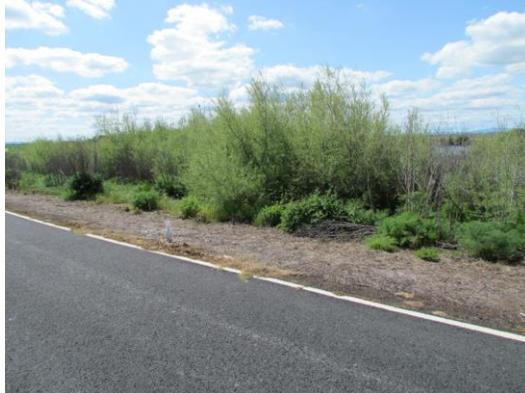
Photo 1 of 1 : SP_2015_RD0501_170_8_20150420_00038.jpg

LM Start	1.07	Rating **	M	Issue No.	8
LM End	1.11	Issue Type +	Ma	Location *	WS
Category	Earthen Levee		GPS Latitude/Longitude		
			Start	End	
Item	Vegetation		38.198602 °	38.199148 °	
			-121.655605 °	-121.655490 °	
DWR ID	DWR_RD0501_02_s_2012_8				
Action/Comments					
Remove the wild growth other than native grasses from the levee slopes. Inspector Comments: Remove the unacceptable growth from the waterside slope.

Unacceptable wild growth on the water side levee slope.

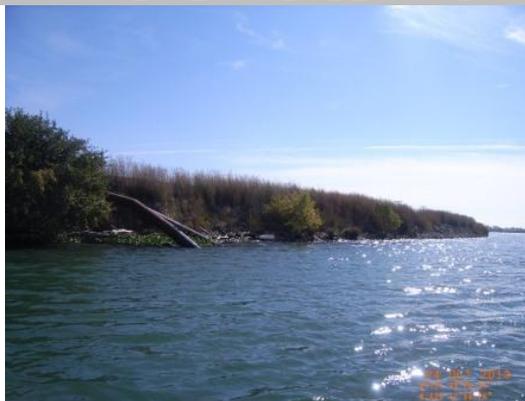
Photo 1 of 1 : SP_2015_RD0501_170_5_20150312_00001.jpg

LM Start	1.10	Rating **	M	Issue No.	5
LM End	1.17	Issue Type +	Ma	Location *	WS
Category	Supplemental		GPS Latitude/Longitude		
			Start	End	
Item	USACE Erosion Survey		38.199128 °	38.200146 °	
			-121.655881 °	-121.655638 °	
DWR ID	DWR_RD0501_02_f_2014_5				
Action/Comments					
Inspector Comments: 2005 - Large vertical sections due to wave wash. New stone dumped on the bank with exposed geotextile. Cohesive toe has thin weak stratigraphic unit that is washing out. 2006 - Partially repaired, but 100 ft in the middle of the reach has exposed filter fabric and stone riprap is gone. 2010 - Site extended downstream to include new erosion pocket. 2013: No observed changes. [2013 Site ID: CHS_15-9_L]

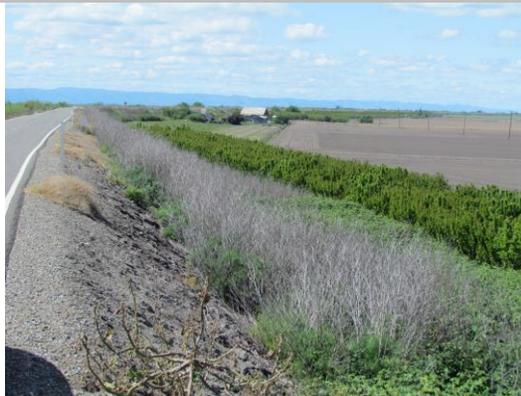
Photo 1 of 1 : SP_2015_RD0501_170_1_20150420_00039.jpg

LM Start	1.51	Rating **	M	Issue No.	1
LM End	2.68	Issue Type +	Ma	Location *	LS
Category	Earthen Levee			GPS Latitude/Longitude	
				Start	End
Item	Vegetation			38.204957 °	38.216130 °
				-121.655087 °	-121.667686 °
DWR ID	DWR_RD0501_02_f_2012_1				
Action/Comments					
Remove the wild growth other than native grasses from the levee slopes. Inspector Comments: Remove the tall weeds from the landward levee section.

Unacceptable tall weeds on the landward levee section.

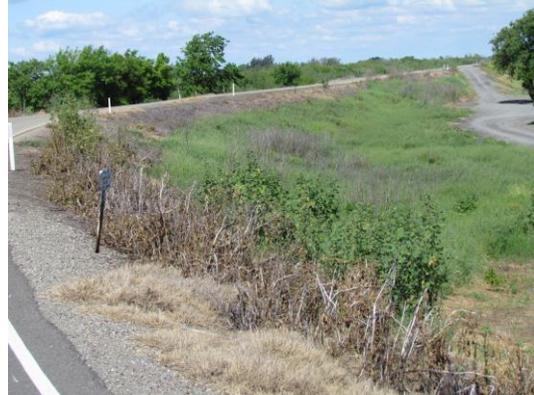
Photo 1 of 1 : SP_2015_RD0501_171_1_20150604_00069.jpg

LM Start	0.01	Rating **	U	Issue No.	1
LM End	0.90	Issue Type +	Ma	Location *	LS
Category	Earthen Levee			GPS Latitude/Longitude	
				Start	End
Item	Vegetation			38.227815 °	38.238702 °
				-121.673129 °	-121.664900 °
DWR ID	DWR_RD0501_03_s_2012_1				
Action/Comments					
Remove the wild growth other than native grasses from the levee slopes. Inspector Comments: Remove the unwanted tall weeds from the landside slope.

View looking downstream along the landside shoulder.

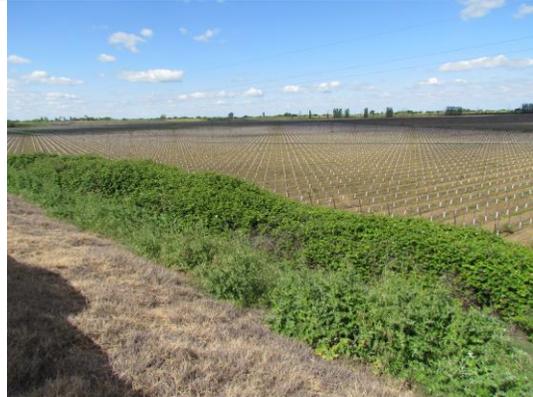
Photo 1 of 1 : SP_2015_RD0501_171_430_20150604_00070.jpg

LM Start	4.57	Rating **	U	Issue No.	430
LM End	5.00	Issue Type +	Ma	Location *	LS
Category	Earthen Levee			GPS Latitude/Longitude	
				Start	End
Item	Vegetation			38.279153 °	38.283603 °
				-121.638700 °	-121.643350 °
DWR ID	DWR_RD0501_03_s_2015_430				
Action/Comments					
Control annual grass and weeds on the levee slopes and easements. Inspector Comments: Remove the wild berries from the levee section.

Looking downstream at the landside the slope and toe covered with unacceptable wild growth.

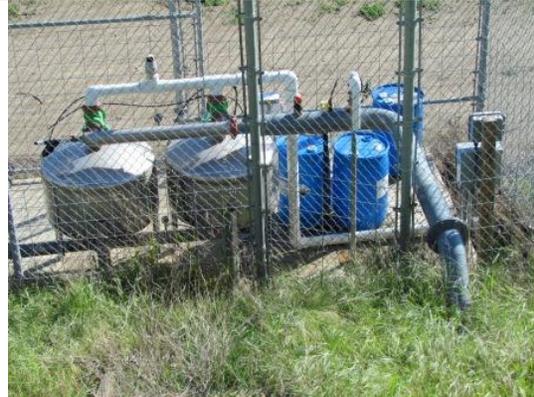
Photo 1 of 1 : SP_2015_RD0501_171_28_20150312_00002.jpg

LM Start	7.23	Rating **	U	Issue No.	28
LM End	7.23	Issue Type +	En	Location *	LS
Category	Earthen Levee		GPS Latitude/Longitude		
			Start	End	
Item	Encroachments		38.287750 °	38.287750 °	
			-121.613335 °	-121.613335 °	
DWR ID	DWR_RD0501_03_f_2012_28				
Action/Comments					
Pipe Inspector Comments: There is new pipe, sand filter, concrete pad, and fence within the 10 foot easement landside. There is a new pump and fence on the waterside toe of levee. At this site there is an open trench on the landward slope. Discovered 11-26-2012. District has not pursued this matter any further to date.

This filtration system sits within 10-foot of the landward toe, there is no CVFPB permit on file.

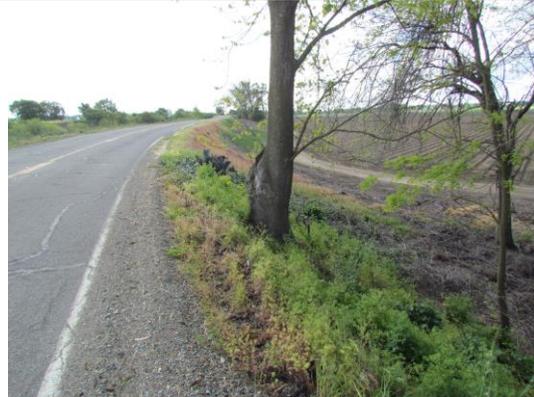
Photo 1 of 1 : SP_2015_RD0501_172_3_20150604_00045.jpg

LM Start	0.01	Rating **	M	Issue No.	3
LM End	0.04	Issue Type +	Ma	Location *	LS
Category	Earthen Levee		GPS Latitude/Longitude		
			Start	End	
Item	Vegetation		38.285529 °	38.285074 °	
			-121.606258 °	-121.605489 °	
DWR ID	DWR_RD0501_04_f_2012_3				
Action/Comments					
Remove the wild growth other than native grasses from the levee slopes. Inspector Comments: Control the vegetation on the landside slope.

View looking downstream from the landside shoulder.
