**Flood Control Project Maintenance
Levee Inspections**

Maintenance Issue Types Only, Levee Inspection Report By Mile - Fall 2015

Reclamation District No. 0501 Ryer Island

Waterway	Bank	Unit Miles	Inspection Start/End	Inspector
Unit No. 01 Steamboat Slough	Right	6.71	10/01/2015 10/01/2015	Herman Phillips

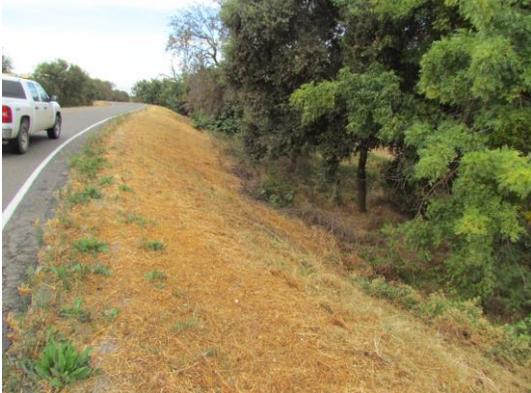
Photo 1 of 1 : FA_2015_RD0501_169_4_20151005_00012.jpg

LM Start	0.04	Rating **	A	Issue No.	4
LM End	0.07	Issue Type +	Ma	Location *	WS
Category	Earthen Levee		GPS Latitude/Longitude		
			Start	End	
Item	Vegetation		38.230288 °	-121.603781 °	
			38.253518 °	-121.602252 °	
DWR ID	DWR_RD0501_01_s_2012_4				
Action/Comments					
Remove the wild growth other than native grasses from the levee slopes.

RD 501 Unit 1 looking downstream from the landside levee slope.

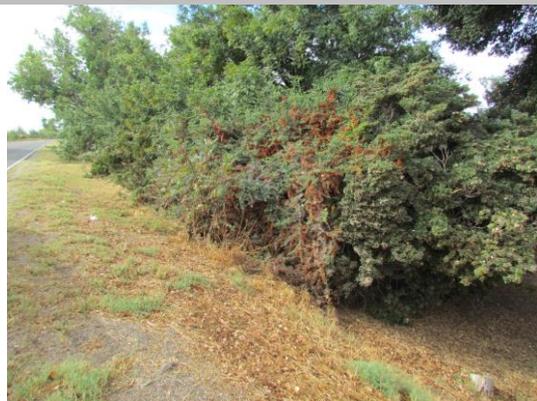
Photo 1 of 1 : FA_2015_RD0501_169_116_20151005_00014.jpg

LM Start	2.31	Rating **	U	Issue No.	116
LM End	2.31	Issue Type +	Ma	Location *	LS
Category	Earthen Levee		GPS Latitude/Longitude		
			Start	End	
Item	Trim / Thin Trees		38.221620 °	38.221620 °	
			-121.603390 °	-121.603393 °	
DWR ID	DWR_RD0501_01_f_2014_116				
Action/Comments					
Trim trees to at least five feet above ground level. Inspector Comments: Trim the trees to allow slope to be seen.

Looking downstream at the woody tree growth on the landward levee slope.

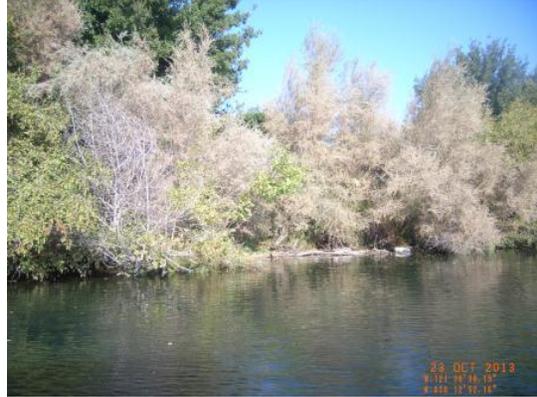
Photo 1 of 1 : USACE2013A_STM_18-9_R_3.jpg

LM Start	2.85	Rating **	M	Issue No.	3
LM End	2.91	Issue Type +	Ma	Location *	WS
Category	Supplemental			GPS Latitude/Longitude	
				Start	End
Item	2015 USACE Erosion Survey, DRAFT			38.214838 °	38.214075 °
				-121.608129 °	-121.608750 °
DWR ID					
Action/Comments					
Inspector Comments: 2009 - Rock is starting to unravel, probably from a tree pop-out, hard toe. 2015: No observed changes. [2015 Site ID: STM_18-9_R]

USACE 2013 Photo #1

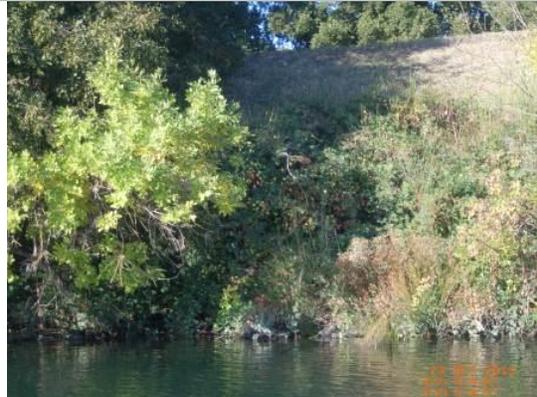
Photo 1 of 1 : USACE2013A_STM_18-8_R_5.jpg

LM Start	3.04	Rating **	M	Issue No.	2
LM End	3.11	Issue Type +	Ma	Location *	WS
Category	Supplemental			GPS Latitude/Longitude	
				Start	End
Item	2015 USACE Erosion Survey, DRAFT			38.212573 °	38.211596 °
				-121.609760 °	-121.609928 °
DWR ID					
Action/Comments					
Inspector Comments: 2000 - Slow erosion of lower and mid-slope with rock bench at the low water line. 2015: No observed changes. [2015 Site ID: STM_18-8_R]

USACE 2013 Photo #1

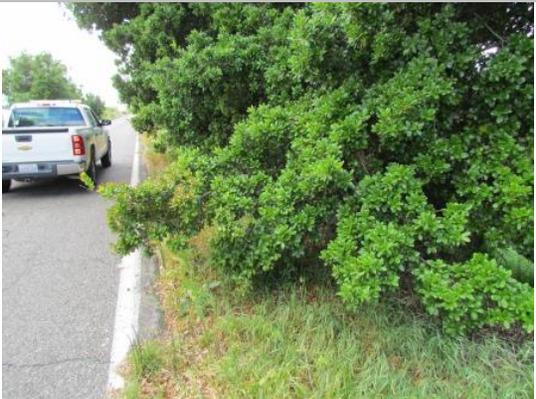
Photo 1 of 1 : FA_2015_RD0501_169_43_20150915_00004.jpg

LM Start	3.33	Rating **	M	Issue No.	43
LM End	3.35	Issue Type +	Ma	Location *	LS
Category	Earthen Levee		GPS Latitude/Longitude		
			Start	End	
Item	Trim / Thin Trees		38.208468 °	38.208292 °	
			-121.611348 °	-121.611437 °	
DWR ID	DWR_RD0501_01_s_2012_43				
Action/Comments					
Trim trees to at least five feet above ground level. Inspector Comments: Trim trees 5-feet above ground, can't see levee slope.

Woody tree growth on levee slope and shoulder of the landside. No new photo taken.

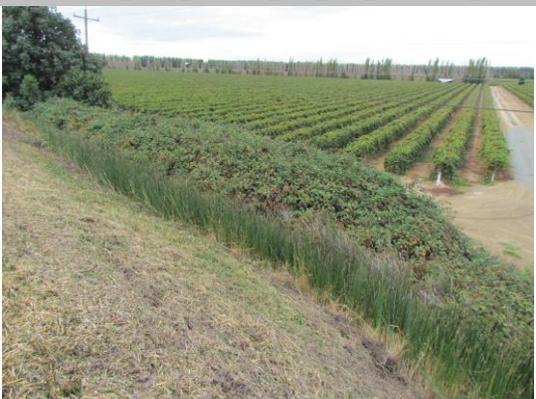
Photo 1 of 1 : FA_2015_RD0501_169_140_20151005_00016.jpg

LM Start	3.48	Rating **	M	Issue No.	140
LM End	3.58	Issue Type +	Ma	Location *	LS
Category	Earthen Levee		GPS Latitude/Longitude		
			Start	End	
Item	Vegetation		38.206494 °	38.205020 °	
			-121.612244 °	-121.612824 °	
DWR ID	DWR_RD0501_01_f_2013_140				
Action/Comments					
Remove the wild growth other than native grasses from the levee slopes. Inspector Comments: RD 501 was working in this area during inspection and plans to remove these berries.

Unsatisfactory wild growth of berries on the landward levee slope and toe.

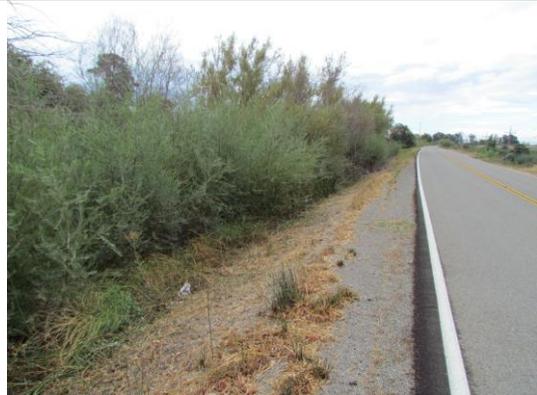
Photo 1 of 1 : FA_2015_RD0501_169_974_20151005_00017.jpg

LM Start	3.75	Rating **	U	Issue No.	974
LM End	4.12	Issue Type +	Ma	Location *	WS
Category	Earthen Levee		GPS Latitude/Longitude		
			Start	End	
Item	Vegetation		38.202657 °	38.197778 °	
			-121.613553 °	-121.616080 °	
DWR ID	DWR_RD0501_01_s_2012_974				
Action/Comments					
Remove the wild growth other than native grasses from the levee slopes. Inspector Comments: Remove the wild growth from the waterside slope.

Unsatisfactory wild tree growth on the waterside slope.

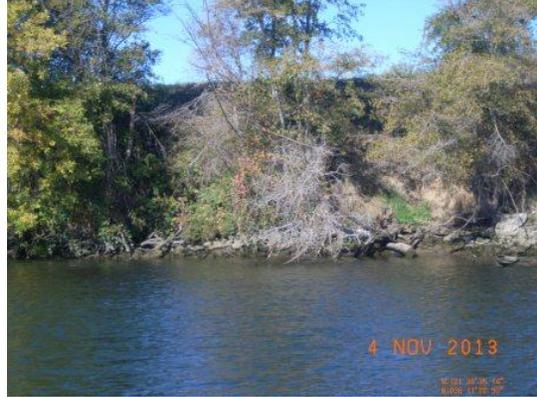
Photo 1 of 1 : USACE2013A_STM_15-7_R_5.jpg

LM Start	5.77	Rating **	M	Issue No.	1
LM End	5.84	Issue Type +	Ma	Location *	WS
Category	Supplemental			GPS Latitude/Longitude	
				Start	End
Item	2015 USACE Erosion Survey, DRAFT			38.190001 °	38.189311 °
				-121.643160 °	-121.643917 °
DWR ID					
Action/Comments					
Inspector Comments: 2008 - Overstepped levee section with multiple small pockets of erosion 10 - 20 ft wide. 2013 - Site has fresh erosion and taller vertical sections. 2015: No observed changes. [2015 Site ID: STM_15-7_R]

USACE 2013 Photo #1

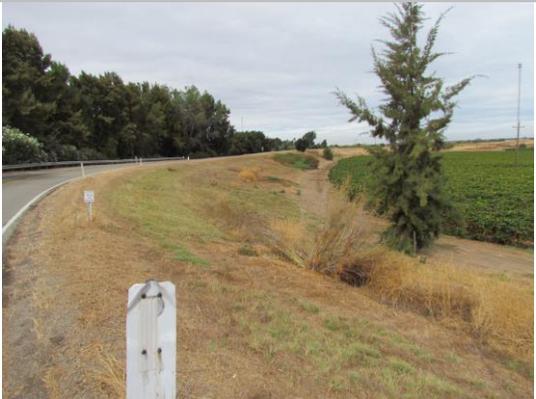
Photo 1 of 1 : FA_2015_RD0501_170_21_20151006_00006.jpg

LM Start	0.00	Rating **	M	Issue No.	21
LM End	0.00	Issue Type +	Ma	Location *	LS
Category	Earthen Levee		GPS Latitude/Longitude		
			Start	End	
Item	Vegetation		38.188260 °	38.188260 °	
			-121.648701 °	-121.648700 °	
DWR ID	DWR_RD0501_02_s_2012_21				
Action/Comments					
Remove the wild growth other than native grasses from the levee slopes. Inspector Comments: Mow the tall weeds at toe of levee slope.

Looking downstream from levee mile 0.00 at the landside slope. Few scattered tall weeds at the toe.

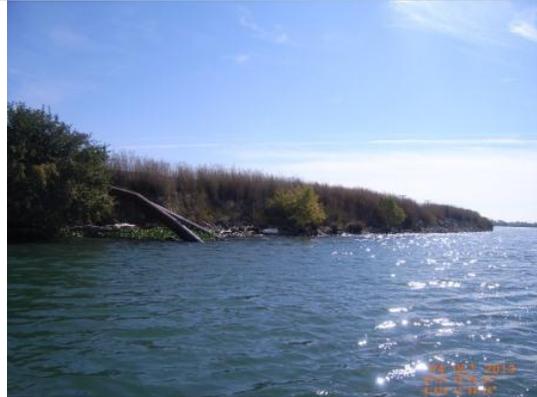
Photo 1 of 1 : USACE2013A_CHS_15-9_L_1.jpg

LM Start	1.10	Rating **	M	Issue No.	1
LM End	1.17	Issue Type +	Ma	Location *	WS
Category	Supplemental			GPS Latitude/Longitude	
				Start	End
Item	2015 USACE Erosion Survey, DRAFT			38.199128 °	38.200146 °
				-121.655881 °	-121.655638 °
DWR ID					
Action/Comments					
Inspector Comments: 2005 - Large vertical sections due to wave wash. New stone dumped on the bank with exposed geotextile. Cohesive toe has thin weak stratigraphic unit that is washing out. 2006 - Partially repaired, but 100 ft in the middle of the reach has exposed filter fabric and stone riprap is gone. 2010 - Site extended downstream to include new erosion pocket. 2015: No observed changes. [2015 Site ID: CHS_15-9_L]

USACE 2013 Photo #1
