**Flood Control Project Maintenance
Levee Inspections**

Fall 2008 Levee Maintenance Deficiency Summary Report

Reclamation District No. 0524

Waterway		Bank	Unit Miles
Unit No. 01 San Joaquin River		Left	6.30

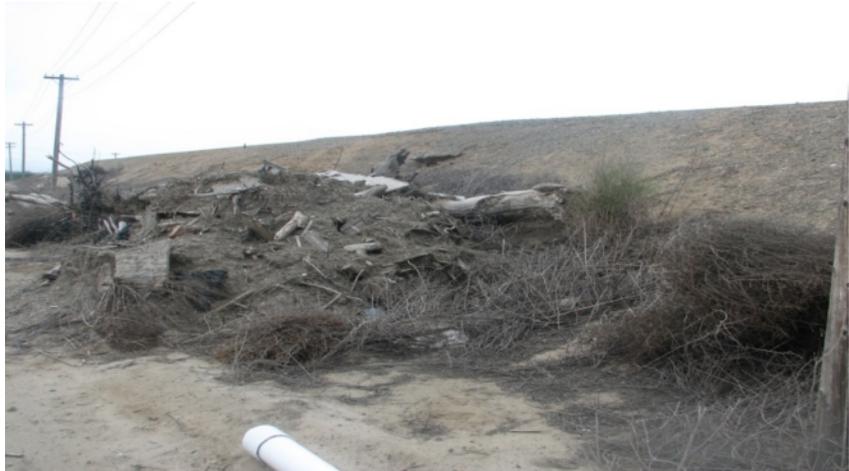
Levee Mile Report Line	2
Start Levee Mile	0.36
End Levee Mile	0.36
Location	
Category	Earthen Levee
Item	Encroachments
Garbage pile at landward toe at LM 0.36

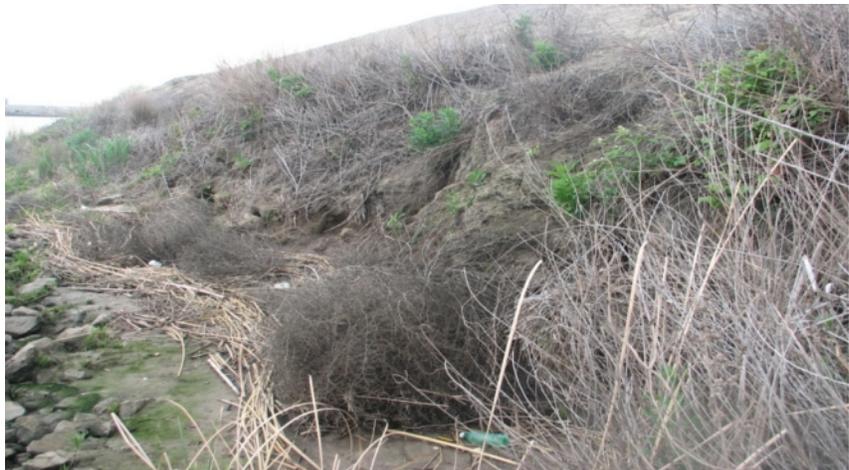
Levee Mile Report Line	3
Start Levee Mile	0.38
End Levee Mile	0.39
Location	
Category	Earthen Levee
Item	Erosion / Bank Caving
Minor erosion from LM 0.38 to 0.39

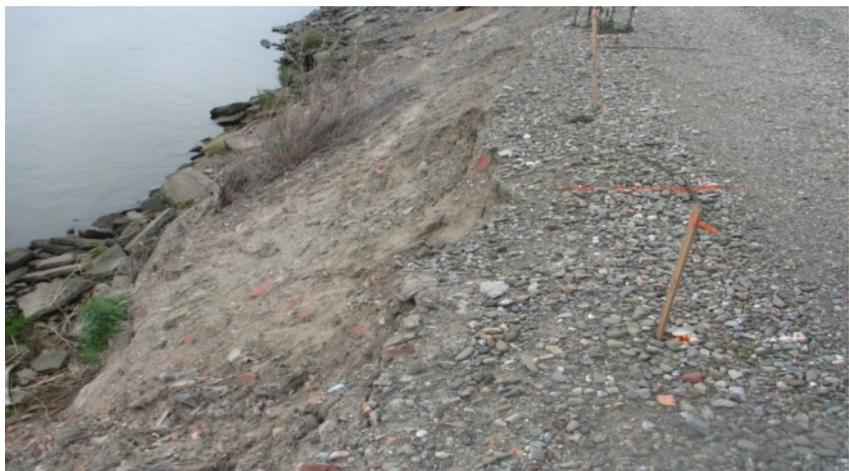
Levee Mile Report Line	5
Start Levee Mile	0.48
End Levee Mile	0.49
Location	
Category	Earthen Levee
Item	Erosion / Bank Caving
Major erosion from LM 0.48 to 0.49

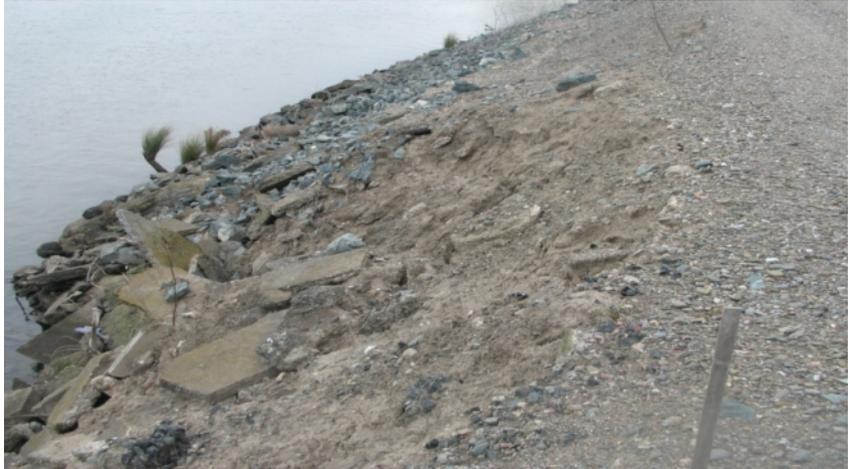
6	0.51	0.52	Earthen Levee	Erosion / Bank Caving	WS	M	Note and monitor erosion site.	37.938682 ° -121.338518 °	37.938657 ° -121.338425 °	Y	7
7	0.53	0.54	Earthen Levee	Erosion / Bank Caving	WS	M	Note and monitor erosion site.	37.938623 ° -121.338182 °	37.938617 ° -121.338045 °		8
8	0.58	0.59	Earthen Levee	Erosion / Bank Caving	WS	M	Note and monitor erosion site.	37.938512 ° -121.337335 °	37.938495 ° -121.337212 °		9
9	0.63	0.63	Earthen Levee	Slope Stability	WS	M	Repair the levee slope damaged by foot traffic and prevent access where possible.	37.938247 ° -121.336503 °	37.938247 ° -121.336503 °		10
10	0.63	0.64	Earthen Levee	Vegetation	WS	U	Remove the wild growth other than native grasses from the levee slopes.	37.938247 ° -121.336503 °	37.938197 ° -121.336405 °		11
11	0.64	0.64	Earthen Levee	Crown Surface / Depressions / Rutting	CR	U	Regrade the crown roadway for proper drainage.	37.938198 ° -121.336407 °	37.938198 ° -121.336407 °	Y	12

Levee Mile Report Line	6
Start Levee Mile	0.51
End Levee Mile	0.52
Location	
Category	Earthen Levee
Item	Erosion / Bank Caving
Erosion from LM 0.51 to 0.52

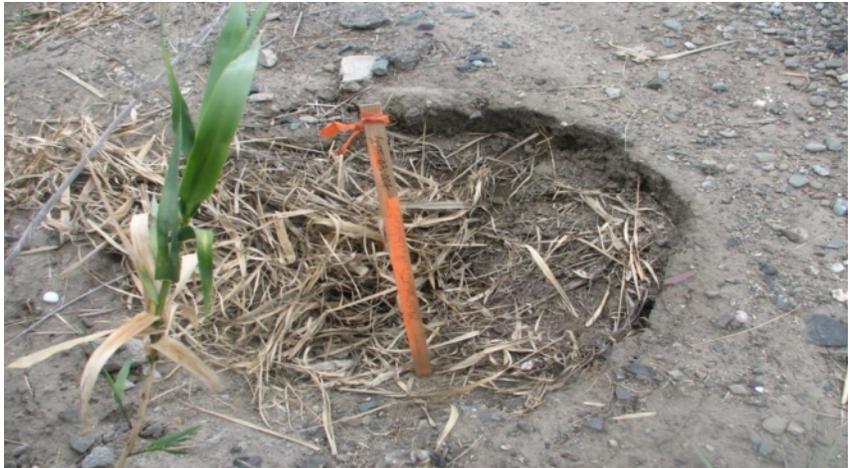
Levee Mile Report Line	11
Start Levee Mile	0.64
End Levee Mile	0.64
Location	
Category	Earthen Levee
Item	Crown Surface / Depressions / Rutting
Large hole 3 x 3 on levee crown near waterside shoulder at LM 0.64

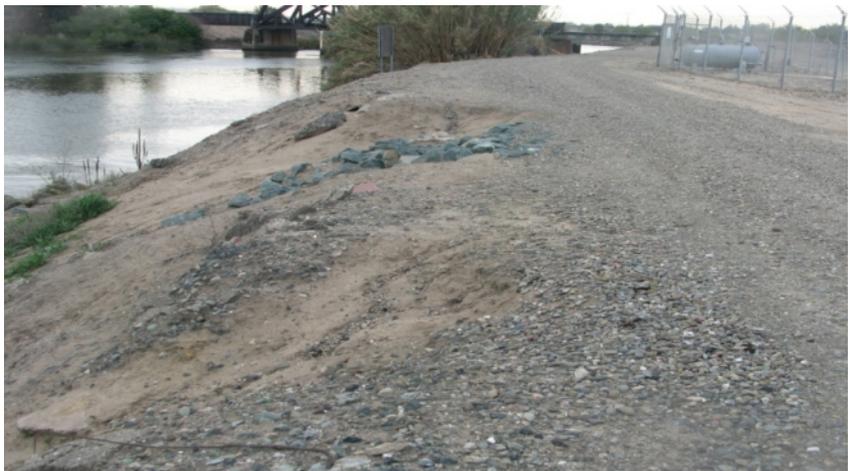
12	0.65	0.66	Earthen Levee	Slope Stability	WS	M	Repair slope instability.	37.938105 ° -121.336288 °	37.938023 ° -121.336173 °	Y	13
13	0.68	0.68	Earthen Levee	Vegetation	WS	U	Remove the wild growth other than native grasses from the levee slopes.	37.937808 ° -121.335913 °	37.937808 ° -121.335913 °	Y	14
14	0.79	0.79	Earthen Levee	Trim / Thin Trees	LS	M	Trim trees to at least five feet above ground level.	37.936444 ° -121.334797 °	37.936444 ° -121.334797 °		76
15	0.79	0.79	Boat Survey	Boat Survey Erosion	LS	M	Inspector Comments: Another site near Site 9.5 about 50 ft. upstream of fence; exposed pipe	37.936540 ° -121.334810 °	° °		913
16	0.81	0.81	Earthen Levee	Erosion / Bank Caving	WS	M	Note and monitor erosion site.	37.936217 ° -121.334698 °	37.936217 ° -121.334698 °		16
17	0.94	1.02	Earthen Levee	Trim / Thin Trees	LS	M	Trim trees to at least five feet above ground level.	37.935259 ° -121.332864 °	37.935049 ° -121.331334 °		77

Levee Mile Report Line	12
Start Levee Mile	0.65
End Levee Mile	0.66
Location	
Category	Earthen Levee
Item	Slope Stability
Erosion from LM 0.65 to 0.66

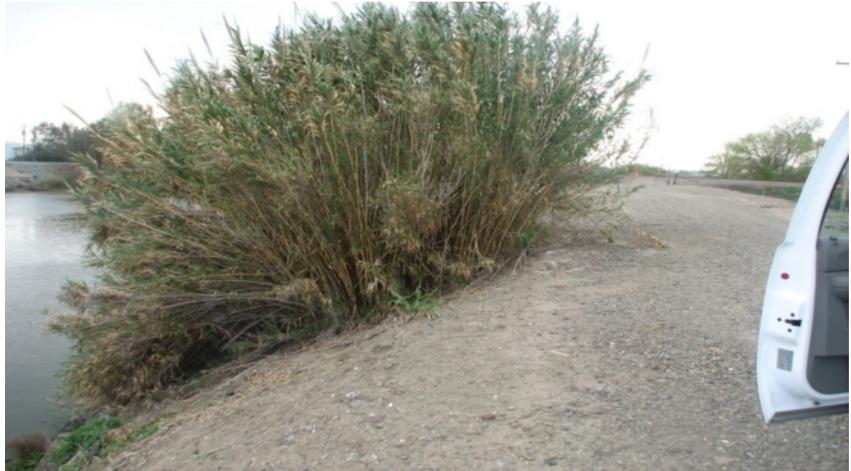
Levee Mile Report Line	13
Start Levee Mile	0.68
End Levee Mile	0.68
Location	
Category	Earthen Levee
Item	Vegetation
Bamboo on waterward slope at LM 0.68

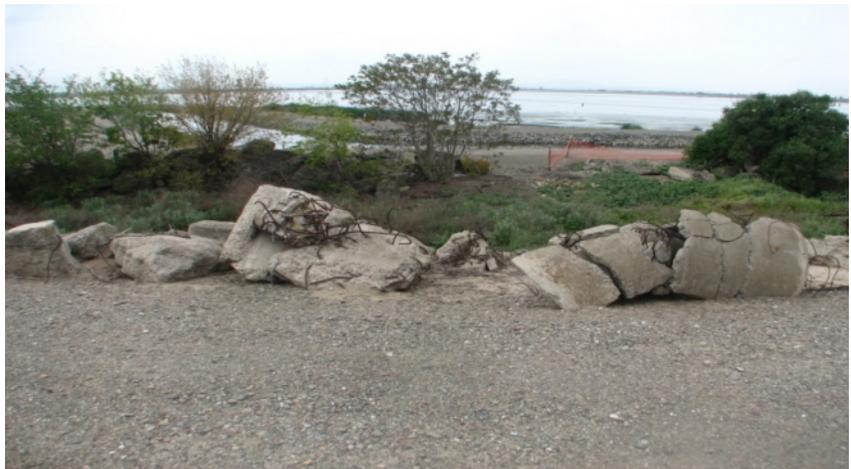
Levee Mile Report Line	21
Start Levee Mile	1.25
End Levee Mile	1.25
Location	
Category	Earthen Levee
Item	Encroachments
Concrete rubble with rebar on landward shoulder at LM 1.25

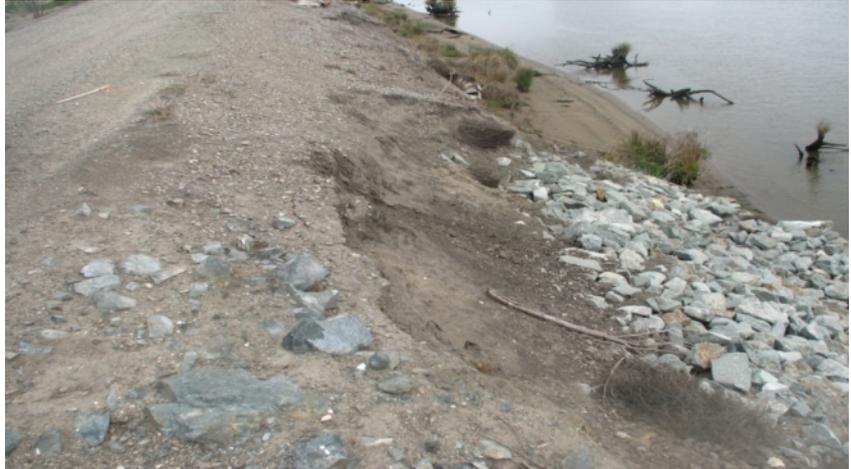
Levee Mile Report Line	22
Start Levee Mile	1.32
End Levee Mile	1.33
Location	
Category	Earthen Levee
Item	Erosion / Bank Caving
Erosion from LM 1.32 to 1.33

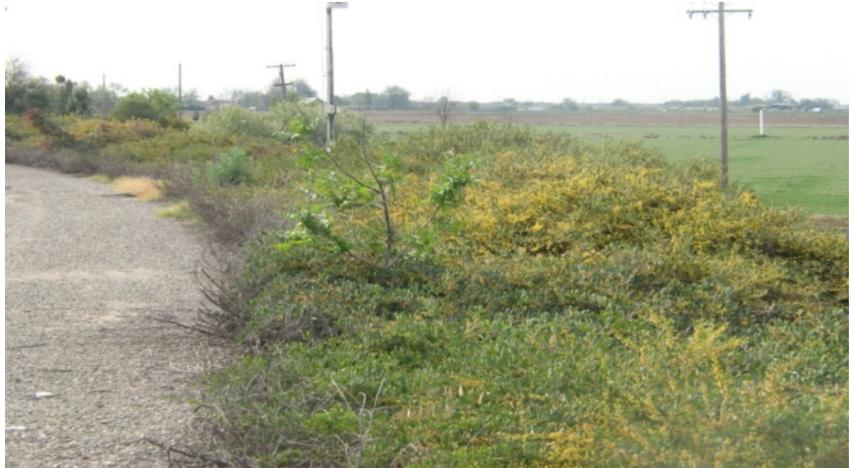
Levee Mile Report Line	24
Start Levee Mile	1.56
End Levee Mile	1.74
Location	
Category	Earthen Levee
Item	Encroachments
Overgrown landscaping on landward slope from LM 1.56 to 1.74

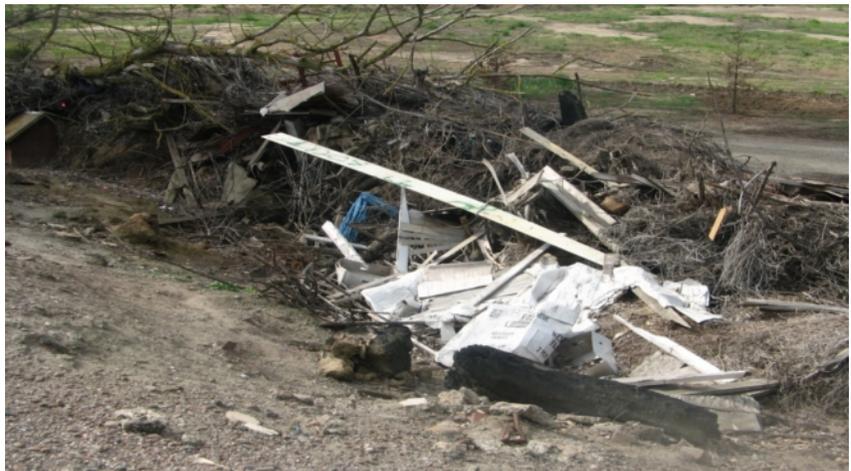
Levee Mile Report Line	29
Start Levee Mile	1.75
End Levee Mile	1.76
Location	
Category	Earthen Levee
Item	Encroachments
Garbage on landward toe from LM 1.75 to 1.76

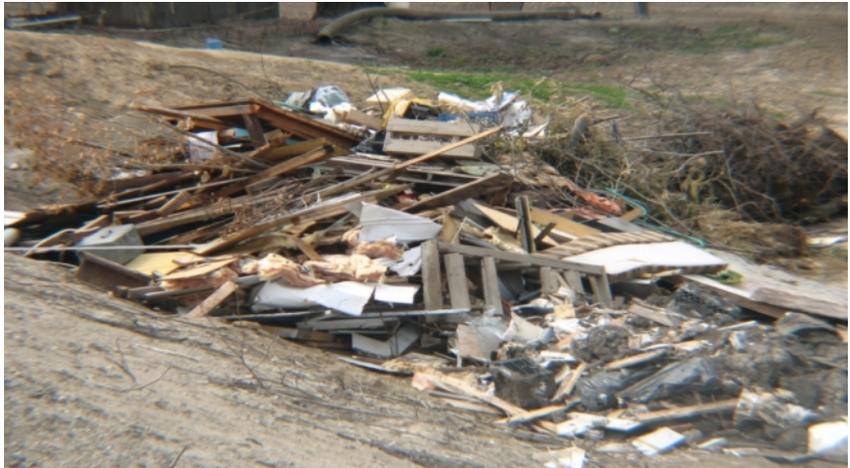
Levee Mile Report Line	70
Start Levee Mile	4.05
End Levee Mile	4.05
Location	
Category	Earthen Levee
Item	Encroachments
Garbage at landward toe at LM 4.05

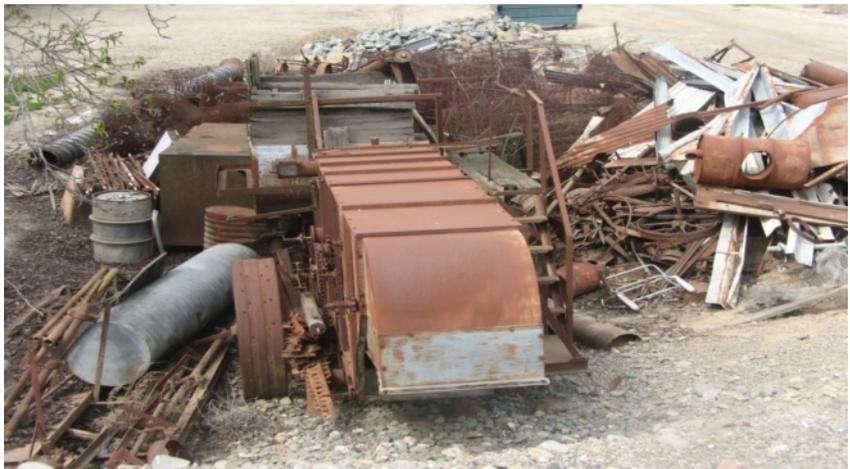
Levee Mile Report Line	73
Start Levee Mile	4.64
End Levee Mile	4.64
Location	
Category	Earthen Levee
Item	Encroachments
Garbage at landward toe next to ramp at LM 4.64

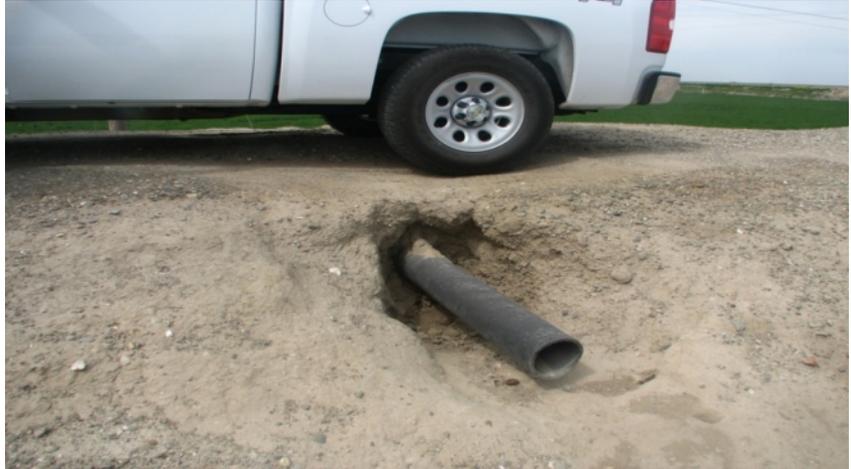
Levee Mile Report Line	82
Start Levee Mile	5.87
End Levee Mile	5.87
Location	
Category	Earthen Levee
Item	Encroachments
Abandoned pipe at LM 5.87 wateside view

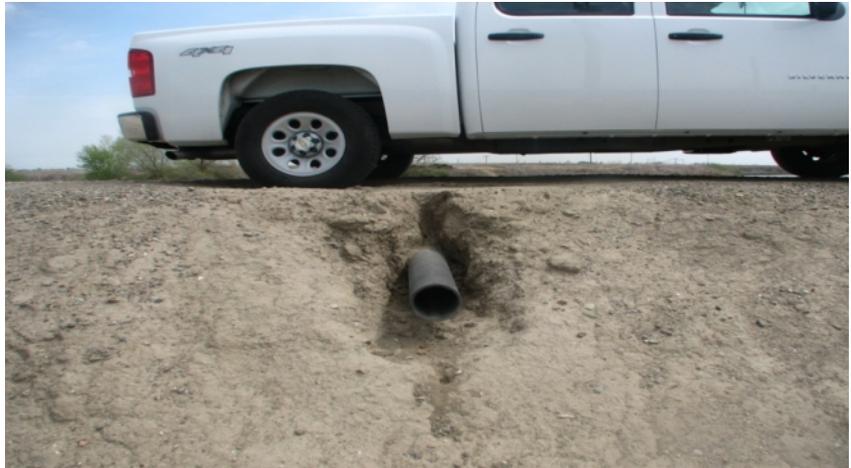
Levee Mile Report Line	82
Start Levee Mile	5.87
End Levee Mile	5.87
Location	
Category	Earthen Levee
Item	Encroachments
Abandoned pipe at LM 5.87 landside view

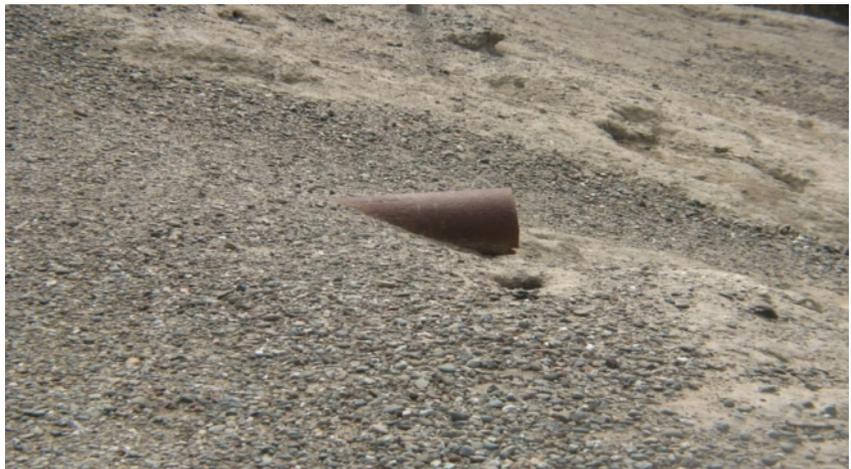
Levee Mile Report Line	83
Start Levee Mile	5.92
End Levee Mile	5.92
Location	
Category	Earthen Levee
Item	Encroachments
Abandoned pipe at LM 5.92 wateside view

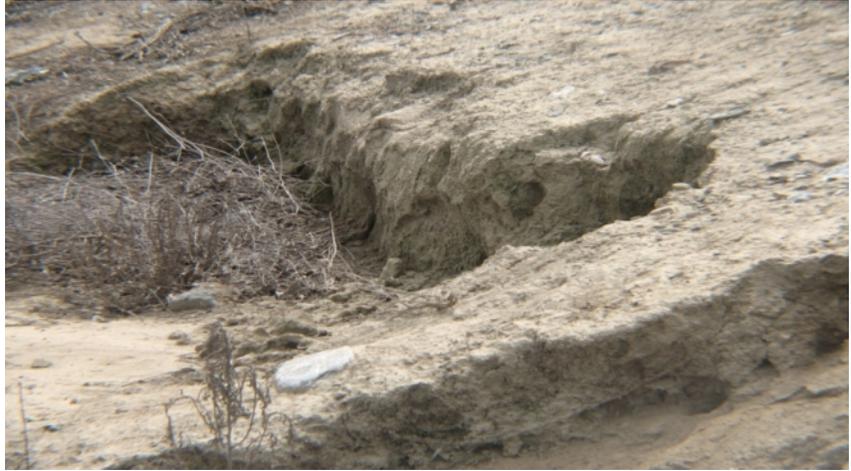
Levee Mile Report Line	84
Start Levee Mile	5.92
End Levee Mile	5.92
Location	
Category	Earthen Levee
Item	Erosion / Bank Caving
Erosion at waterward toe at LM 5.92
