**Flood Control Project Maintenance  
Levee Inspections**

**Fall 2010 Levee Maintenance Deficiency Summary Report**

**Reclamation District No. 0524 Middle Roberts Island**

Waterway		Bank	Unit Miles
Unit No. 01 San Joaquin River		Left	6.26

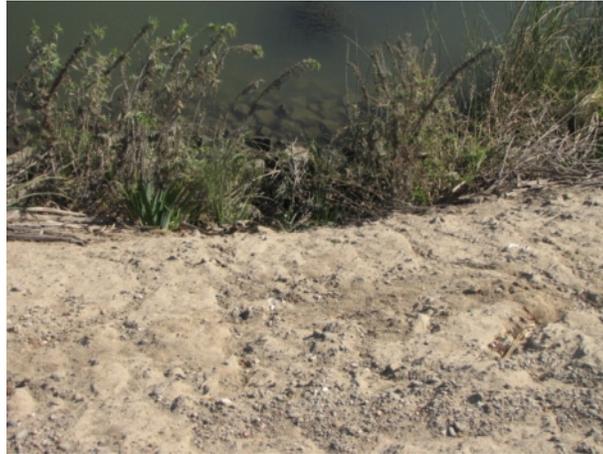
Levee Mile Report Line	1
Start Levee Mile	0.20
End Levee Mile	0.20
Location	Water Side
Category	Earthen Levee
Item	Erosion / Bank Caving
Looking northeast from crown	
richard_f_20101001_315.jpg

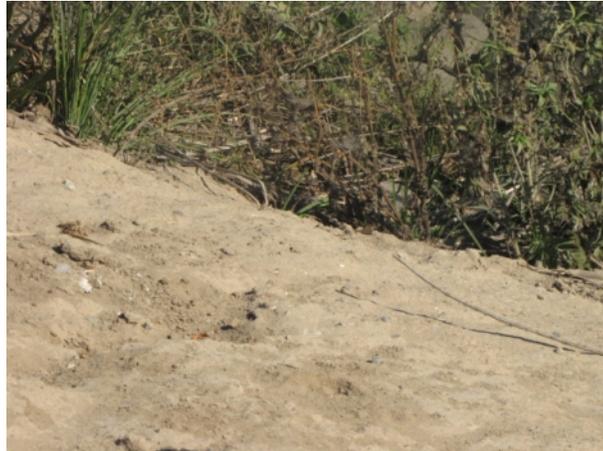
Levee Mile Report Line	3
Start Levee Mile	0.36
End Levee Mile	0.36
Location	Land Side
Category	Earthen Levee
Item	Encroachments
Garbage pile at landward toe at LM 0.36	
richard_f_20100921_108.jpg

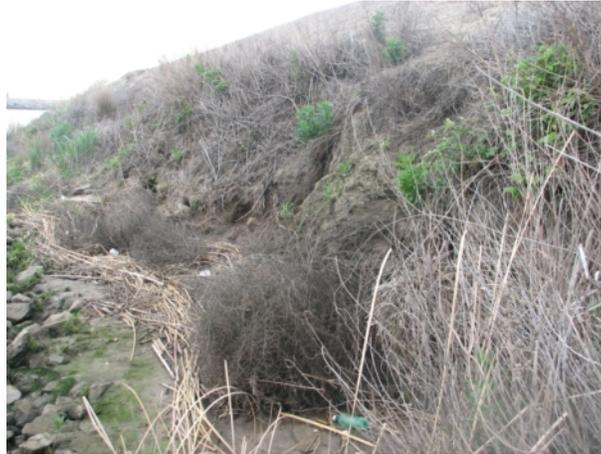
Levee Mile Report Line	6
Start Levee Mile	0.48
End Levee Mile	0.49
Location	Water Side
Category	Earthen Levee
Item	Erosion / Bank Caving
Major erosion from LM 0.48 to 0.49	
richard_f_20100921_092.jpg

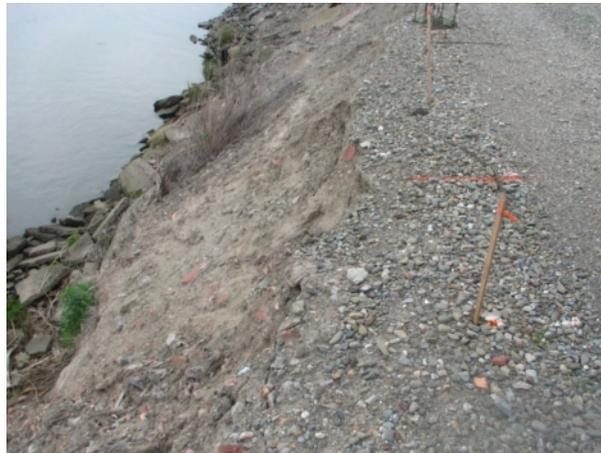
Levee Mile Report Line	6
Start Levee Mile	0.48
End Levee Mile	0.49
Location	Water Side
Category	Earthen Levee
Item	Erosion / Bank Caving
Update of erosion site at LM 0.48 to 0.49	
richard_f_20100921_093.jpg

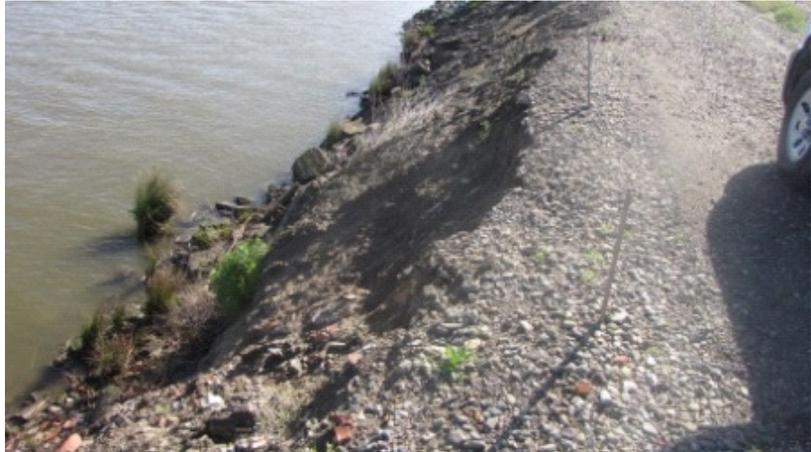
Levee Mile Report Line	6
Start Levee Mile	0.48
End Levee Mile	0.49
Location	Water Side
Category	Earthen Levee
Item	Erosion / Bank Caving
Looking at erosion from the top of the levee (no change as of 4/2010)	
richard_f_20100921_095.jpg

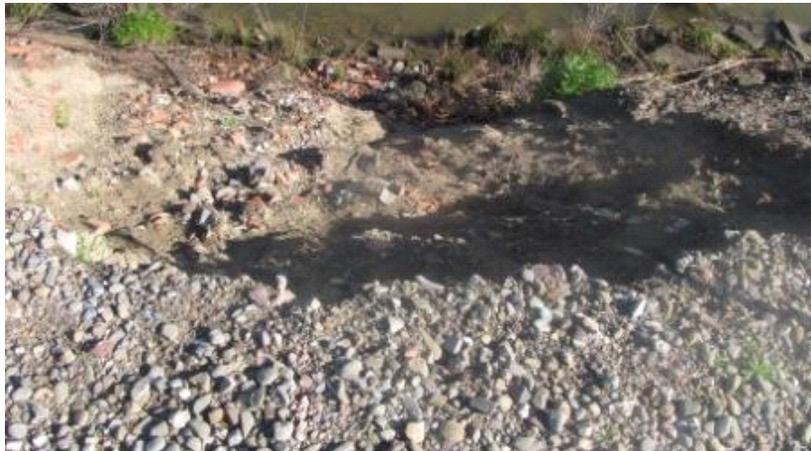
Levee Mile Report Line	7
Start Levee Mile	0.51
End Levee Mile	0.52
Location	Water Side
Category	Earthen Levee
Item	Erosion / Bank Caving
Erosion from LM 0.51 to 0.52	
richard_f_20100921_096.jpg

7	0.51	0.52	Earthen Levee	Erosion / Bank Caving	WS	U	Schedule repair of erosion site prior to the next inspection.	37.938682 ° -121.338518 °	37.938657 ° -121.338425 °	7 Y
8	0.53	0.60	Supplemental	DWR Erosion Survey	WS	U	Inspector Comments: 09/07/2010: No significant changes observed on site. Some emergent vegetation at the lower and middle slope. Existing revetment is no longer adequately protecting the oversteepened slope. Some of the broken concrete used as revetment has slid, dragging levee materials away from the slope and creating notches. [2010 SiteID: RD0524U01RM41.15]	37.938895 ° -121.337602 °	37.938895 ° -121.337602 °	1 Y
9	0.63	0.63	Earthen Levee	Slope Stability	WS	M	Repair the levee slope damaged by foot traffic and prevent access where possible.	37.938247 ° -121.336503 °	37.938247 ° -121.336503 °	10 Y
10	0.63	0.64	Earthen Levee	Vegetation	WS	U	Remove the wild growth other than native grasses from the levee slopes.	37.938247 ° -121.336503 °	37.938197 ° -121.336405 °	11 Y

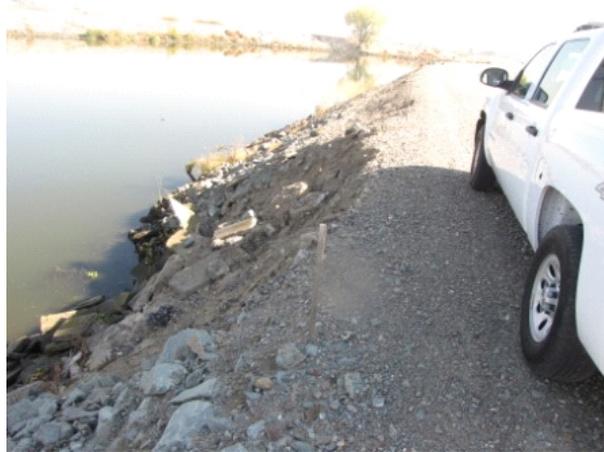
Levee Mile Report Line	7
Start Levee Mile	0.51
End Levee Mile	0.52
Location	Water Side
Category	Earthen Levee
Item	Erosion / Bank Caving
Looking southeast at erosion on waterside slope , no change as of 4/2010)	
richard_f_20100921_098.jpg

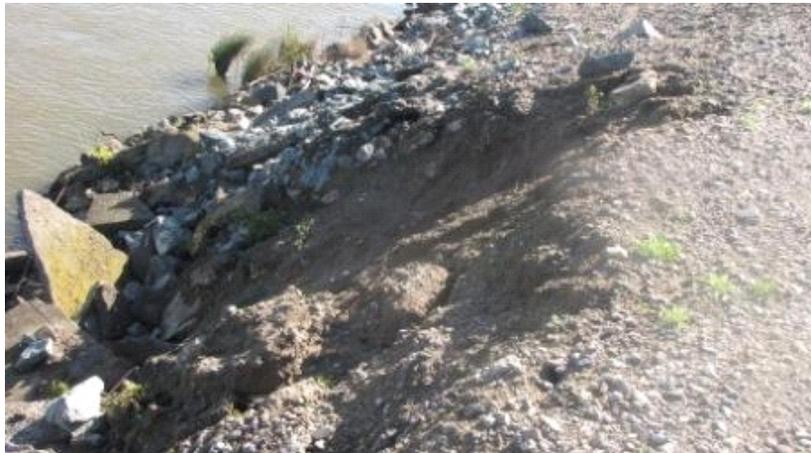
Levee Mile Report Line	7
Start Levee Mile	0.51
End Levee Mile	0.52
Location	Water Side
Category	Earthen Levee
Item	Erosion / Bank Caving
Looking at erosion from the top of the levee. No change as of 4/2010	
richard_f_20100921_099.jpg

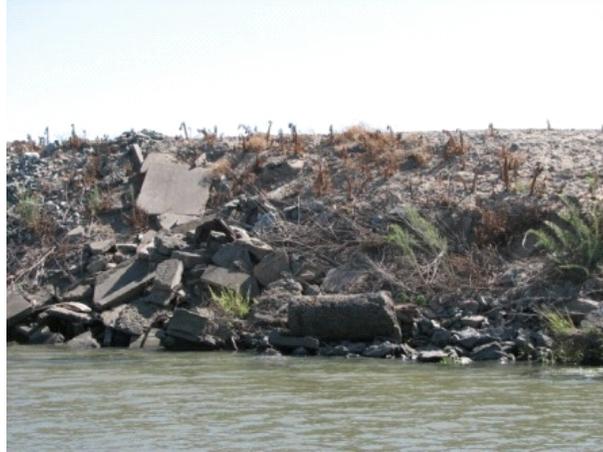
Levee Mile Report Line	8
Start Levee Mile	0.53
End Levee Mile	0.60
Location	Water Side
Category	Supplemental
Item	DWR Erosion Survey
Upstream view of site. Some of the broken concrete used as revetment is sliding, dragging down levee materials.	
SJR2010_RM41.15U1LM.56LBa.jpg

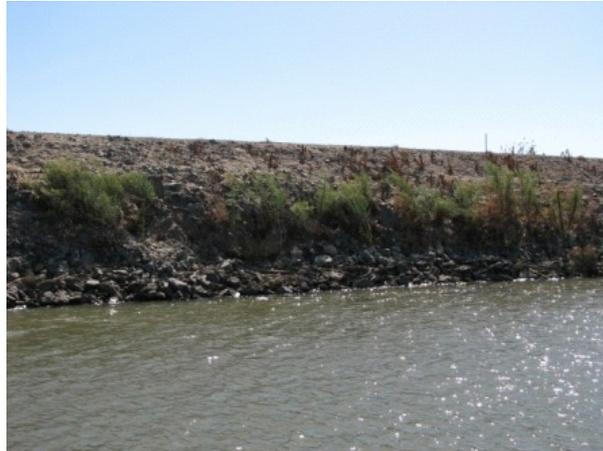
Levee Mile Report Line	8
Start Levee Mile	0.53
End Levee Mile	0.60
Location	Water Side
Category	Supplemental
Item	DWR Erosion Survey
Direct view of site.	
SJR2010_RM41.15U1LM.56LBB.jpg

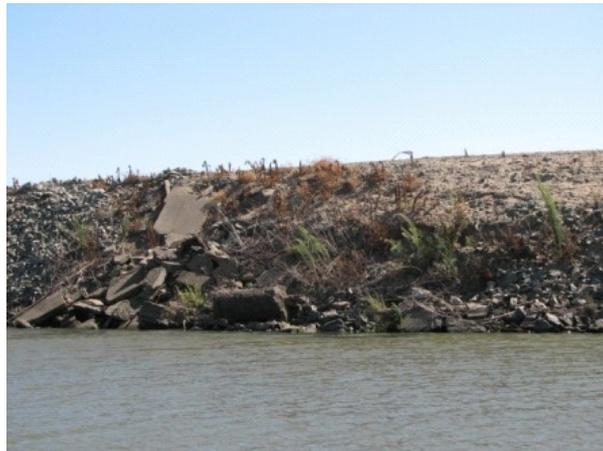
Levee Mile Report Line	8
Start Levee Mile	0.53
End Levee Mile	0.60
Location	Water Side
Category	Supplemental
Item	DWR Erosion Survey
Upstream view. Sloughing mid-slope possibly caused by sliding of the revetment.	
SJR2010_RM41.15U1LM.56LBC.jpg

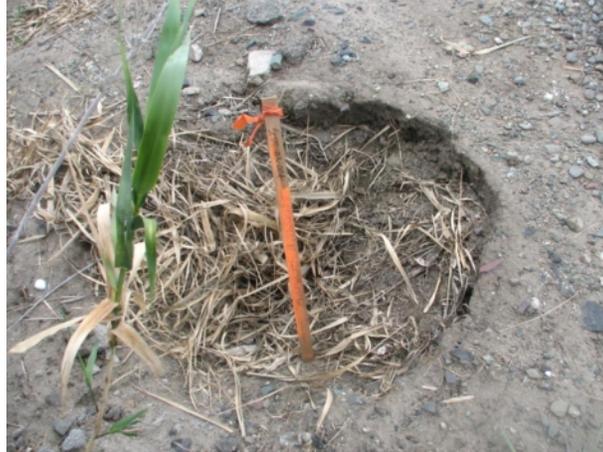
Levee Mile Report Line	12
Start Levee Mile	0.65
End Levee Mile	0.66
Location	Water Side
Category	Earthen Levee
Item	Slope Stability
Erosion from LM 0.65 to 0.66	
richard_f_20100921_103.jpg

11	0.64	0.64	Earthen Levee	Crown Surface / Depressions / Rutting	CR	M	Regrade the crown roadway for proper drainage.	37.938198 ° -121.336407 °	37.938198 ° -121.336407 °	12 Y
12	0.65	0.66	Earthen Levee	Slope Stability	WS	M	Repair slope instability.	37.938105 ° -121.336288 °	37.938023 ° -121.336173 °	13 Y
13	0.68	0.68	Earthen Levee	Vegetation	WS	U	Remove the wild growth other than native grasses from the levee slopes.	37.937808 ° -121.335913 °	37.937808 ° -121.335913 °	14 Y
14	0.79	0.79	Earthen Levee	Trim / Thin Trees	LS	M	Trim trees to at least five feet above ground level.	37.936444 ° -121.334797 °	37.936444 ° -121.334797 °	76 Y
15	0.81	0.81	Earthen Levee	Erosion / Bank Caving	WS	M	Note and monitor erosion site.	37.936217 ° -121.334698 °	37.936217 ° -121.334698 °	16 Y
16	0.94	1.02	Earthen Levee	Trim / Thin Trees	LS	M	Trim trees to at least five feet above ground level.	37.935259 ° -121.332864 °	37.935049 ° -121.331334 °	77 Y

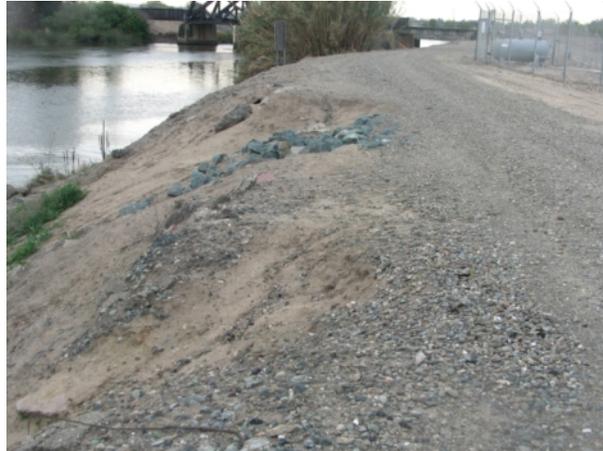
Levee Mile Report Line	12
Start Levee Mile	0.65
End Levee Mile	0.66
Location	Water Side
Category	Earthen Levee
Item	Slope Stability
Update of erosion site at LM 0.65 to 0.66	
richard_f_20100921_104.jpg

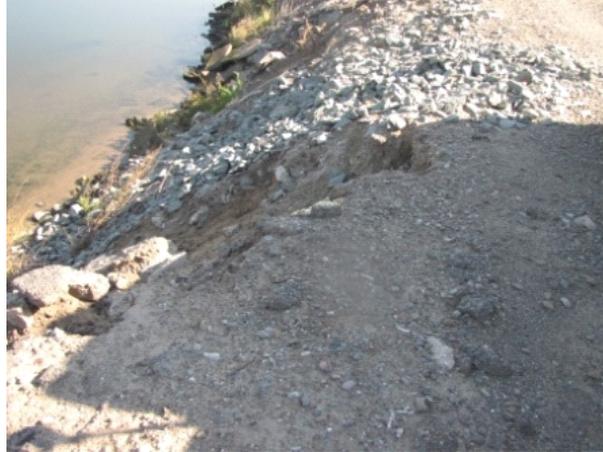
Levee Mile Report Line	18
Start Levee Mile	1.09
End Levee Mile	1.09
Location	Land Side
Category	Earthen Levee
Item	Slope Stability
Landward slope damage at LM 1.09	
richard_f_20100921_110.jpg

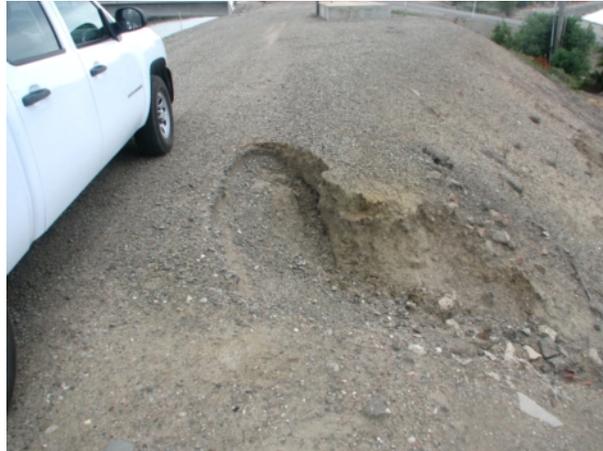
Levee Mile Report Line	18
Start Levee Mile	1.09
End Levee Mile	1.09
Location	Land Side
Category	Earthen Levee
Item	Slope Stability
Updated picture of erosion site on landside shoulder.	
richard_f_20100921_111.jpg

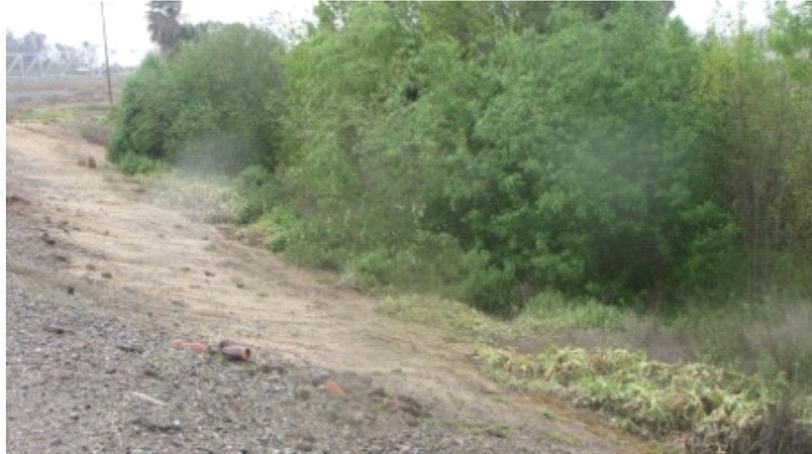
Levee Mile Report Line	22
Start Levee Mile	1.25
End Levee Mile	1.25
Location	Land Side
Category	Earthen Levee
Item	Encroachments
Concrete rubble with rebar on landward shoulder at LM 1.25	
richard_f_20100921_114.jpg

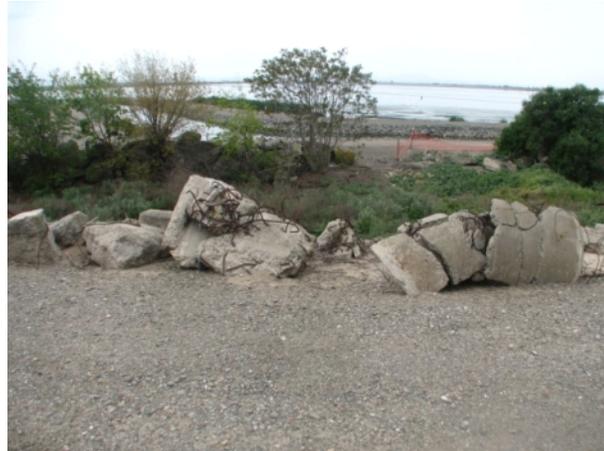
Levee Mile Report Line	22
Start Levee Mile	1.25
End Levee Mile	1.25
Location	Land Side
Category	Earthen Levee
Item	Encroachments
Looking south at concrete rubble on landside slope.	
richard_f_20100921_115.jpg

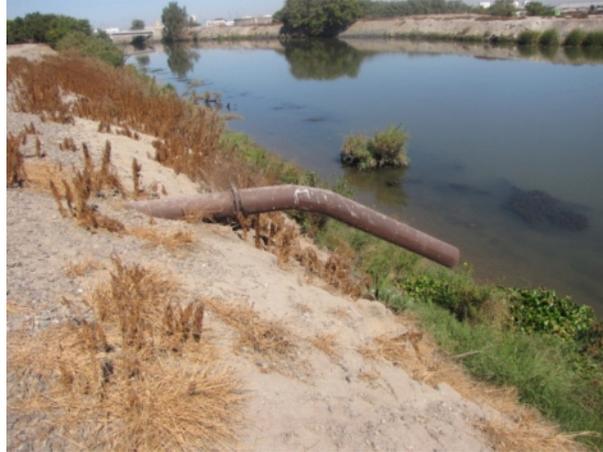
Levee Mile Report Line	23
Start Levee Mile	1.31
End Levee Mile	1.31
Location	Water Side
Category	Earthen Levee
Item	Encroachments
Looking west at pipe on landside slope.	
richard_f_20101001_317.jpg

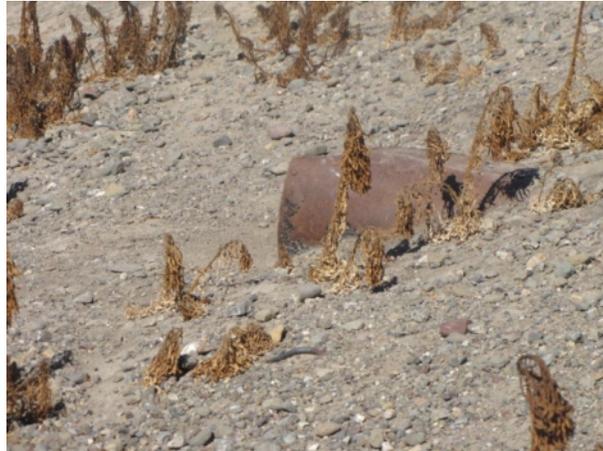
Levee Mile Report Line	24
Start Levee Mile	1.32
End Levee Mile	1.33
Location	Water Side
Category	Earthen Levee
Item	Erosion / Bank Caving
Erosion from LM 1.32 to 1.33	
richard_f_20100921_116.jpg

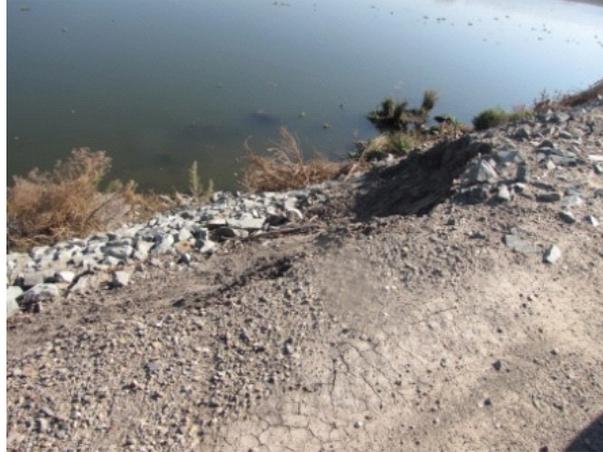
Levee Mile Report Line	24
Start Levee Mile	1.32
End Levee Mile	1.33
Location	Water Side
Category	Earthen Levee
Item	Erosion / Bank Caving
Looking at update of erosion site at LM 1.32 to 1.33	
richard_f_20100921_118.jpg

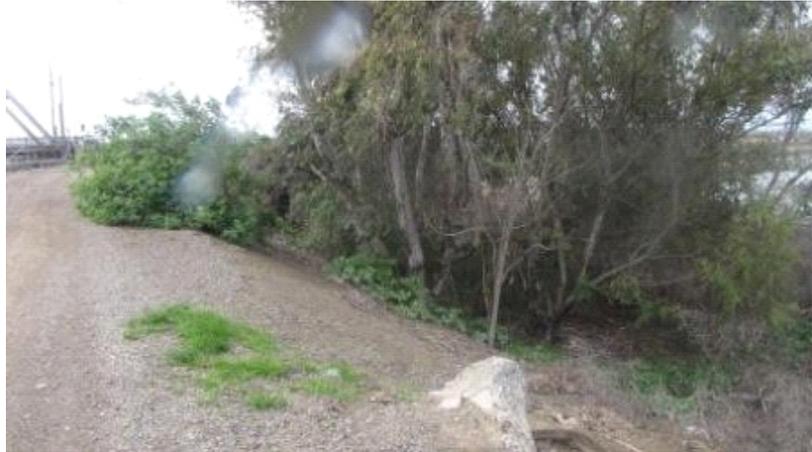
Levee Mile Report Line	27
Start Levee Mile	1.56
End Levee Mile	1.74
Location	Land Side
Category	Earthen Levee
Item	Encroachments
Overgrown landscaping on landward slope from LM 1.56 to 1.74	
richard_f_20100921_119.jpg

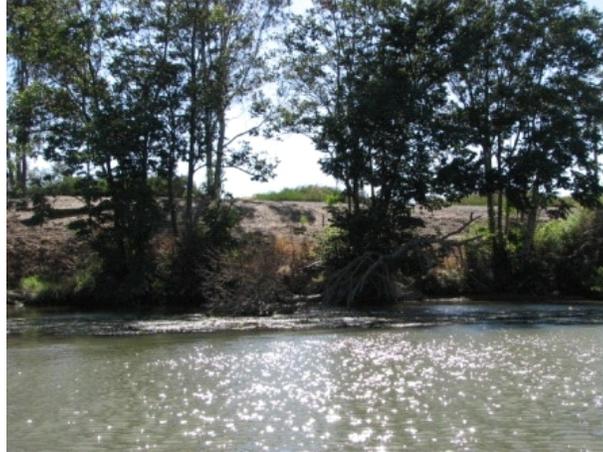
Levee Mile Report Line	28
Start Levee Mile	1.58
End Levee Mile	1.64
Location	Water Side
Category	Supplemental
Item	DWR Erosion Survey
<p>Large trees along the levee toe where undermining at the toe has occurred.</p>	
<p>SJR2010_RM42.20U1LM1.61LBc.jpg</p>

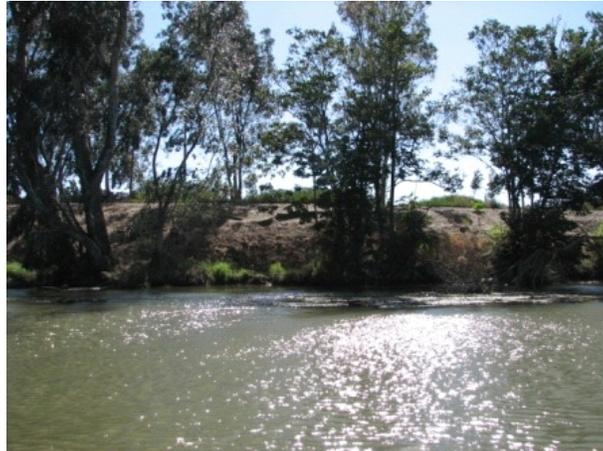
Levee Mile Report Line	28
Start Levee Mile	1.58
End Levee Mile	1.64
Location	Water Side
Category	Supplemental
Item	DWR Erosion Survey
<p>Close up view of a pocket erosion that is directly affecting the base of a tree. Note the exposed tree roots. This image was taken on 09/29/2009.</p>	
<p>SJR2010_RM42.20U1LM1.61LBd.jpg</p>

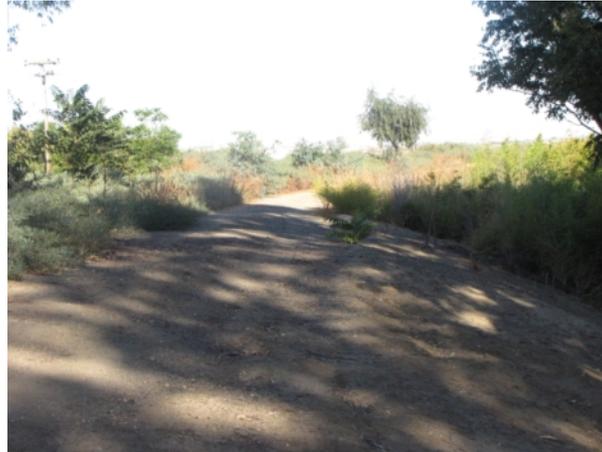
Levee Mile Report Line	30
Start Levee Mile	1.62
End Levee Mile	1.63
Location	Water Side
Category	Earthen Levee
Item	Vegetation
Looking southeast at dense veg. on waterside slope.	
richard_f_20100921_120.jpg

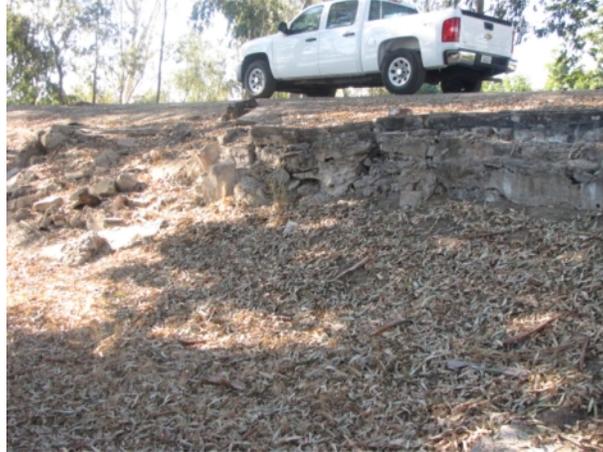
Levee Mile Report Line	36
Start Levee Mile	1.75
End Levee Mile	1.75
Location	Land Side
Category	Earthen Levee
Item	Encroachments
Garbage on landward toe from LM 1.75 to 1.76	
richard_f_20100921_121.jpg

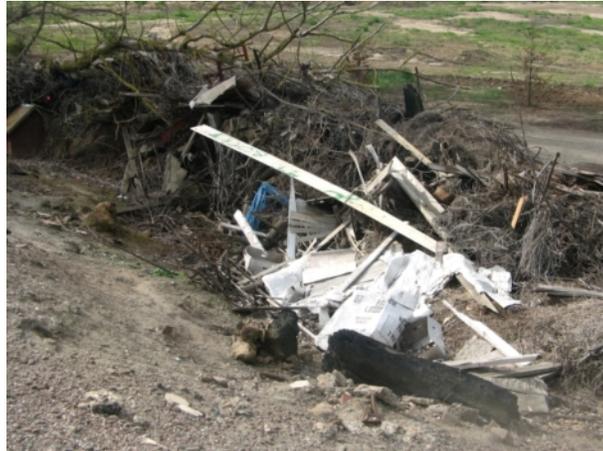
Levee Mile Report Line	36
Start Levee Mile	1.75
End Levee Mile	1.75
Location	Land Side
Category	Earthen Levee
Item	Encroachments
Looking at updated trash pile on landside slope and toe.	
richard_f_20100921_122.jpg
