**Flood Control Project Maintenance
Levee Inspections**

Fall 2009 Levee Maintenance Deficiency Summary Report

Reclamation District No. 0524 Middle Roberts Island

Levee Inspection Report By Mile - Fall 2009

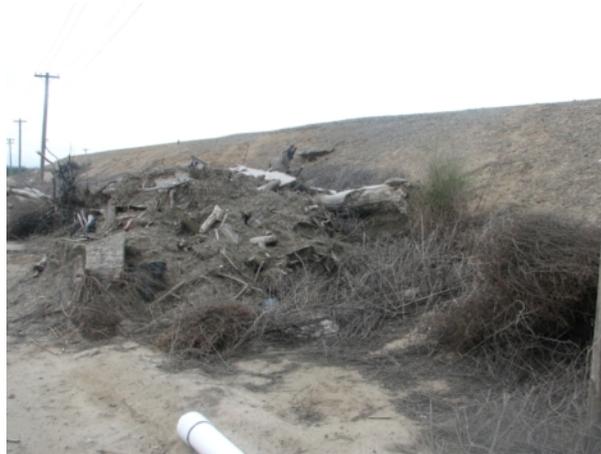
Levee Mile Report Line	2
Start Levee Mile	0.36
End Levee Mile	0.36
Location	Land Side
Category	Earthen Levee
Item	Encroachments
Garbage pile at landward toe at LM 0.36	
richard_20091104_38.jpg

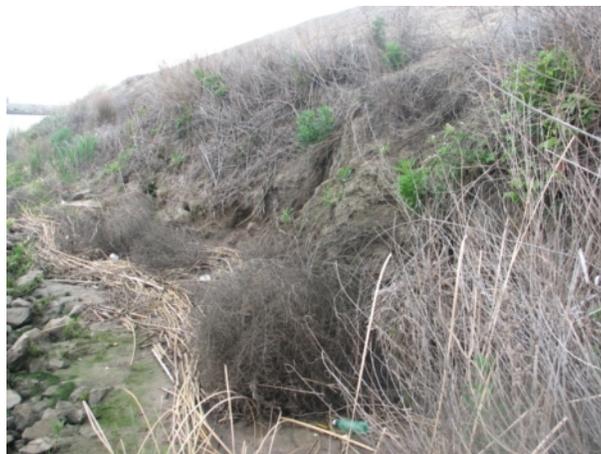
Levee Mile Report Line	3
Start Levee Mile	0.38
End Levee Mile	0.39
Location	Water Side
Category	Earthen Levee
Item	Erosion / Bank Caving
Minor erosion from LM 0.38 to 0.39	
richard_20091104_32.jpg

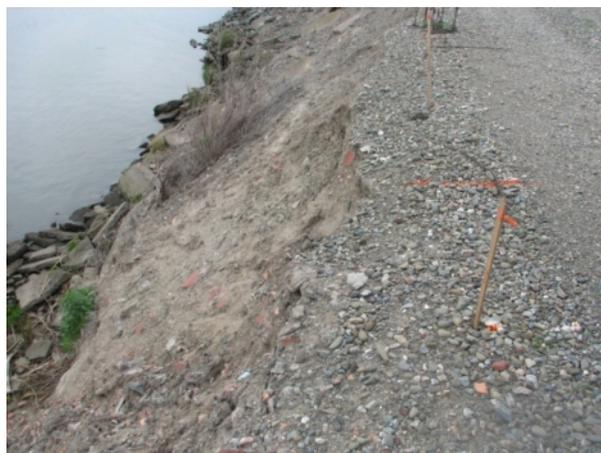
Levee Mile Report Line	5
Start Levee Mile	0.48
End Levee Mile	0.49
Location	Water Side
Category	Earthen Levee
Item	Erosion / Bank Caving
Major erosion from LM 0.48 to 0.49	
richard_20091104_33.jpg

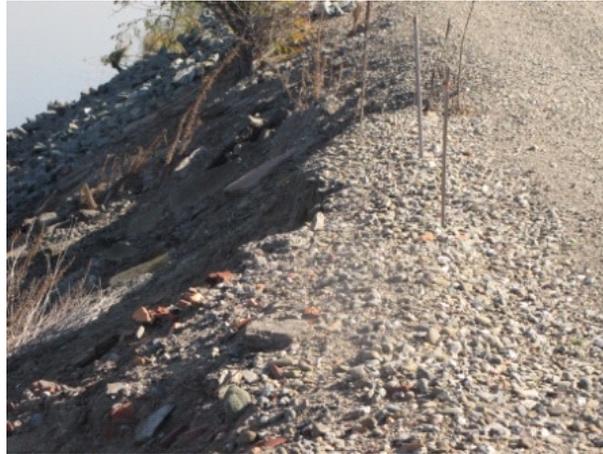
Levee Mile Report Line	5
Start Levee Mile	0.48
End Levee Mile	0.49
Location	Water Side
Category	Earthen Levee
Item	Erosion / Bank Caving
Update of erosion site at LM 0.48 to 0.49	
richard_20091110_91.jpg

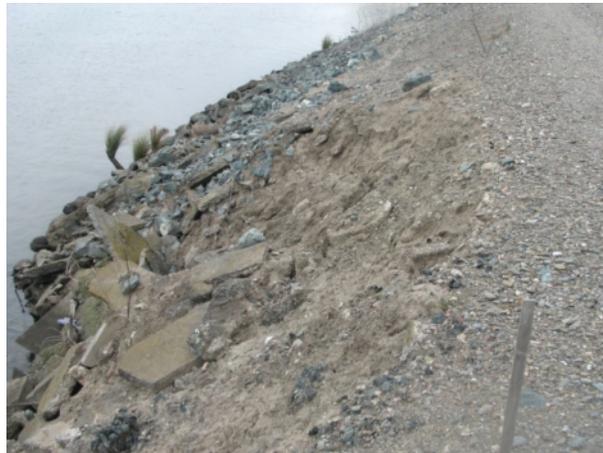
Levee Mile Report Line	6
Start Levee Mile	0.51
End Levee Mile	0.52
Location	Water Side
Category	Earthen Levee
Item	Erosion / Bank Caving
Erosion from LM 0.51 to 0.52	
richard_20091104_34.jpg

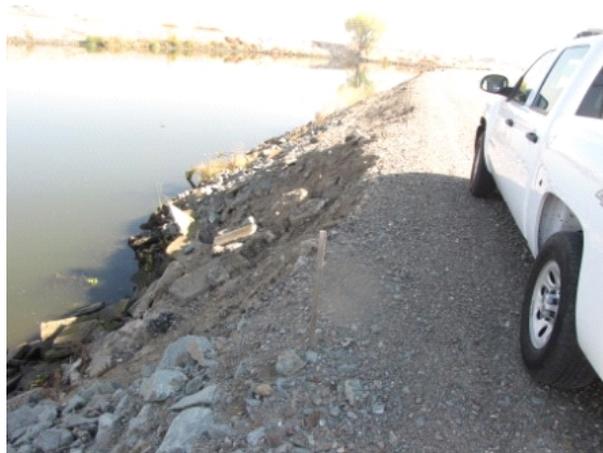
Levee Mile Report Line	6
Start Levee Mile	0.51
End Levee Mile	0.52
Location	Water Side
Category	Earthen Levee
Item	Erosion / Bank Caving
Update of erosion site at LM 0.51 to 0.52	
richard_20091110_92.jpg

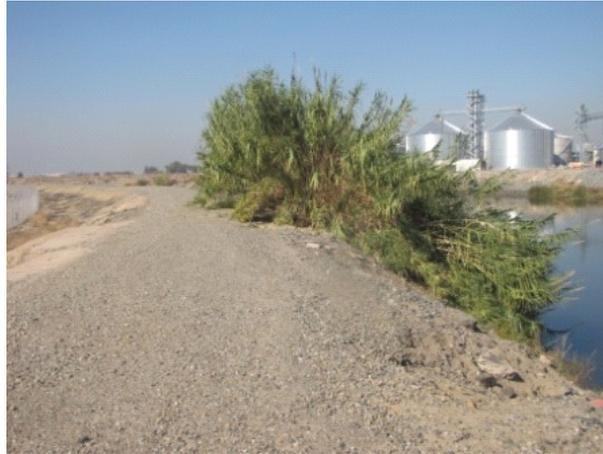
Levee Mile Report Line	11
Start Levee Mile	0.63
End Levee Mile	0.64
Location	Water Side
Category	Earthen Levee
Item	Vegetation
Looking north at bamboo on waterside slope.	
richard_20091110_93.jpg

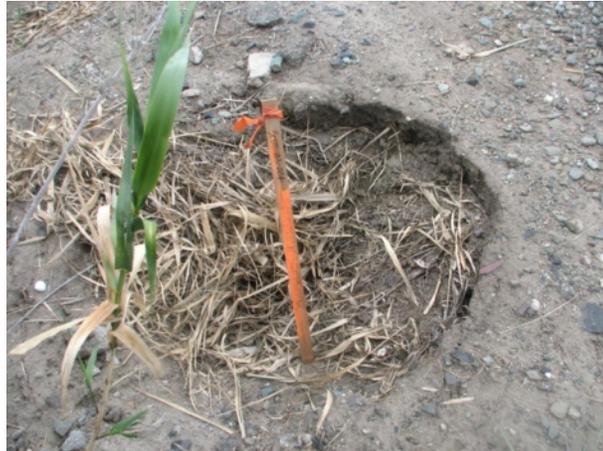
Levee Mile Report Line	12
Start Levee Mile	0.64
End Levee Mile	0.64
Location	Crown
Category	Earthen Levee
Item	Crown Surface / Depressions / Rutting
Large hole 3 x 3 on levee crown near waterside shoulder at LM 0.64	
richard_20091104_35.jpg

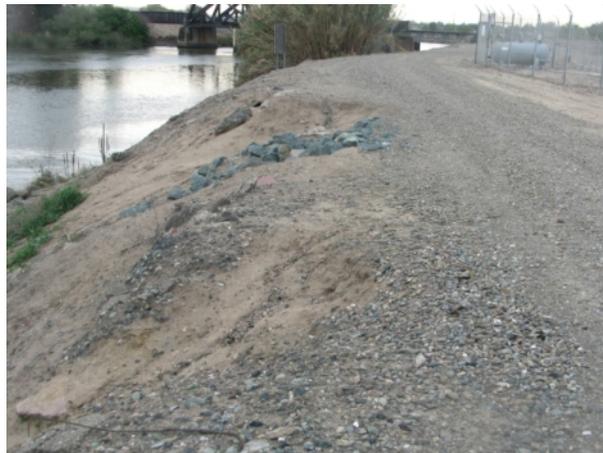
Levee Mile Report Line	13
Start Levee Mile	0.65
End Levee Mile	0.66
Location	Water Side
Category	Earthen Levee
Item	Slope Stability
Erosion from LM 0.65 to 0.66	
richard_20091104_36.jpg

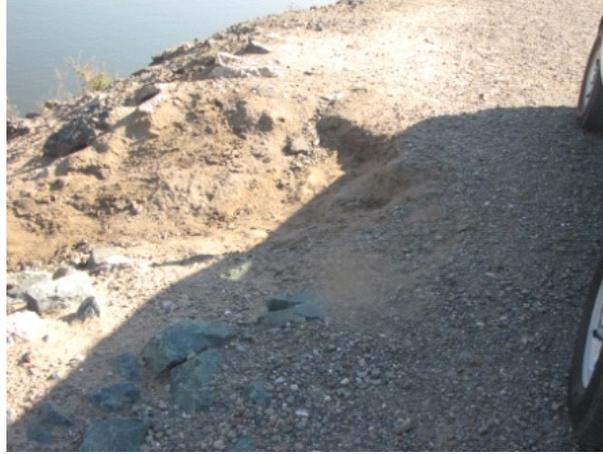
Levee Mile Report Line	13
Start Levee Mile	0.65
End Levee Mile	0.66
Location	Water Side
Category	Earthen Levee
Item	Slope Stability
Update of erosion site at LM 0.65 to 0.66	
richard_20091110_94.jpg

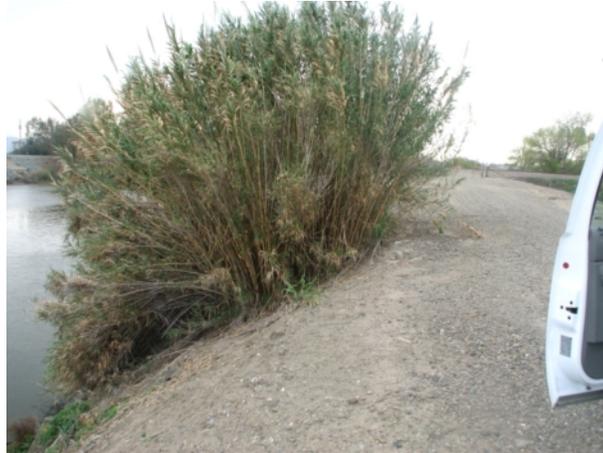
Levee Mile Report Line	14
Start Levee Mile	0.68
End Levee Mile	0.68
Location	Water Side
Category	Earthen Levee
Item	Vegetation
Bamboo on waterward slope at LM 0.68	
richard_20091104_37.jpg

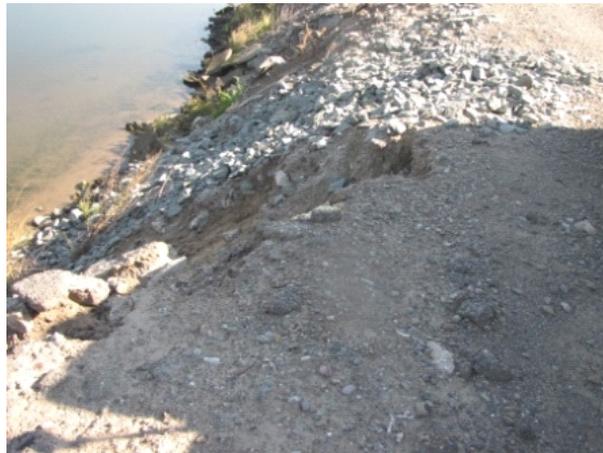
Levee Mile Report Line	19
Start Levee Mile	1.01
End Levee Mile	1.03
Location	Water Side
Category	Earthen Levee
Item	Erosion / Bank Caving
Looking upstream (south) at erosion site.	
richard_20091110_95.jpg

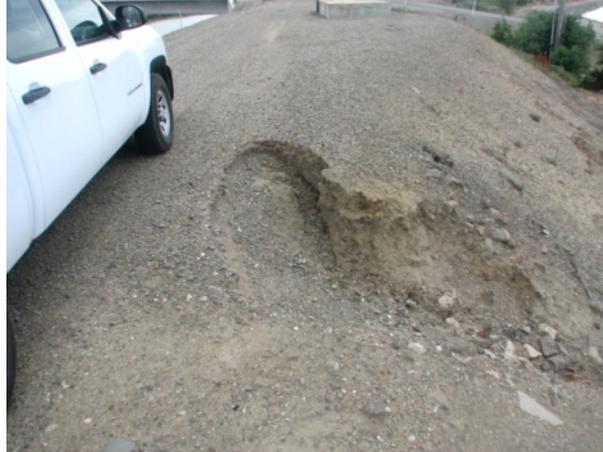
Levee Mile Report Line	20
Start Levee Mile	1.09
End Levee Mile	1.09
Location	Land Side
Category	Earthen Levee
Item	Slope Stability
Landward slope damage at LM 1.09	
richard_20091104_39.jpg

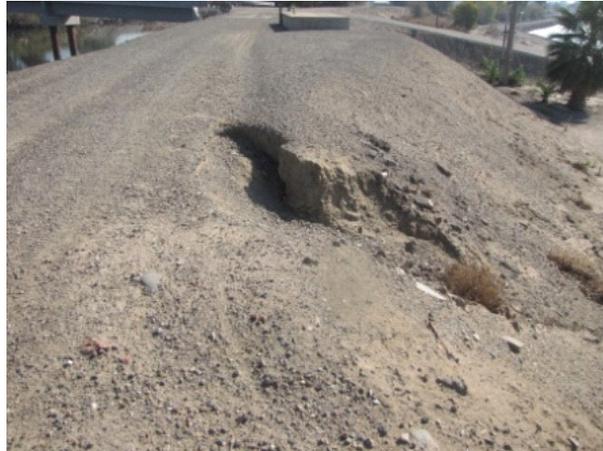
Levee Mile Report Line	20
Start Levee Mile	1.09
End Levee Mile	1.09
Location	Land Side
Category	Earthen Levee
Item	Slope Stability
Updated picture of erosion site on landside shoulder.	
richard_20091110_96.jpg

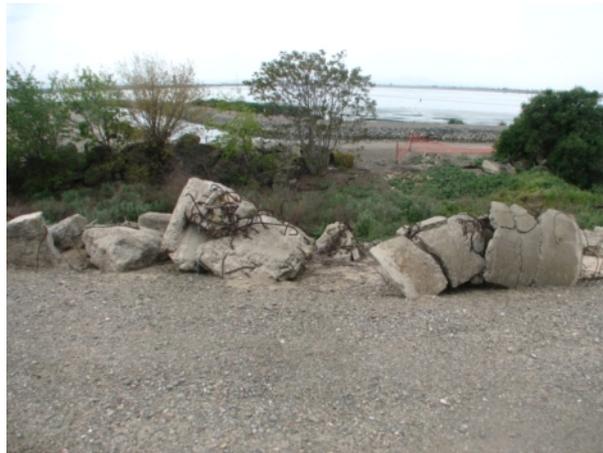
Levee Mile Report Line	24
Start Levee Mile	1.25
End Levee Mile	1.25
Location	Land Side
Category	Earthen Levee
Item	Encroachments
Concrete rubble with rebar on landward shoulder at LM 1.25	
richard_20091104_40.jpg

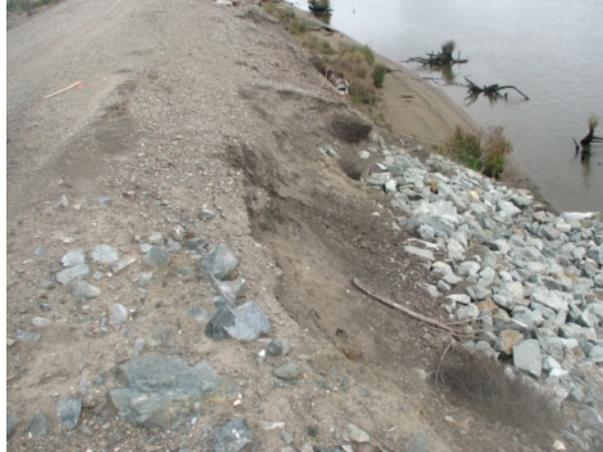
Levee Mile Report Line	25
Start Levee Mile	1.32
End Levee Mile	1.33
Location	Water Side
Category	Earthen Levee
Item	Erosion / Bank Caving
Erosion from LM 1.32 to 1.33	
richard_20091104_41.jpg

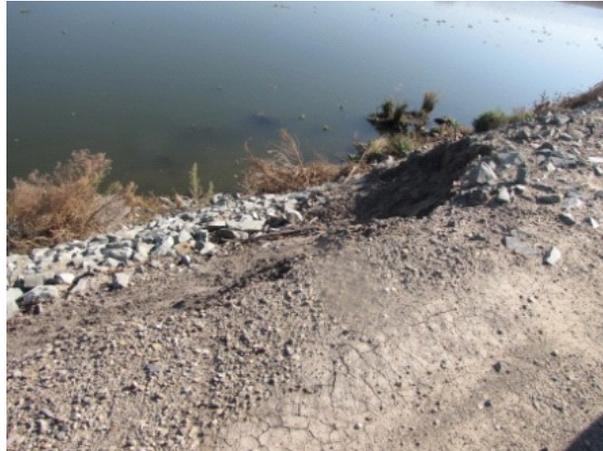
Levee Mile Report Line	25
Start Levee Mile	1.32
End Levee Mile	1.33
Location	Water Side
Category	Earthen Levee
Item	Erosion / Bank Caving
Looking at erosion from top of levee	
richard_20091110_97.jpg

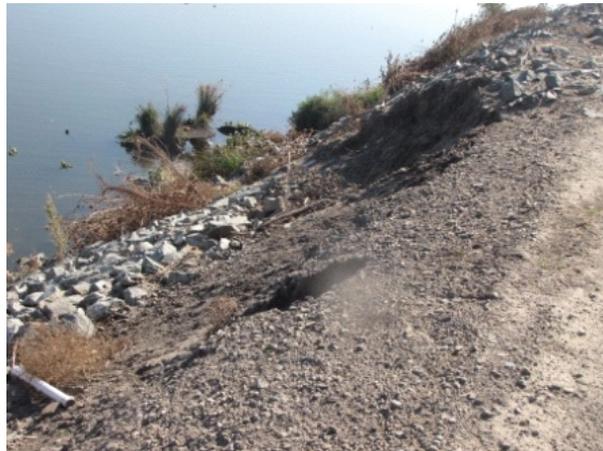
Levee Mile Report Line	25
Start Levee Mile	1.32
End Levee Mile	1.33
Location	Water Side
Category	Earthen Levee
Item	Erosion / Bank Caving
Looking at update of erosion site at LM 1.32 to 1.33	
richard_20091110_98.jpg

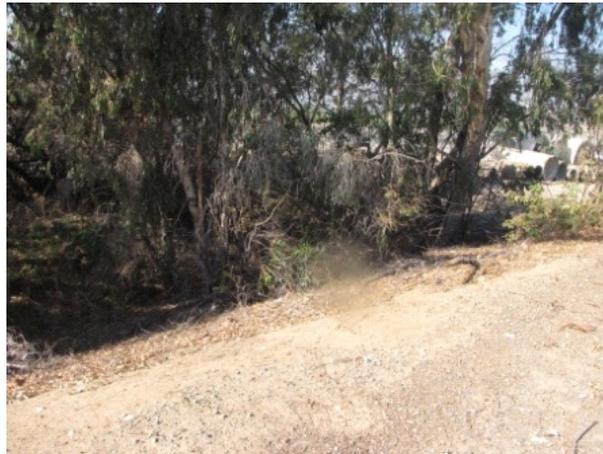
Levee Mile Report Line	27
Start Levee Mile	1.51
End Levee Mile	1.51
Location	Land Side
Category	Earthen Levee
Item	Trim / Thin Trees
Dense vegetation on landside toe.	
richard_20091110_99.jpg

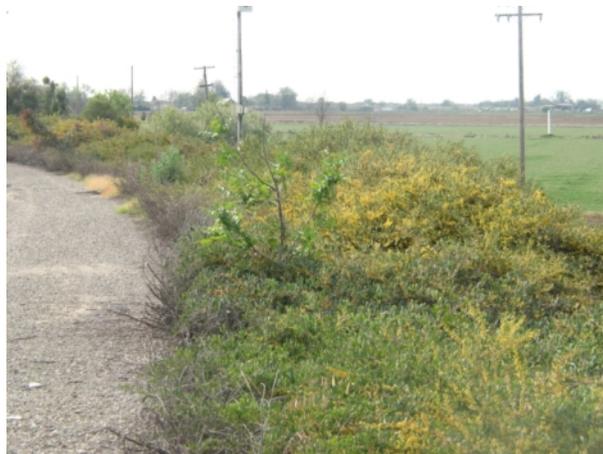
Levee Mile Report Line	28
Start Levee Mile	1.56
End Levee Mile	1.74
Location	Land Side
Category	Earthen Levee
Item	Encroachments
Overgrown landscaping on landward slope from LM 1.56 to 1.74	
richard_20091104_42.jpg

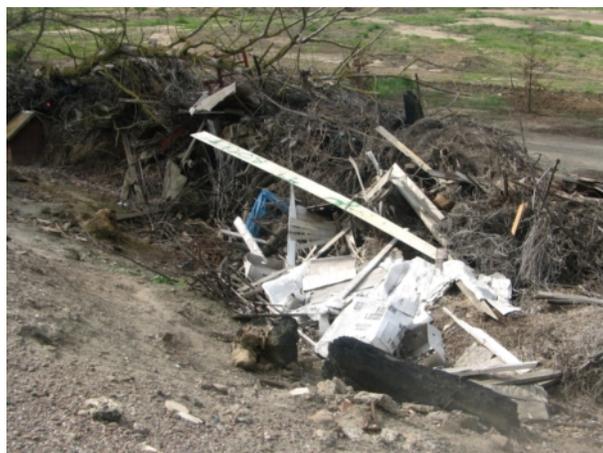
Levee Mile Report Line	34
Start Levee Mile	1.75
End Levee Mile	1.76
Location	Land Side
Category	Earthen Levee
Item	Encroachments
Garbage on landward toe from LM 1.75 to 1.76	
richard_20091104_43.jpg

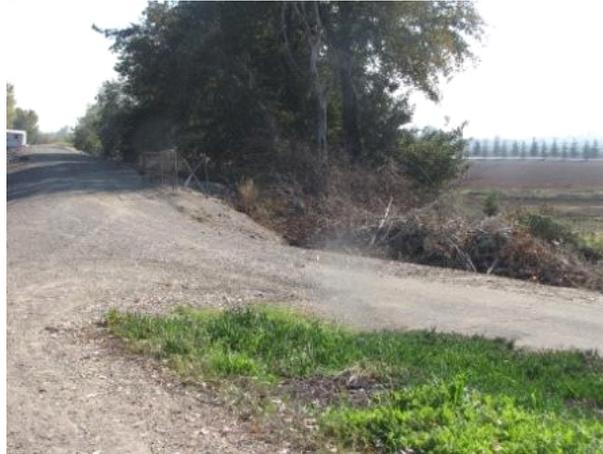
Levee Mile Report Line	34
Start Levee Mile	1.75
End Levee Mile	1.76
Location	Land Side
Category	Earthen Levee
Item	Encroachments
Looking at updated trash pile on landside slope and toe.	
richard_20091110_100.jpg

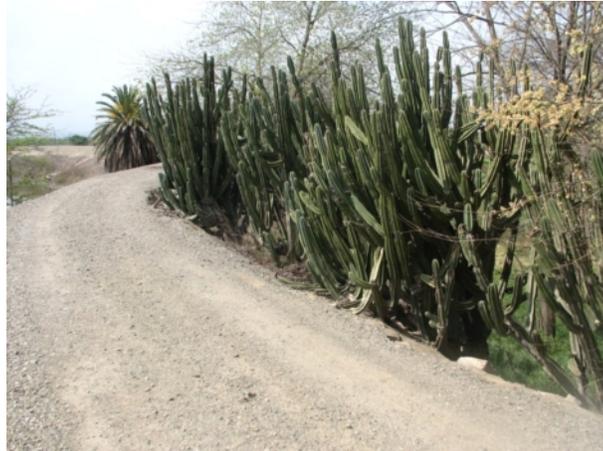
Levee Mile Report Line	60
Start Levee Mile	2.78
End Levee Mile	2.79
Location	Land Side
Category	Earthen Levee
Item	Encroachments
Landscaping (Cactus) on landward slope from LM 2.78 to 2.79	
richard_20091104_44.jpg

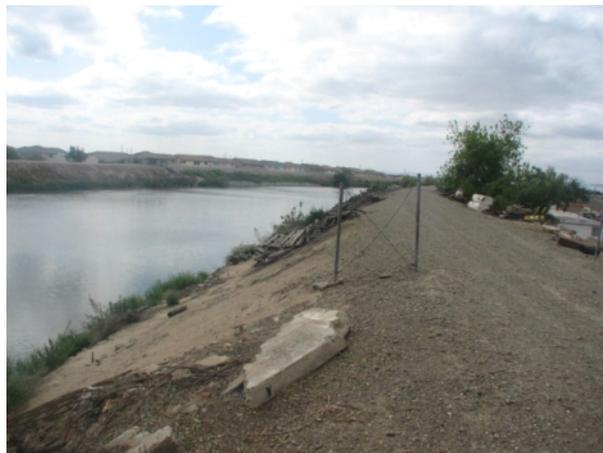
Levee Mile Report Line	82
Start Levee Mile	3.88
End Levee Mile	4.02
Location	Water Side
Category	Earthen Levee
Item	Encroachments
Looking upstream at prunings on waterside slope	
richard_20091104_45.jpg

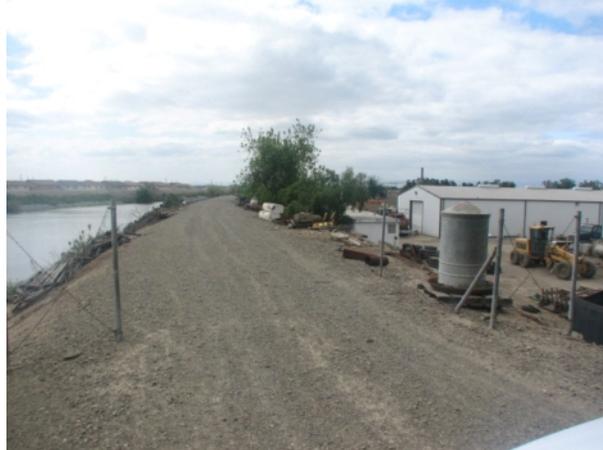
Levee Mile Report Line	84
Start Levee Mile	3.89
End Levee Mile	4.01
Location	Land Side
Category	Earthen Levee
Item	Encroachments
Looking upstream at equipment on landside shoulder	
richard_20091104_46.jpg

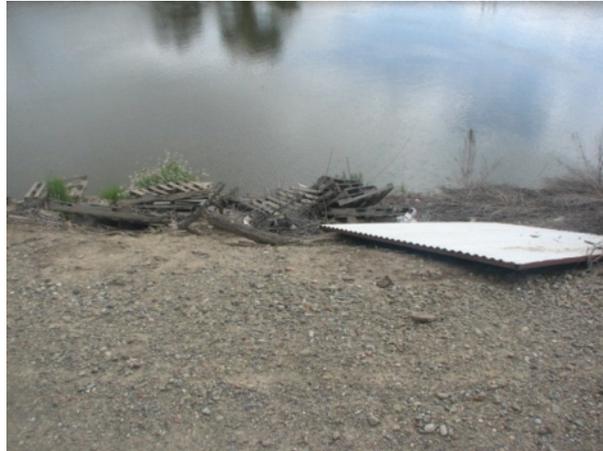
Levee Mile Report Line	85
Start Levee Mile	3.91
End Levee Mile	3.91
Location	Water Side
Category	Earthen Levee
Item	Encroachments
Looking at garbage (pallets) on waterside slope.	
richard_20091104_54.jpg

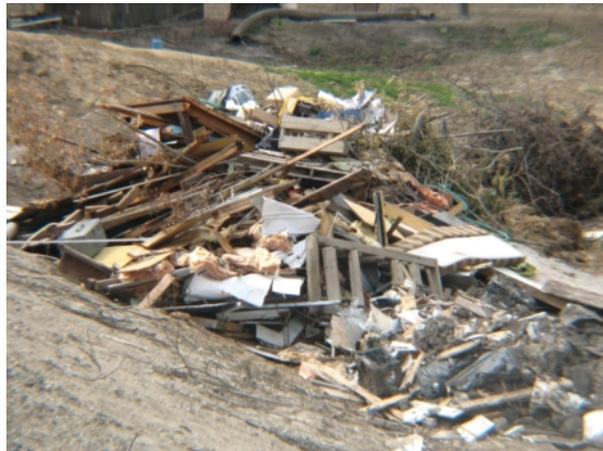
Levee Mile Report Line	87
Start Levee Mile	4.05
End Levee Mile	4.05
Location	Land Side
Category	Earthen Levee
Item	Encroachments
Garbage at landward toe at LM 4.05	
richard_20091104_47.jpg

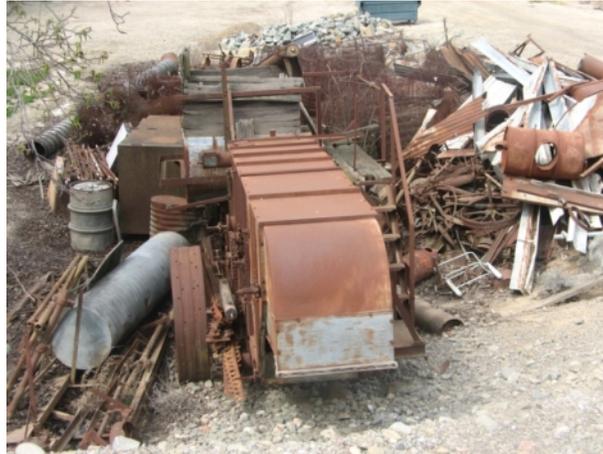
Levee Mile Report Line	91
Start Levee Mile	4.64
End Levee Mile	4.64
Location	Land Side
Category	Earthen Levee
Item	Encroachments
Garbage at landward toe next to ramp at LM 4.64	
richard_20091104_48.jpg

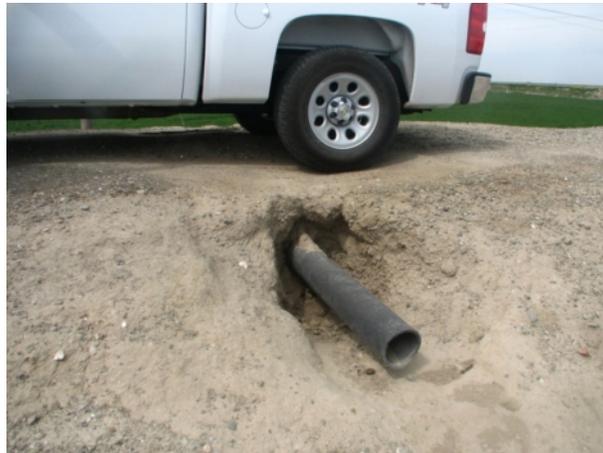
Levee Mile Report Line	101
Start Levee Mile	5.87
End Levee Mile	5.87
Location	Crown
Category	Earthen Levee
Item	Encroachments
Abandoned pipe at LM 5.87 wateside view	
richard_20091104_49.jpg

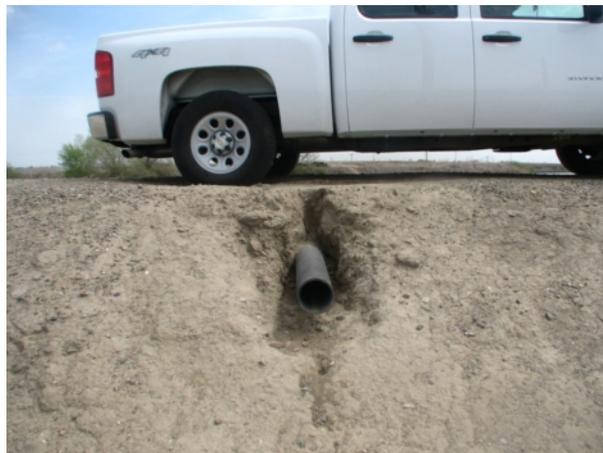
Levee Mile Report Line	101
Start Levee Mile	5.87
End Levee Mile	5.87
Location	Crown
Category	Earthen Levee
Item	Encroachments
Abandoned pipe at LM 5.87 landside view	
richard_20091104_50.jpg

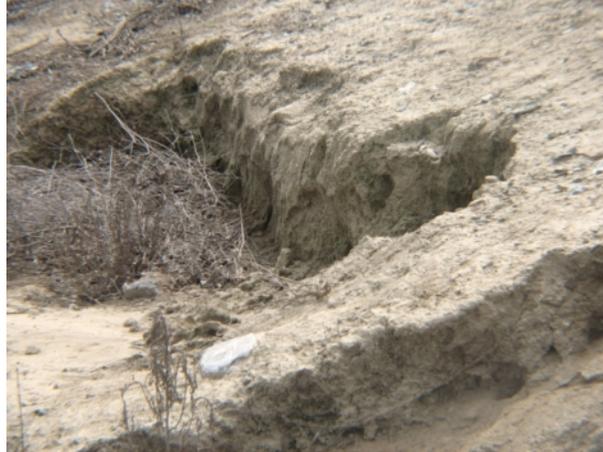
Levee Mile Report Line	104
Start Levee Mile	5.92
End Levee Mile	5.92
Location	Water Side
Category	Earthen Levee
Item	Erosion / Bank Caving
Erosion at waterward toe at LM 5.92	
richard_20091104_52.jpg

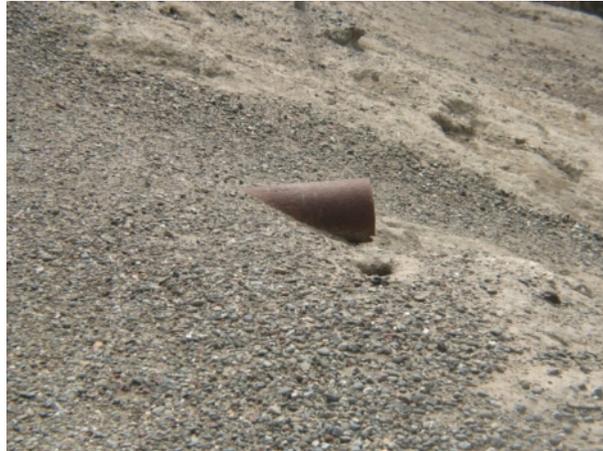
Levee Mile Report Line	105
Start Levee Mile	5.92
End Levee Mile	5.92
Location	Crown
Category	Earthen Levee
Item	Encroachments
Abandoned pipe at LM 5.92 waterside view	
richard_20091104_51.jpg

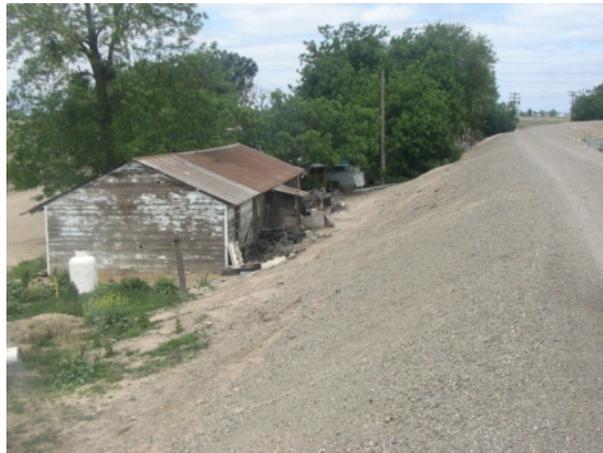
Levee Mile Report Line	109
Start Levee Mile	6.01
End Levee Mile	6.05
Location	Land Side
Category	Earthen Levee
Item	Encroachments
Looking downstream at building on landside toe.	
richard_20091104_53.jpg
