**Flood Control Project Maintenance  
Levee Inspections**

**Fall 2011 Levee Maintenance Deficiency Summary Report**

***San Joaquin River Basin***

**Reclamation District No. 0524 Middle Roberts Island**

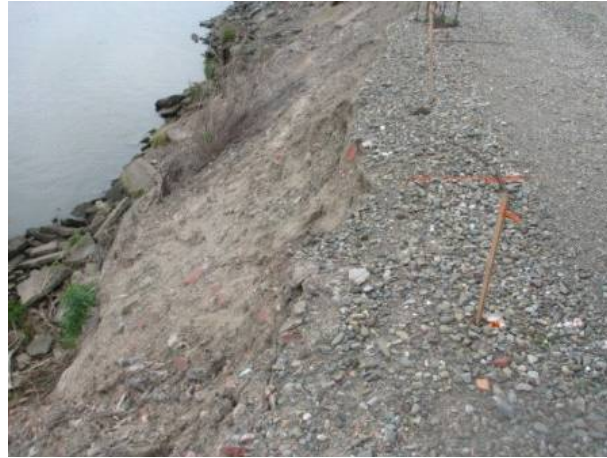
Levee Mile Report Line	4
Start Levee Mile	0.48
End Levee Mile	0.49
Location	Water Side
Category	Earthen Levee
Item	Erosion / Bank Caving

Update of erosion site at LM 0.48 to 0.49

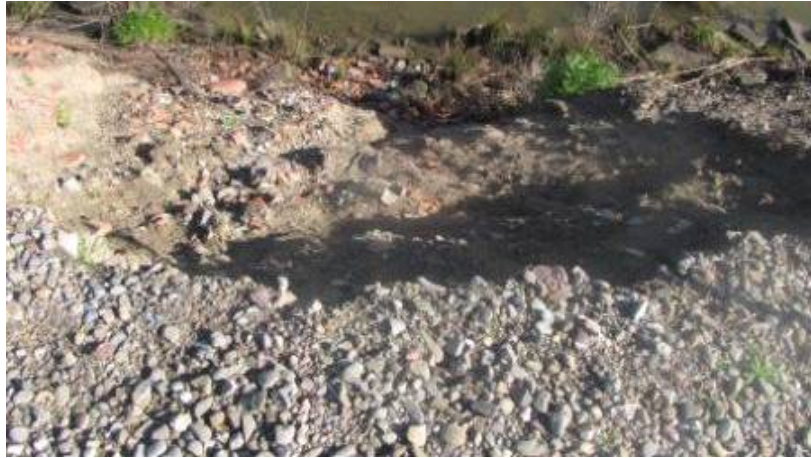
Levee Mile Report Line	5
Start Levee Mile	0.51
End Levee Mile	0.52
Location	Water Side
Category	Earthen Levee
Item	Erosion / Bank Caving

Erosion from LM 0.51 to 0.52

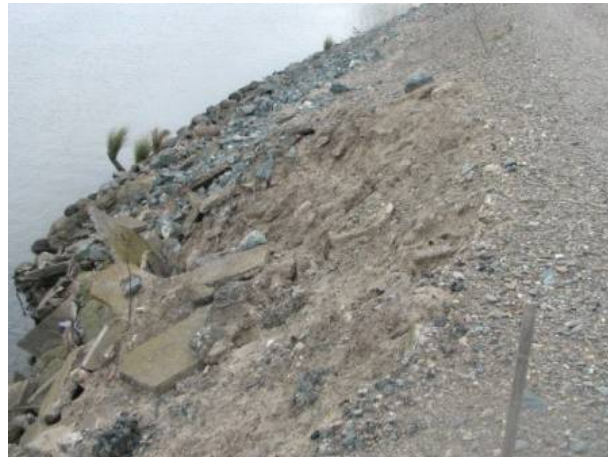
Levee Mile Report Line	5
Start Levee Mile	0.51
End Levee Mile	0.52
Location	Water Side
Category	Earthen Levee
Item	Erosion / Bank Caving

Update of erosion site at LM 0.51 to 0.52

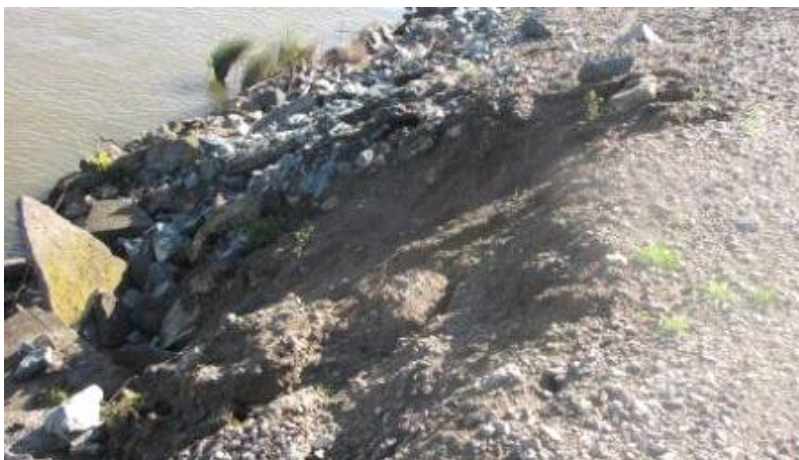
Levee Mile Report Line	5
Start Levee Mile	0.51
End Levee Mile	0.52
Location	Water Side
Category	Earthen Levee
Item	Erosion / Bank Caving

Looking at erosion from the top of the levee. No change as of 4/2010

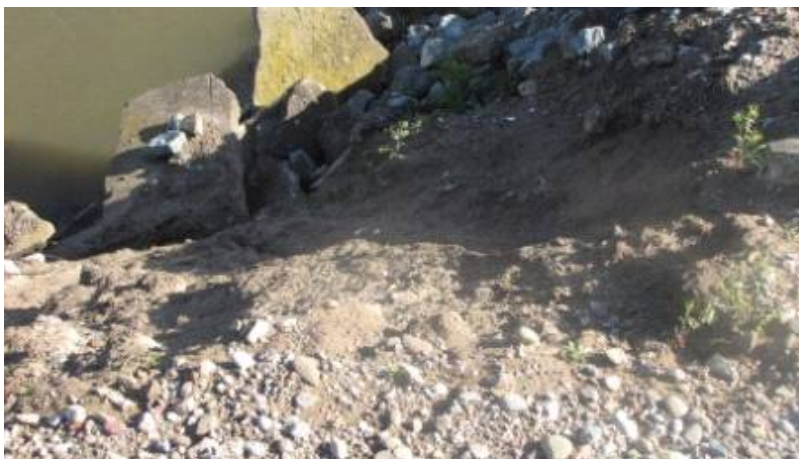
Levee Mile Report Line	6
Start Levee Mile	0.53
End Levee Mile	0.60
Location	Water Side
Category	Supplemental
Item	DWR Erosion Survey

6	0.53	0.60	Supplemental	DWR Erosion Survey	WS	U	Inspector Comments: 08/23/2011: No significant changes observed on site.09/07/2010: No significant changes observed on site. Some emergent vegetation at the lower and middle slope. Existing revetment is no longer adequately protecting the oversteepened slope. Some of the broken concrete used as revetment has slid, dragging levee materials away from the slope and creating notches.  09/29/2009: Erosion site extends from RM 41.11 to 41.18; existing revetment is no longer adequately protecting the oversteepened slope.2008: Existing concrete slabs were placed as temporary fix; some of the slabs have started to slide, dragging levee materials away from the slope and creating notches; note that a sewage treatment plant is located on the landside of the levee. [2011 Site ID:RD0524U01RM41.15]	37.938895 ° -121.337602 °	37.938895 ° -121.337602 °	79 Y
7	0.63	0.63	Earthen Levee	Slope Stability	WS	M	Repair the levee slope damaged by foot traffic and prevent access where possible.	37.938247 ° -121.336503 °	37.938247 ° -121.336503 °	10

Upstream view of the site. Broken concrete used as revetment is sliding, dragging down levee materials.

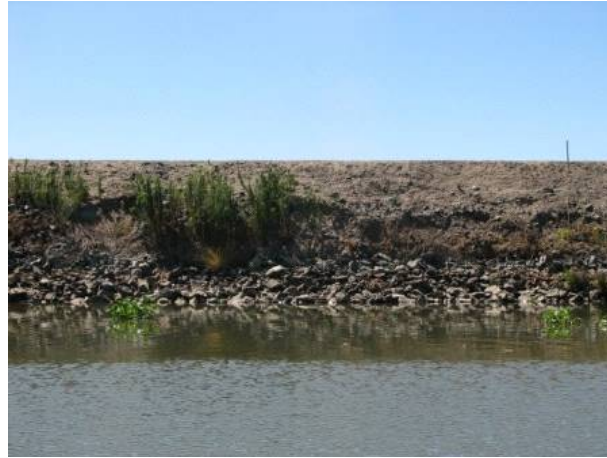
Levee Mile Report Line	6
Start Levee Mile	0.53
End Levee Mile	0.60
Location	Water Side
Category	Supplemental
Item	DWR Erosion Survey

Upstream view. Sloughing mid-slope possibly caused by sliding of the revetment.

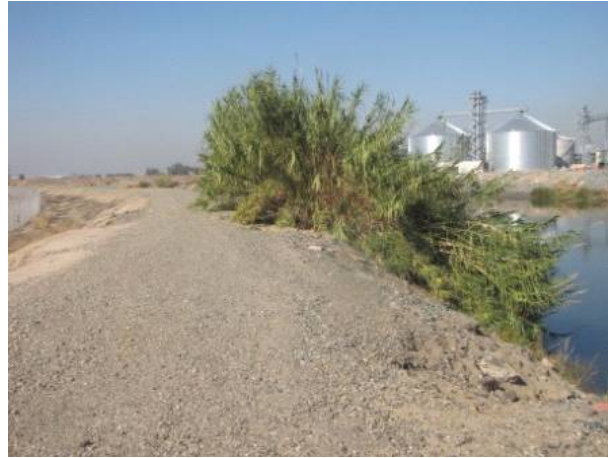
Levee Mile Report Line	8
Start Levee Mile	0.63
End Levee Mile	0.64
Location	Water Side
Category	Earthen Levee
Item	Vegetation

8	0.63	0.64	Earthen Levee	Vegetation	WS	U	Remove the wild growth other than native grasses from the levee slopes.	37.938247 ° -121.336503 °	37.938197 ° -121.336405 °	11 Y
9	0.64	0.64	Earthen Levee	Crown Surface / Depressions / Rutting	CR	M	Regrade the crown roadway for proper drainage.	37.938198 ° -121.336407 °	37.938198 ° -121.336407 °	12 Y
10	0.65	0.66	Earthen Levee	Slope Stability	WS	M	Repair slope instability.	37.938105 ° -121.336288 °	37.938023 ° -121.336173 °	13 Y
11	0.68	0.68	Earthen Levee	Vegetation	WS	U	Remove the wild growth other than native grasses from the levee slopes.	37.937808 ° -121.335913 °	37.937808 ° -121.335913 °	14 Y

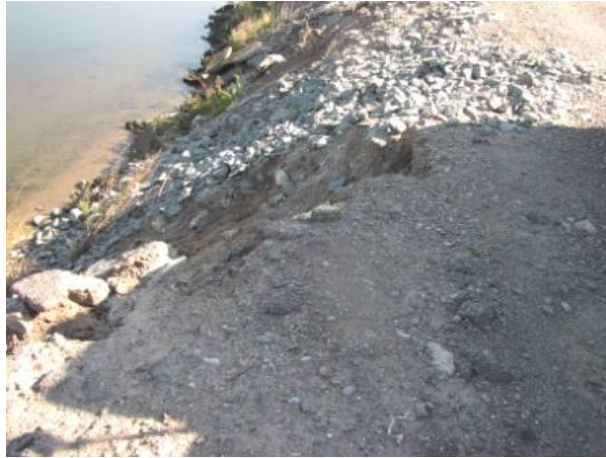
Levee Mile Report Line	20
Start Levee Mile	1.09
End Levee Mile	1.09
Location	Land Side
Category	Earthen Levee
Item	Slope Stability

Landward slope damage at LM 1.09

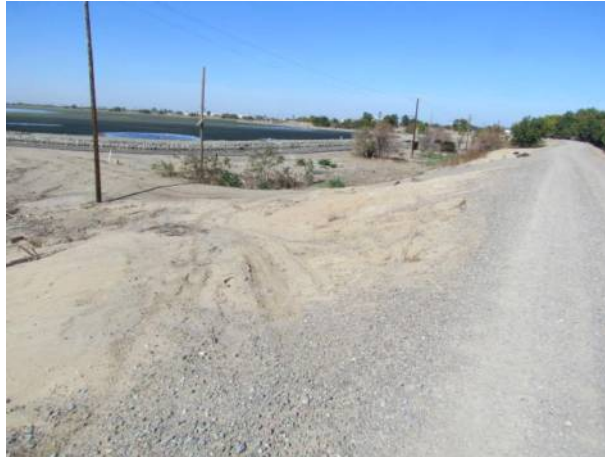
Levee Mile Report Line	26
Start Levee Mile	1.31
End Levee Mile	1.31
Location	Water Side
Category	Earthen Levee
Item	Encroachments

Looking north at broken pipe.

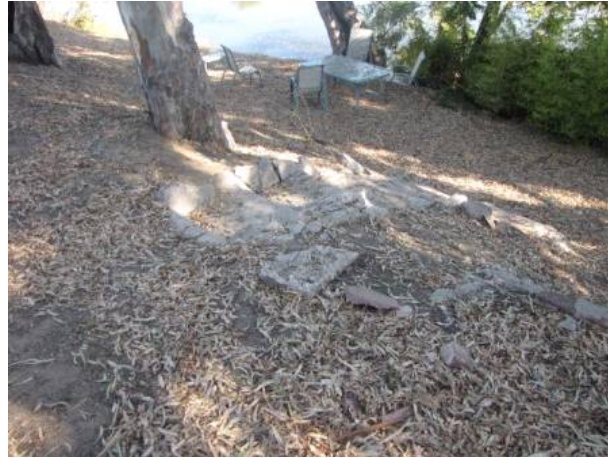
Levee Mile Report Line	37
Start Levee Mile	1.69
End Levee Mile	1.69
Location	Water Side
Category	Earthen Levee
Item	Encroachments
Looking northeast on non-permitted concrete stairs on waterside slope.	
richard_f_20111014_497.jpg

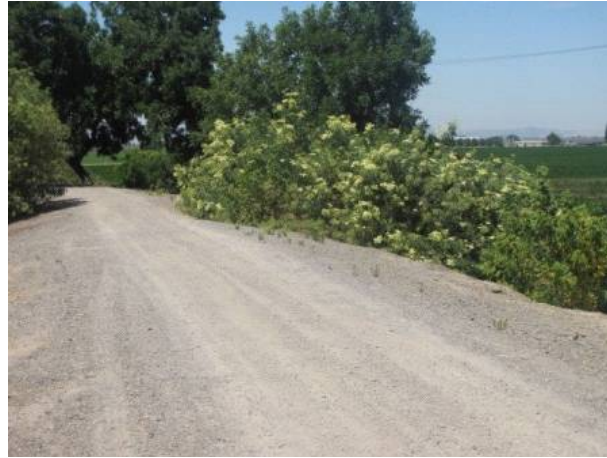
Levee Mile Report Line	50
Start Levee Mile	2.52
End Levee Mile	2.52
Location	Land Side
Category	Earthen Levee
Item	Vegetation

50	2.52	2.52	Earthen Levee	Vegetation	LS	U	Elderberries are blocking visibility and flood fight capability.	37.918345 ° -121.321765 °	37.918302 ° -121.321923 °	37 Y
51	2.53	2.53	Earthen Levee	Vegetation	WS	U	Elderberries are blocking visibility and flood fight capability.	37.918287 ° -121.321980 °	37.918287 ° -121.321980 °	38 Y
52	2.55	2.59	Earthen Levee	Slope Stability	LS	M	Repair slope instability.	37.918060 ° -121.322384 °	37.917667 ° -121.322713 °	82
53	2.56	2.56	Earthen Levee	Vegetation	LS	M	Elderberries are blocking visibility and flood fight capability.	37.918047 ° -121.322415 °	37.918047 ° -121.322415 °	40
54	2.59	2.59	Earthen Levee	Vegetation	LS	M	Elderberries are blocking visibility and flood fight capability.	37.917673 ° -121.322718 °	37.917673 ° -121.322718 °	41
55	2.59	2.59	Earthen Levee	Encroachments	WS	CO	Buildings	37.917673 ° -121.322718 °	37.917673 ° -121.322718 °	42 Y
56	2.60	2.60	Earthen Levee	Animal Control	LS	M	Repair the levee slope damaged by livestock and prevent large animal access.	37.917475 ° -121.322808 °	37.917475 ° -121.322808 °	917

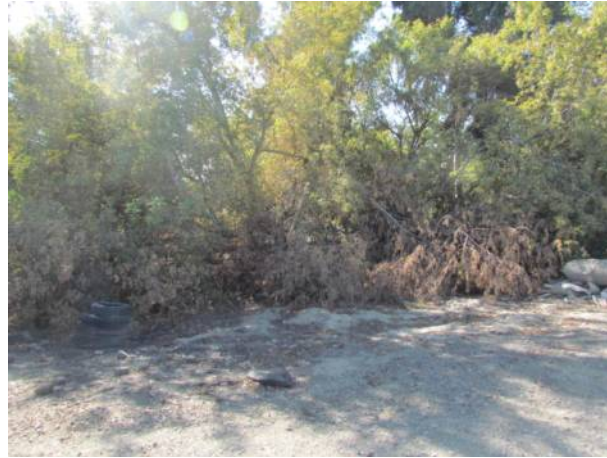
Levee Mile Report Line	85
Start Levee Mile	3.68
End Levee Mile	3.68
Location	Water Side
Category	Earthen Levee
Item	Slope Stability

85	3.68	3.68	Earthen Levee	Slope Stability	WS	M	Repair the levee slope damaged by foot traffic and prevent access where possible. Inspector Comments: Landowner cut steps into waterside slope.	37.904113 ° -121.325080 °	37.904113 ° -121.325080 °	58 Y
86	3.80	3.80	Earthen Levee	Trim / Thin Trees	LS	M	Trim trees to at least five feet above ground level.	37.902645 ° -121.326340 °	37.902645 ° -121.326340 °	927
87	3.82	3.82	Earthen Levee	Trim / Thin Trees	LS	W	Trim trees to at least five feet above ground level.	37.902417 ° -121.326482 °	37.902417 ° -121.326482 °	59
88	3.82	3.82	Earthen Levee	Encroachments	CR	M	Equipment Inspector Comments: Landowner installed temporary piping system without permit.	37.902365 ° -121.326453 °	37.902365 ° -121.326453 °	266 Y
89	3.84	3.85	Earthen Levee	Trim / Thin Trees	LS	W	Trim trees to at least five feet above ground level.	37.902155 ° -121.326523 °	37.902002 ° -121.326550 °	928

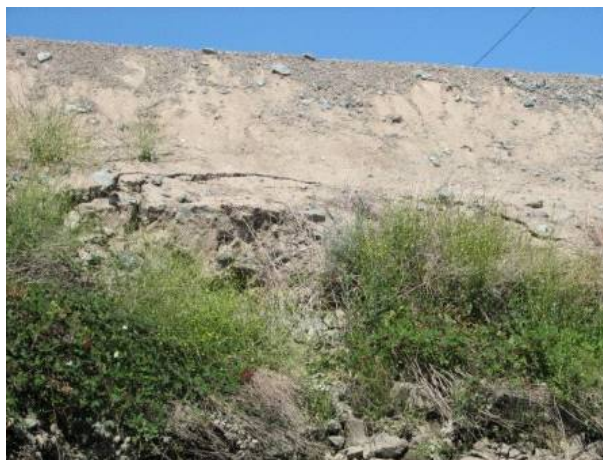
101	4.71	4.71	Supplemental	DWR Erosion Survey	WS	U	Inspector Comments: 08/23/2011: Cracking erosion along the levee bank. Erosion appears to be caused by river flows. [2011 Site ID:RD0524U01RM45.27]	37.889809 ° -121.329342 °	37.889809 ° -121.329342 °	47 Y
102	4.74	4.74	Earthen Levee	Trim / Thin Trees	LS	M	Trim trees to at least five feet above ground level.	37.890108 ° -121.329523 °	37.890108 ° -121.329523 °	67
103	4.95	4.95	Earthen Levee	Trim / Thin Trees	LS	M	Trim trees to at least five feet above ground level. Inspector Comments: Down tree laying on landside toe.	37.887578 ° -121.331237 °	37.887578 ° -121.331237 °	95
104	4.98	4.98	Earthen Levee	Trim / Thin Trees	LS	M	Trim trees to at least five feet above ground level.	37.887277 ° -121.331609 °	37.887277 ° -121.331609 °	84
105	5.11	5.11	Earthen Levee	Trim / Thin Trees	LS	M	Trim trees to at least five feet above ground level.	37.885400 ° -121.332153 °	37.885400 ° -121.332153 °	68

Front view of the erosion. Note the notches caused by the cracking
