**Flood Control Project Maintenance
Levee Inspections**

Fall 2012 Levee Maintenance Deficiency Summary Report

Reclamation District No. 0524 Middle Roberts Island

Waterway			Bank	Unit Miles
Unit No. 01 San Joaquin River			Left	6.26
	Spring (March - May)	Summer (June - August)	(September - November) Fall	Winter (December - February)
Unit Maintenance Rating (Fall Only)			U	
Date of Inspection	05/08/2012 - 05/09/2012		10/09/2012 - 10/11/2012	
DWR Inspector	Richard Willoughby		Richard Willoughby	
Accompanied By	Mario Jaques RD 524		Mario Jaques RD 524

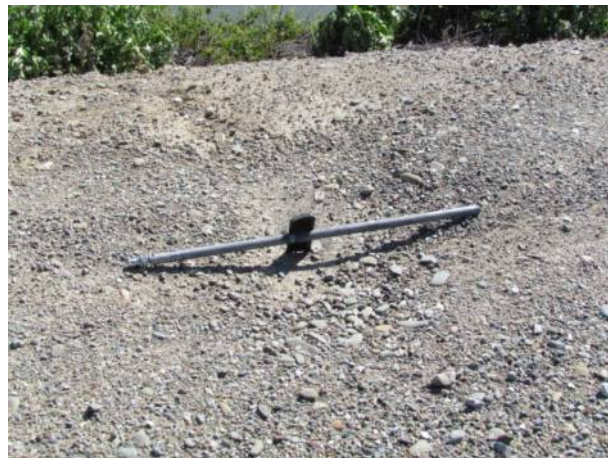
Levee Mile Report Line	4
Start Levee Mile	0.22
End Levee Mile	0.22
Location	Crown
Category	Earthen Levee
Item	Crown Surface / Depressions / Rutting
Looking east at 3" depression on levee crown. (Spring 2012)	
richard_f_20121008_063.jpg

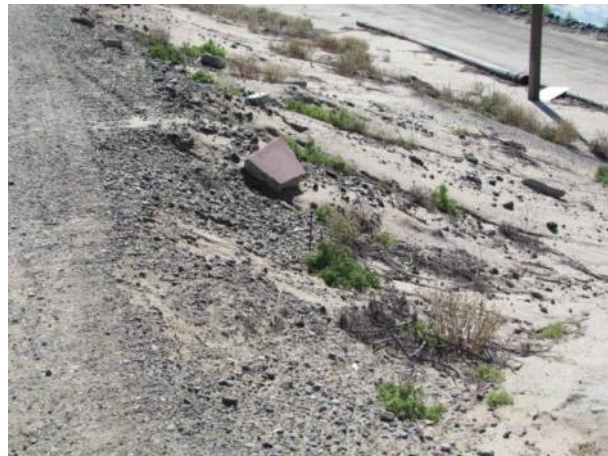
Levee Mile Report Line	7
Start Levee Mile	0.41
End Levee Mile	0.73
Location	Land Side
Category	Earthen Levee
Item	Erosion / Bank Caving

DWR ID:									
7	0.41	0.73	Earthen Levee	Erosion / Bank Caving	LS U Ma	Inspector Comments: Landside erosion caused by run-off.	37.938625 ° -121.340388 °	37.937170 ° -121.335260 °	20 Y
DWR ID: DWR_RD0524_01_s_2012_20									
8	0.53	0.60	Supplemental	DWR Erosion Survey	WS C Ma	Inspector Comments: 08/07/2012: The site has been visited by boat survey. The site seems to have been repaired. 08/23/2011: No significant changes observed on site. 09/07/2010: No significant changes observed on site. Some emergent vegetation at the lower and middle slope. Existing revetment is no longer adequately protecting the oversteepened slope. Some of the broken concrete used as revetment has slid, dragging levee materials away from the slope and creating notches. 09/29/2009: Erosion site extends from RM 41.11 to 41.18; existing revetment is no longer adequately protecting the oversteepened slope. 2008: Existing concrete slabs were placed as temporary fix; some of the slabs have started to slide, dragging levee materials away from the slope and creating notches; note that a sewage treatment plant is located on the landside of the levee. [2012 Site ID:RD0524U01RM41.15]	37.938895 ° -121.337602 °	37.938895 ° -121.337602 °	2

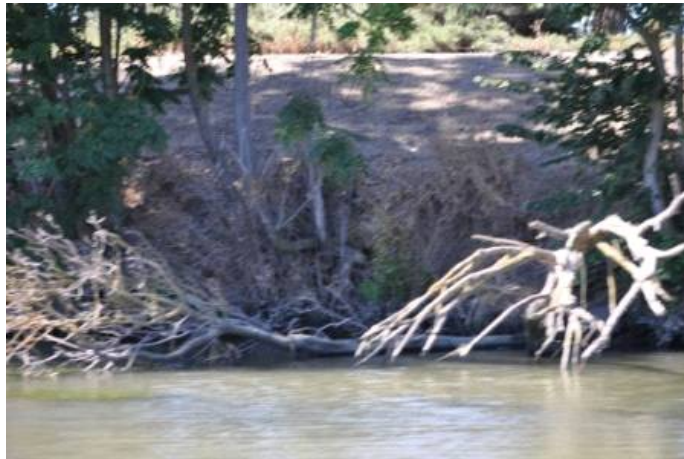
Levee Mile Report Line	33
Start Levee Mile	1.58
End Levee Mile	1.64
Location	Water Side
Category	Supplemental
Item	DWR Erosion Survey
Front view of the site where undermining has occurred.	
SJR2012_RD0524U01RM42.2_1.jpg

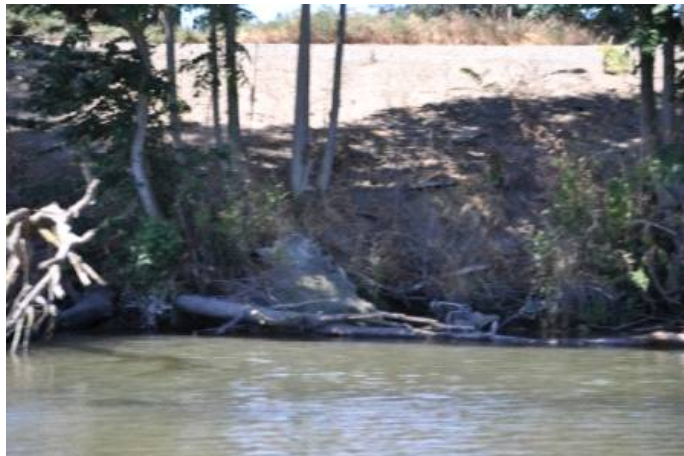
Levee Mile Report Line	33
Start Levee Mile	1.58
End Levee Mile	1.64
Location	Water Side
Category	Supplemental
Item	DWR Erosion Survey
Large trees along the levee toe. There is minimal slope protection. The erosion near tree visible.	
SJR2012_RD0524U01RM42.2_2.jpg
